Expertise

Protocol number: 47187035  
Order No. / Reference: 26755118  
Inspection date: 21 Aug 2026

| Manufacturer: Ford | Model: Focus Turnier 1.5 EcoBlue Start-Stopp-System Aut. ST-LINE X |

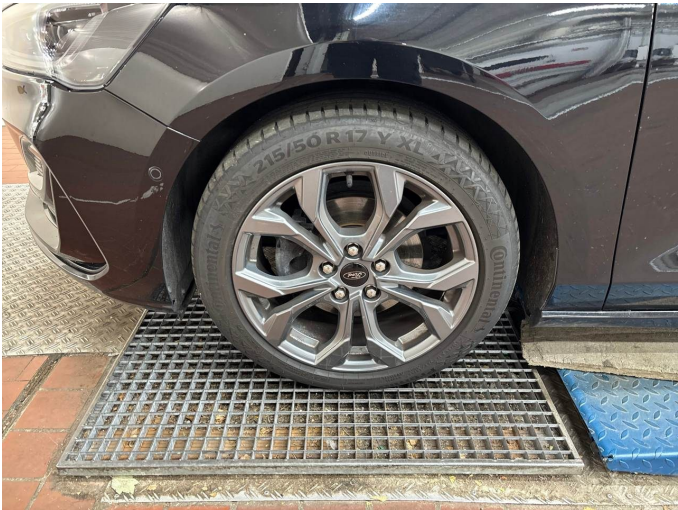
Figure 12: Mounted tyres

| # | Tyre size | Type of tyre | Manufacturer | Tread depth |
|---|---|---|---|---|
| 1) | 215/50 R17 95Y | Summer tyres on Light alloy | Continental | 5mm / 5mm |
| 2) | 215/50 R17 95Y | Summer tyres on Light alloy | Continental | 6mm / 6mm |

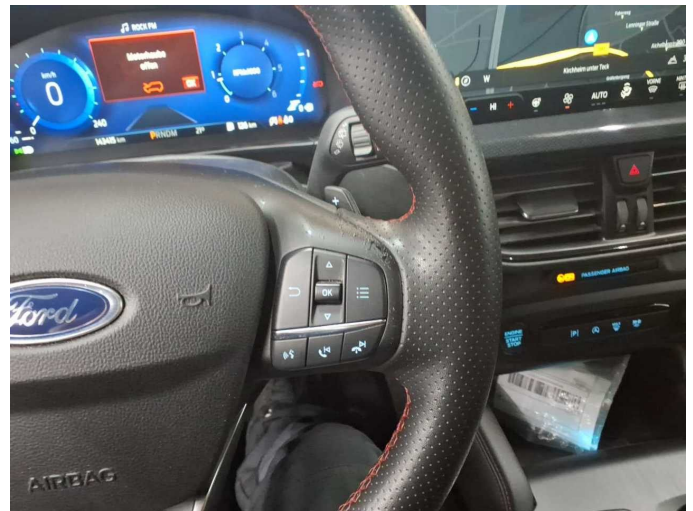
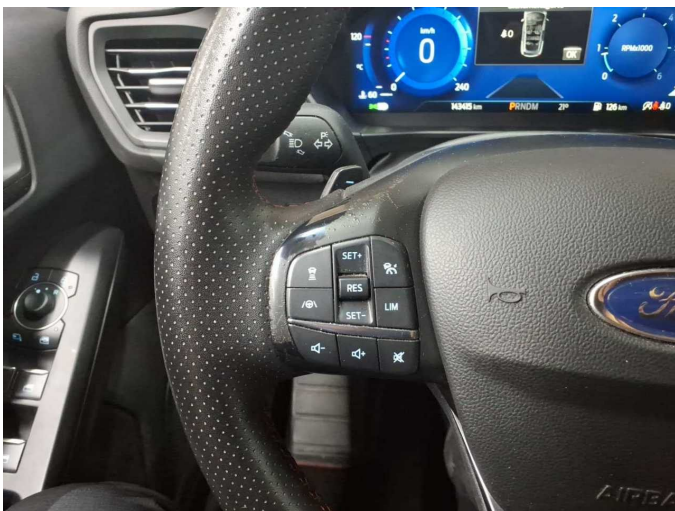
| No. | Component group | Description |
|---|---|---|
| 2 | Steering system | Steering wheel - Abrasion - Loss in value |

**Damage 2:** Steering system: Steering wheel - Abrasion - Loss in value

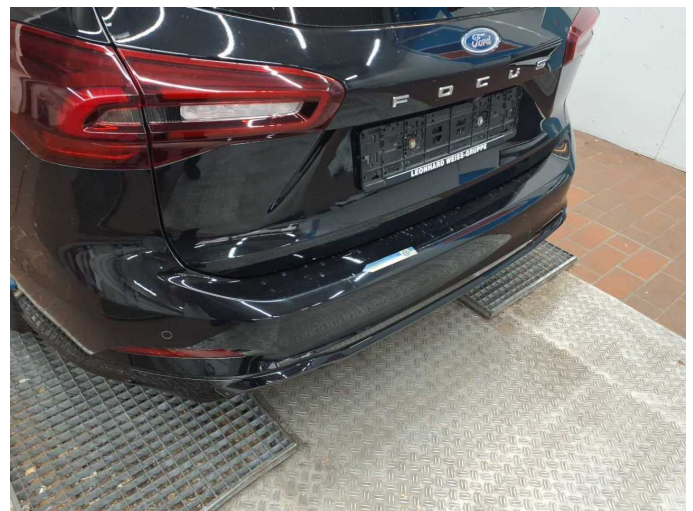
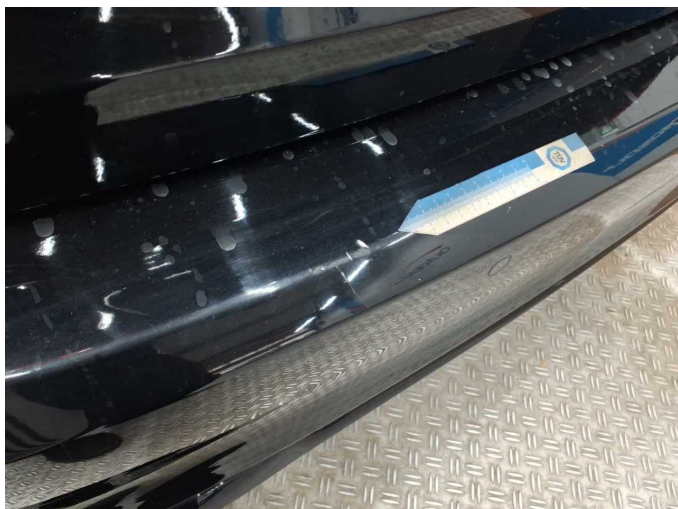
| No. | Component group | Description |
|---|---|---|
| 3 | Rear bumper | Rear bumper - Scratch(es) - Smart repair |

**Damage 3:** Rear bumper: Rear bumper - Scratch(es) - Smart repair

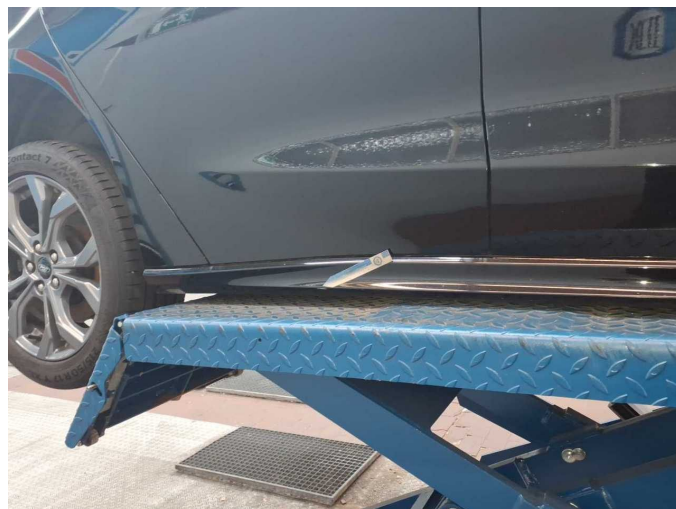
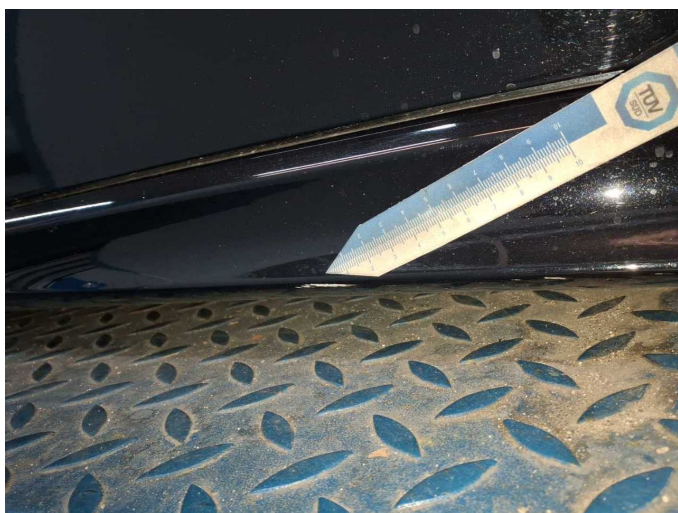
| No. | Component group | Description |
|---|---|---|
| 4 | Sill - right side | Trim - Scratch(es) - Smart repair |

**Damage 4:** Sill - right side: Trim - Scratch(es) - Smart repair

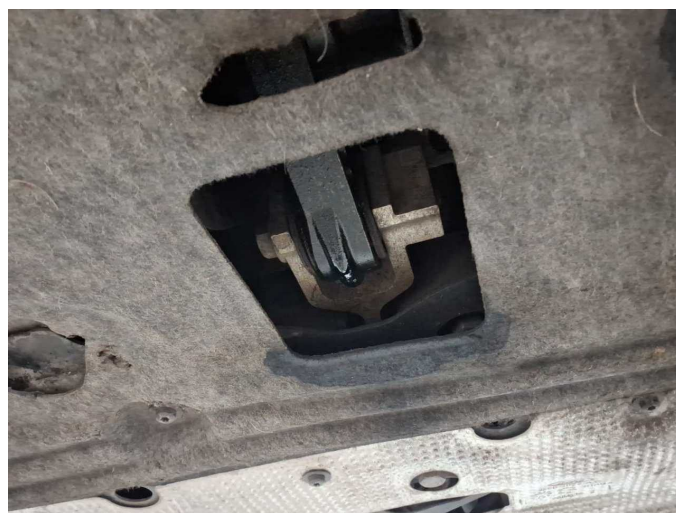
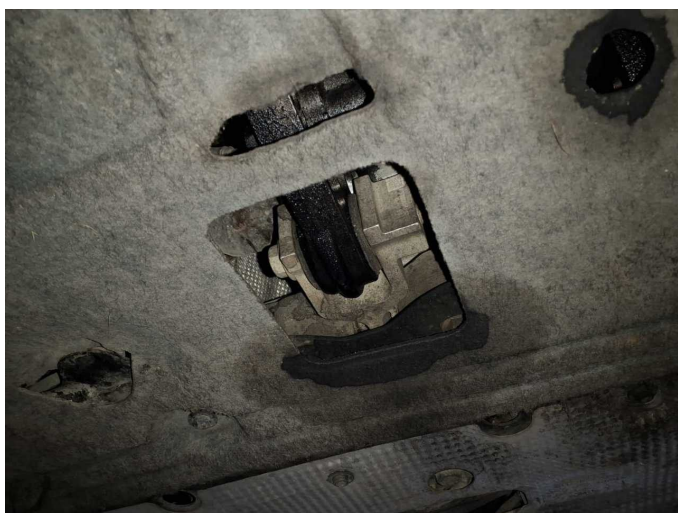
| No. | Component group | Description |
|---|---|---|
| 5 | Engine | Engine - Leaking - Perform diagnosis |

**Damage 5:** Engine: Engine - Leaking - Perform diagnosis

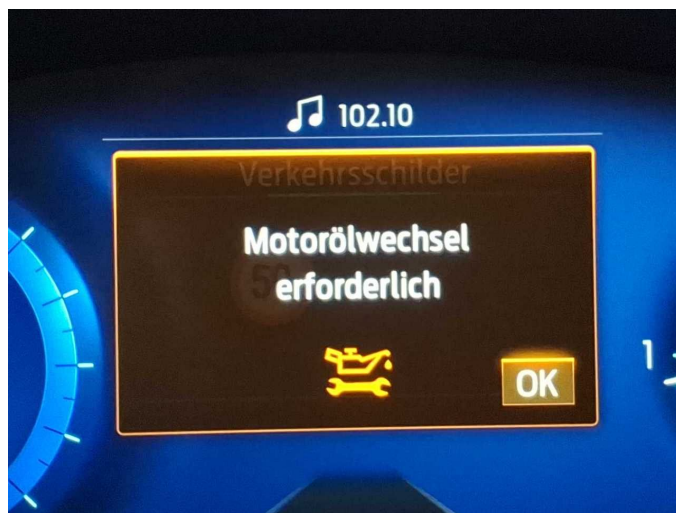
| No. | Component group | Description |
|---|---|---|
| 6 | Misc. | Inspection / maintenance - Due - Perform |

**Damage 6:** Misc.: Inspection / maintenance - Due - Perform

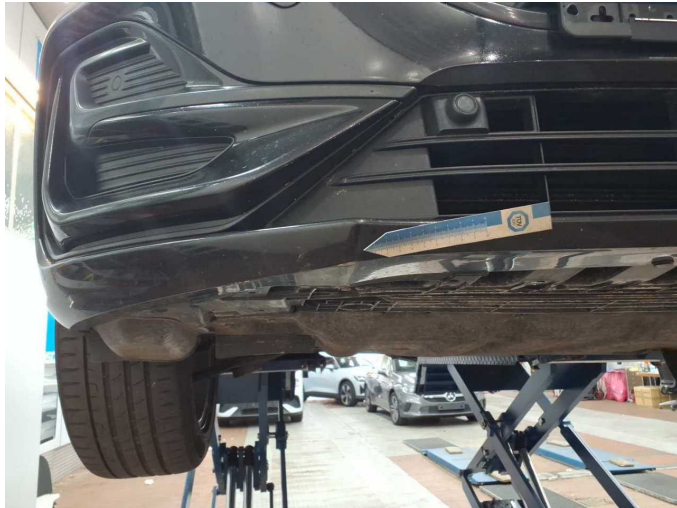
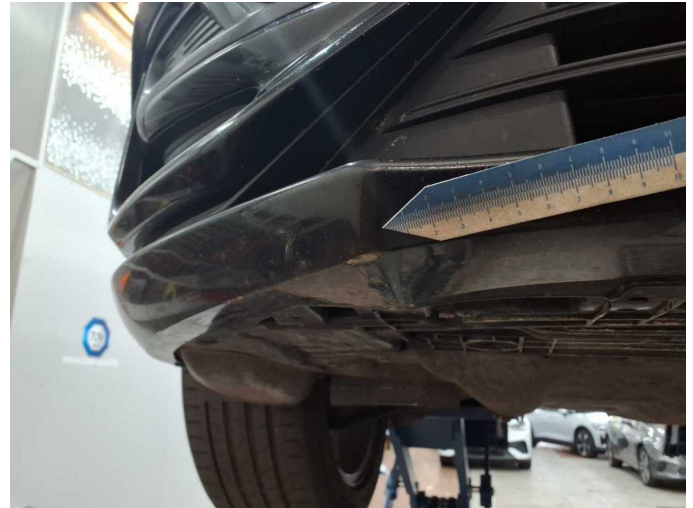
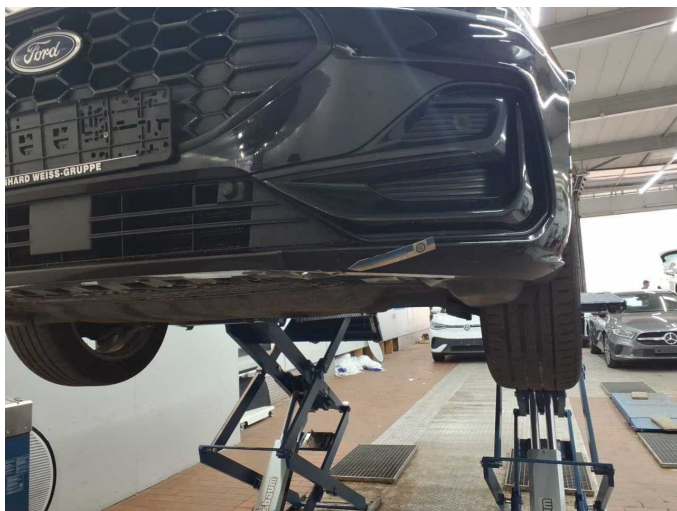
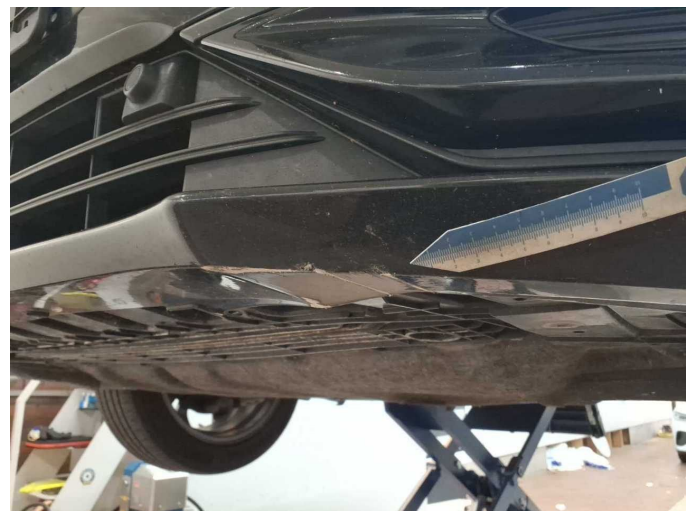
| No. | Component group | Description |
|---|---|---|
| 7 | Front bumper | Front bumper - Scratch(es) - Paint |

**Damage 7:** Front bumper: Front bumper - Scratch(es) - Paint
