Expertise

Protocol number: 47196477  
Order No. / Reference: 26653181-1  
Inspection date: 17 Aug 2026

Manufacturer: Opel

Model: Insignia Sports Tourer 2.0 Diesel Business

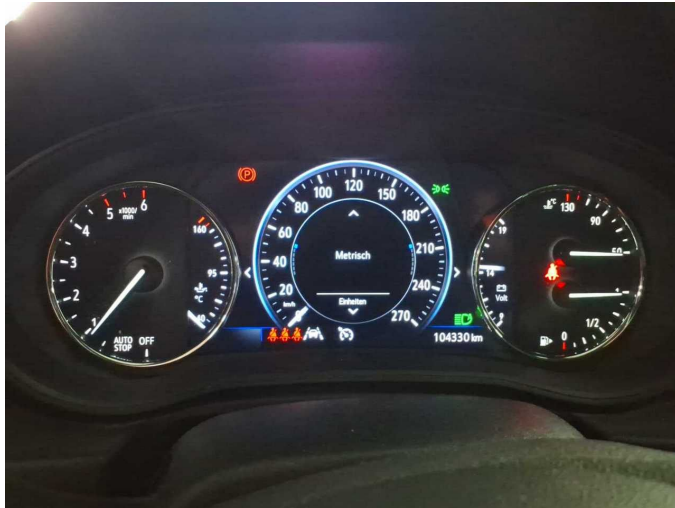
Figure 7: Instrument cluster

| Vehicle details | |
|---|---|
| Mileage (Read) | 104,330 km |

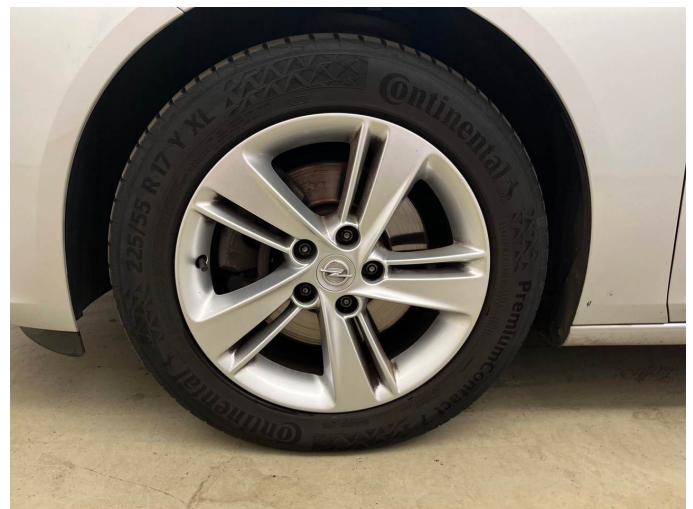
| # | Tyre size | Type of tyre | Manufacturer | Tread depth |
|---|---|---|---|---|
| 1) | 225/55 R17 101Y | Summer tyres on Light alloy | Continental | 4mm / 4mm |
| 2) | 225/55 R17 101Y | Summer tyres on Light alloy | Continental | 3mm / 3mm |

Figure 12: Mounted tyres

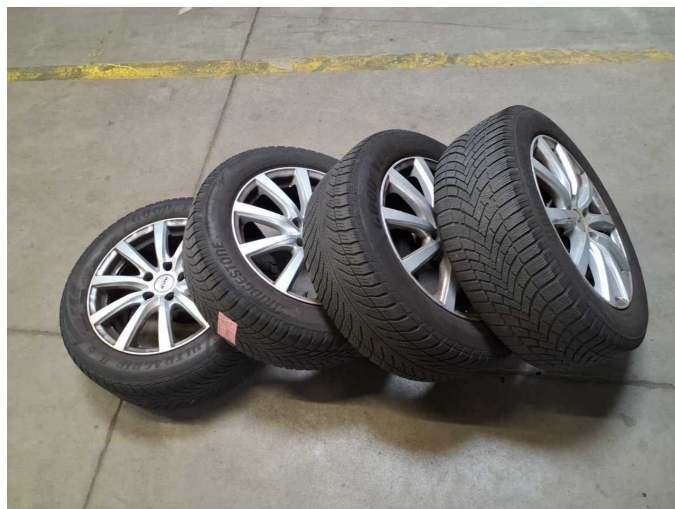
| # | Tyre size | Type of tyre | Manufacturer | Tread depth |
|---|---|---|---|---|
| 1) | 225/55 R17 97H | Winter tyres on Light alloy | Bridgestone | 4mm / 4mm |
| 2) | 225/55 R17 97H | Winter tyres on Light alloy | Bridgestone | 4mm / 4mm |

Figure 14: Additional tyres

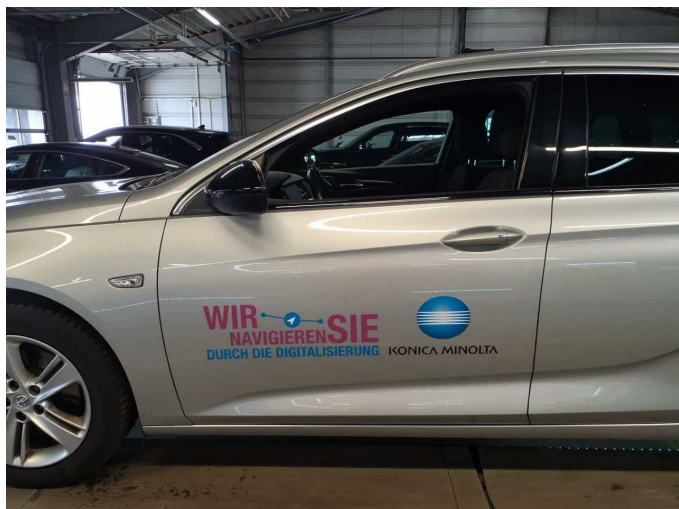
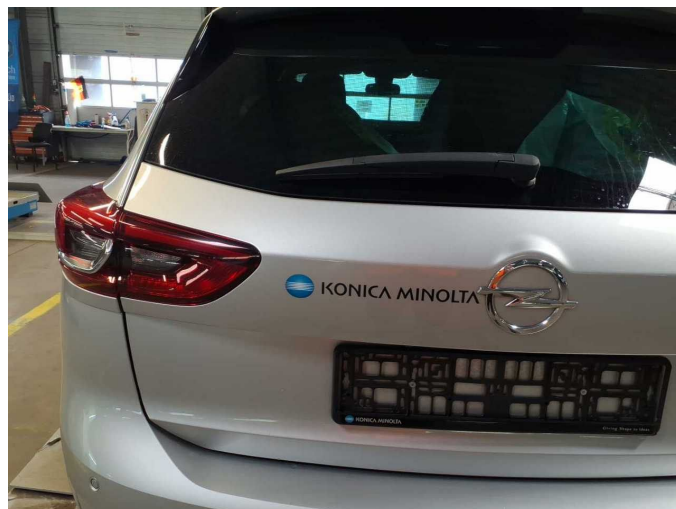
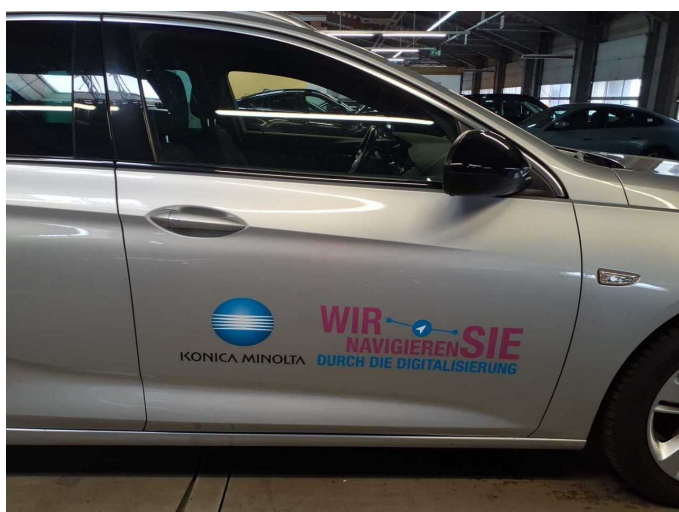
| No. | Component group | Description |
|---|---|---|
| 1 | Body | Body - Glued / labelled - De-glue / neutralise |

**Damage 1:** Body: Body - Glued / labelled - De-glue / neutralise

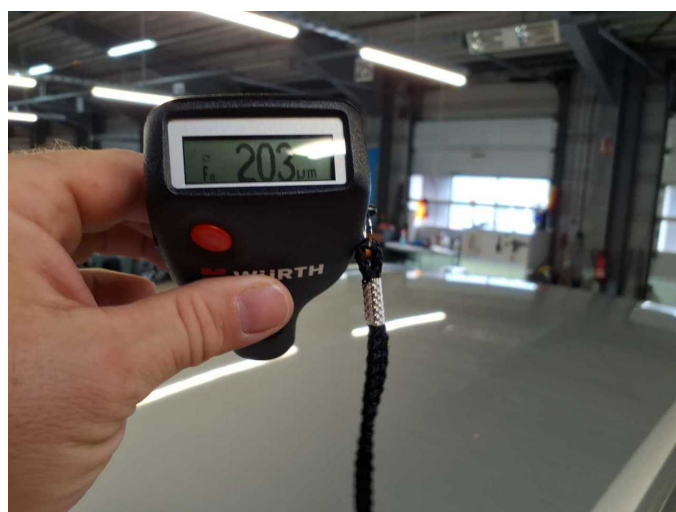
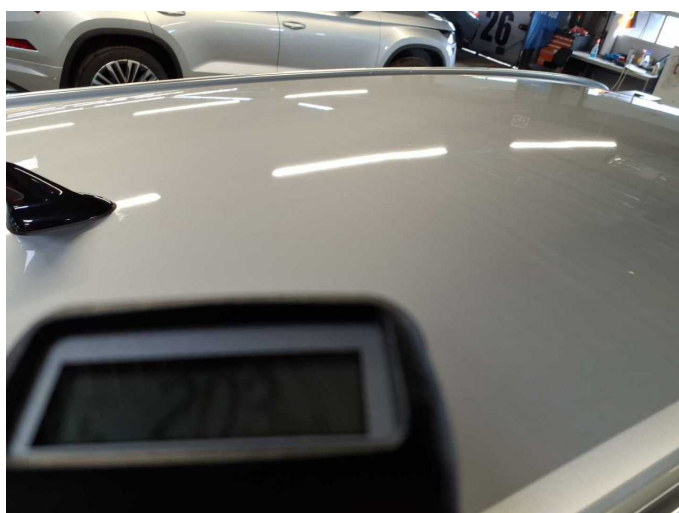
| 1 | Roof, Professionally carried out, Invoice of repair done Non-existent |

| Roof | 203 µm | Roof rail - right side | 207 µm |

**Repainting 1:** Roof

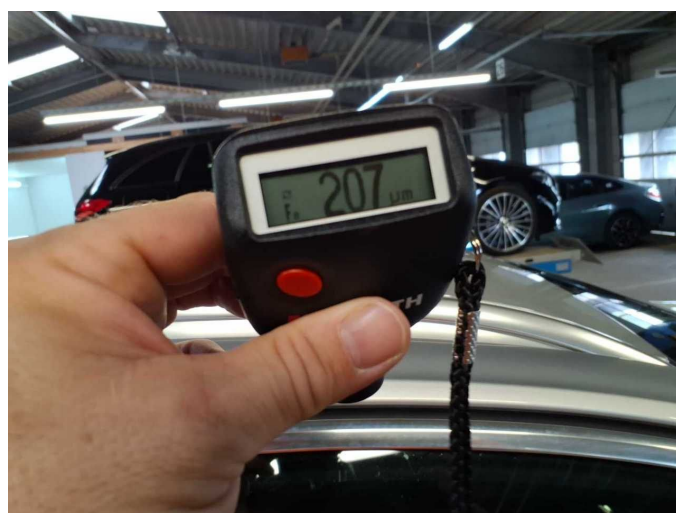
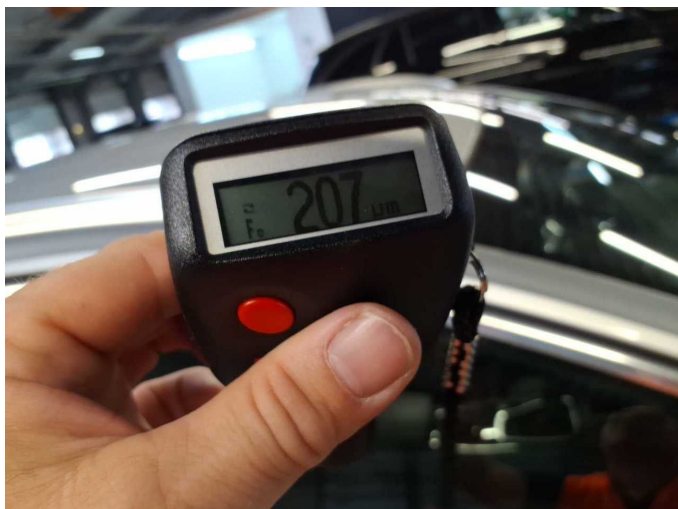
| 2 | Roof rail - right side, Professionally carried out, Invoice of repair done Non-existent |

**Repainting 2:** Roof rail - right side

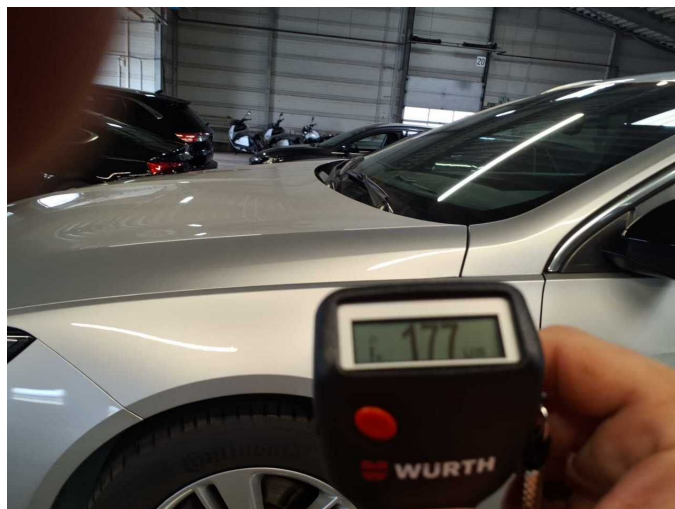
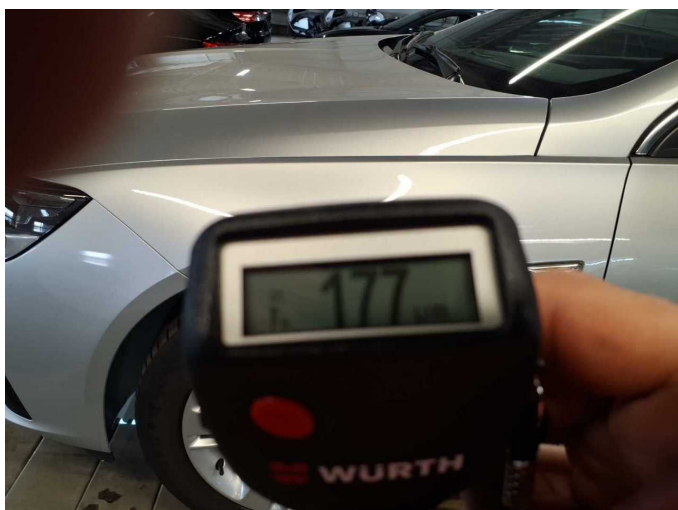
| 3 | Mudguard - left side, Professionally carried out, Invoice of repair done Non-existent |

| Mudguard - left side | 177 µm | Mudguard - right side | 184 µm |

**Repainting 3:** Mudguard - left side

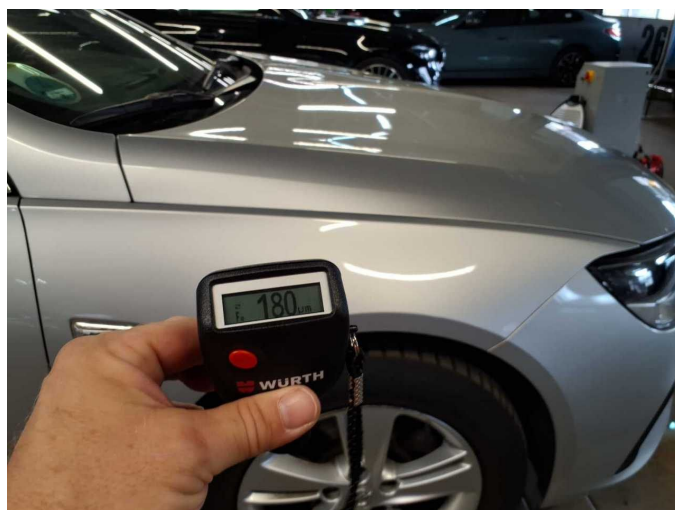
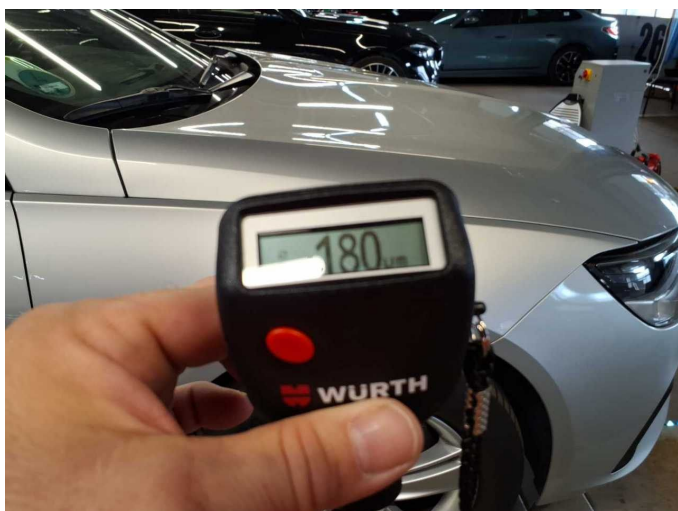
| 4 | Mudguard - right side, Professionally carried out, Invoice of repair done Non-existent |

**Repainting 4:** Mudguard - right side

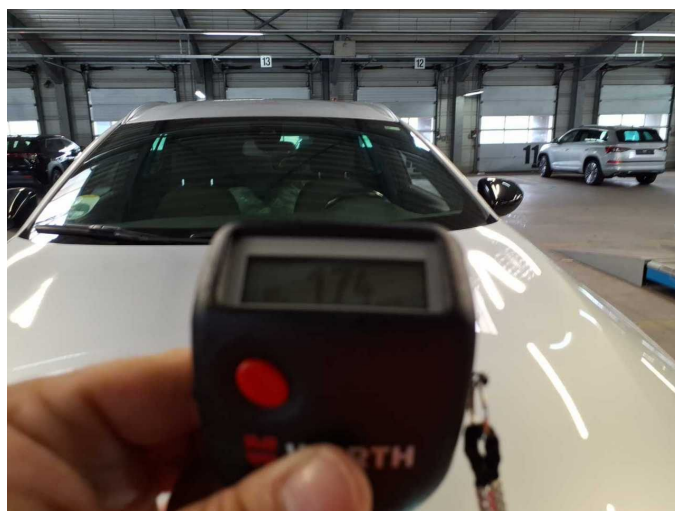
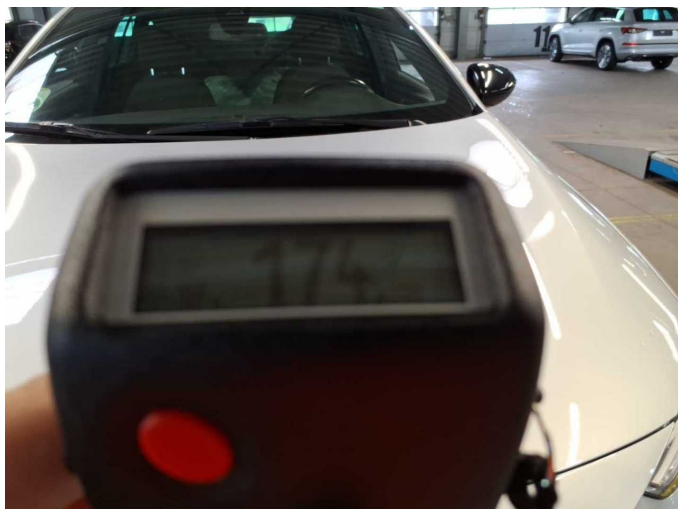
| 5 | Bonnet, Professionally carried out, Invoice of repair done Non-existent |

| Bonnet | 174 µm | Side panel - rear right side | 172 µm |

**Repainting 5:** Bonnet

**Repainting 5: Bonnet**

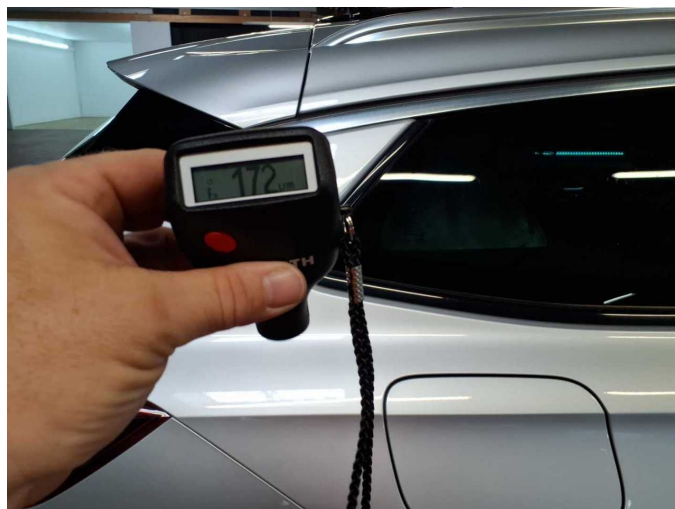
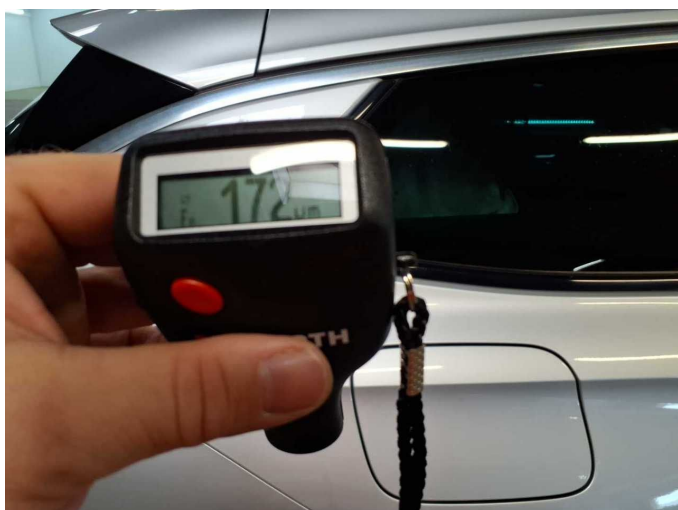
| 6 | Side panel - rear right side, Professionally carried out, Invoice of repair done Non-existent |

**Repainting 6: Side panel - rear right side**

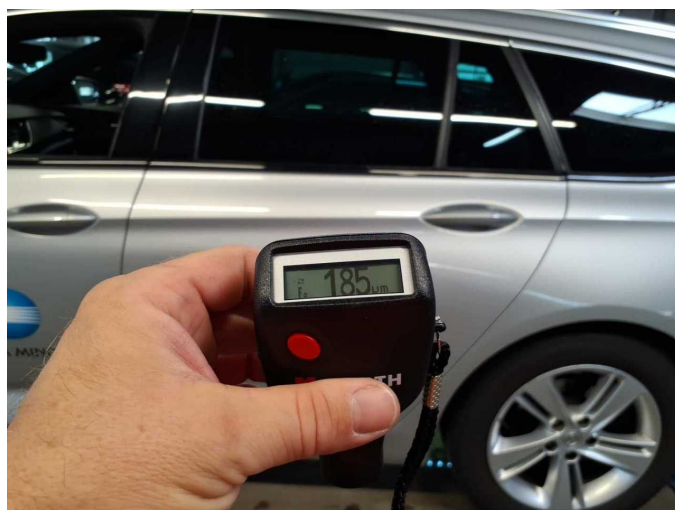
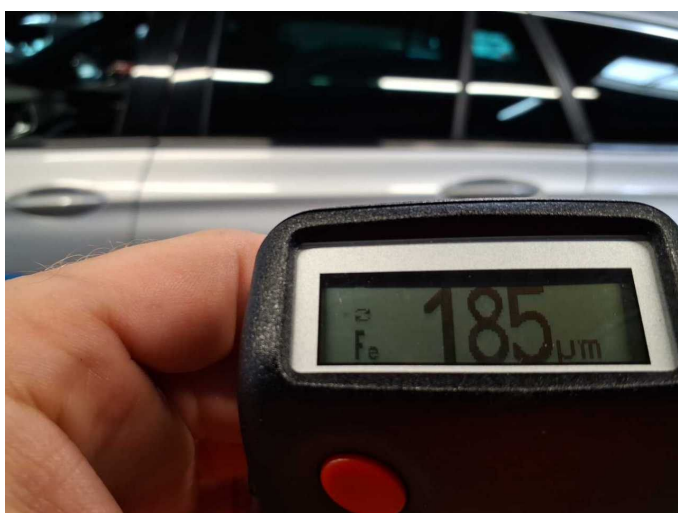
| 7 | Door - rear left side, Professionally carried out, Invoice of repair done Non-existent |

| Door - rear left side | 185 µm | Door - rear right side | 213 µm |

**Repainting 7: Door - rear left side**

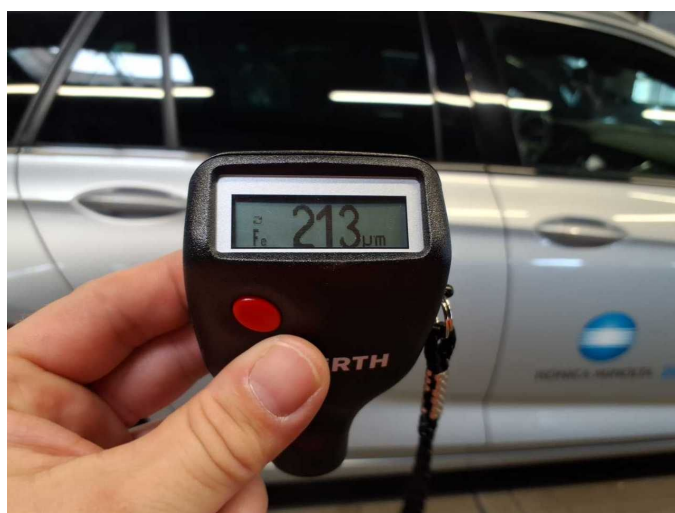
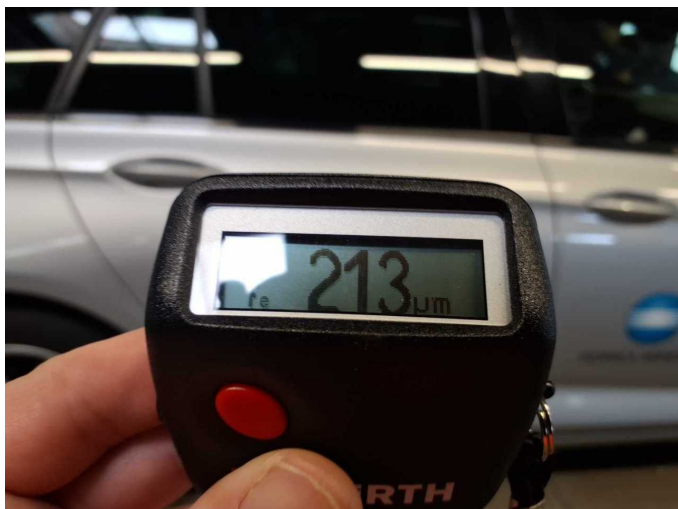
| 8 | Door - rear right side, Professionally carried out, Invoice of repair done Non-existent |

**Repainting 8: Door - rear right side**

**Repainting 8:** Door - rear right side

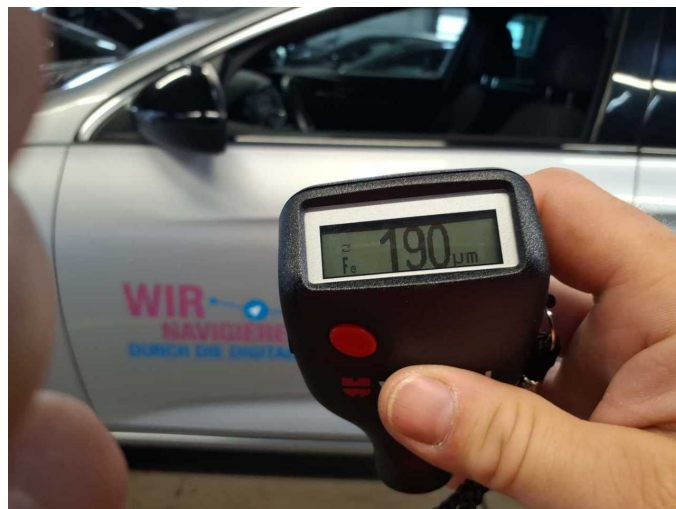
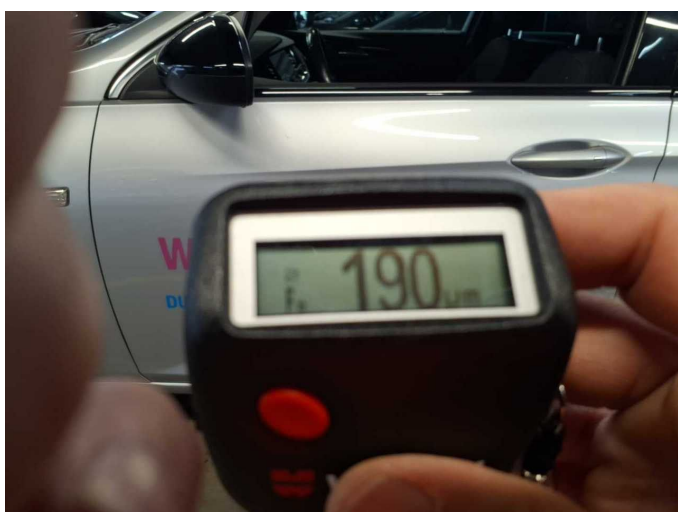
| 9 | Door - front left side |

| Door - front left side | 190 µm | Door - front right side | 191 µm |

**Repainting 9:** Door - front left side

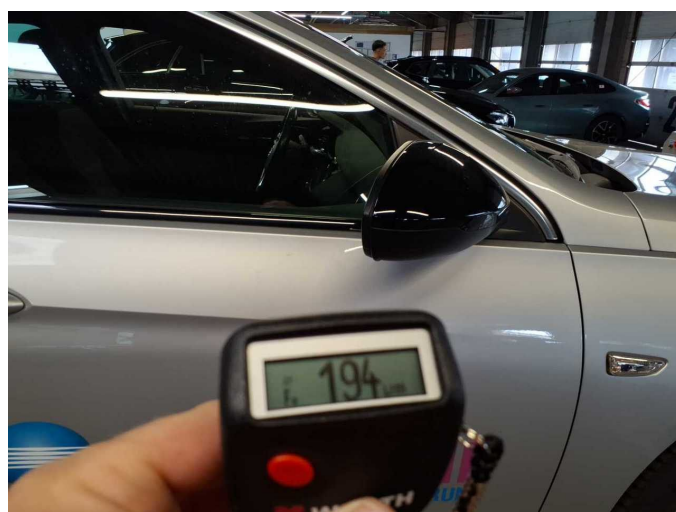
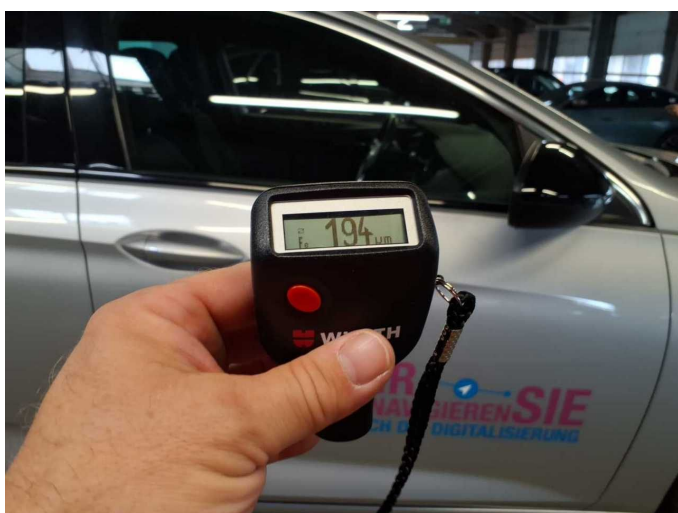
| 10 | Door - front right side, Professionally carried out, Invoice of repair done Non-existent |

**Repainting 10:** Door - front right side
