Expertise

Protocol number: 46419262  
Order No. / Reference: 26568318  
Inspection date: 9 Jul 2026

Manufacturer: Volkswagen

Model: Passat Variant 2.0 TDI SCR DSG Business

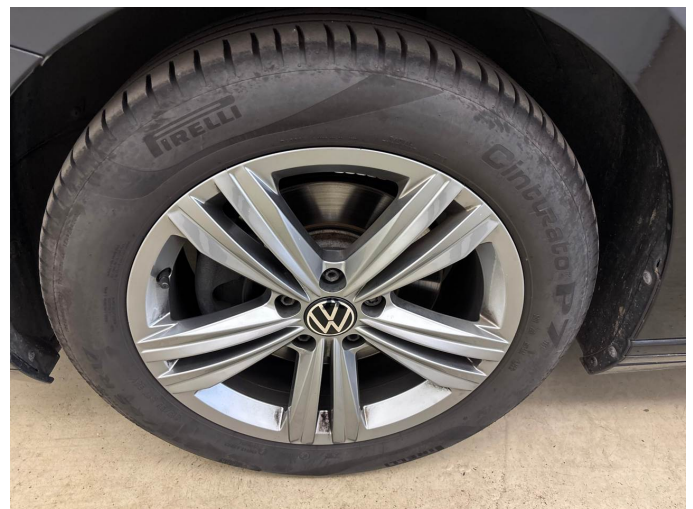
| # | Tyre size | Type of tyre | Manufacturer | Tread depth |
|---|---|---|---|---|
| 1) | 215/55 R17 94V | Summer tires (with run-flat tires) on Light alloy | Pirelli | 3mm / 3mm |
| 2) | 215/55 R17 94V | Summer tires (with run-flat tires) on Light alloy | Pirelli | 4mm / 4mm |

Figure 12: Mounted tyres

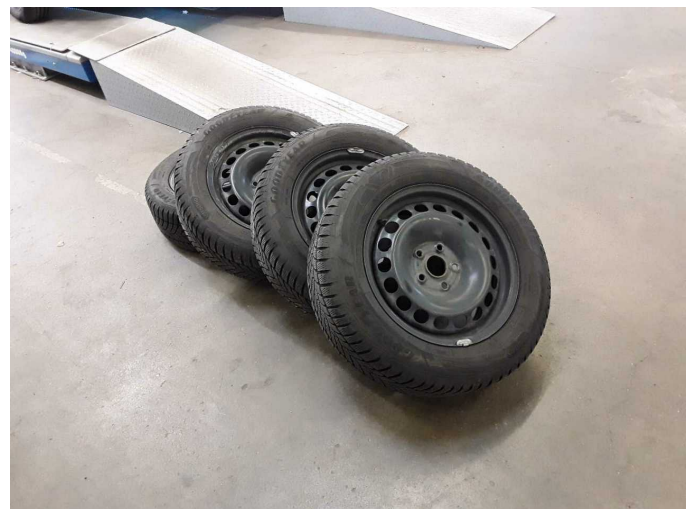
| # | Tyre size | Type of tyre | Manufacturer | Tread depth |
|---|---|---|---|---|
| 1) | 215/60 R16 99H | Winter tyres on Steel | Goodyear | 5mm / 5mm |
| 2) | 215/60 R16 99H | Winter tyres on Steel | Goodyear | 5mm / 5mm |

Figure 18: Additional tyres

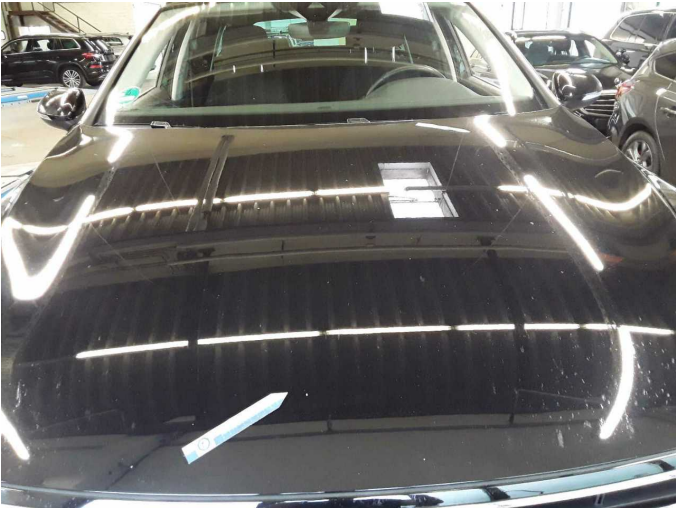
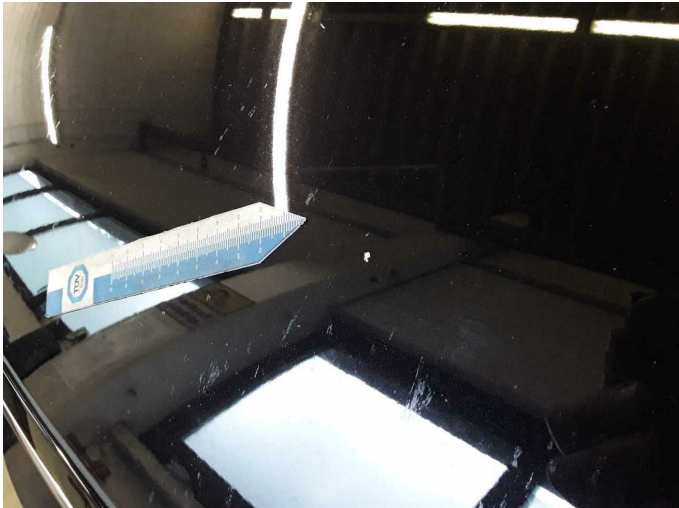
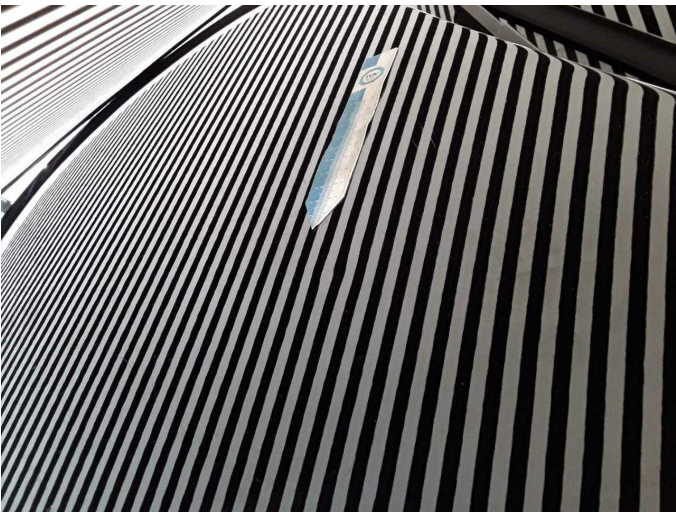
| No. | Component group | Description |
|---|---|---|
| 1 | Bonnet | Bonnet - Dent / paintcoat damage - Repair and paint |

Damage 1: Bonnet: Bonnet - Dent / paintcoat damage - Repair and paint

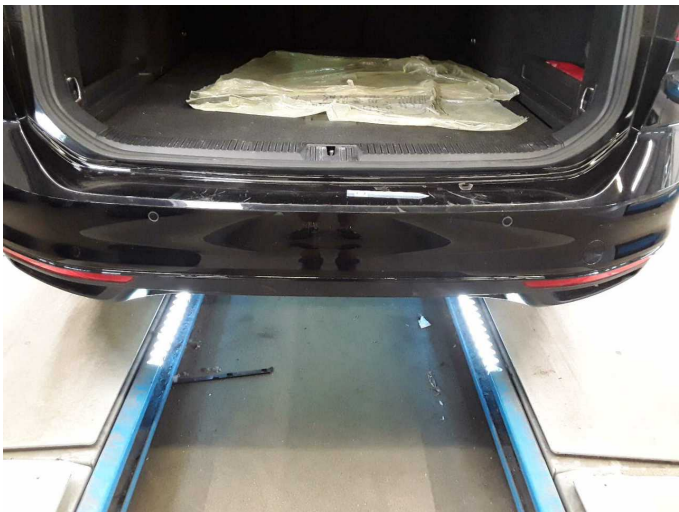
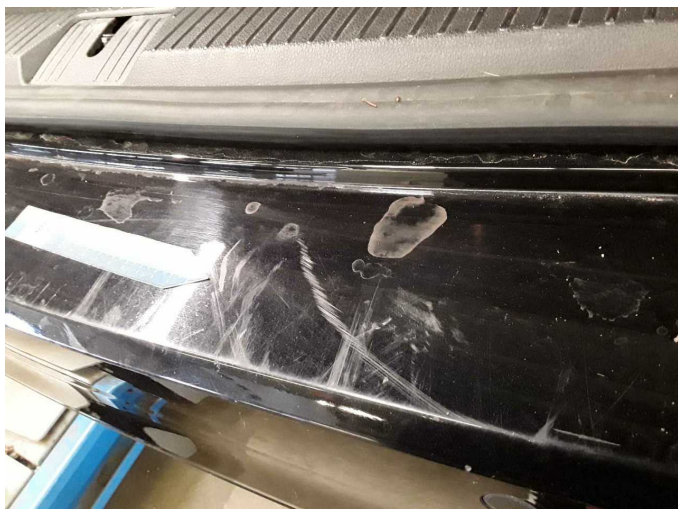
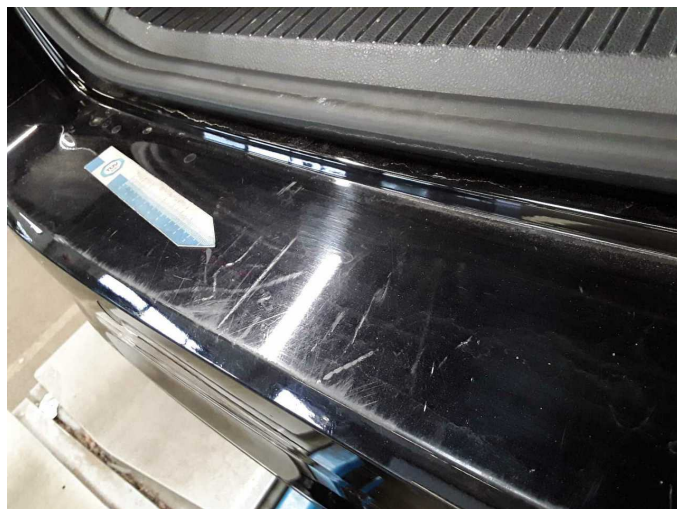
| No. | Component group | Description |
|---|---|---|
| 2 | Rear bumper | Rear bumper - Scratched - Paint |

Damage 2: Rear bumper: Rear bumper - Scratched - Paint

**Damage 2:** Rear bumper: Rear bumper - Scratched - Paint

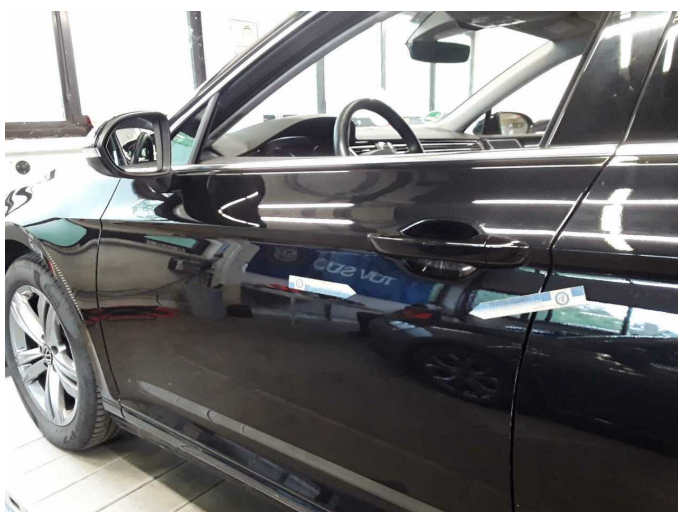
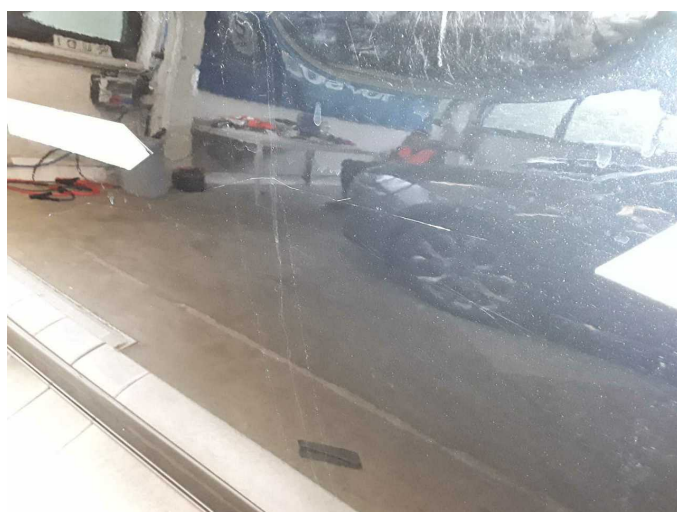
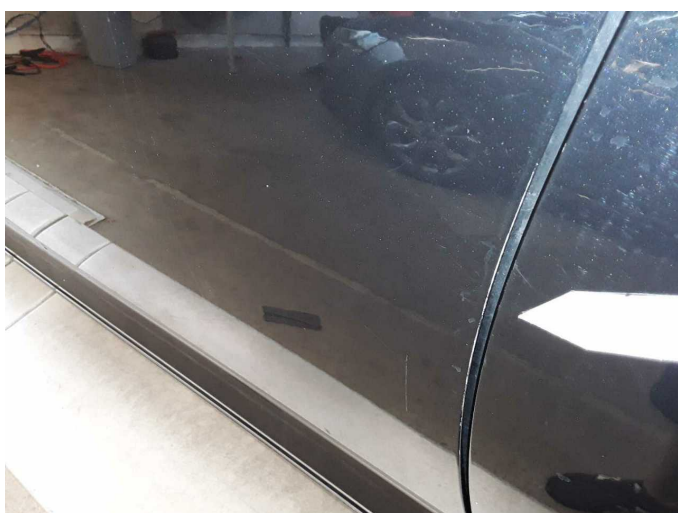
| No. | Component group | Description |
|---|---|---|
| 3 | Door - front left side | Door - Scratch(es) - Paint |

**Damage 3:** Door - front left side: Door - Scratch(es) - Paint

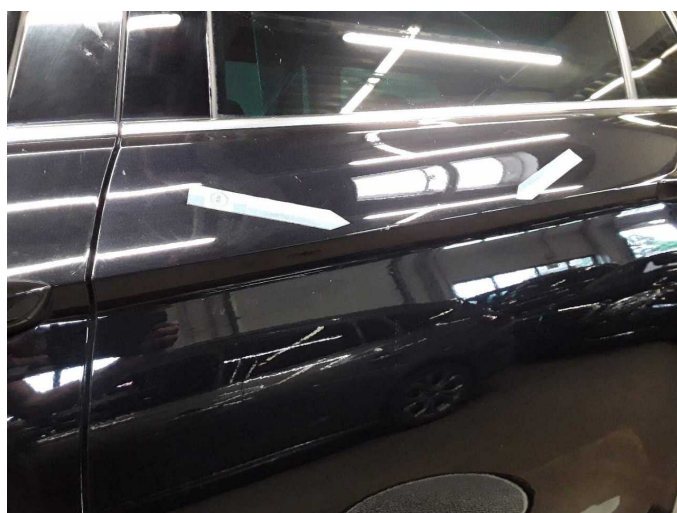
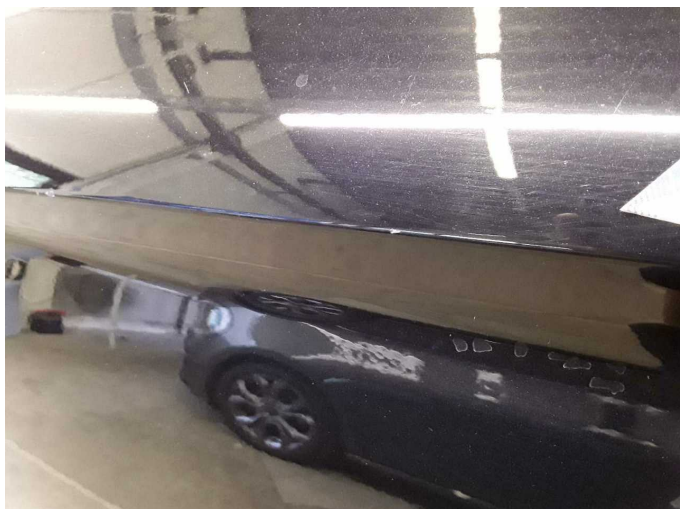
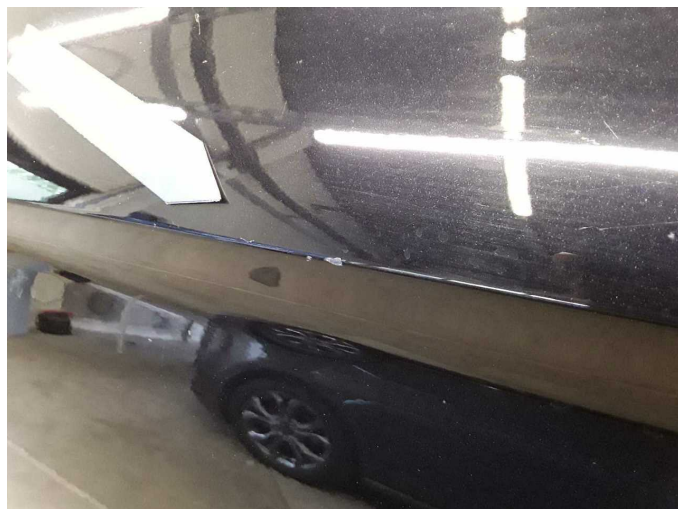
| No. | Component group | Description |
|---|---|---|
| 2 | Door - rear left side | Door - Scratch(es) - No deduction |

**Wear and tear 2:** Door - rear left side: Door - Scratch(es) - No deduction

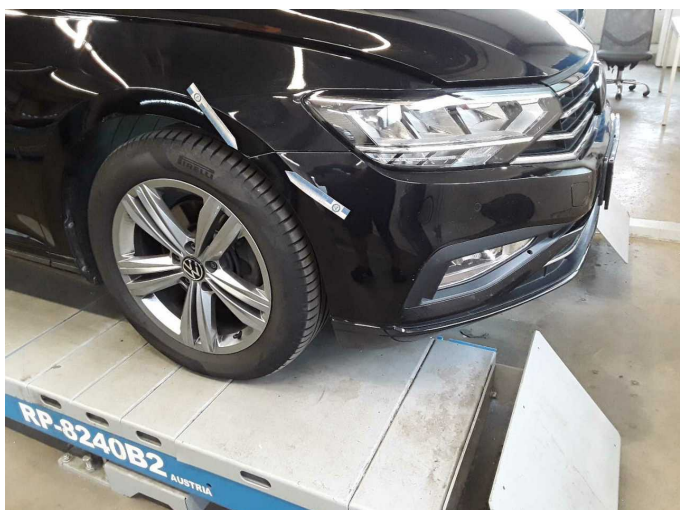
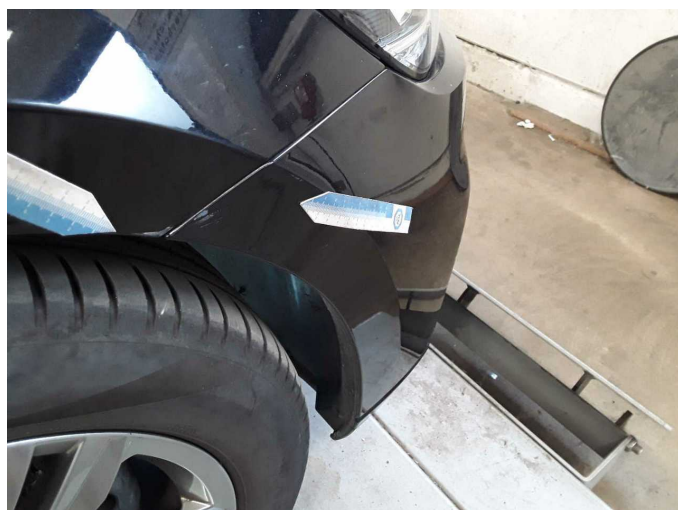
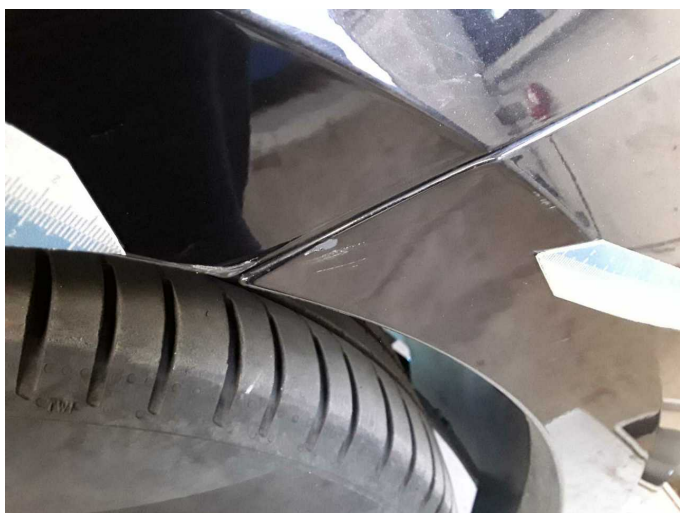
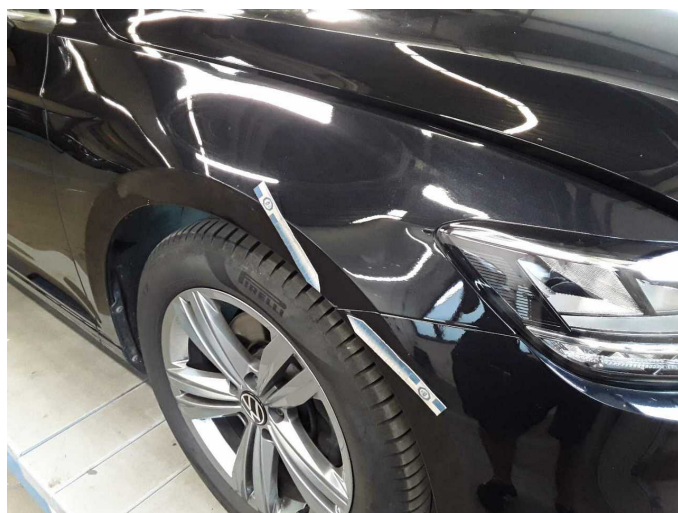
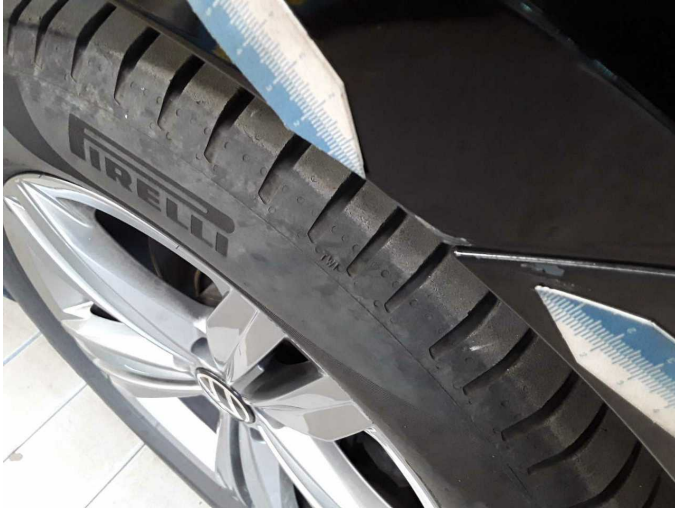
| No. | Accident |
|---|---|
| 1 | Side right |

**Accident 1:** Side right

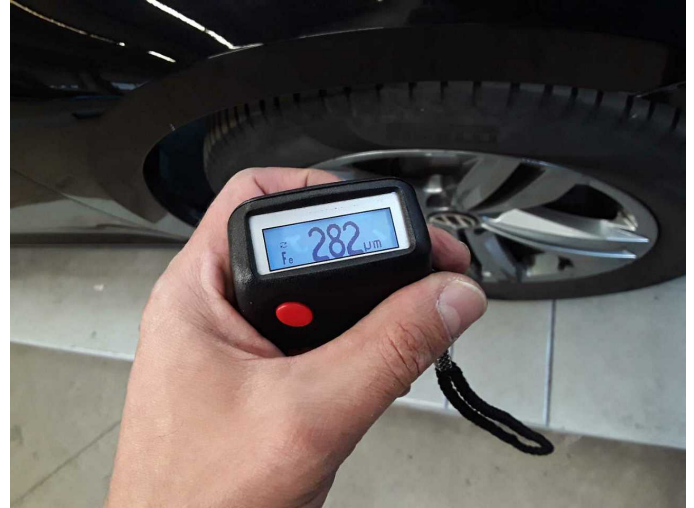
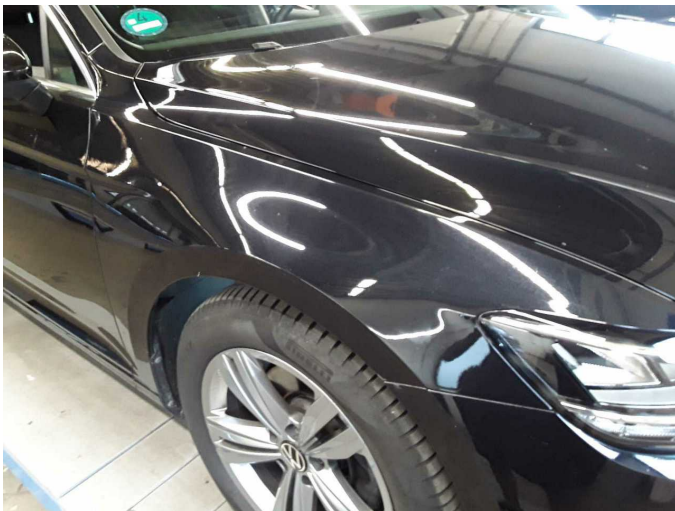
| No. | Repainting |
|---|---|
| 1 | Mudguard - right side, Professionally carried out, Invoice of repair done Non-existent |

| Mudguard - right side | 282 µm |

**Repainting 1:** Mudguard - right side
