Expertise

Protocol number: 46226527  
Order No. / Reference: 26472210  
Inspection date: 30 Jun 2026

| Manufacturer: Skoda | Model: Kodiahq 2.0 TSI 4x4 DSG RS |

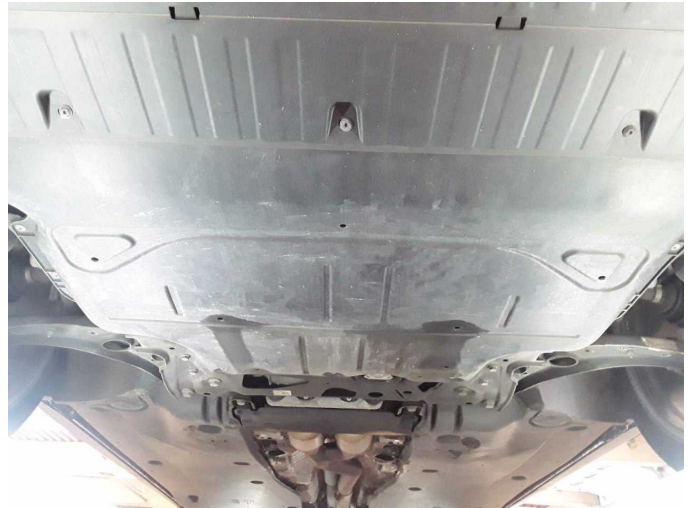
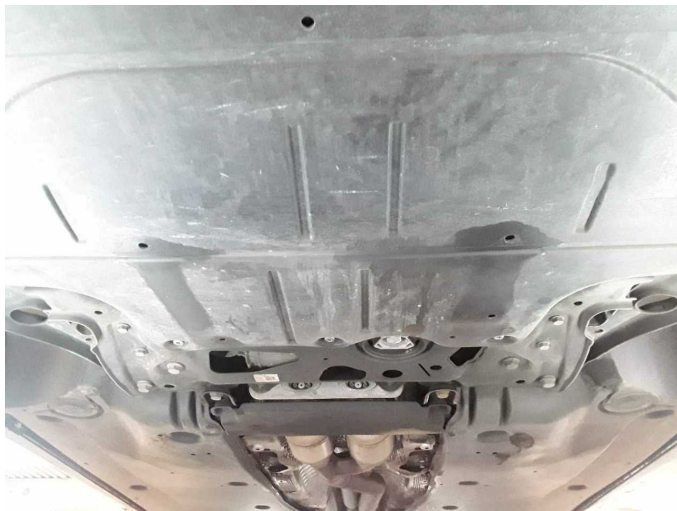
| No. | Component group | Description |
|---|---|---|
| 1 | Engine | Engine - Leaking - Diagnosed and repair if necessary |

**Damage 1:** Engine: Engine - Leaking - Diagnosed and repair if necessary

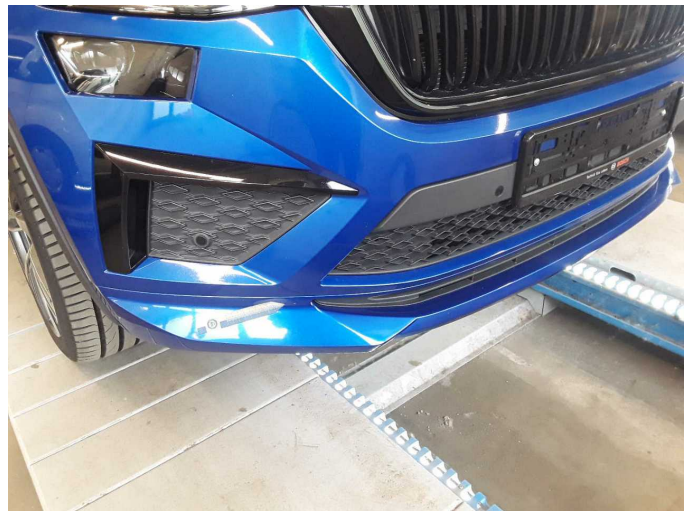
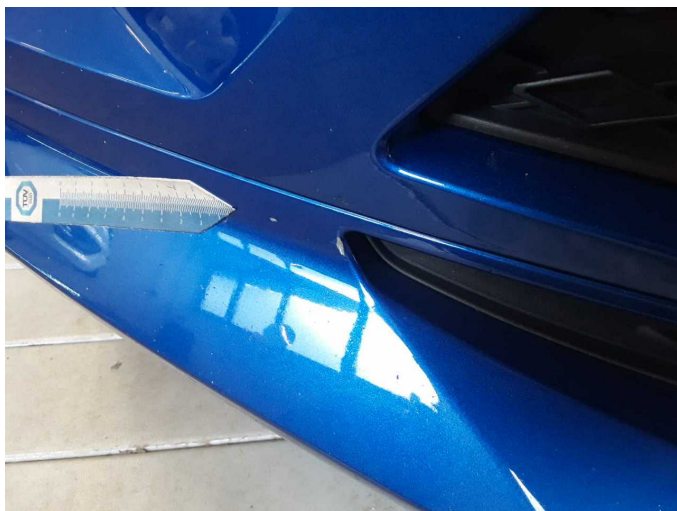
| No. | Component group | Description |
|---|---|---|
| 2 | Front bumper | Front bumper - Scratch(es) - Smart repair |

**Damage 2:** Front bumper: Front bumper - Scratch(es) - Smart repair

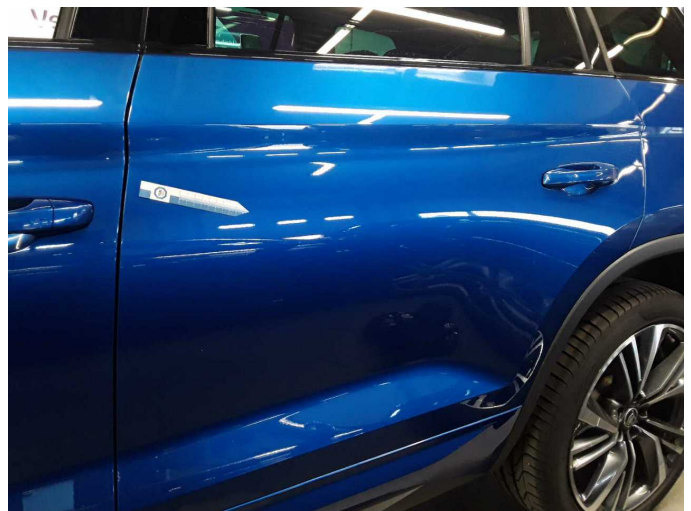
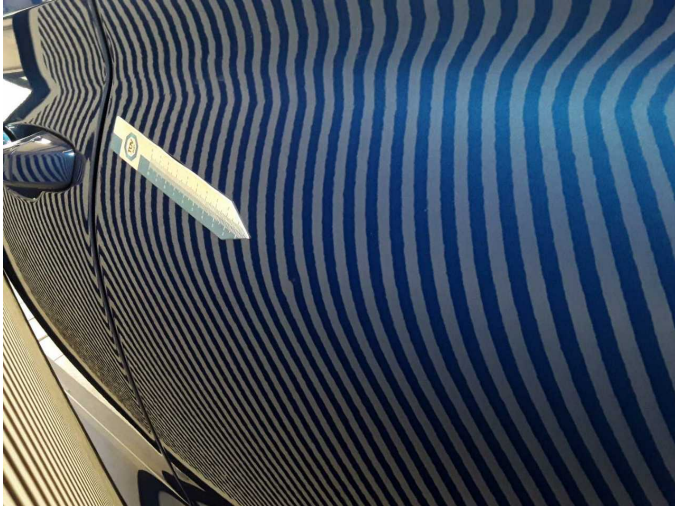
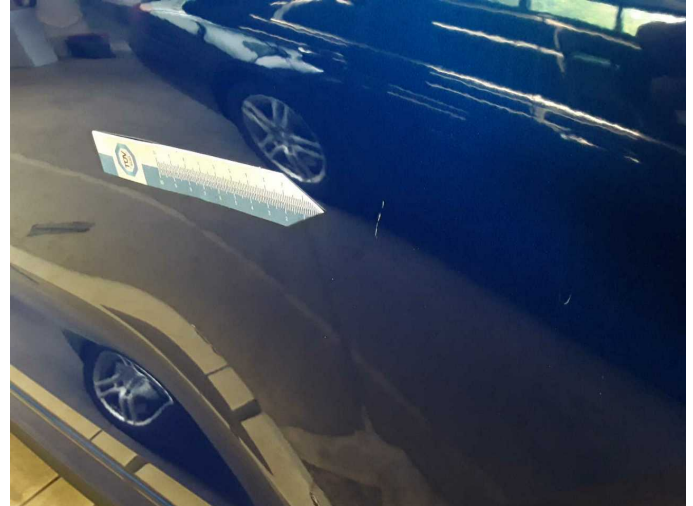
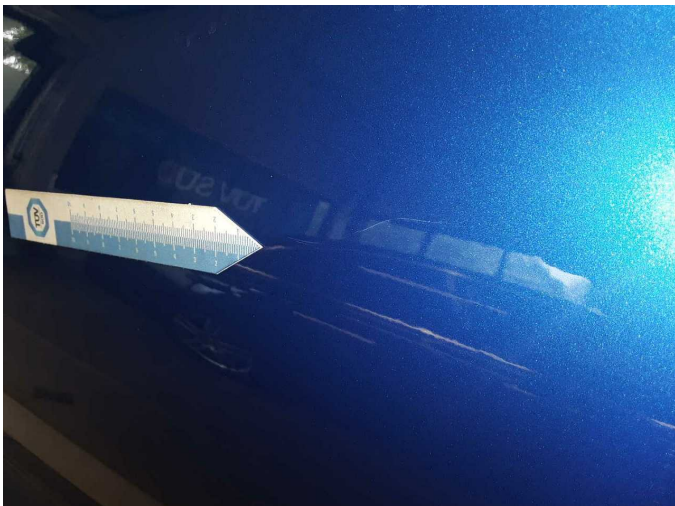
| No. | Component group | Description |
|---|---|---|
| 3 | Door - rear left side | Door - Dent / paintcoat damage - Smart repair |

**Damage 3:** Door - rear left side: Door - Dent / paintcoat damage - Smart repair

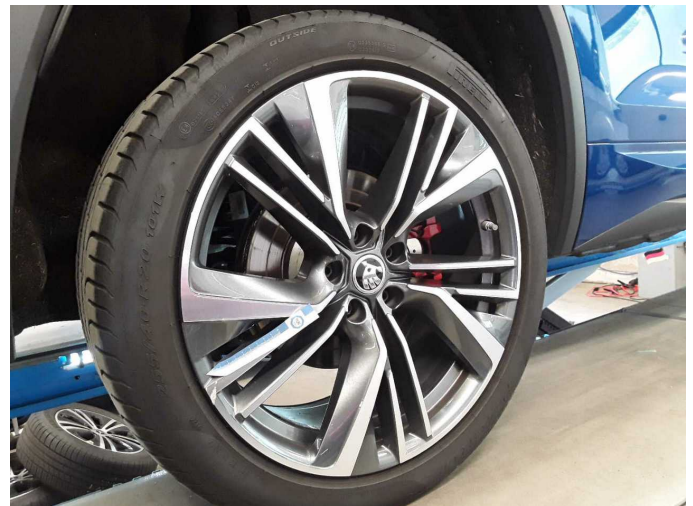
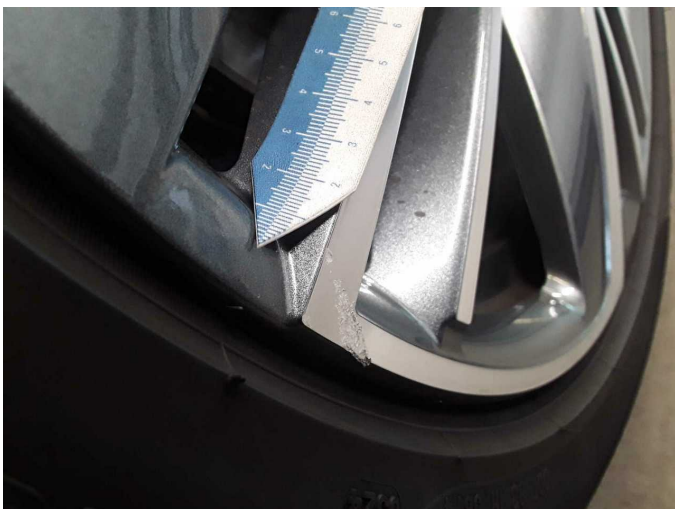
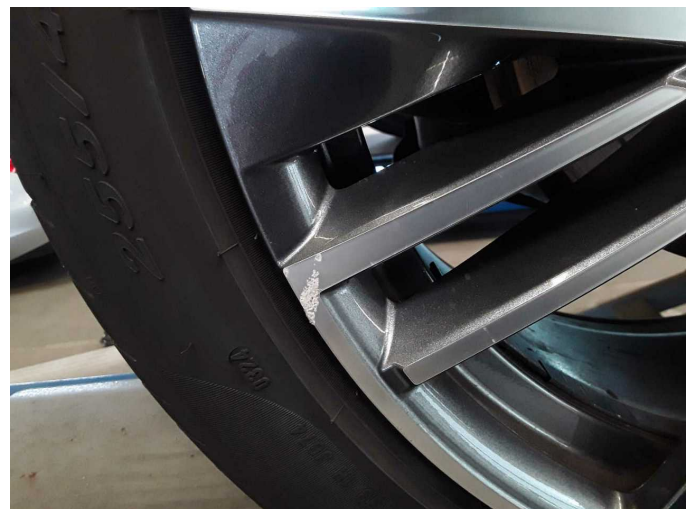
| No. | Component group | Description |
|---|---|---|
| 4 | Wheel / tyres | Alloy rim - rear right side - Scratched - Loss in value |

**Damage 4:** Wheel / tyres: Alloy rim - rear right side - Scratched - Loss in value

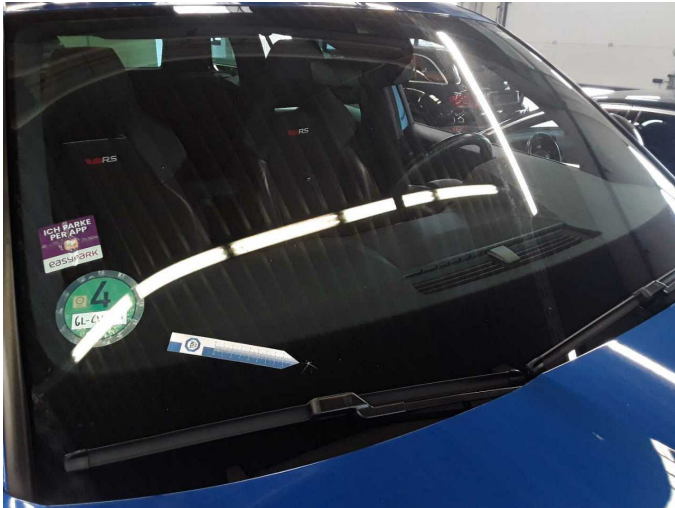
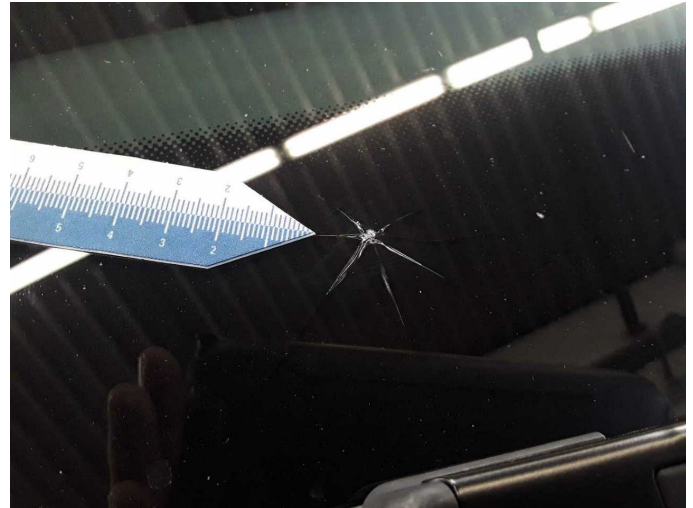
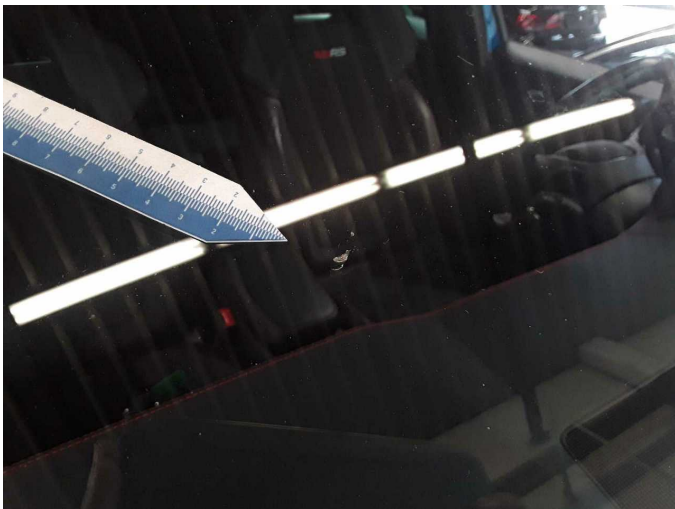
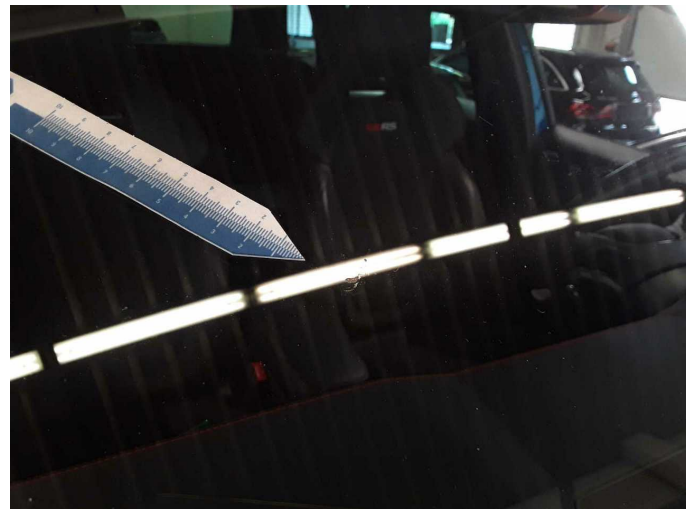
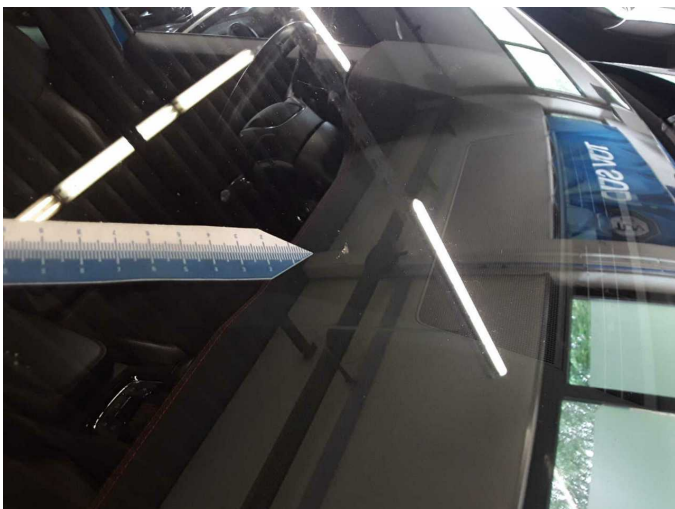
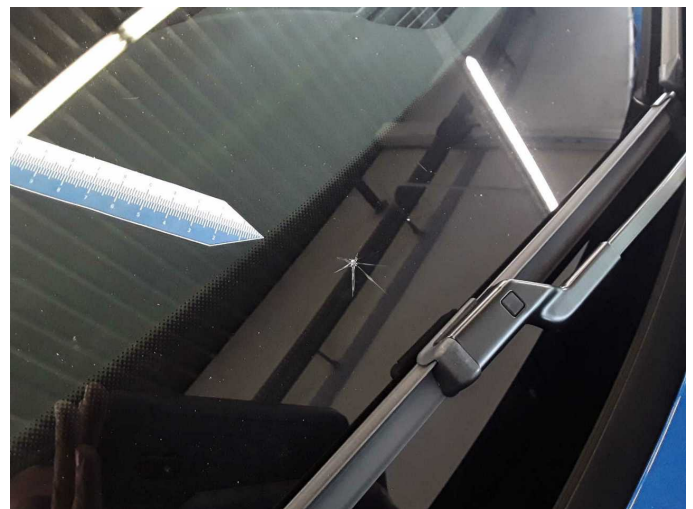
| No. | Component group | Description |
|---|---|---|
| 5 | Vehicle glazing | Windscreen (Rissbildung, Randbereich) - Stone chips - repair according to calculation |

**Damage 5:** Vehicle glazing: Windscreen (Rissbildung, Randbereich) - Stone chips - repair according to calculation

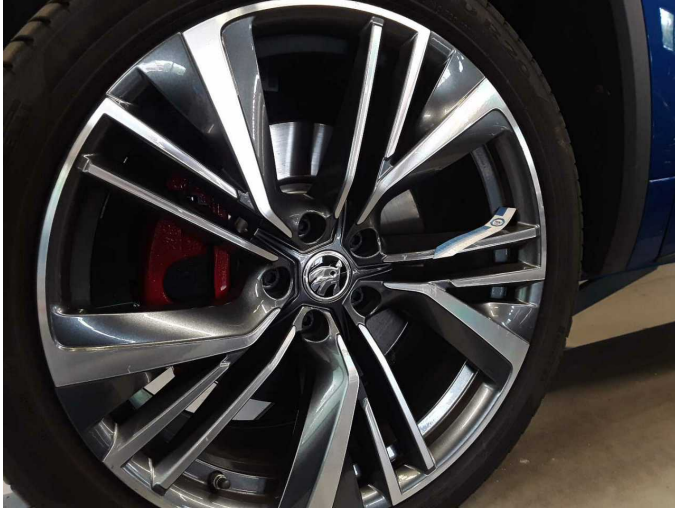
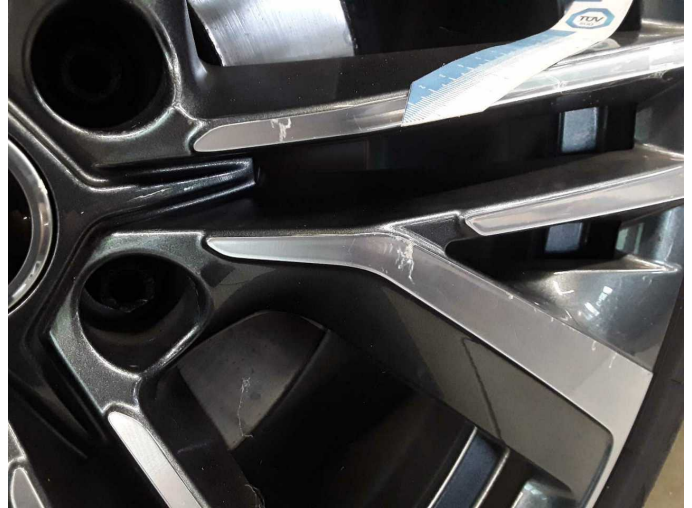
| No. | Component group | Description |
|---|---|---|
| 1 | Wheel / tyres | Alloy rim - front left side (Eingelaufen) - No deduction |

**Wear and tear 1:** Wheel / tyres: Alloy rim - front left side (Eingelaufen) - No deduction

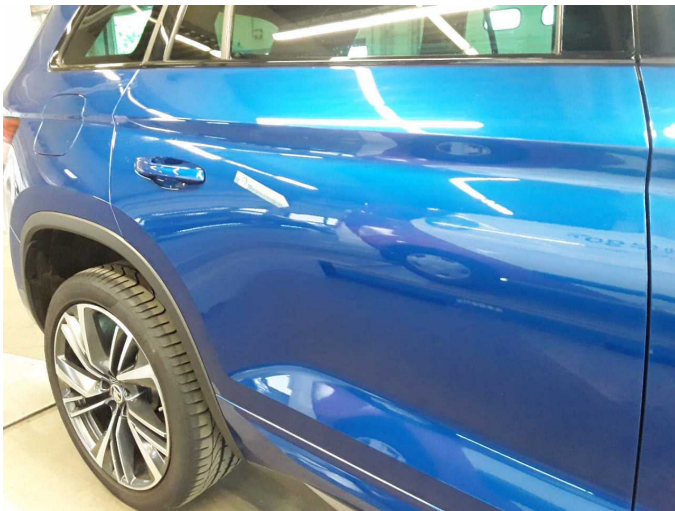
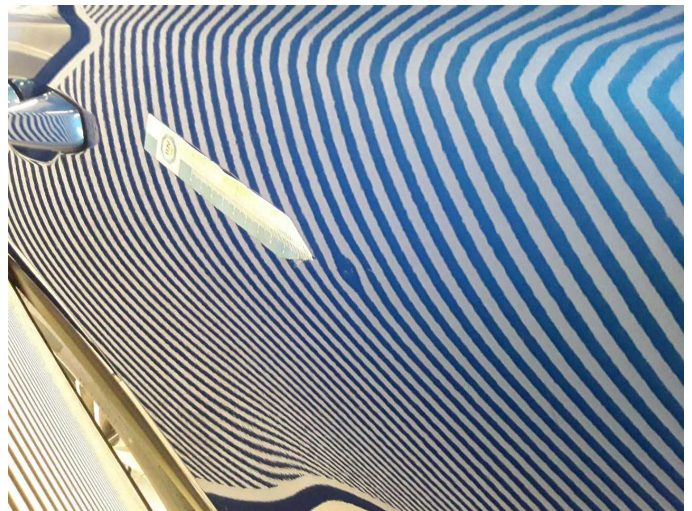
| No. | Component group | Description |
|---|---|---|
| 2 | Door - rear right side | Door - Dent / paintcoat damage - Smart repair |

**Wear and tear 2:** Door - rear right side: Door - Dent / paintcoat damage - Smart repair

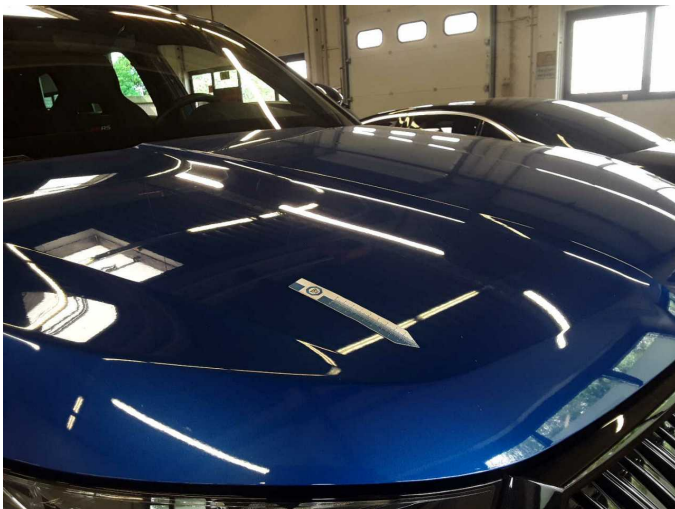
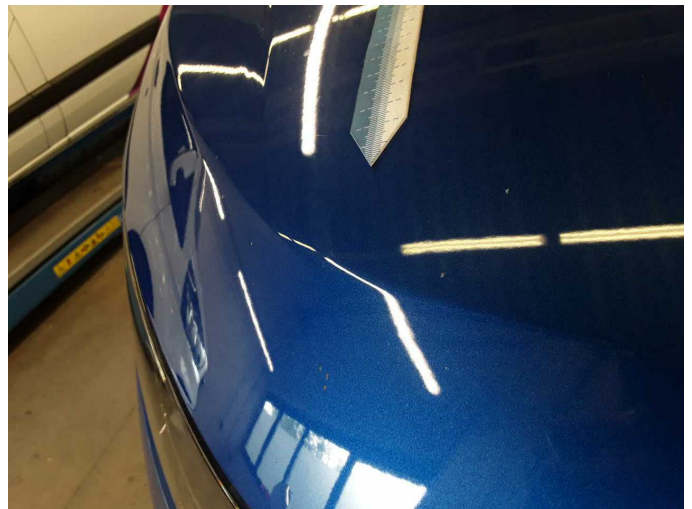
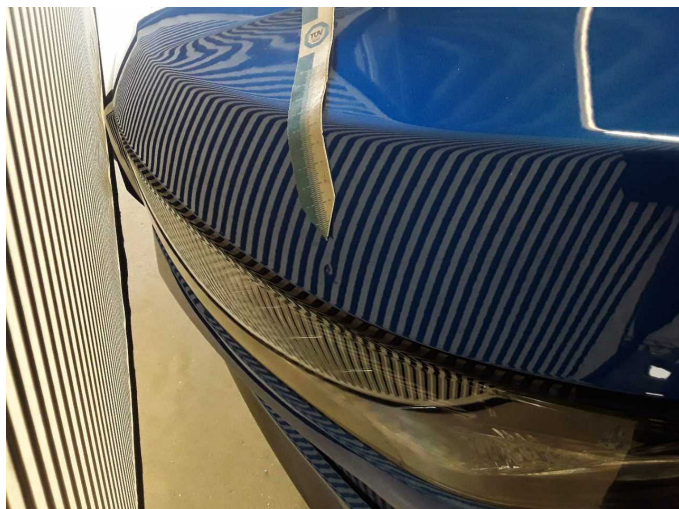
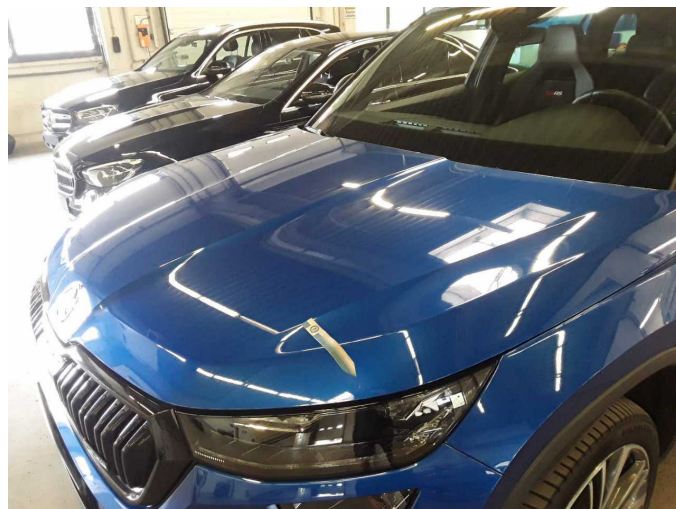
| No. | Component group | Description |
|---|---|---|
| 3 | Bonnet | Bonnet - Dent / paintcoat damage - Smart repair |

**Wear and tear 3:** Bonnet: Bonnet - Dent / paintcoat damage - Smart repair
