Expertise

Protocol number: 46437364  
Order No. / Reference: 26591209  
Inspection date: 10 Jul 2026

Manufacturer: Opel

Model: Mokka-e Elegance

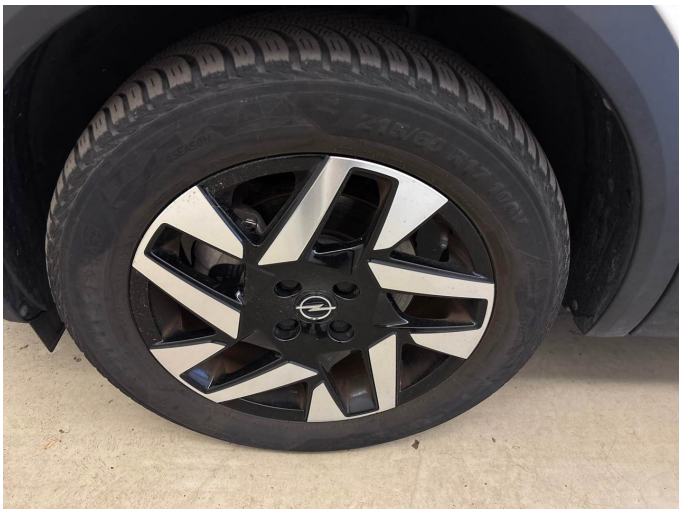
Figure 12: Mounted tyres

| Tyres | | | | |
|---|---|---|---|---|
| 1) | 215/60 R17 100V | All-season tyres on Light alloy | Sonstige | 4mm / 4mm |
| 2) | 215/60 R17 100V | All-season tyres on Light alloy | Sonstige | 4mm / 4mm |

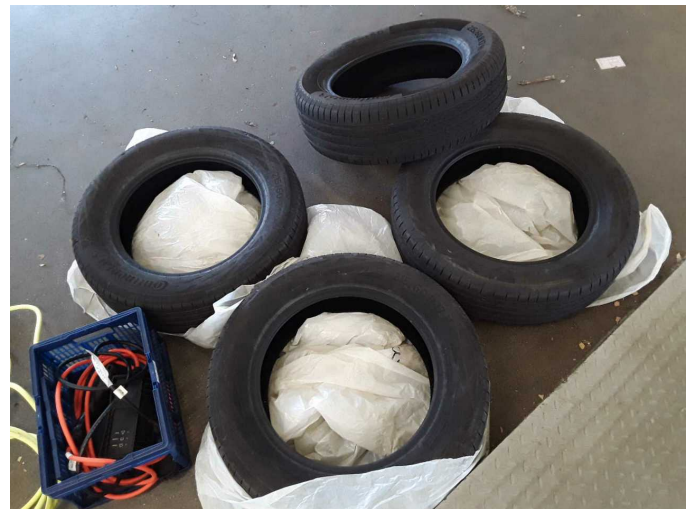
Figure 16: Additional tyres

| Tyres | | | | |
|---|---|---|---|---|
| 1) | 215/60 R17 96H | Summer tyres (Without wheel rim) | Continental | 4mm / 4mm |
| 2) | 215/60 R17 96H | Summer tyres (Without wheel rim) | Continental | 4mm / 4mm |

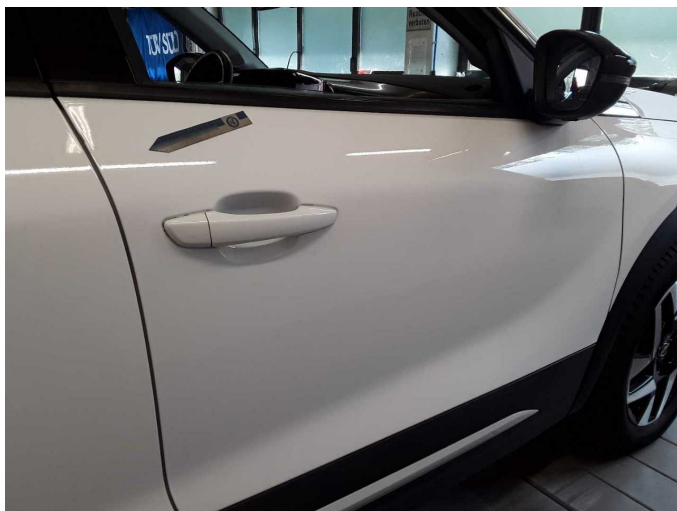
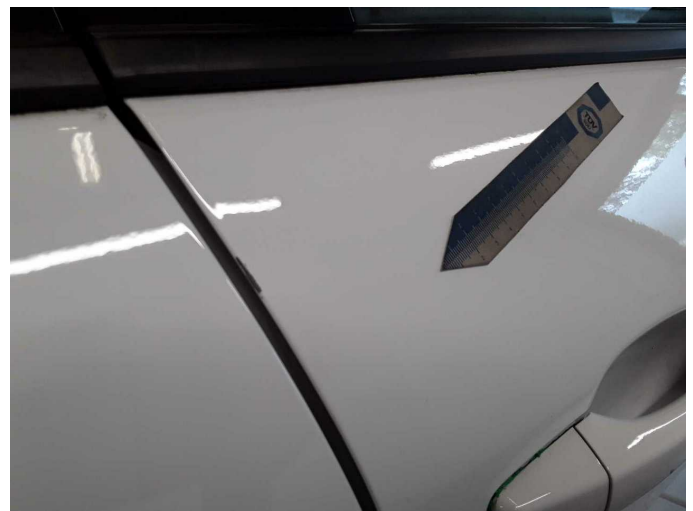
| No. | Component group | Description |
|---|---|---|
| 1 | Door - front right side | Door - Scratch(es) - Smart repair |

Damage 1: Door - front right side: Door - Scratch(es) - Smart repair

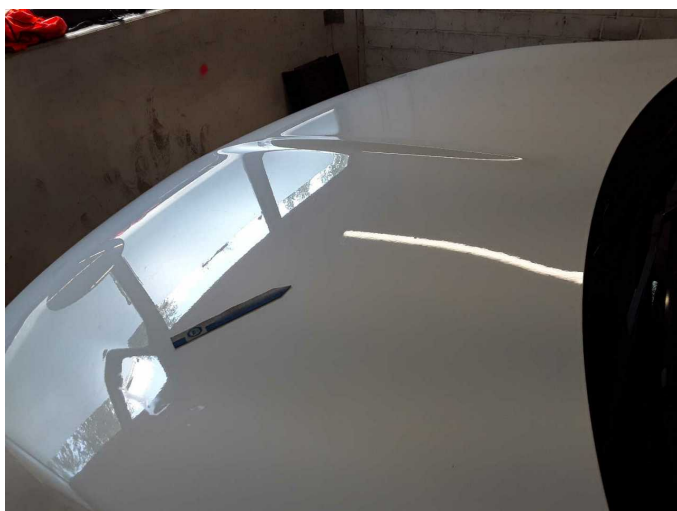
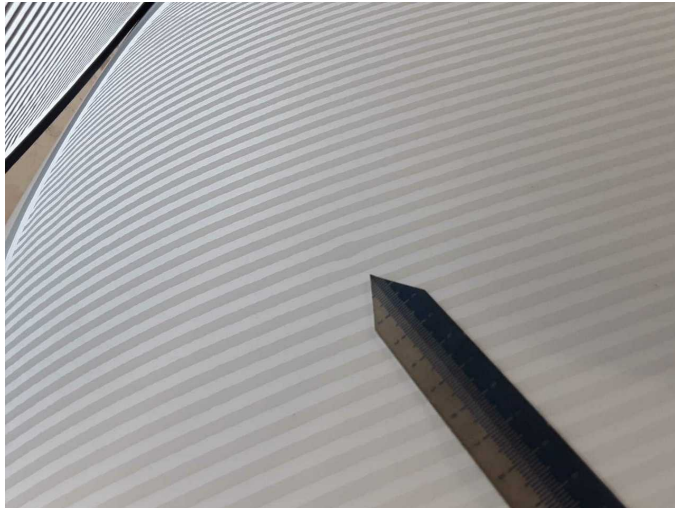
| No. | Component group | Description |
|---|---|---|
| 2 | Bonnet | Bonnet (3;dellen) - dent(s) - Smooth repair work |

Damage 2: Bonnet: Bonnet (3;dellen) - dent(s) - Smooth repair work

**Damage 2:** Bonnet: Bonnet (3;dellen) - dent(s) - Smooth repair work

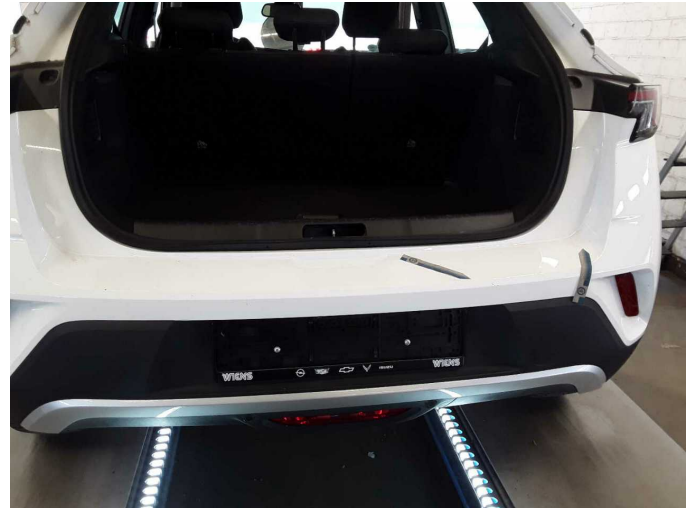
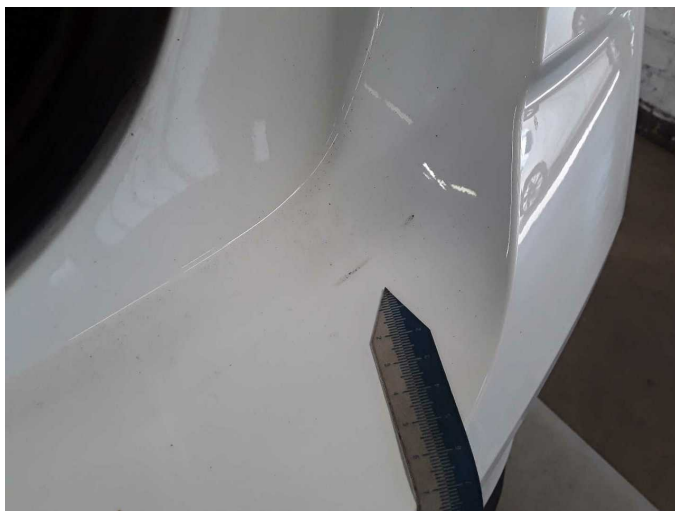
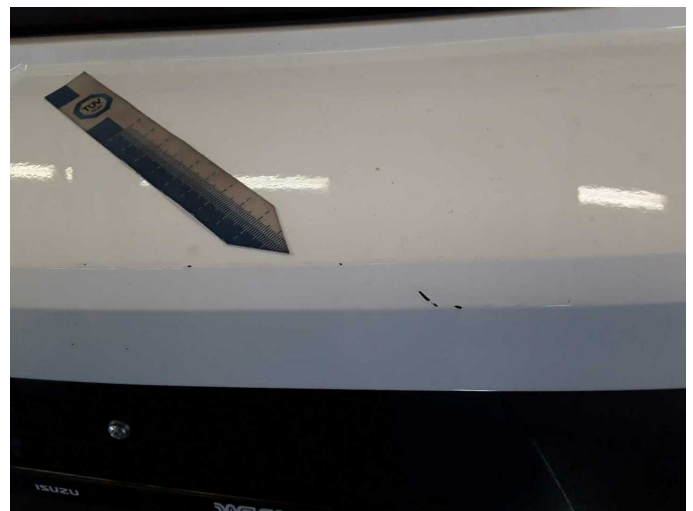
| No. | Component group | Description |
|---|---|---|
| 3 | Rear bumper | Rear bumper - Scratch(es) - Smart repair |

**Damage 3:** Rear bumper: Rear bumper - Scratch(es) - Smart repair

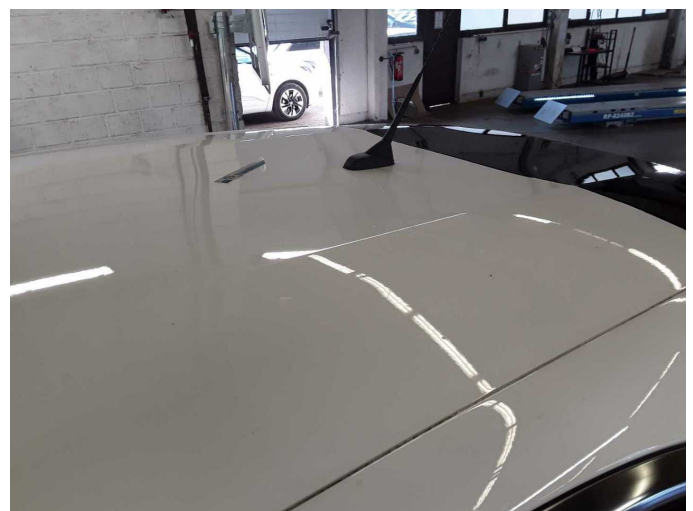
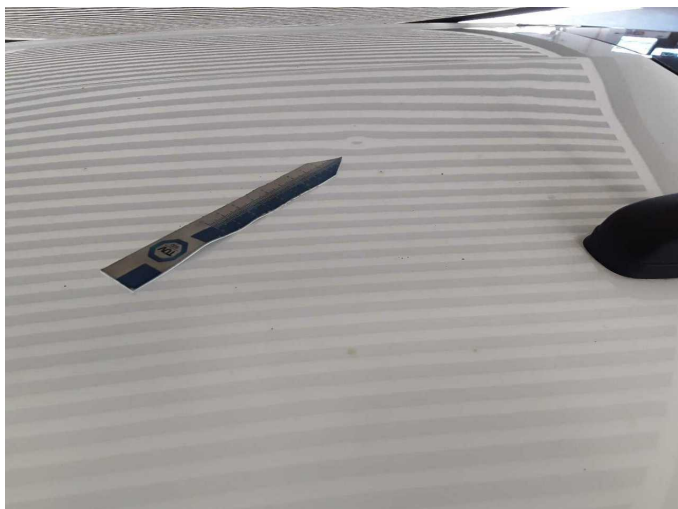
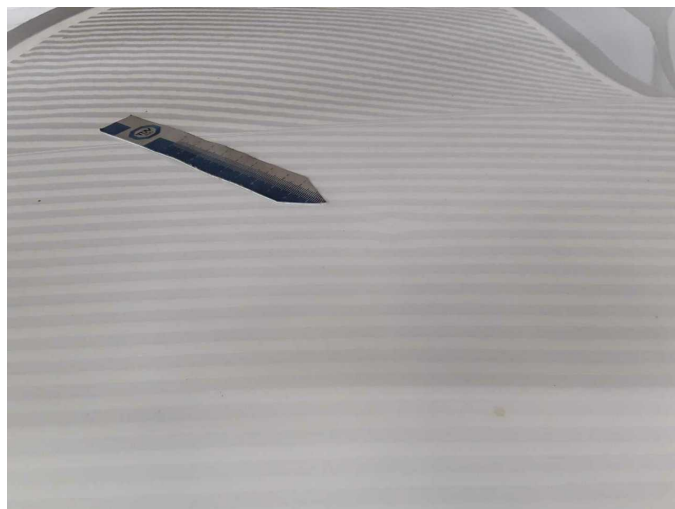
| No. | Component group | Description |
|---|---|---|
| 5 | Roof | Roof - dent(s) - Smooth repair work |

**Damage 5:** Roof: Roof - dent(s) - Smooth repair work

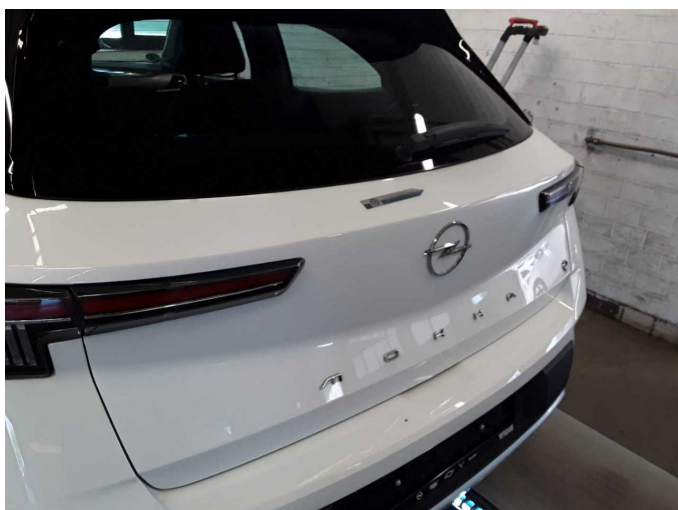
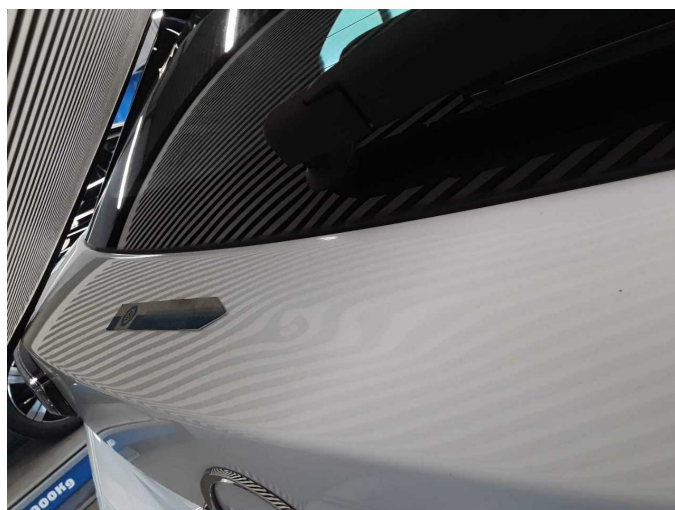
| No. | Component group | Description |
|---|---|---|
| 6 | Boot lid / rear door | Boot lid - dent(s) - Smooth repair work |

**Damage 6:** Boot lid / rear door: Boot lid - dent(s) - Smooth repair work

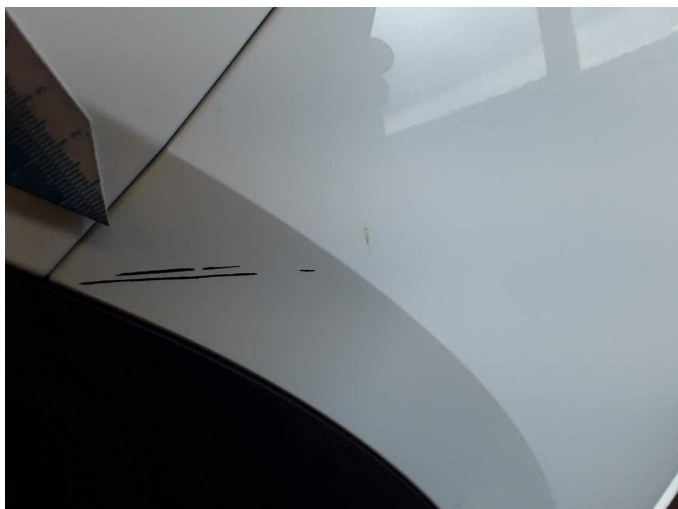
| No. | Component group | Description |
|---|---|---|
| 7 | Front bumper | Front bumper - Scratch(es) - Paint |

**Damage 7:** Front bumper: Front bumper - Scratch(es) - Paint
