Expertise

Protocol number: 46176777  
Order No. / Reference: 26358670  
Inspection date: 26 Jun 2026

Manufacturer: Mercedes-Benz

Model: E 200 d 9G-TRONIC Exclusive

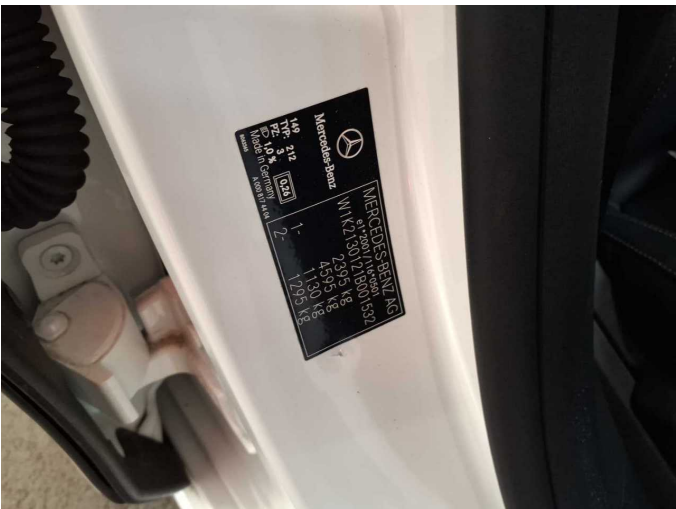
Figure 11: VIN

| VIN comparison | The vehicle identification number (VIN) was read from the vehicle and its conformity with the submitted documents was confirmed by the undersigned during the inspection. |

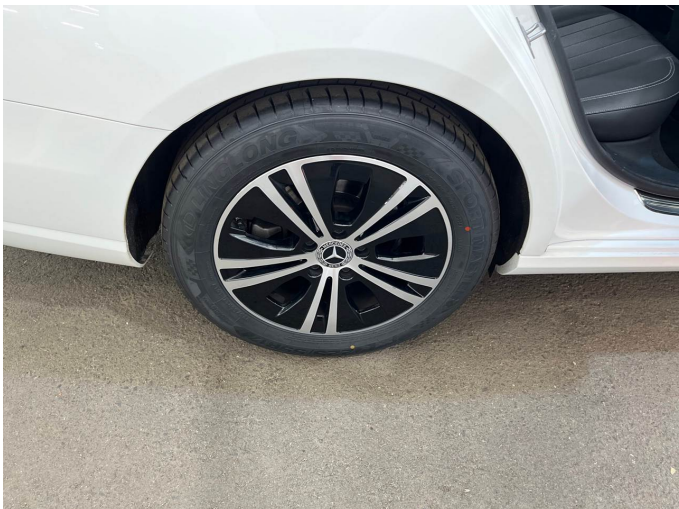
Figure 12: Mounted tyres

| # | Tyre size | Type of tyre | Manufacturer | Tread depth |
|---|---|---|---|---|
| 1) | 225/55 R17 101Y | Summer tyres on Light alloy | Sonstige | 6mm / 6mm |
| 2) | 225/55 R17 101Y | Summer tyres on Light alloy | Sonstige | 6mm / 6mm |

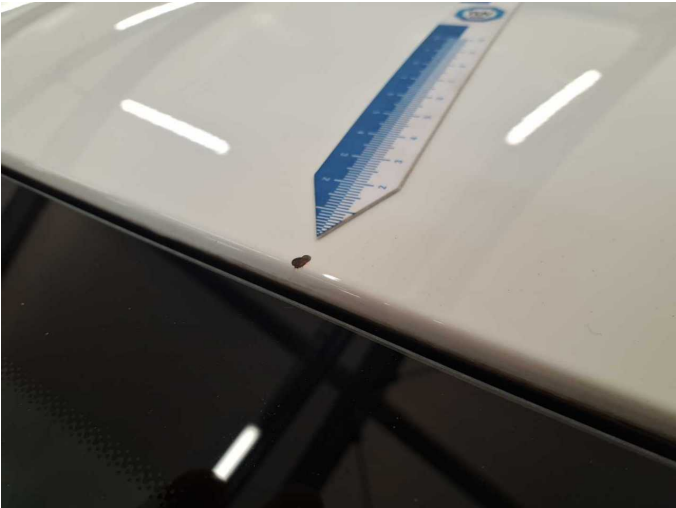
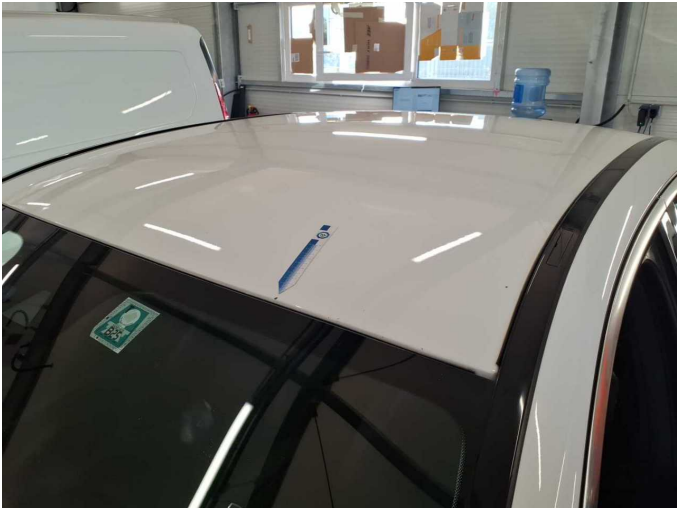
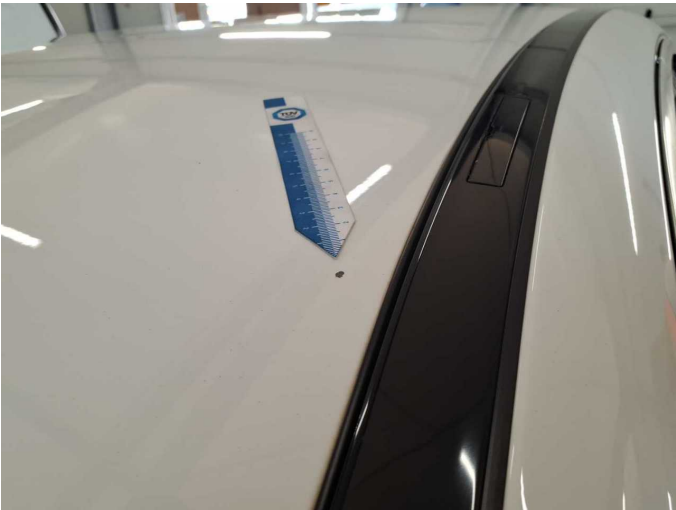
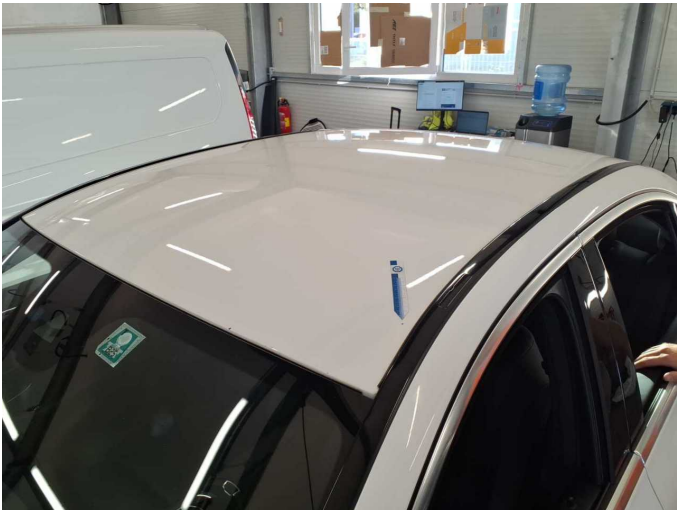
Damage 1: Roof: Roof (Steinschlag mit Korrosion) - Stone chips - Repair and paint

| No. | Component group | Description |
|---|---|---|
| 1 | Roof | Roof (Steinschlag mit Korrosion) - Stone chips - Repair and paint |

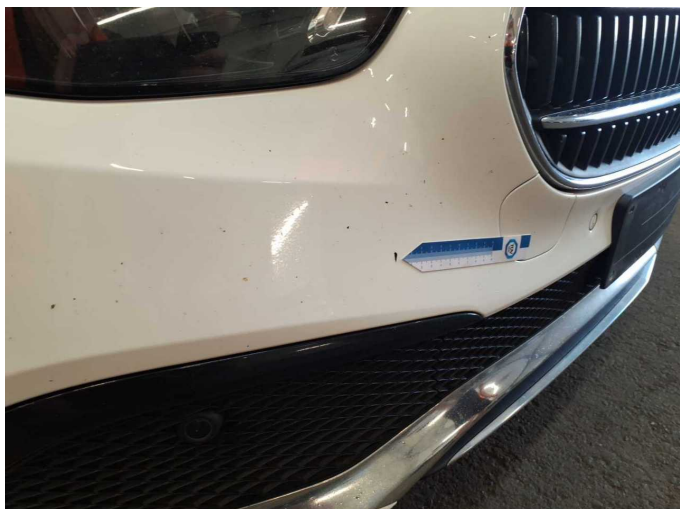
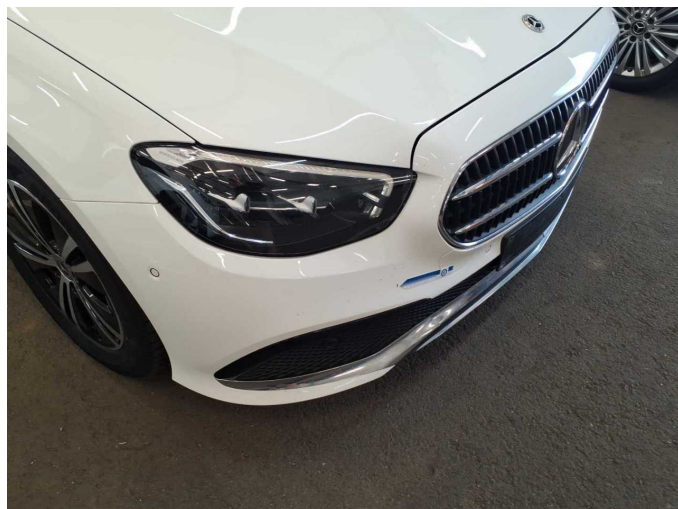
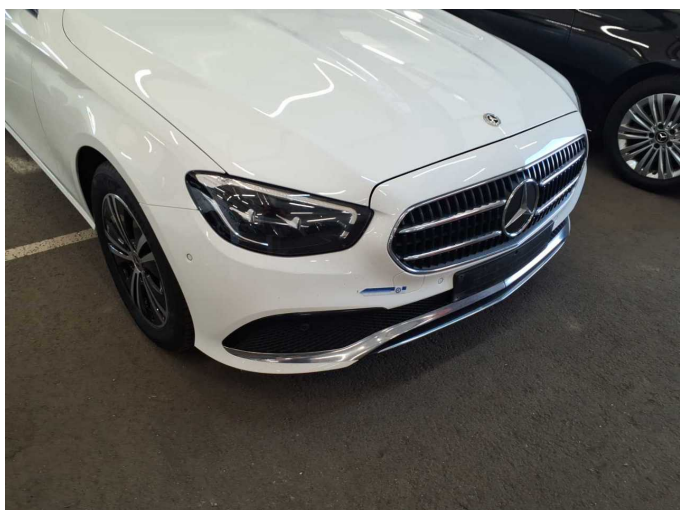
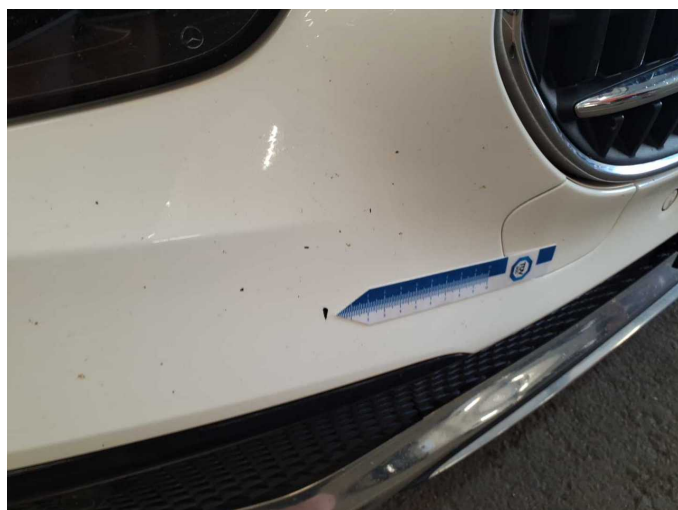
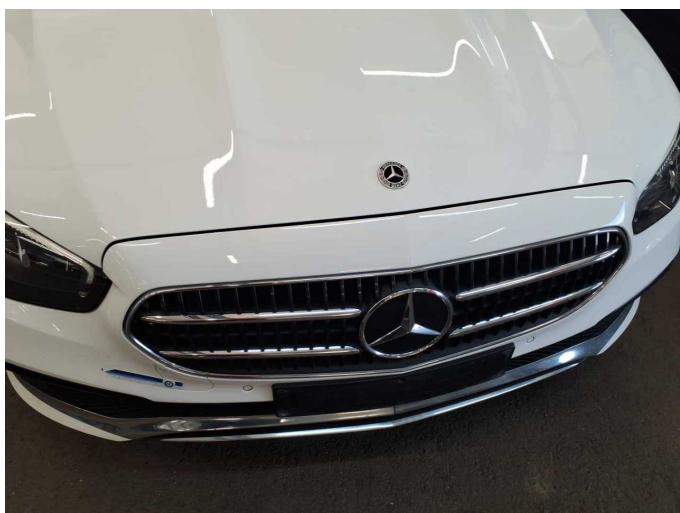
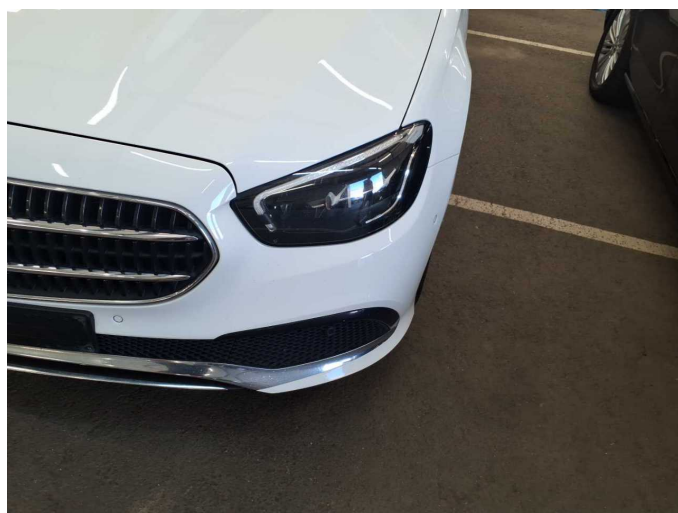
**Damage 2:** Front bumper: Front bumper - Scratch(es) - Paint

| No. | Component group | Description |
|---|---|---|
| 2 | Front bumper | Front bumper - Scratch(es) - Paint |

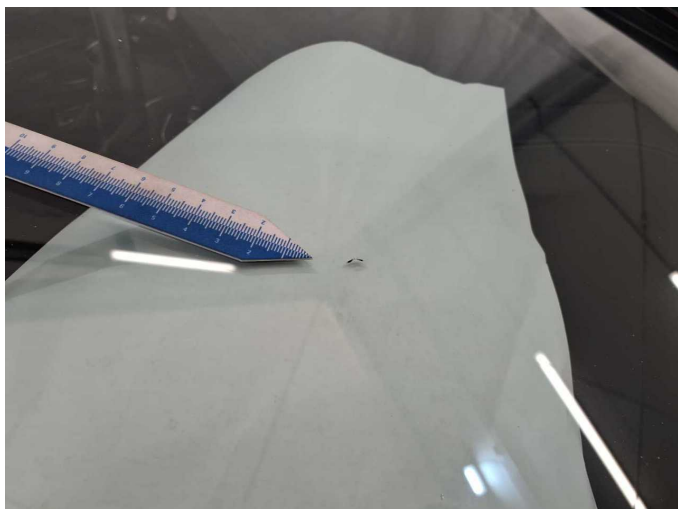
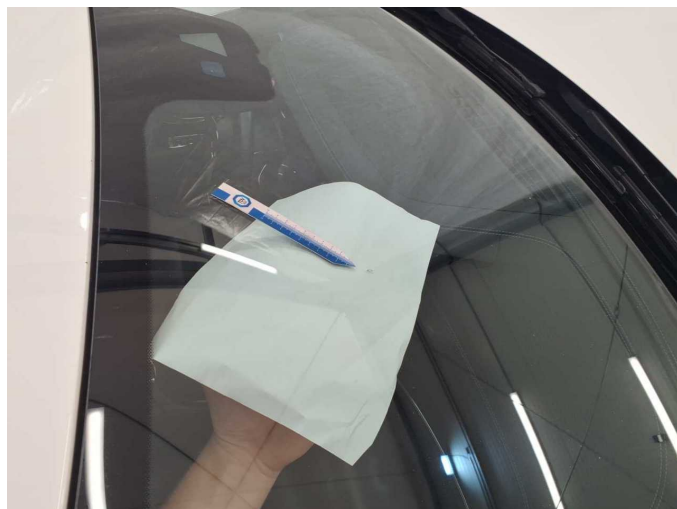
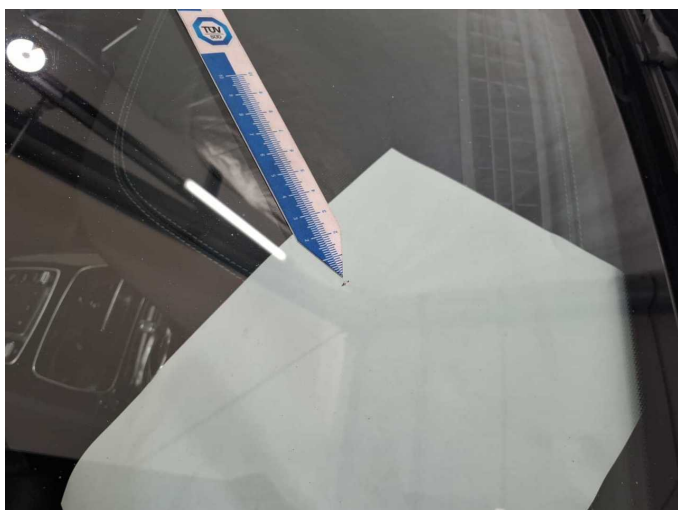
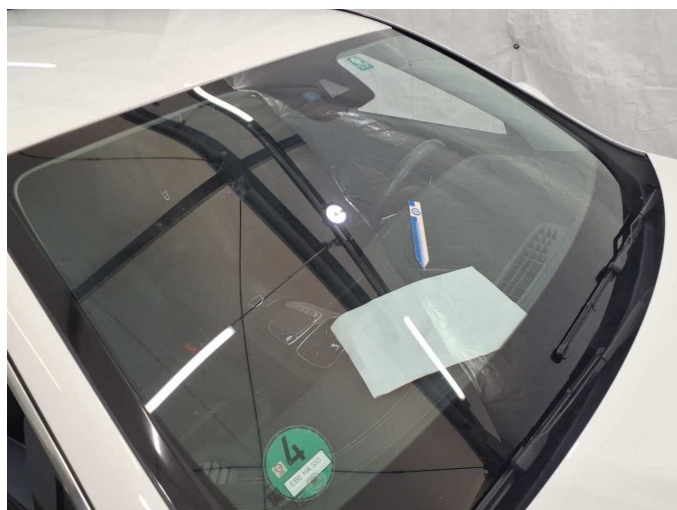
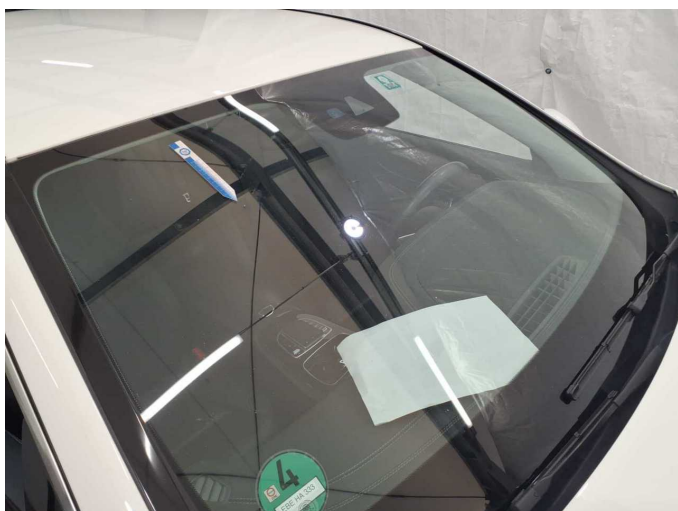
**Damage 3:** Vehicle glazing: Windscreen - Stone chips - Replace

| No. | Component group | Description |
|---|---|---|
| 3 | Vehicle glazing | Windscreen - Stone chips - Replace |

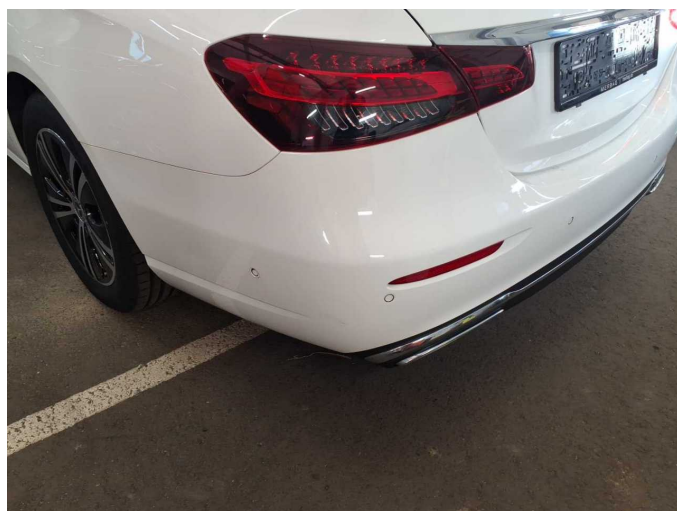
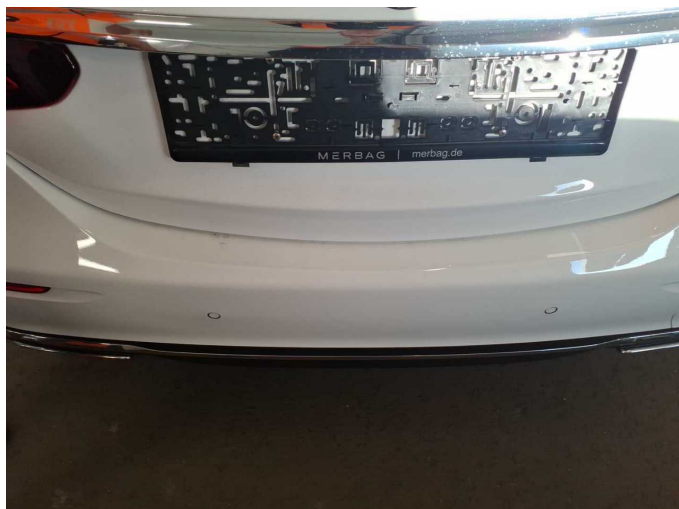
**Wear and tear 1:** Rear bumper: Rear bumper - Scratch(es) - No deduction

| No. | Component group | Description |
|---|---|---|
| 1 | Rear bumper | Rear bumper - Scratch(es) - No deduction |

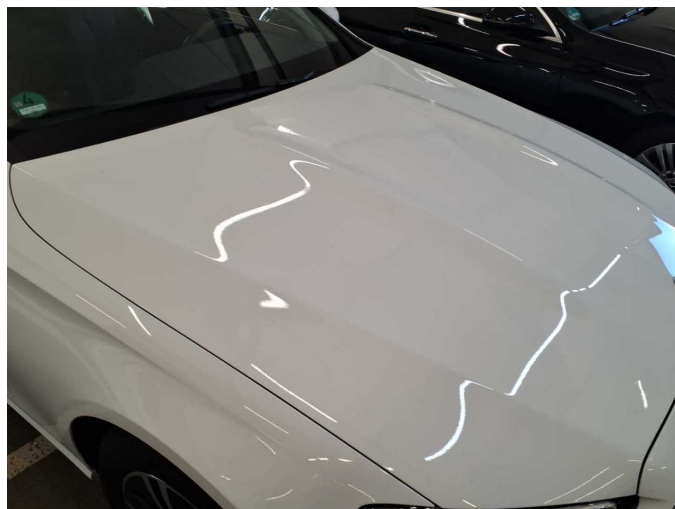
**Wear and tear 3:** Bonnet: Bonnet - Stone chips - No deduction

| No. | Component group | Description |
|---|---|---|
| 3 | Bonnet | Bonnet - Stone chips - No deduction |
