## Expertise

Protocol number: 46061467  
Order No. / Reference: 26417497  
Inspection date: 22 Jun 2026

Model: Transporter T6.1 2.0 TDI SCR DSG 4MOTION Kasten Kurz

An order was placed to prepare a sales report for the described vehicle. This report includes the following:

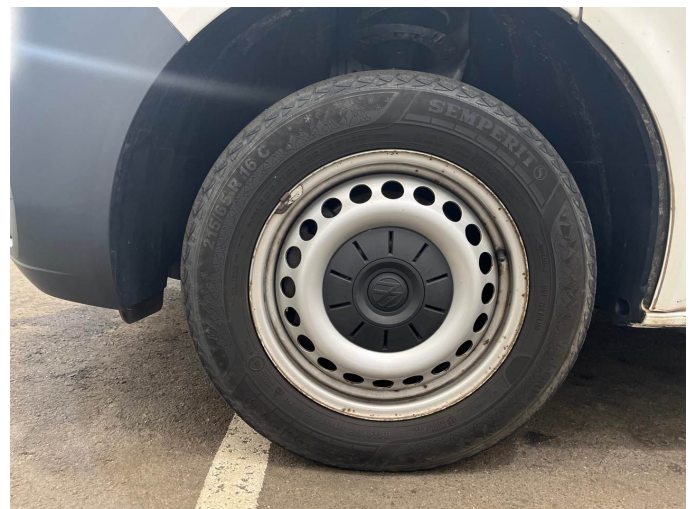
Figure 12: Mounted tyres

#	Tyre size	Type of tyre	Manufacturer	Tread depth
1)	215/65 R16 107R	Winter tyres on Steel rim with wheel cover	Semperit	5mm / 5mm
2)	215/65 R16 107R	Winter tyres on Steel rim with wheel cover	Semperit	7mm / 7mm

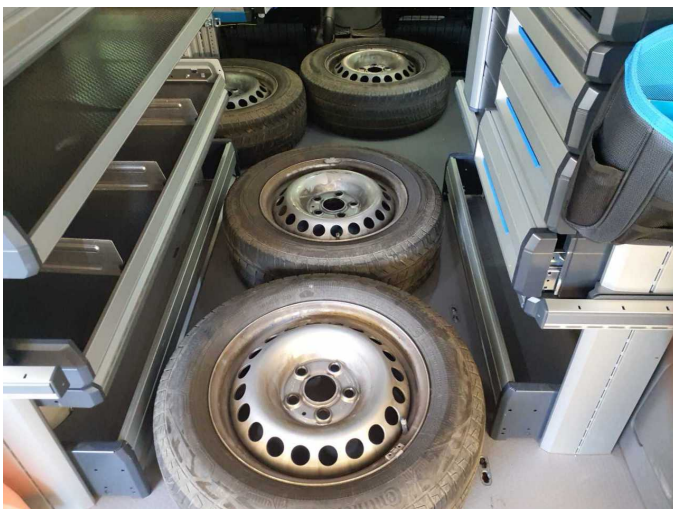
Figure 17: Additional tyres

#	Tyre size	Type of tyre	Manufacturer	Tread depth
1)	205/65 R16 105T	Summer tyres on Light alloy	Continental	7mm / 7mm
2)	205/65 R16 105T	Summer tyres on Light alloy	Continental	6mm / 6mm

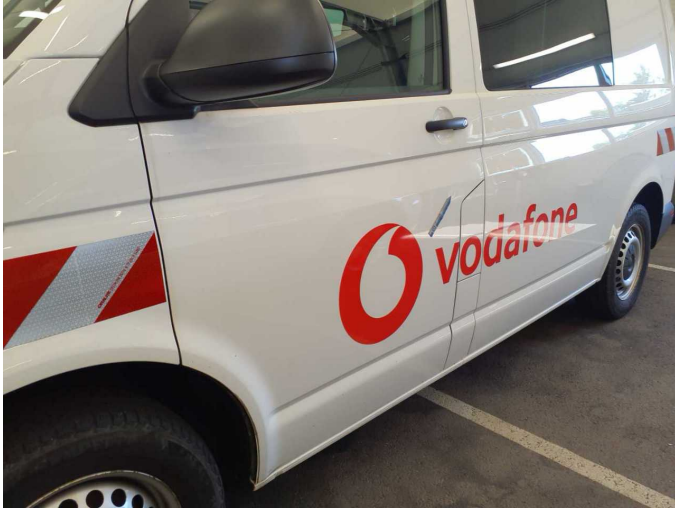
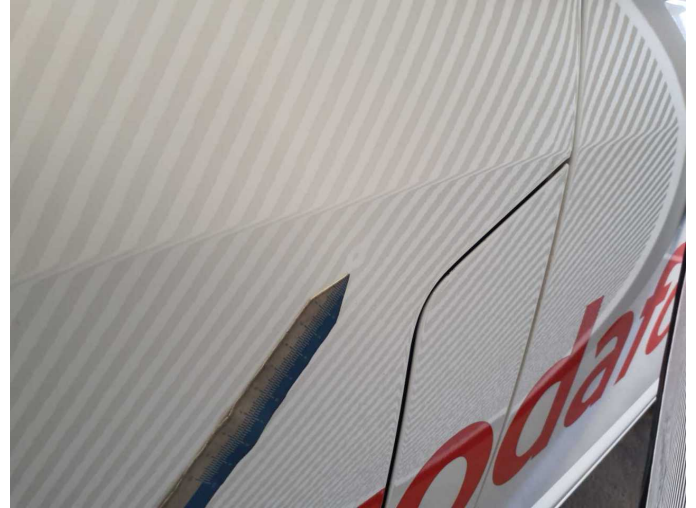
**Damage 2:** Door - front left side: Door - dent(s) - Smart repair

No.	Component group	Description
1	Interior	Cargo space partition (Sortimo Regaleinbauten) - Differs from the original configuration - No deduction
2	Door - front left side	Door - dent(s) - Smart repair
3	Body	Body - Glued / labelled - De-glue / neutralise

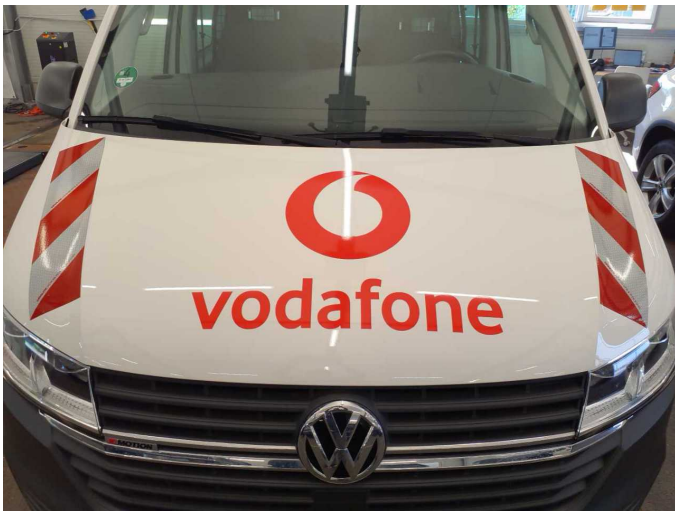
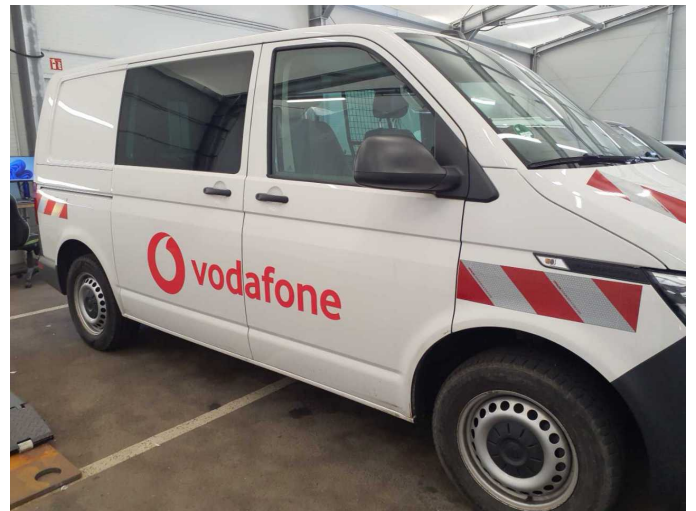
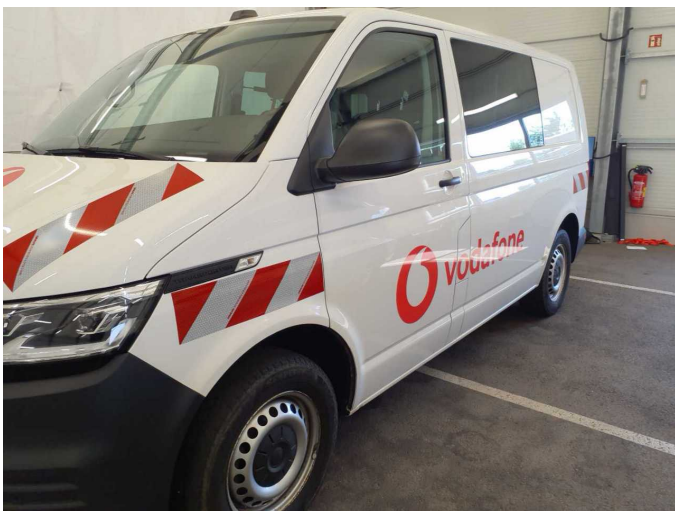
**Damage 3:** Body: Body - Glued / labelled - De-glue / neutralise
