Expertise

Protocol number: 46409136  
Order No. / Reference: 26508848  
Inspection date: 8 Jul 2026

Manufacturer: Mercedes-Benz

Model: EQC 400 4Matic AMG Line

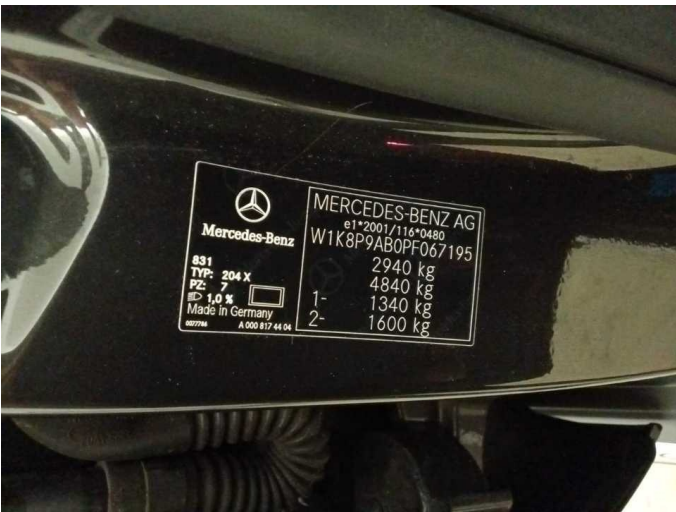
| VIN comparison | The vehicle identification number (VIN) was read from the vehicle and its conformity with the submitted documents was confirmed by the undersigned during the inspection. |

Figure 11: VIN

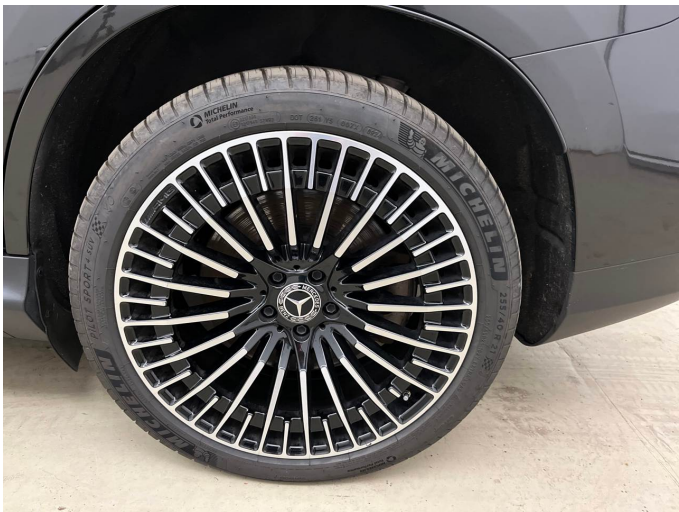
| # | Tyre size | Type of tyre | Manufacturer | Tread depth |
|---|---|---|---|---|
| 1) | 235/45 R21 101Y | Summer tyres on Light alloy | Michelin | 5mm / 5mm |
| 2) | 255/40 R21 102Y | Summer tyres on Light alloy | Michelin | 6mm / 6mm |

Figure 12: Mounted tyres

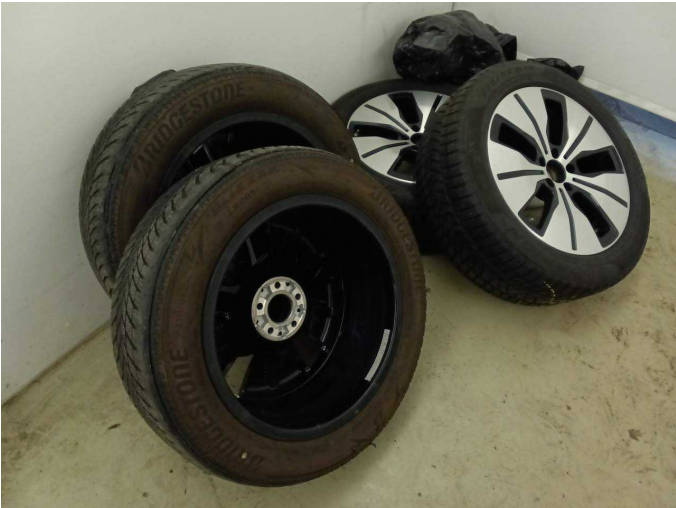
| # | Tyre size | Type of tyre | Manufacturer | Tread depth |
|---|---|---|---|---|
| 1) | 235/55 R19 105H | Winter tyres on Light alloy | Bridgestone | 4mm / 4mm |
| 2) | 235/55 R19 105H | Winter tyres on Light alloy | Pirelli | 5mm / 5mm |

Figure 15: Additional tyres

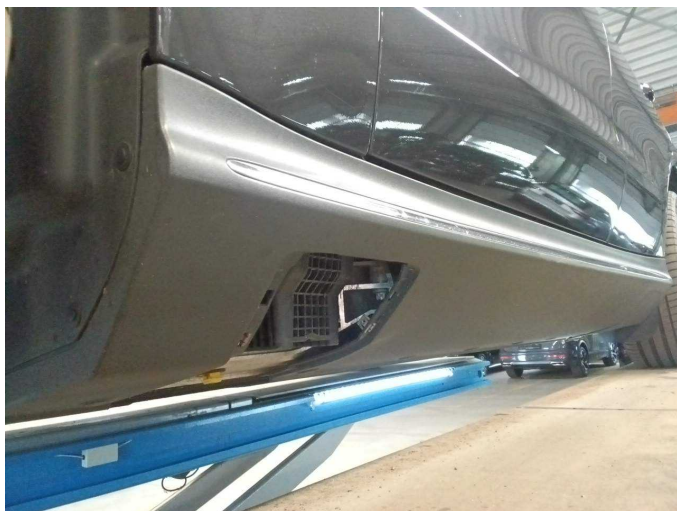
| No. | Component group | Description |
|---|---|---|
| 1 | Sill - left side | Trim (Abdeckungs fehlt) - Missing - Perform |

Damage 1: Sill - left side: Trim (Abdeckungs fehlt) - Missing - Perform

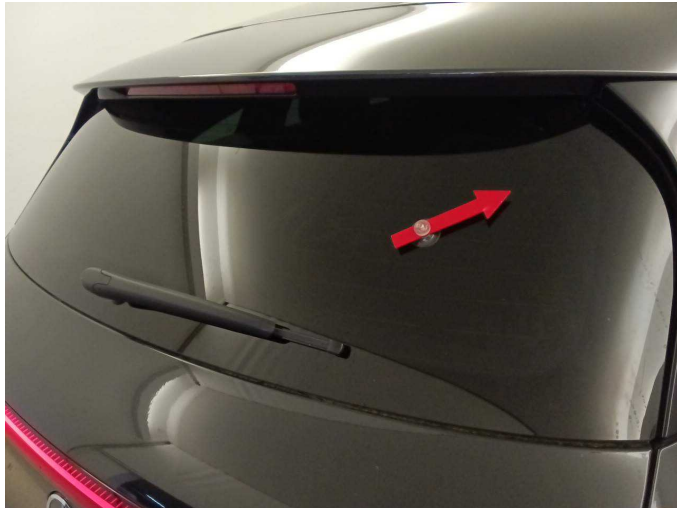
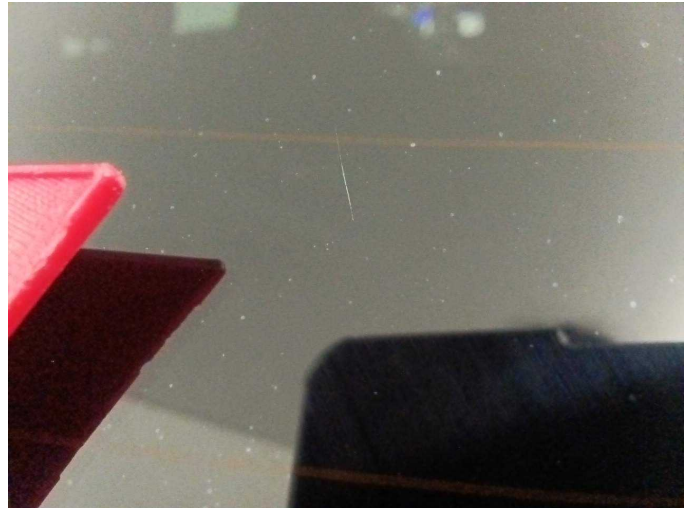
| No. | Component group | Description |
|---|---|---|
| 2 | Vehicle glazing | Rear window - Scratch(es) - Loss in value |

**Damage 2:** Vehicle glazing: Rear window - Scratch(es) - Loss in value

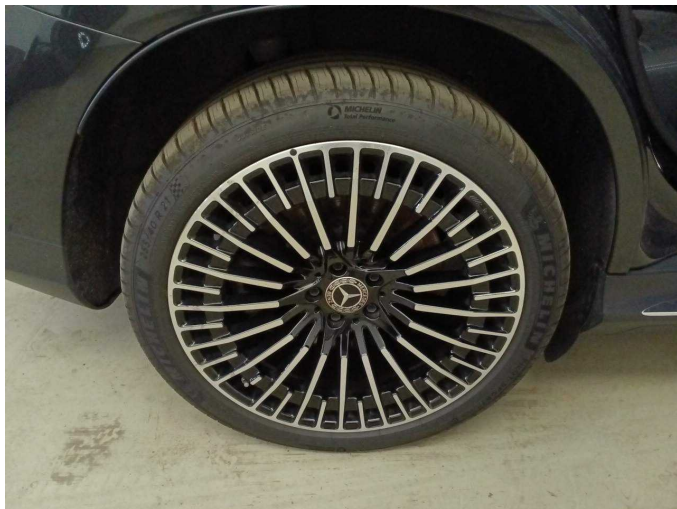
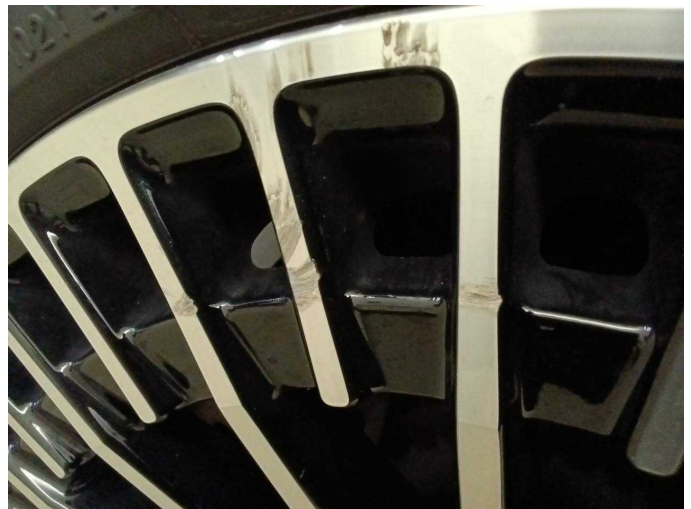
| No. | Component group | Description |
|---|---|---|
| 3 | Wheel / tyres | Alloy rim - rear right side - Scratch(es) - Loss in value |

**Damage 3:** Wheel / tyres: Alloy rim - rear right side - Scratch(es) - Loss in value

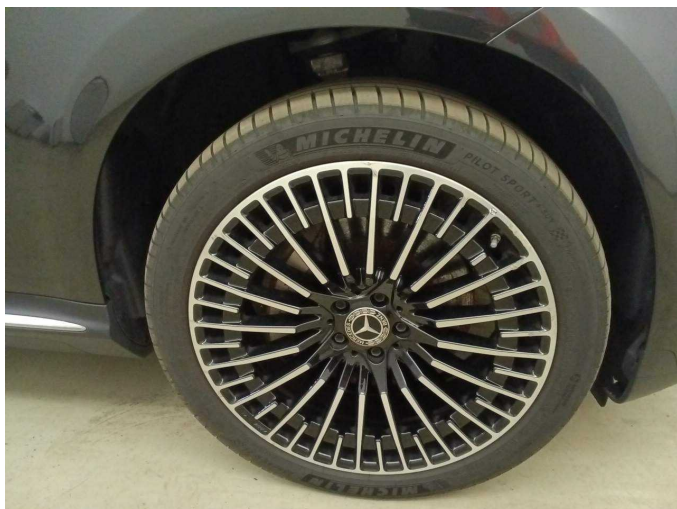
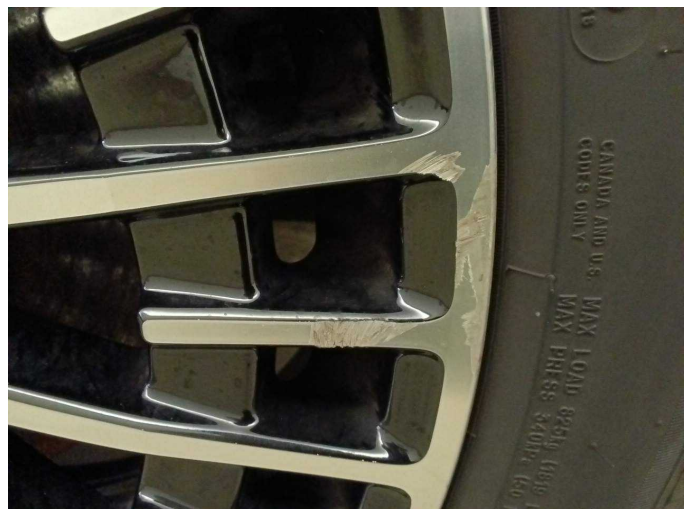
| No. | Component group | Description |
|---|---|---|
| 4 | Wheel / tyres | Alloy rim - front right side - Scratched - Loss in value |

**Damage 4:** Wheel / tyres: Alloy rim - front right side - Scratched - Loss in value

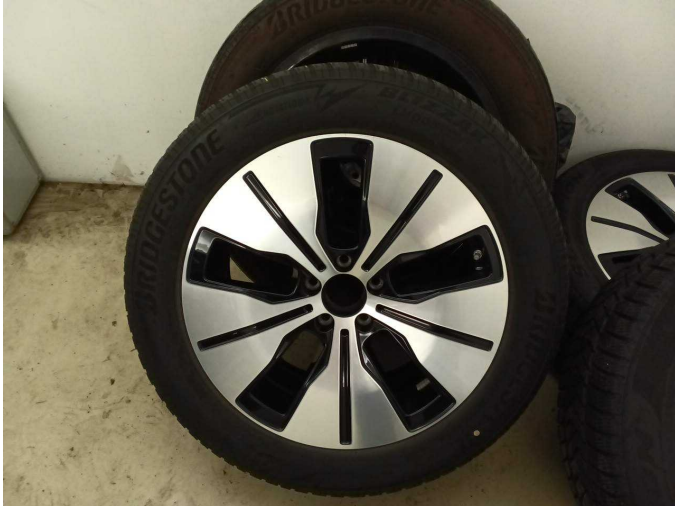
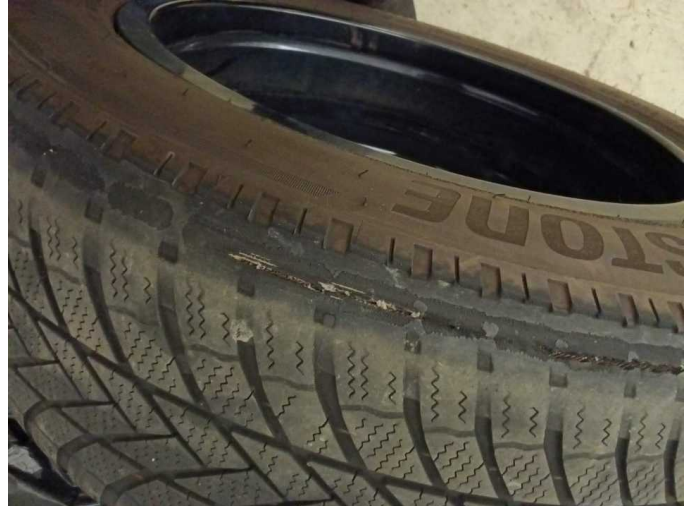
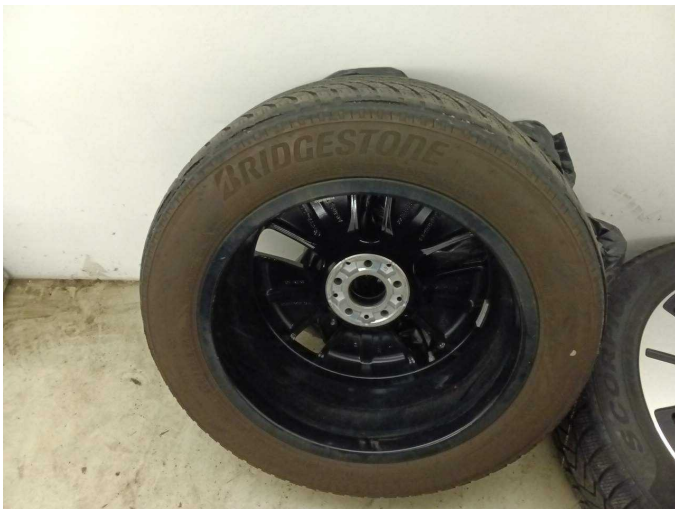
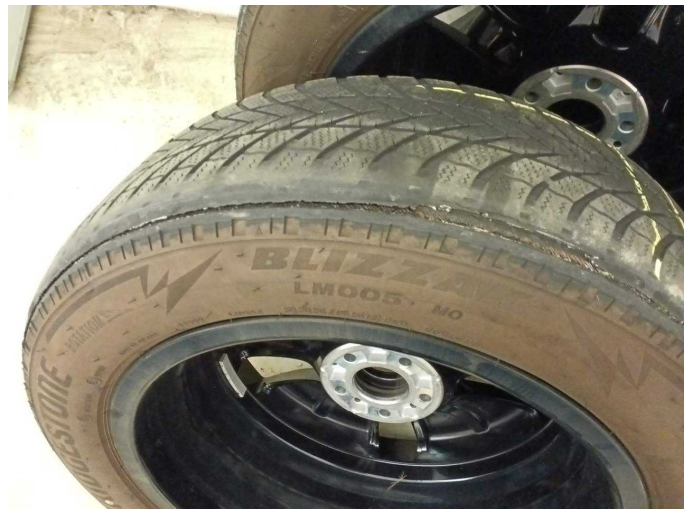
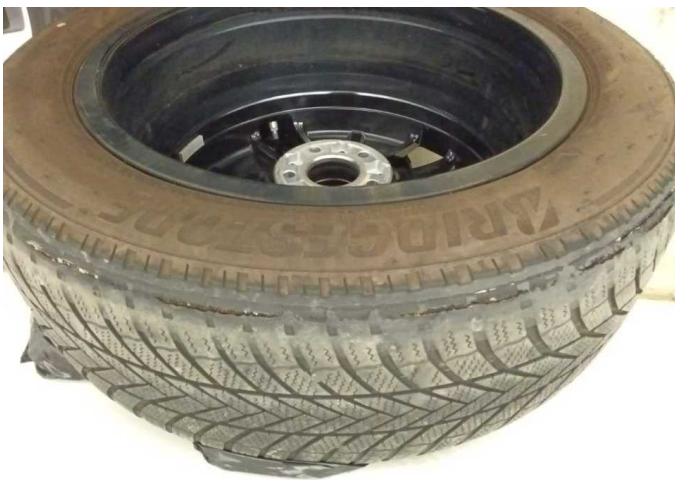
| No. | Component group | Description |
|---|---|---|
| 5 | 2nd wheel set | 2 tyres - Worn - Replace |

**Damage 5:** 2nd wheel set: 2 tyres - Worn - Replace

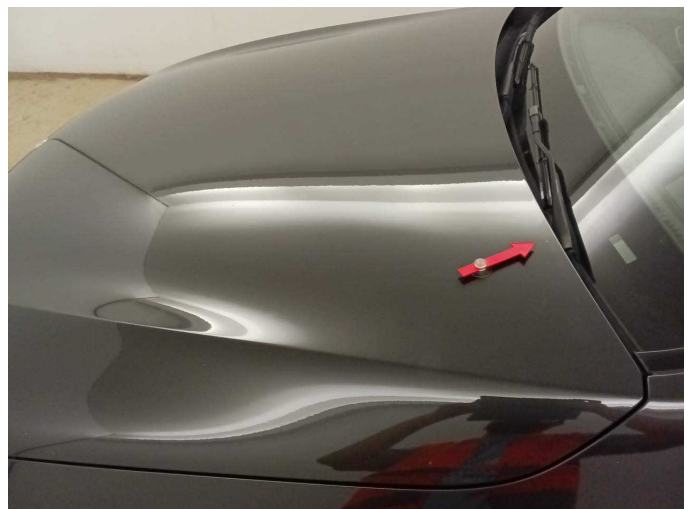
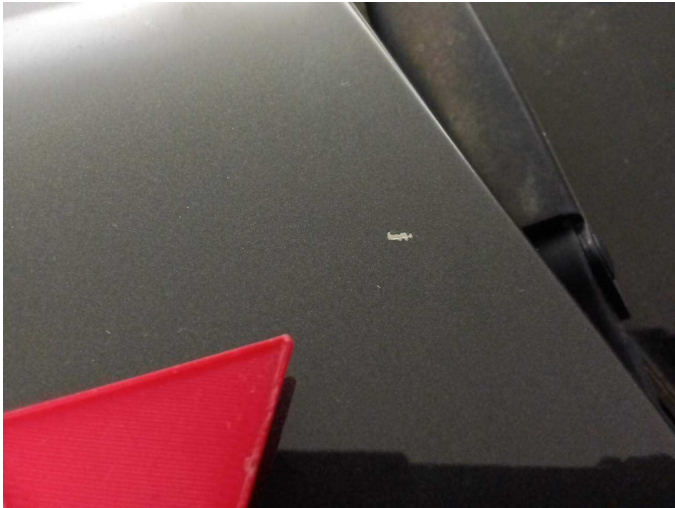
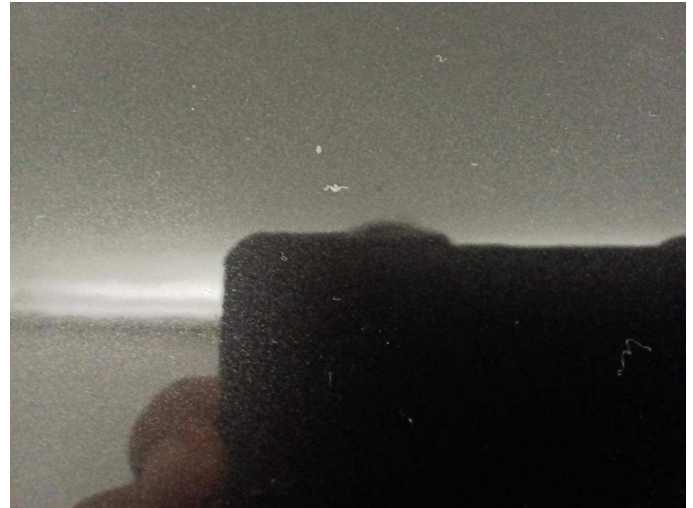
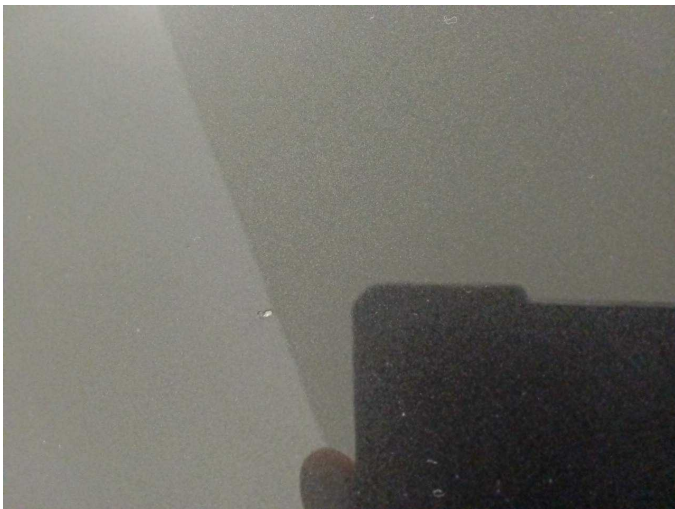
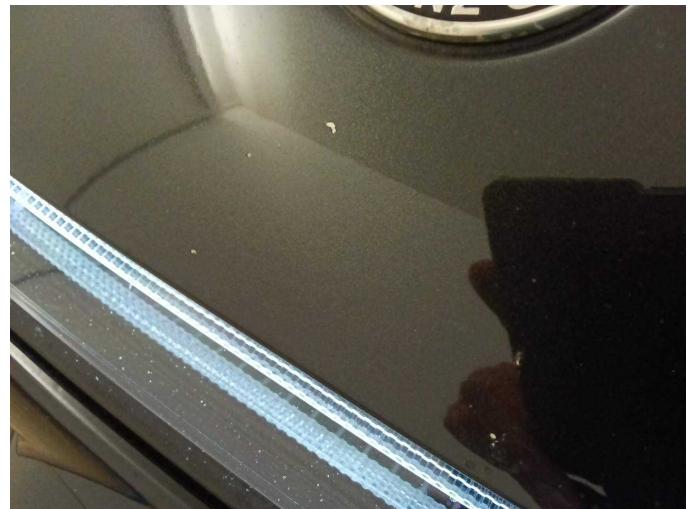
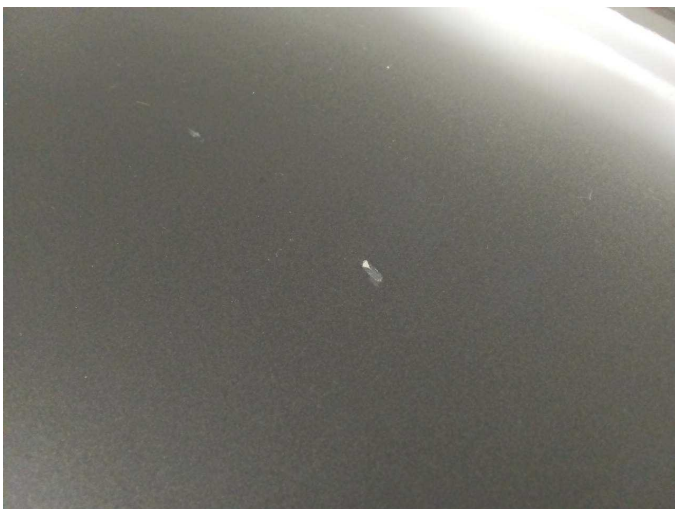
| No. | Component group | Description |
|---|---|---|
| 6 | Bonnet | Bonnet - Stone chips - Paint |

**Damage 6:** Bonnet: Bonnet - Stone chips - Paint

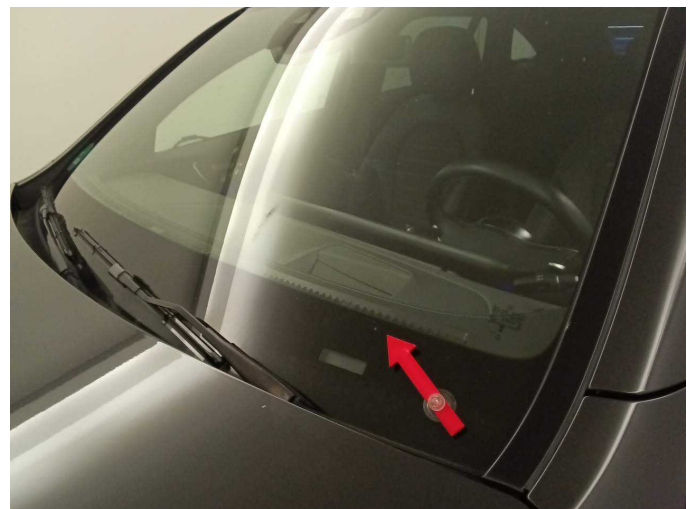
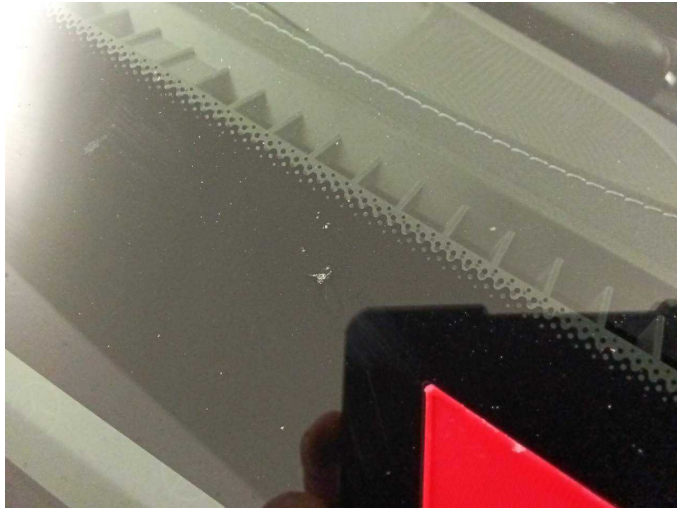
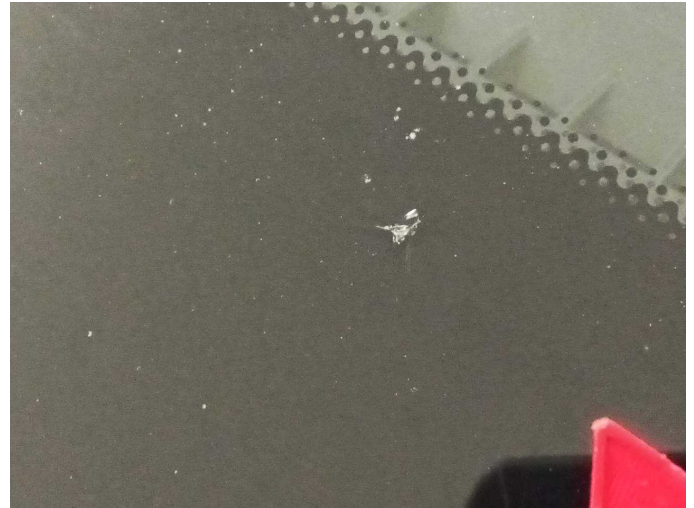
| No. | Component group | Description |
|---|---|---|
| 7 | Vehicle glazing | Windscreen - Stone chips - Replace |

**Damage 7:** Vehicle glazing: Windscreen - Stone chips - Replace
