Expertise

Protocol number: 46265990  
Order No. / Reference: 26605555  
Inspection date: 29 Jun 2026

Manufacturer: Volkswagen  
VIN: WVGZZCD2PW008303

Model: Golf 2.0 TDI SCR DSG Life

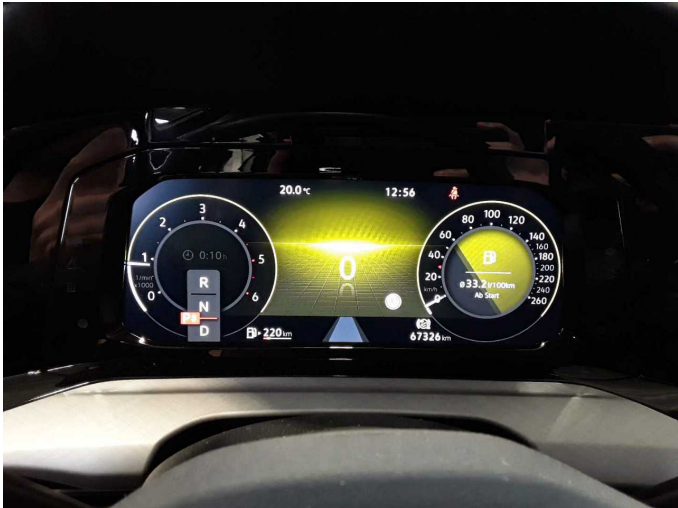
Figure 7: Instrument cluster

| Vehicle details | |
|---|---|
| Mileage (Read) | 67,326 km |

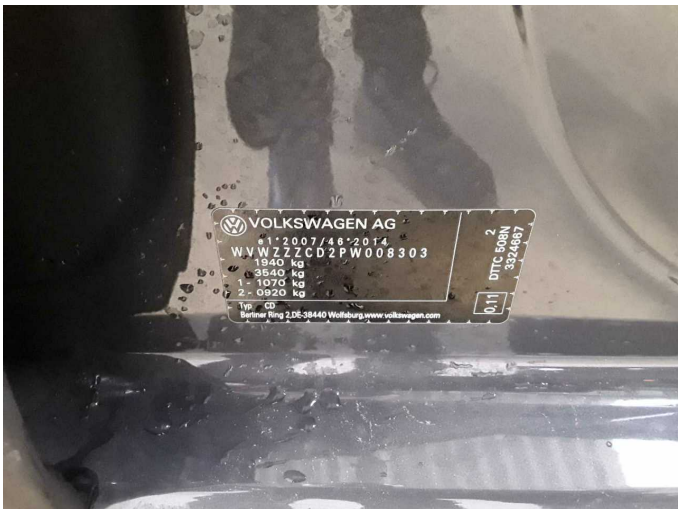
Figure 11: VIN

| VIN comparison | The vehicle identification number (VIN) was read from the vehicle and its conformity with the submitted documents was confirmed by the undersigned during the inspection. |

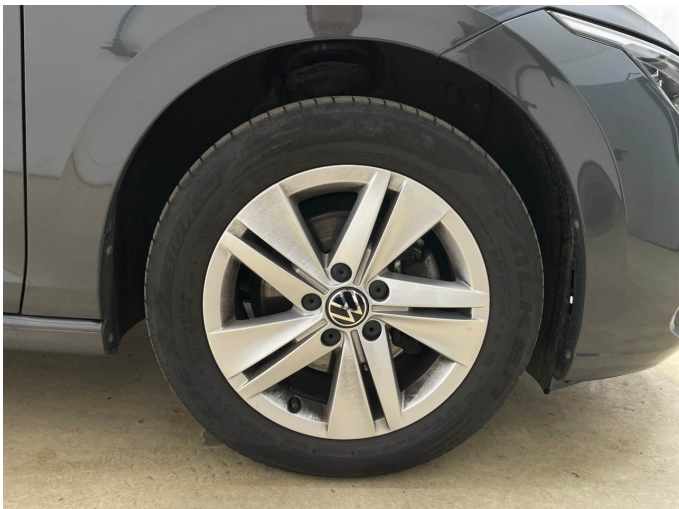
Figure 12: Mounted tyres

| # | Tyre size | Type of tyre | Manufacturer | Tread depth |
|---|---|---|---|---|
| 1) | 205/55 R16 91V | Summer tyres on Light alloy | Falken | 3mm / 3mm |
| 2) | 205/55 R16 91V | Summer tyres on Light alloy | Falken | 4mm / 4mm |

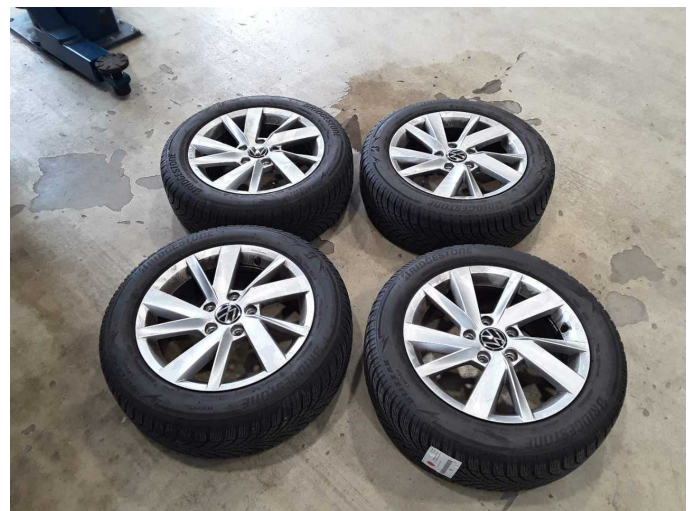
Figure 16: Additional tyres

| # | Tyre size | Type of tyre | Manufacturer | Tread depth |
|---|---|---|---|---|
| 1) | 205/55 R16 91H | Winter tyres on Light alloy | Bridgestone | 5mm / 5mm |
| 2) | 205/55 R16 91H | Winter tyres on Light alloy | Bridgestone | 6mm / 6mm |

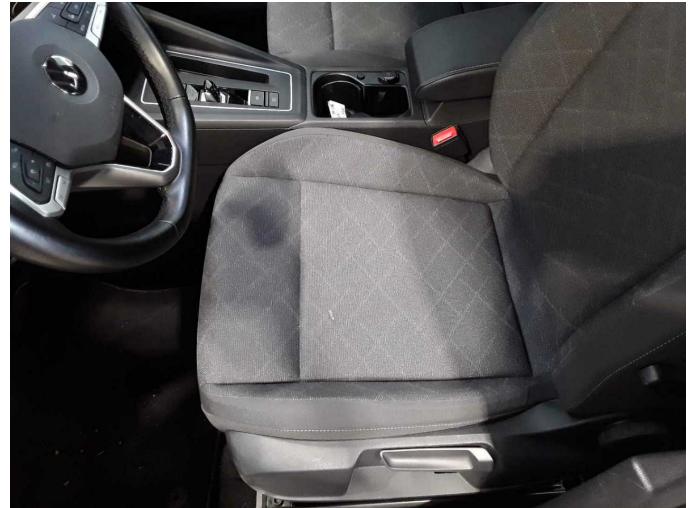
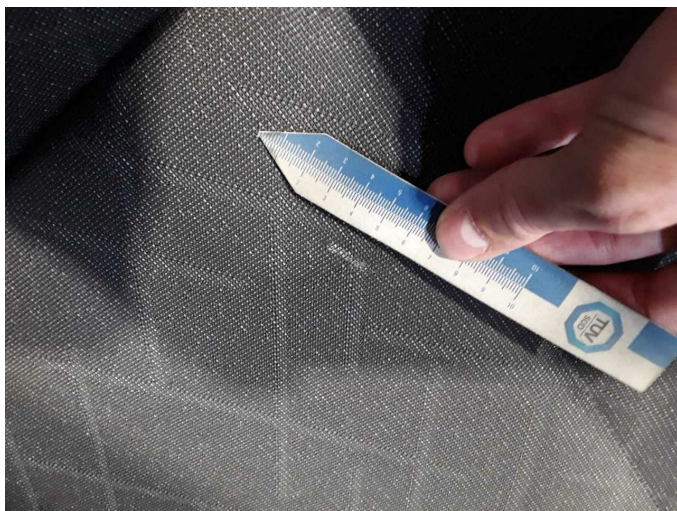
| No. | Component group | Description |
|---|---|---|
| 1 | Seat - front | Seat cover - left side - Soiled - Clean |

**Damage 1:** Seat - front: Seat cover - left side - Soiled - Clean

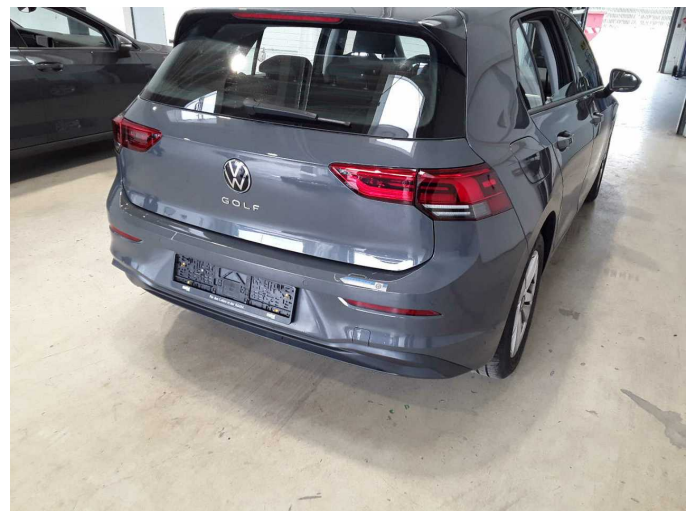
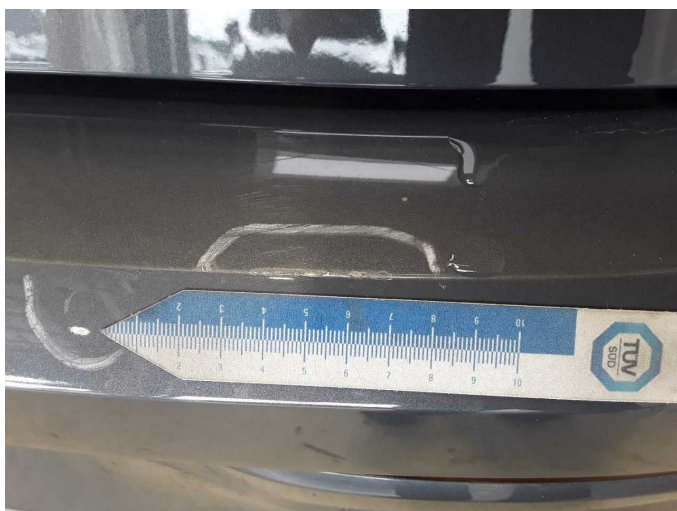
| No. | Component group | Description |
|---|---|---|
| 2 | Rear bumper | Rear bumper - Scratch(es) - Smart repair |

**Damage 2:** Rear bumper: Rear bumper - Scratch(es) - Smart repair
