Expertise

Protocol number: 46516429  
Order No. / Reference: 26541530  
Inspection date: 7 Jul 2026

Manufacturer: Hyundai

Model: IONIQ 5 77,4 kWh Techniq

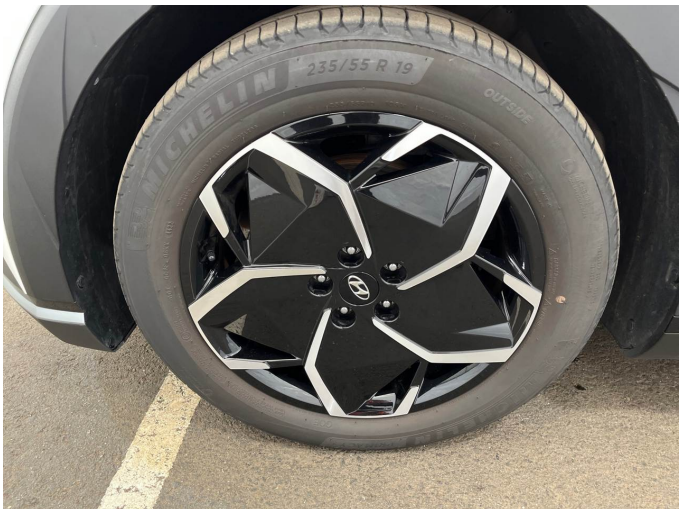
| Tyres | | | | |
|---|---|---|---|---|
| 1) | 235/55 R19 105W | Summer tyres on Light alloy | Michelin | 5mm / 5mm |
| 2) | 235/55 R19 105W | Summer tyres on Light alloy | Michelin | 5mm / 5mm |

Figure 12: Mounted tyres

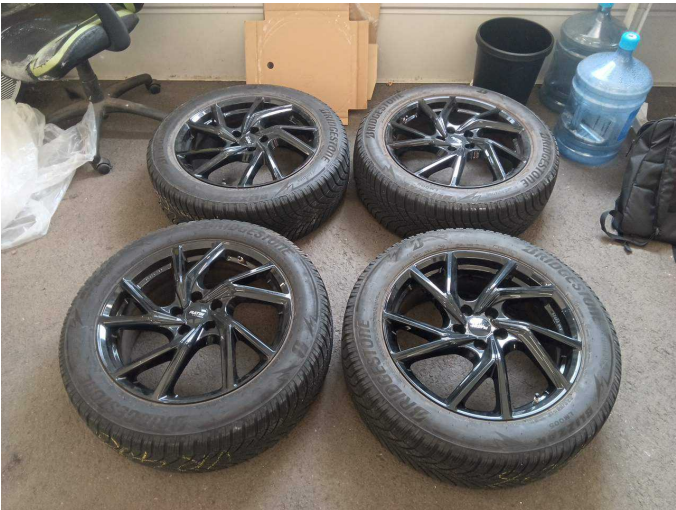
| Tyres | | | | |
|---|---|---|---|---|
| 1) | 235/55 R19 105V | Winter tyres on Light alloy | Bridgestone | 5mm / 5mm |
| 2) | 235/55 R19 105V | Winter tyres on Light alloy | Bridgestone | 5mm / 5mm |

Figure 17: Additional tyres

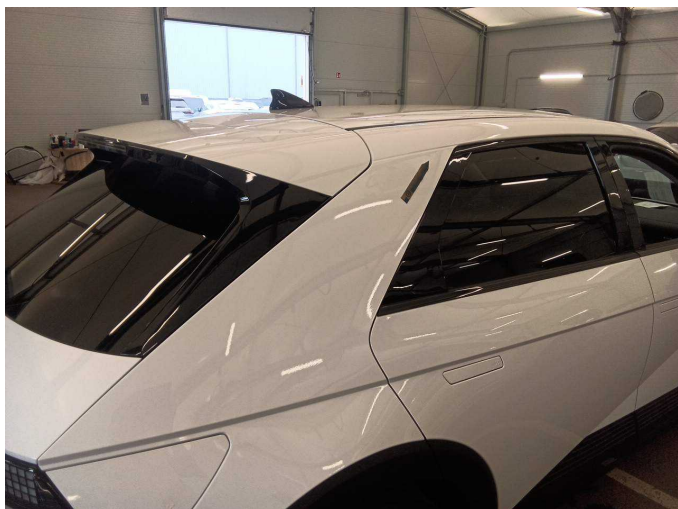
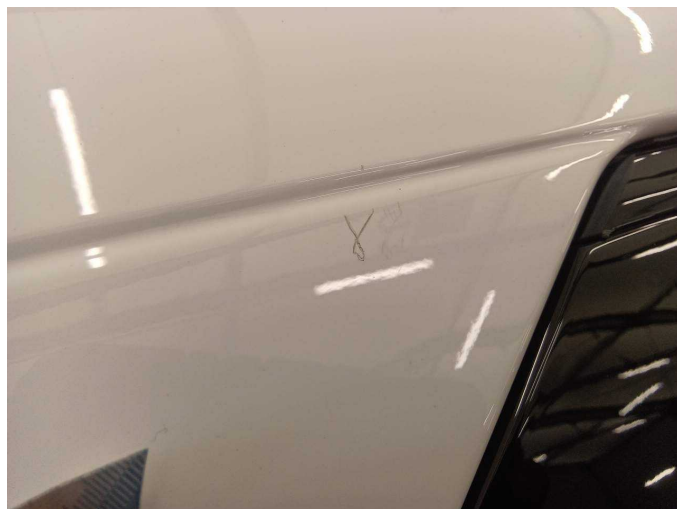
| No. | Component group | Description |
|---|---|---|
| 1 | Side panel - rear right side | Side panel - Scratched - Paint |

**Damage 1:** Side panel - rear right side: Side panel - Scratched - Paint

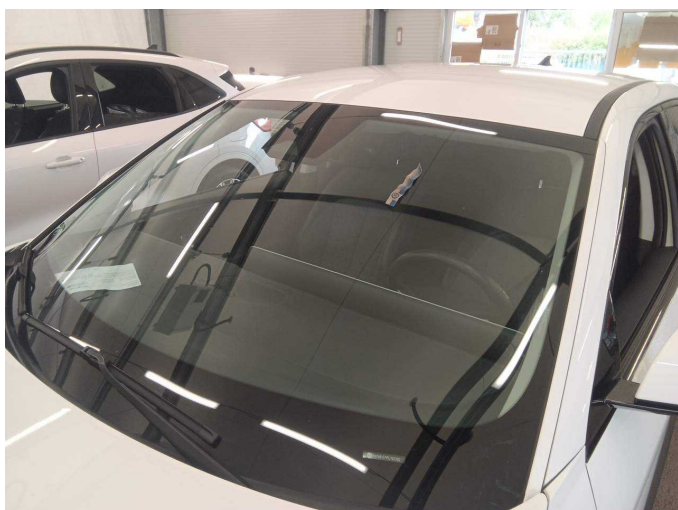
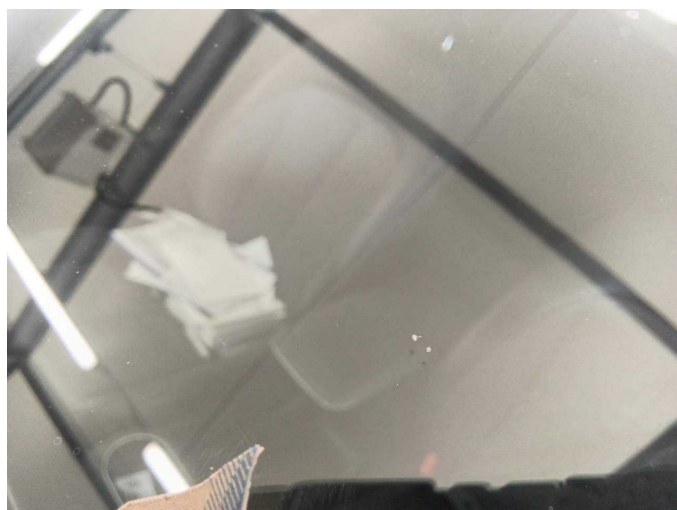
| No. | Component group | Description |
|---|---|---|
| 1 | Vehicle glazing | Windscreen - Stone chips - No deduction |

**Wear and tear 1:** Vehicle glazing: Windscreen - Stone chips - No deduction

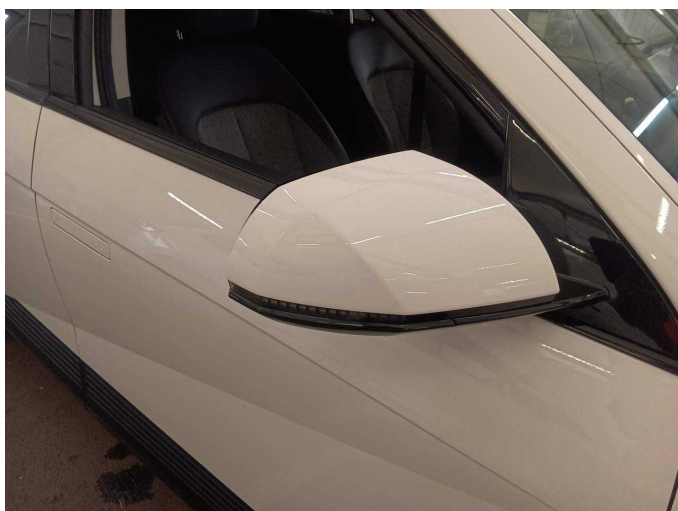
| No. | Component group | Description |
|---|---|---|
| 2 | Wing mirror - right side | Cap - Scratch(es) - No deduction |

**Wear and tear 2:** Wing mirror - right side: Cap - Scratch(es) - No deduction
