Expertise

Protocol number: 46392394  
Order No. / Reference: 26612432  
Inspection date: 7 Jul 2026

| Manufacturer: Opel | Model: Astra Sports Tourer 1.5 D Automatik Business Elegance |

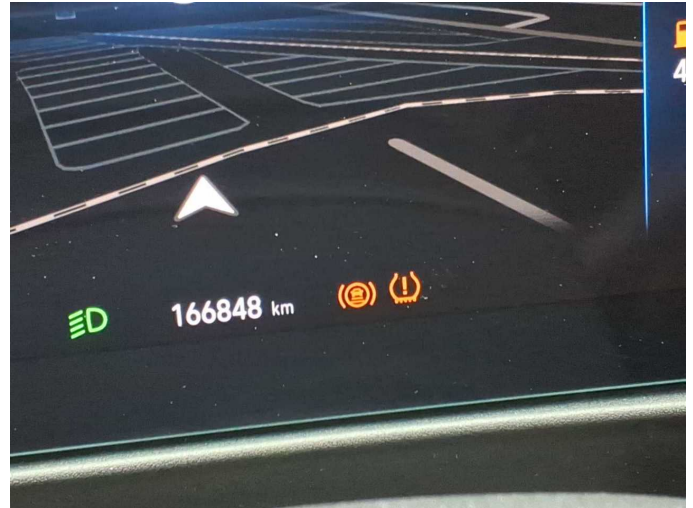
| No. | Component group | Description |
|---|---|---|
| 1 | Instrument panel | Indicator light (Reifendruck) - on - Perform diagnosis |

**Damage 1:** Instrument panel: Indicator light (Reifendruck) - on - Perform diagnosis

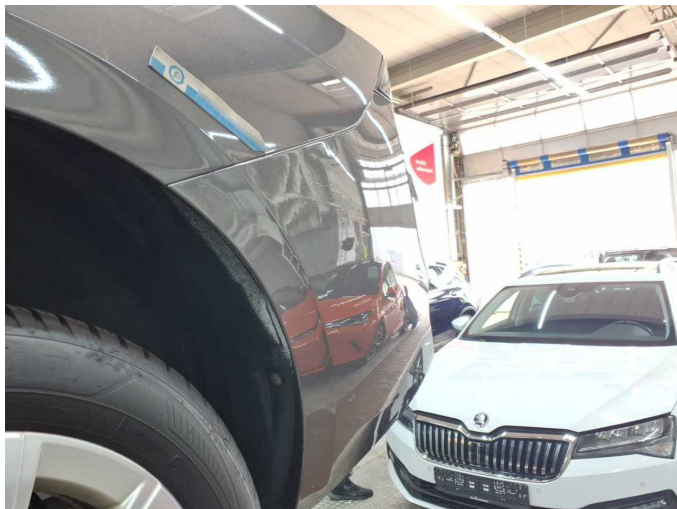
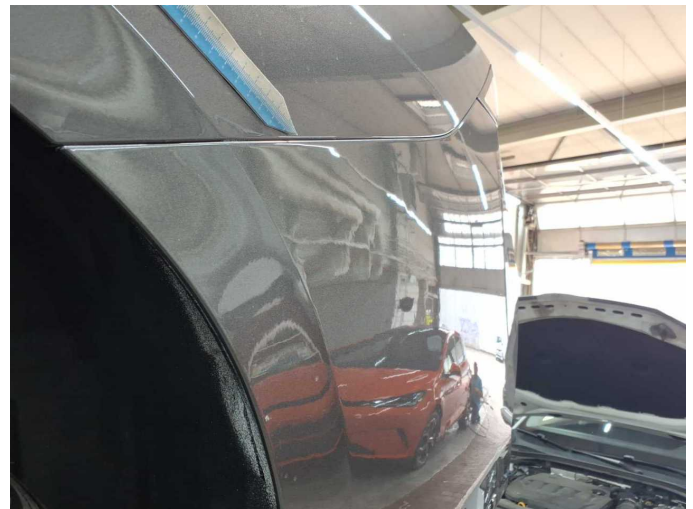
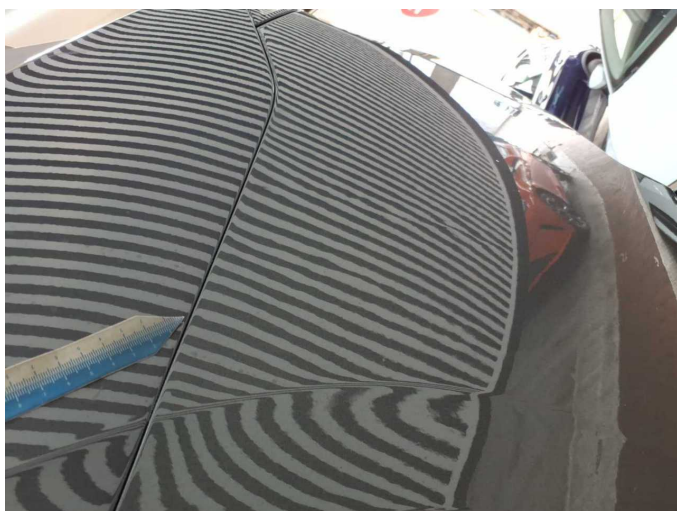
| No. | Component group | Description |
|---|---|---|
| 2 | Rear bumper | Rear bumper (wellig) - Paint defect - Paint |

**Damage 2:** Rear bumper: Rear bumper (wellig) - Paint defect - Paint

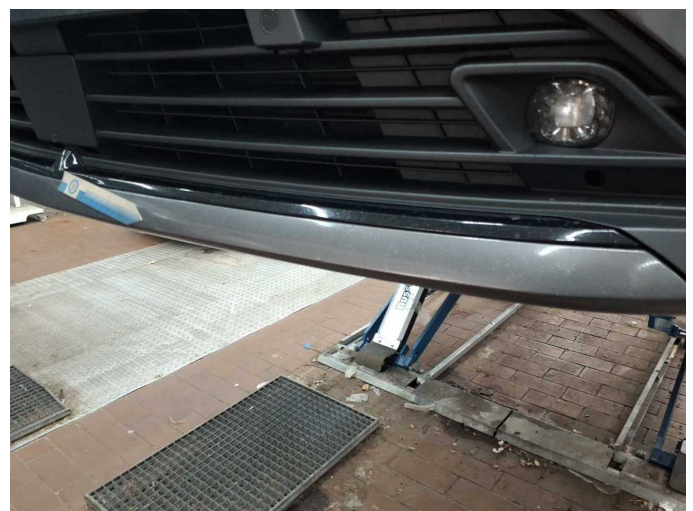
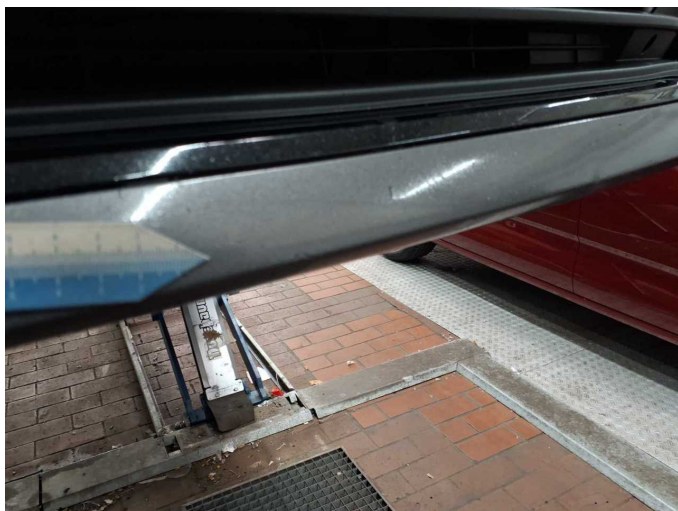
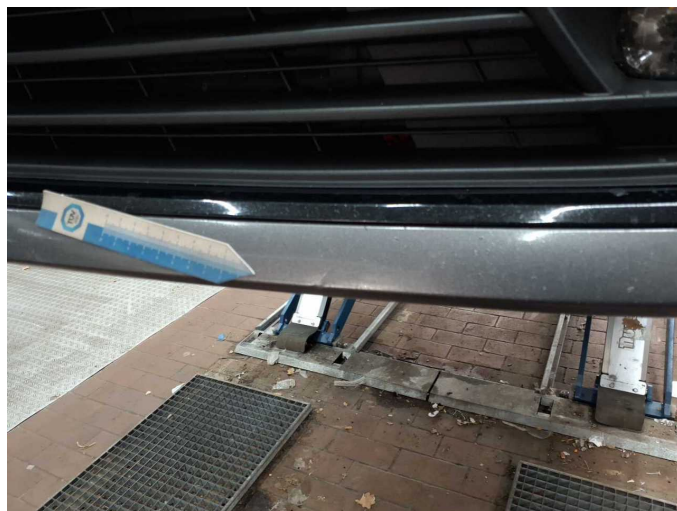
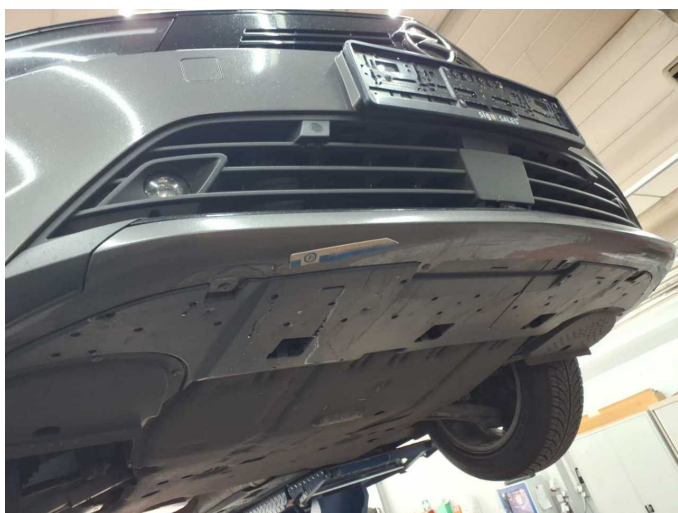
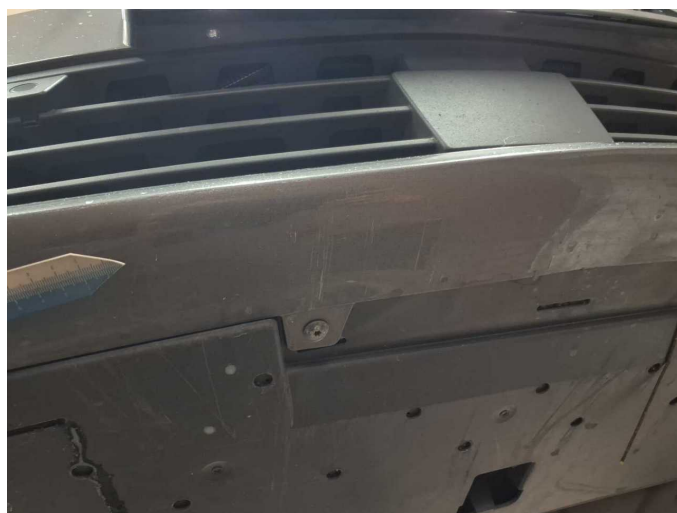
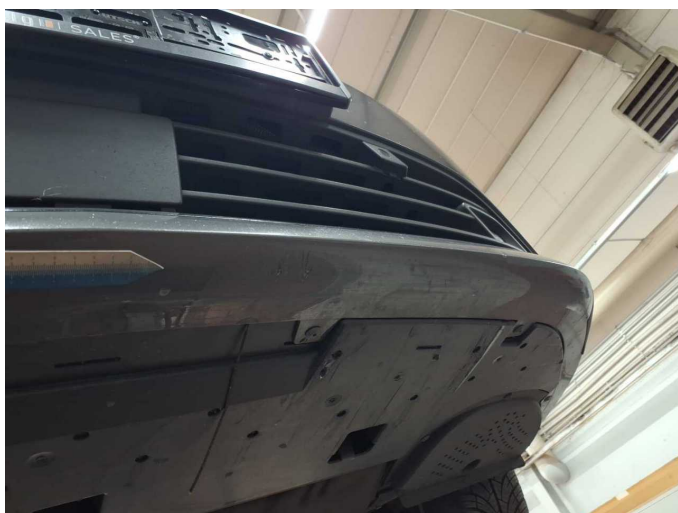
| No. | Component group | Description |
|---|---|---|
| 4 | Front bumper | Front bumper (Steinschläge) - Scratch(es) - No deduction |

**Wear and tear 4:** Front bumper: Front bumper (Steinschläge) - Scratch(es) - No deduction

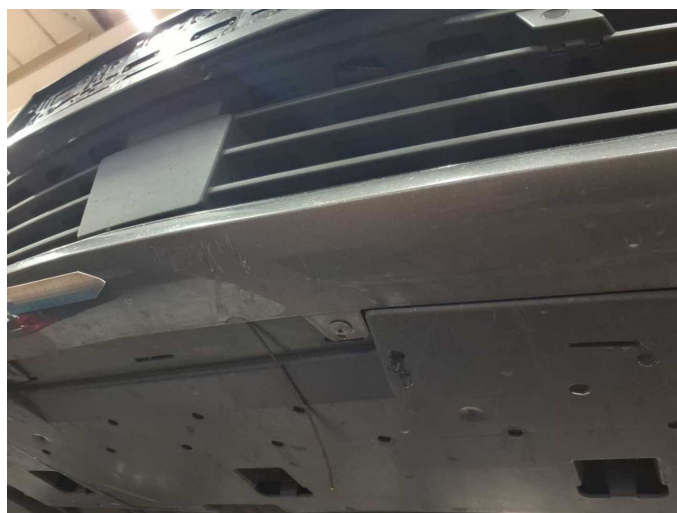
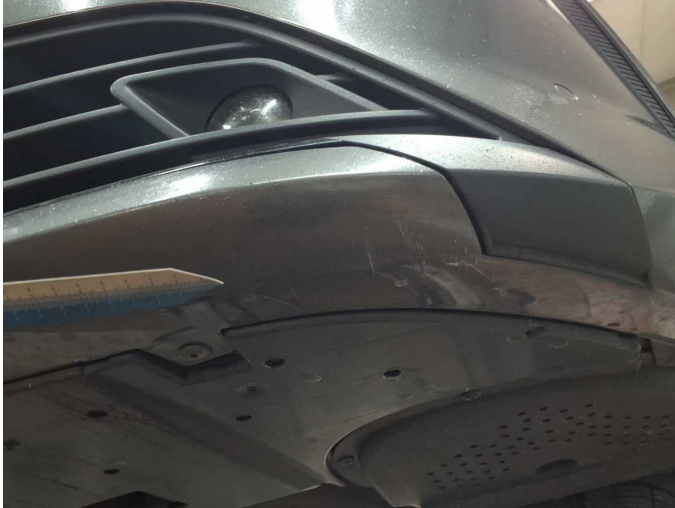
**Wear and tear 4:** Front bumper: Front bumper (Steinschläge) -  
Scratch(es) - No deduction

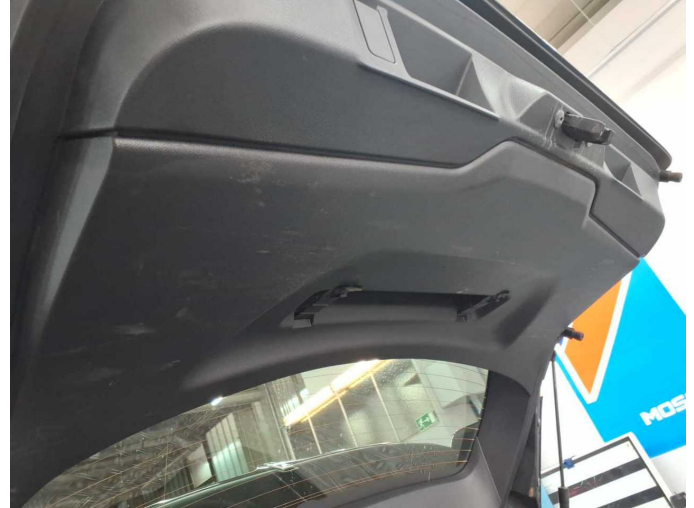
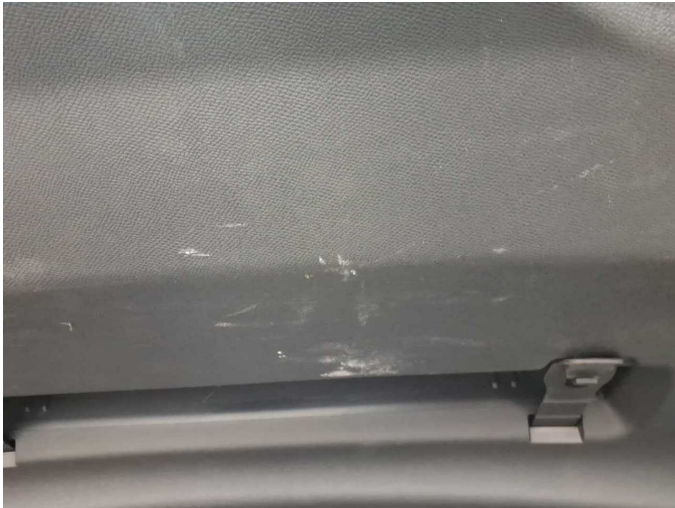
| No. | Component group | Description |
|---|---|---|
| 5 | Boot lid / rear door | Boot lid (Verkleidung) - Scratch(es) - No deduction |

**Wear and tear 5:** Boot lid / rear door: Boot lid (Verkleidung) - Scratch(es) - No deduction
