Expertise

Protocol number: 46904729  
Order No. / Reference: 26841514  
Inspection date: 4 Aug 2026

Manufacturer: Volkswagen

Model: Golf Variant 2.0 TDI 4Motion SCR DSG Alltrack

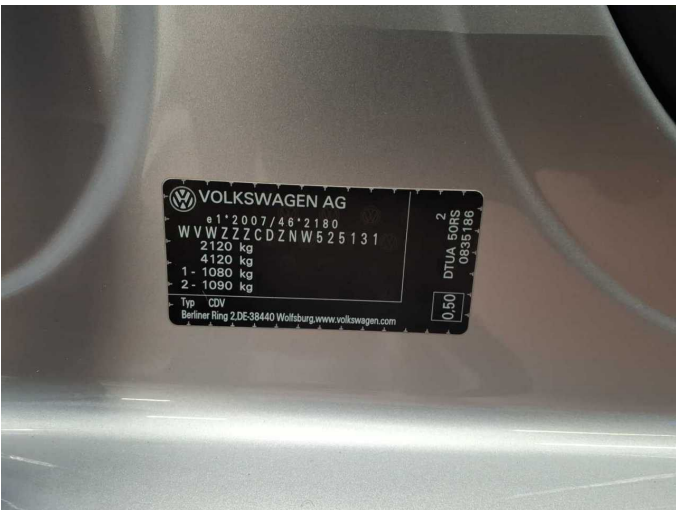
Figure 11: VIN

| VIN comparison | The vehicle identification number (VIN) was read from the vehicle and its conformity with the submitted documents was confirmed by the undersigned during the inspection. |

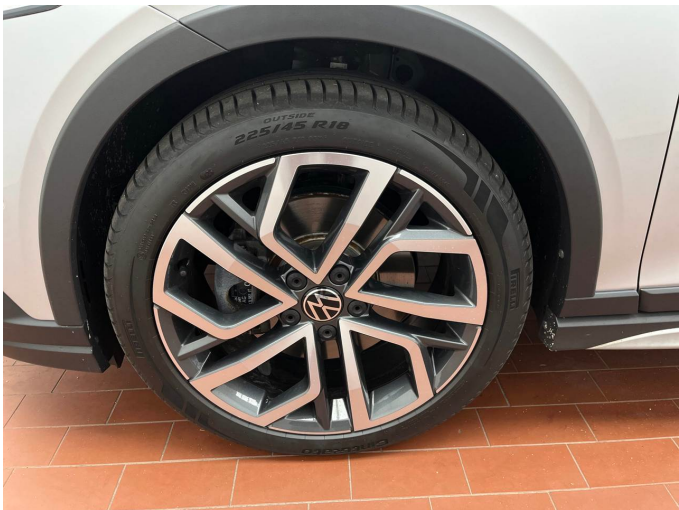
| # | Tyre size | Type of tyre | Manufacturer | Tread depth |
|---|---|---|---|---|
| 1) | 225/45 R18 95Y | Summer tyres on Light alloy | Pirelli | 7mm / 7mm |
| 2) | 225/45 R18 95Y | Summer tyres on Light alloy | Pirelli | 7mm / 7mm |

Figure 12: Mounted tyres

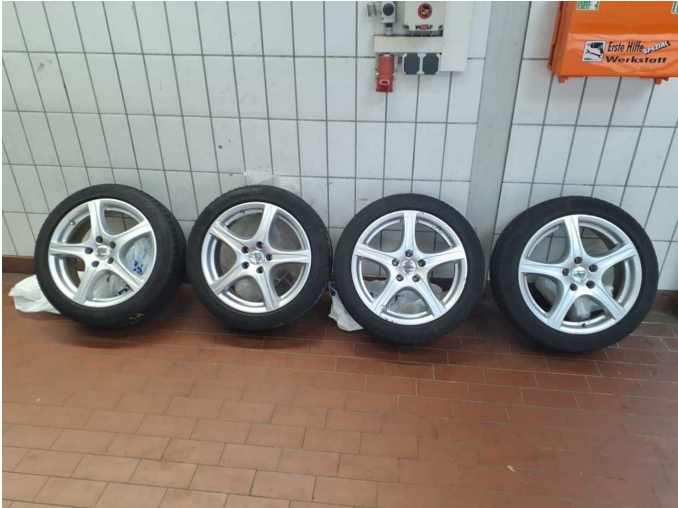
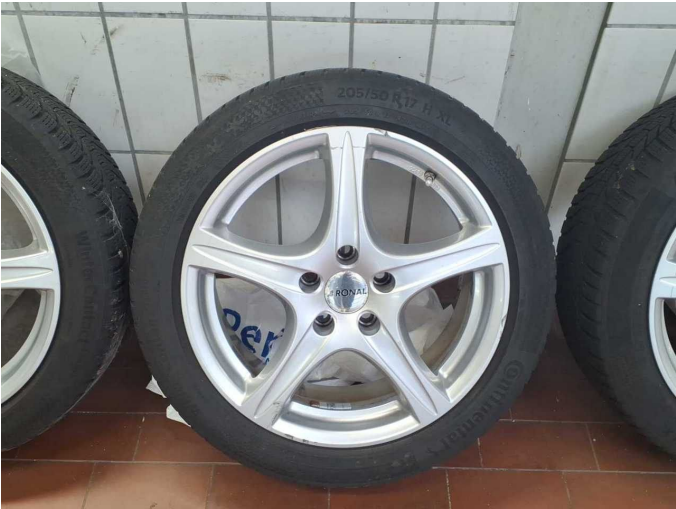
| # | Tyre size | Type of tyre | Manufacturer | Tread depth |
|---|---|---|---|---|
| 1) | 205/50 R17 93H | Winter tyres on Light alloy | Continental | 6mm / 6mm |
| 2) | 205/50 R17 93H | Winter tyres on Light alloy | Continental | 6mm / 6mm |

Figure 16: Additional tyres

Figure 17: Additional tyres

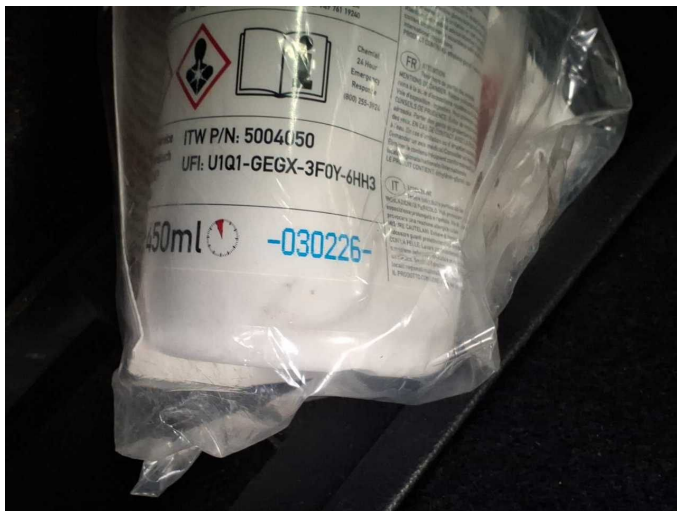
| No. | Component group | Description |
|---|---|---|
| 1 | Equipment | Tirefit filler - Expired - Replace |

**Damage 1:** Equipment: Tirefit filler - Expired - Replace

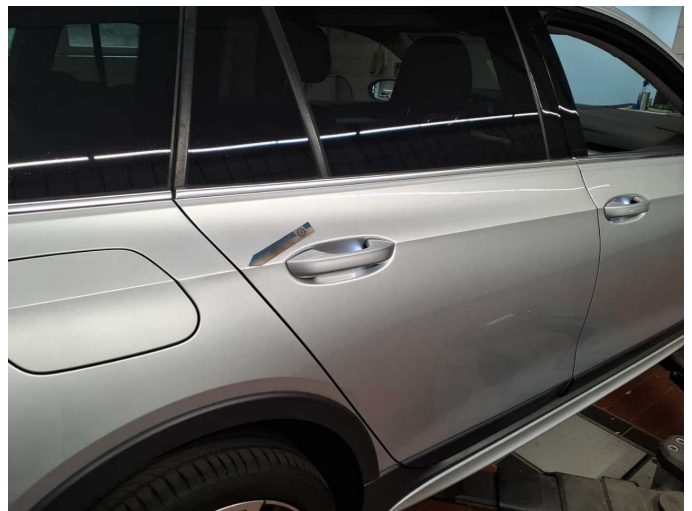
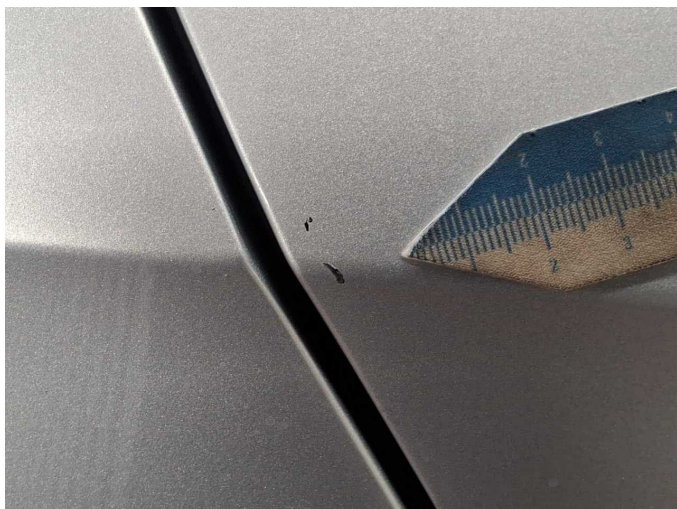
| No. | Component group | Description |
|---|---|---|
| 2 | Door - rear right side | Door - Scratch(es) - Smart repair |

**Damage 2:** Door - rear right side: Door - Scratch(es) - Smart repair

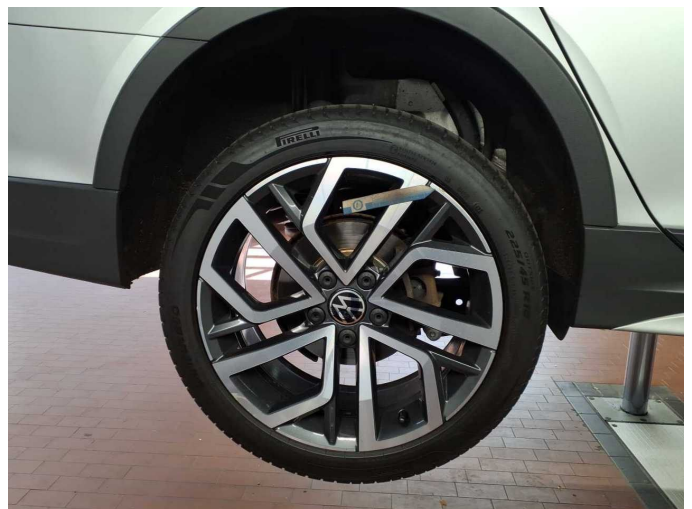
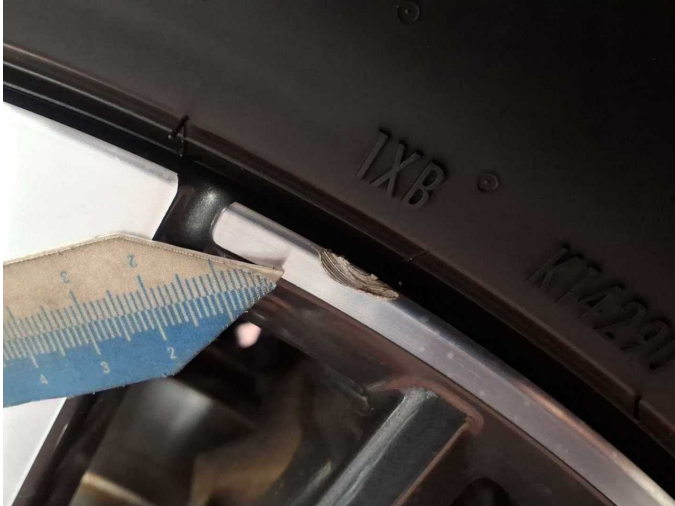
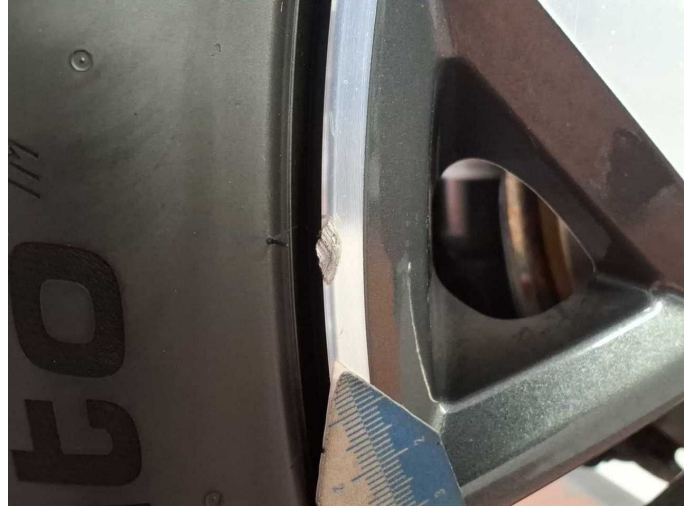
| No. | Component group | Description |
|---|---|---|
| 3 | Wheel / tyres | Alloy rim - rear right side - Scratched - Loss in value |

**Damage 3:** Wheel / tyres: Alloy rim - rear right side - Scratched - Loss in value

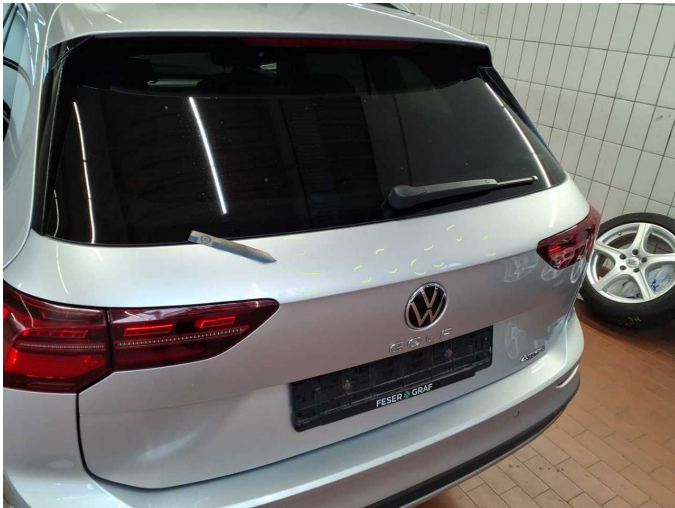
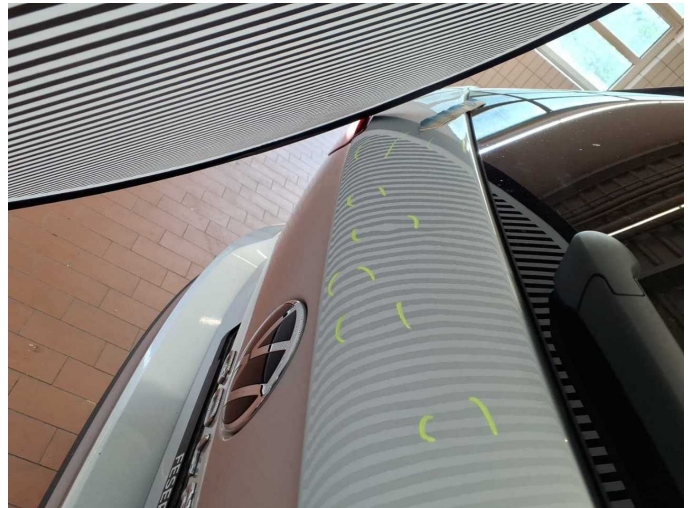
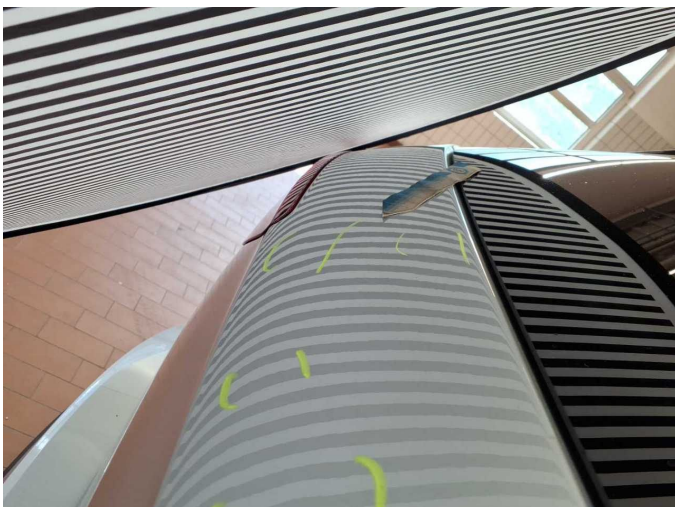
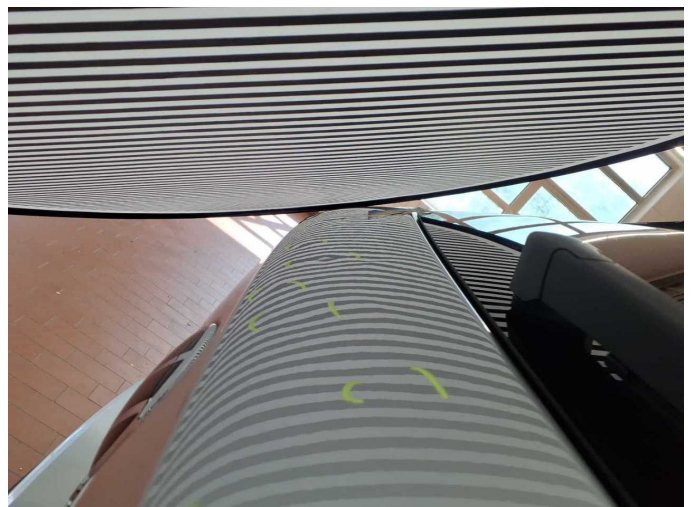
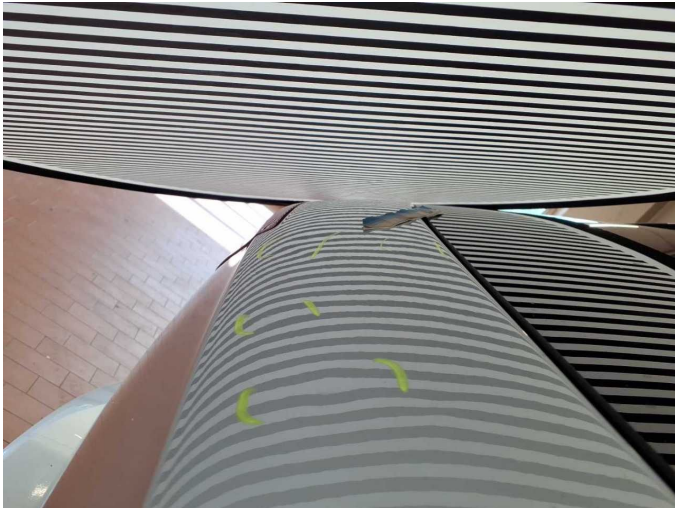
| No. | Component group | Description |
|---|---|---|
| 4 | Boot lid / rear door | Boot lid - dent(s) - Smooth repair work |

**Damage 4:** Boot lid / rear door: Boot lid - dent(s) - Smooth repair work

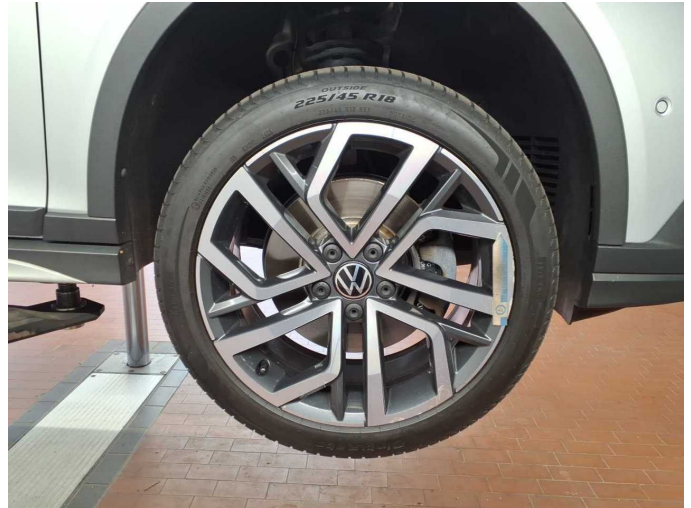
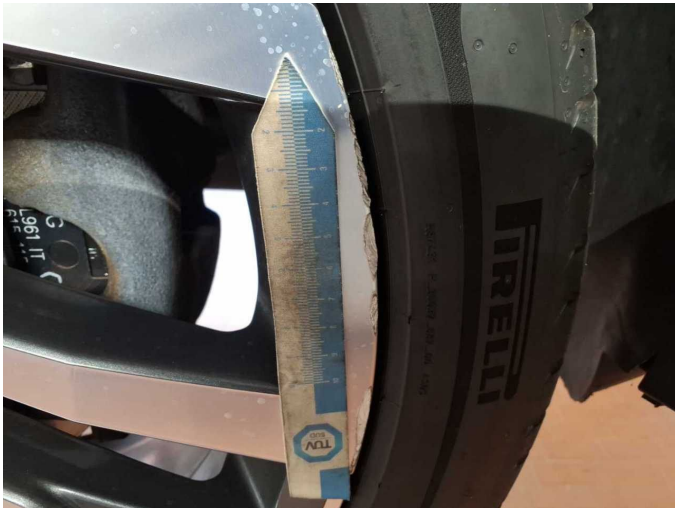
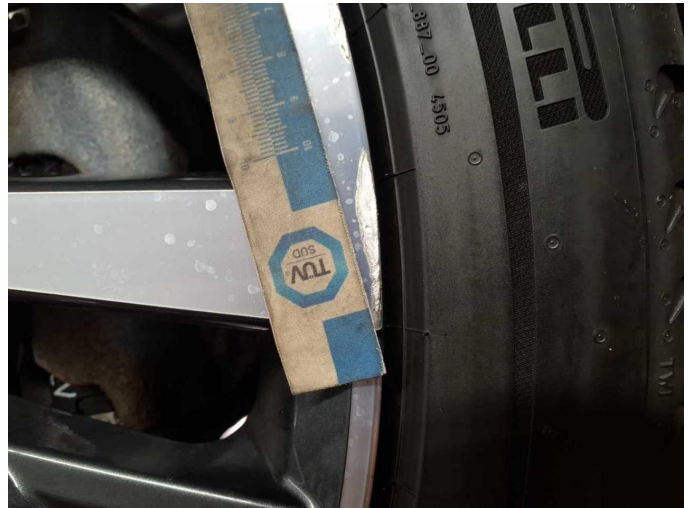
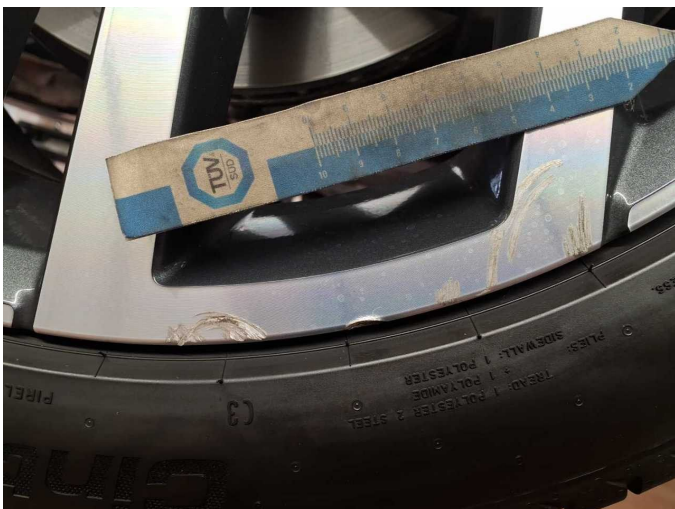
| No. | Component group | Description |
|---|---|---|
| 5 | Wheel / tyres | Alloy rim - front right side - Scratched - Replace |

**Damage 5:** Wheel / tyres: Alloy rim - front right side - Scratched - Replace

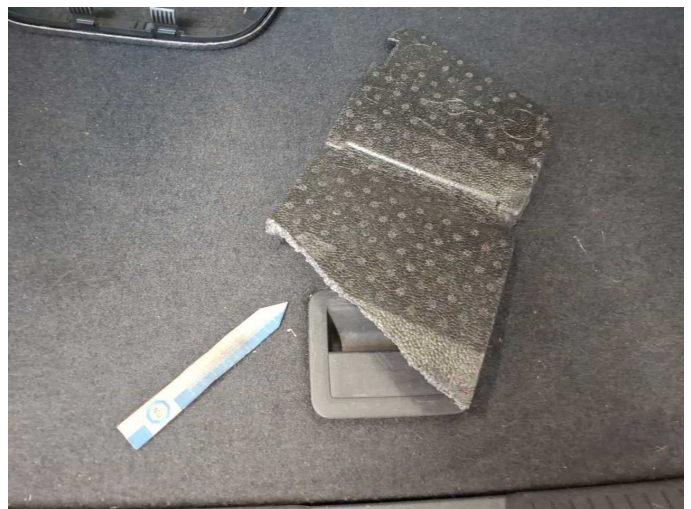
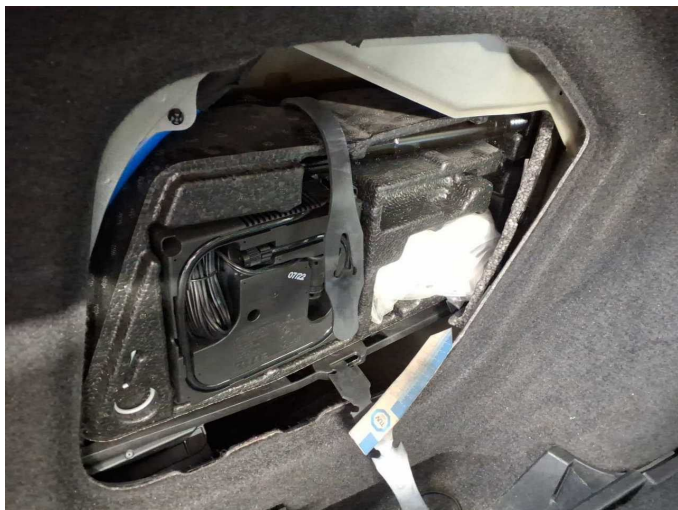
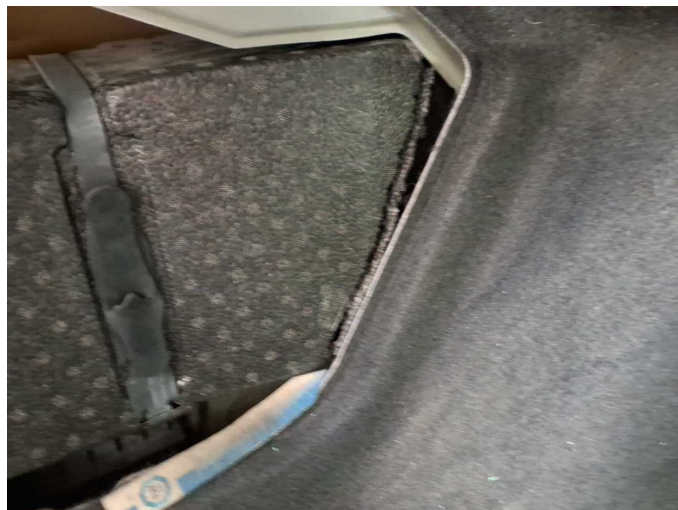
| No. | Component group | Description |
|---|---|---|
| 1 | Misc. | Misc. (Gehäuse für Pannenset) - Broken / torn - No deduction |

**Wear and tear 1:** Misc.: Misc. (Gehäuse für Pannenset) - Broken / torn - No deduction

**Wear and tear 1:** Misc.: Misc. (Gehäuse für Pannenset) - Broken / torn -  
No deduction

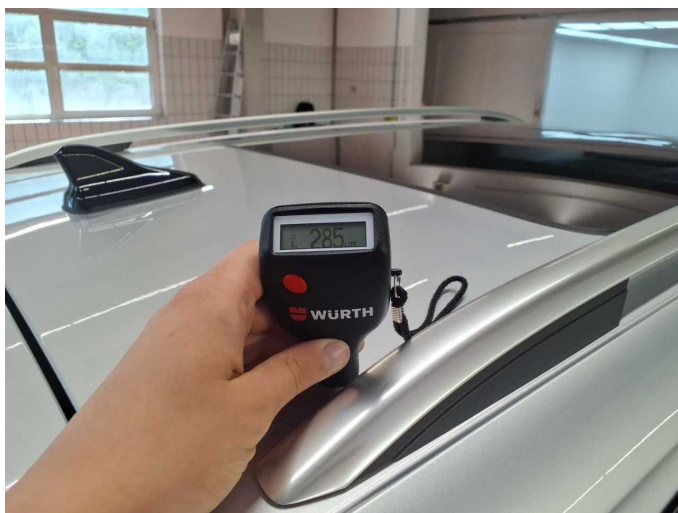
| No. | Repainting |
|---|---|
| 1 | Roof, Professionally carried out, Invoice of repair done Non-existent |

| Roof | 285 µm | Mudguard - left side | 188 µm |

**Repainting 1:** Roof

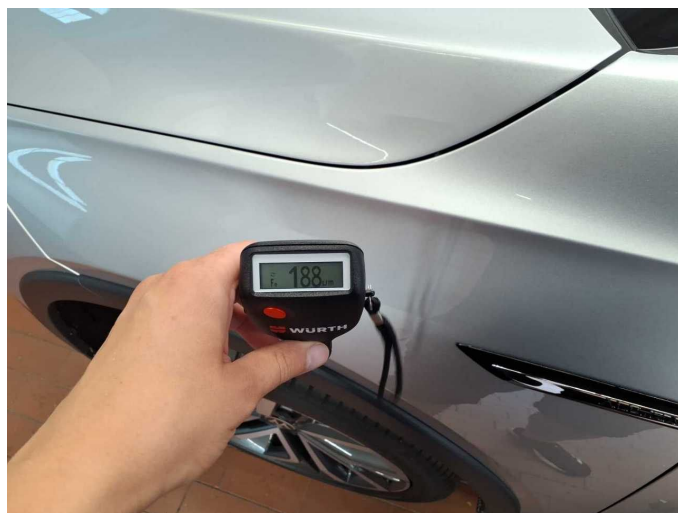
| No. | Repainting |
|---|---|
| 2 | Mudguard - left side, Professionally carried out, Invoice of repair done Non-existent |

**Repainting 2:** Mudguard - left side

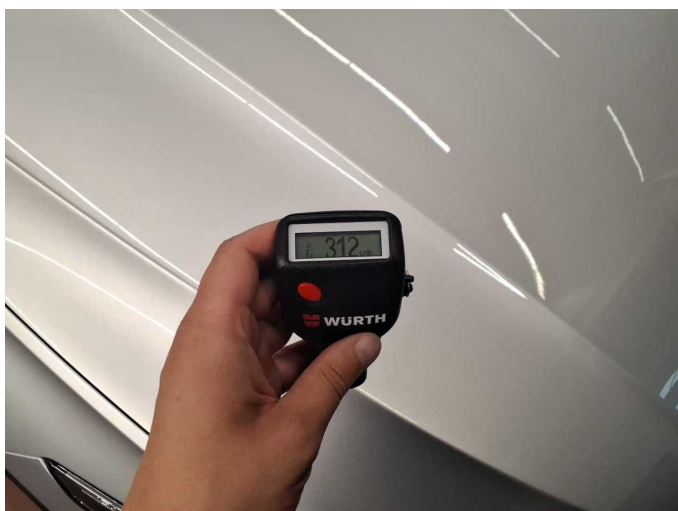
| No. | Repainting |
|---|---|
| 3 | Bonnet, Professionally carried out, Invoice of repair done Non-existent |

| Bonnet | 312 µm | | |

**Repainting 3:** Bonnet
