Expertise

Protocol number: 45530743
Order No. / Reference: 26277009
Inspection date: 7 May 2026

Model: Focus Turnier 1.5 EcoBlue Start-Stopp-System Aut. TITANIUM
STYLE

VIN: WF0PXXGCHPNT51419

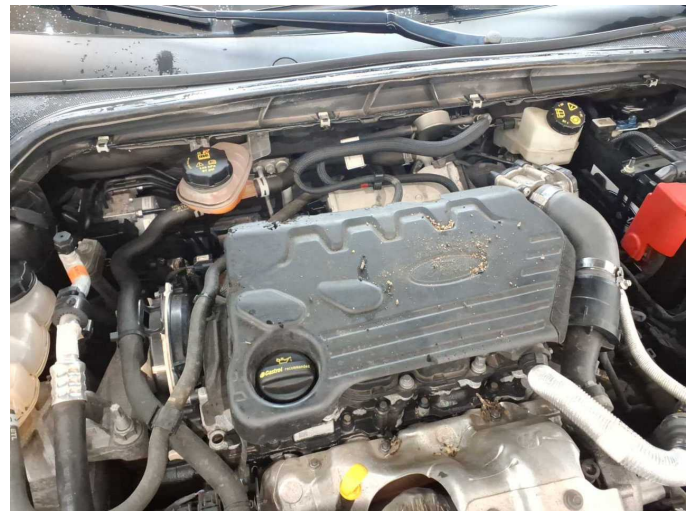
Marder Spuren sind im Motorraum, weitere Schäden sind möglich.

Damage 1: Engine: Engine cover - Damage caused by marten / rodent - Replace

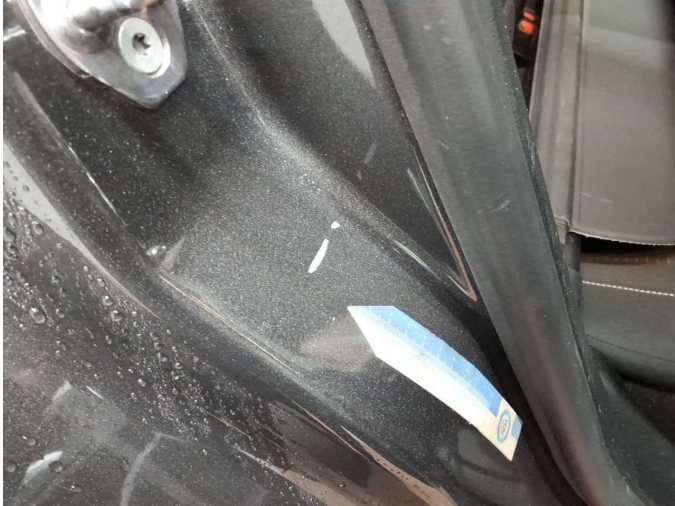
Damage 2: Side panel - rear right side: Sill - Scratch(es) - Smart repair

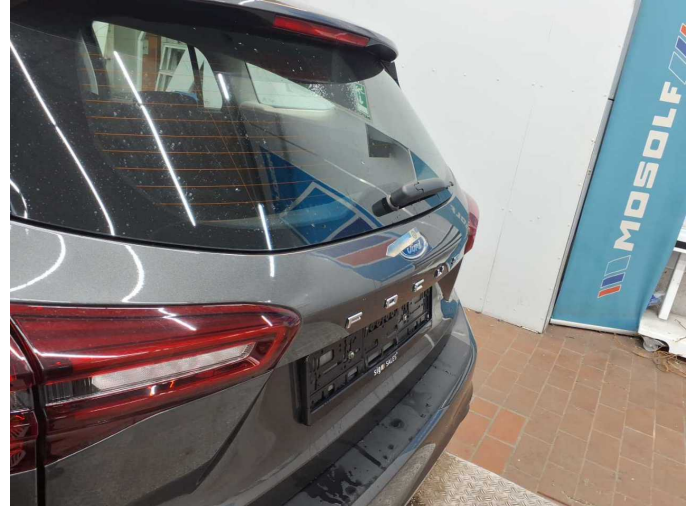
Damage 3: Boot lid / rear door: Boot lid - dent(s) - Smart repair

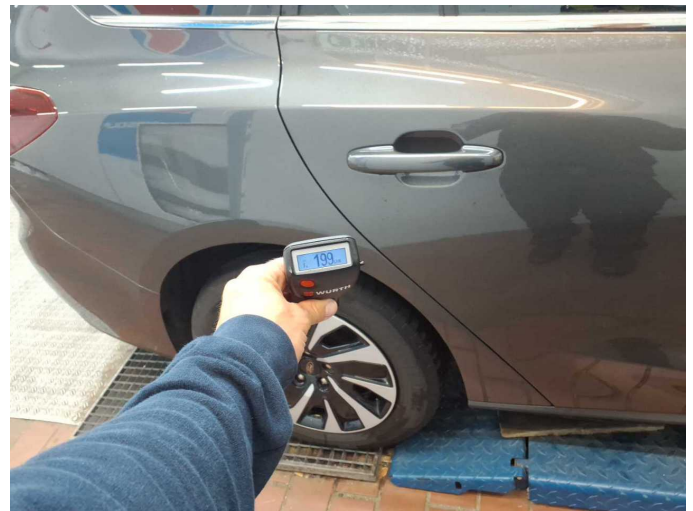
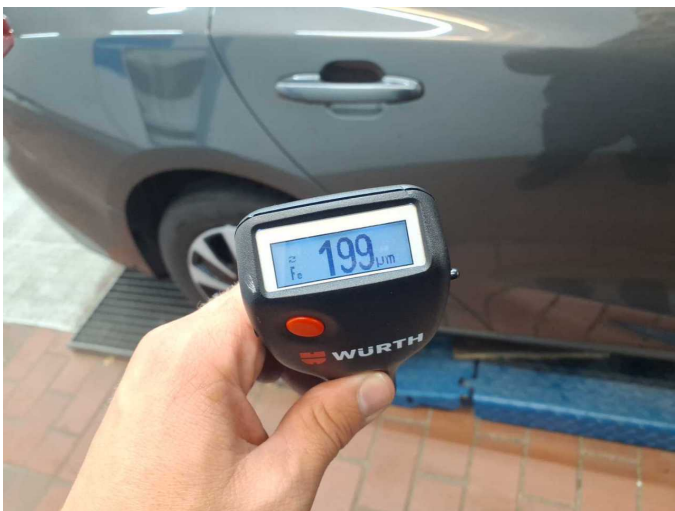
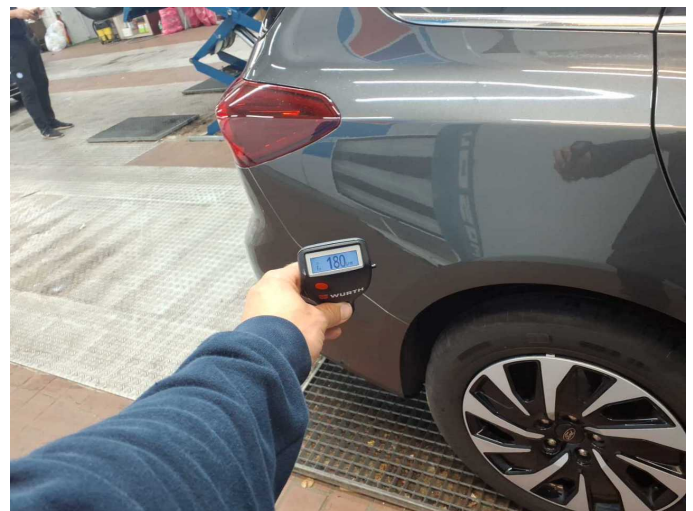
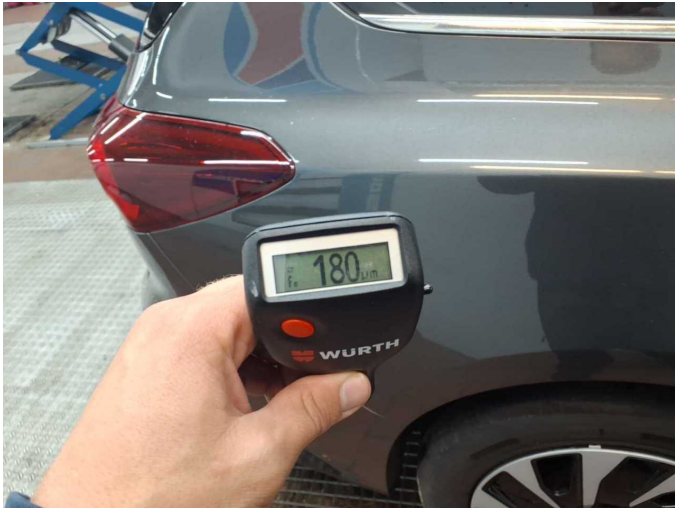
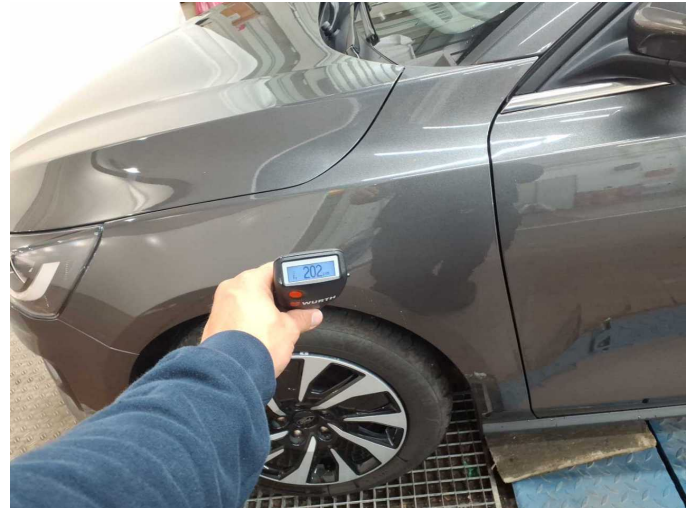
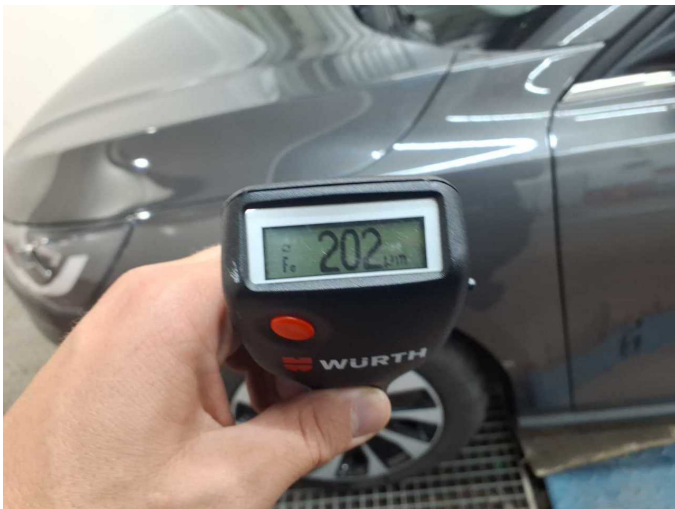
No.	Repainting
1	Mudguard - left side, Side panel - rear right side, Door - rear right side, Professionally carried out, Invoice of repair done Non-existent

Mudguard - left side	202 µm	Side panel - rear right side	180 µm
Door - rear right side	199 µm

Repainting 1: Mudguard - left side, Side panel - rear right side, Door - rear right side
