Expertise

Protocol number: 46276651  
Order No. / Reference: 26561964  
Inspection date: 24 Jun 2026

Manufacturer: Ford

Model: S-Max 2.0 EcoBlue Aut. TITANIUM

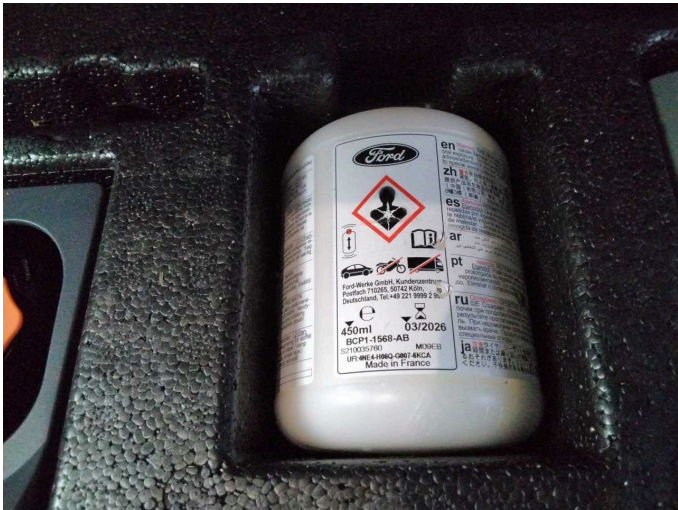
Damage 1: Equipment: Tirefit filler - Expired - Replace

| No. | Component group | Description |
|---|---|---|
| 1 | Equipment | Tirefit filler - Expired - Replace |

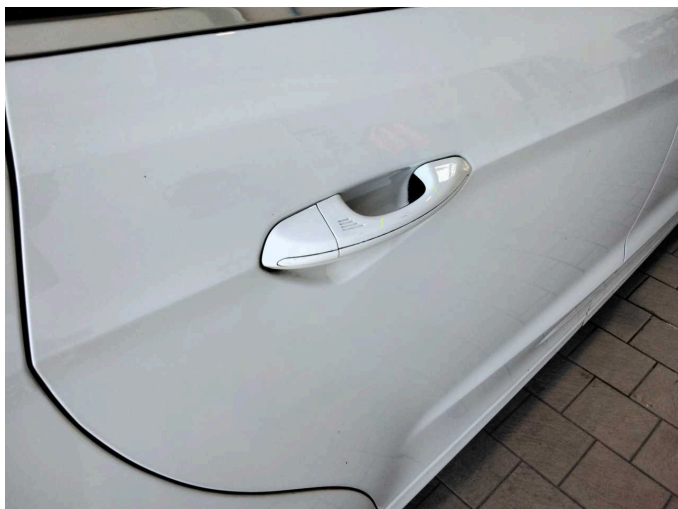
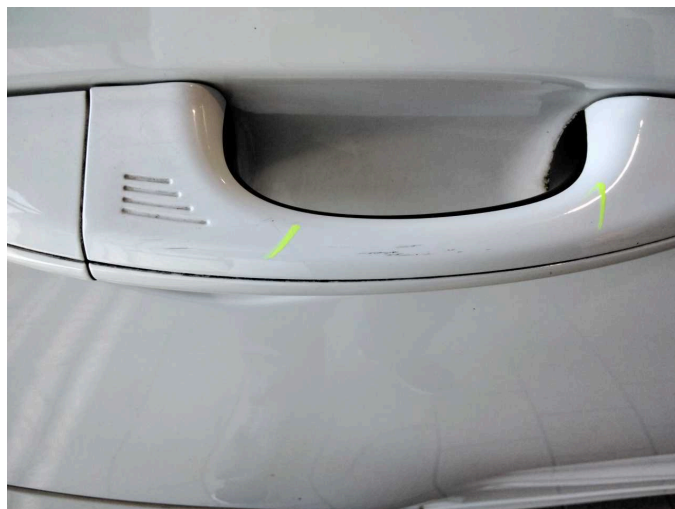
**Damage 2:** Door - rear right side: Door handle - outside - Scratch(es) - Smart repair

| No. | Component group | Description |
|---|---|---|
| 2 | Door - rear right side | Door handle - outside - Scratch(es) - Smart repair |

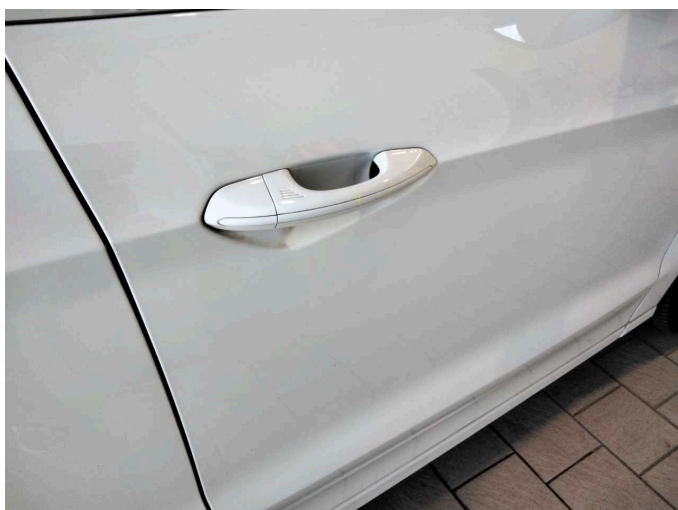
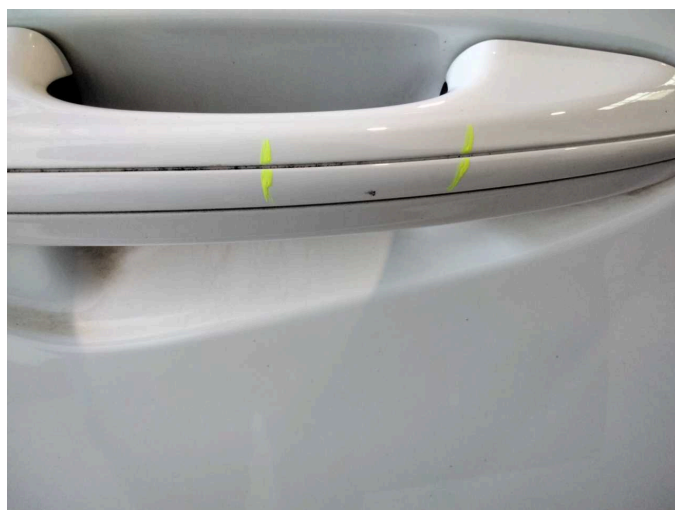
**Damage 3:** Door - front right side: Door handle - outside - Scratch(es) - Smart repair

| No. | Component group | Description |
|---|---|---|
| 3 | Door - front right side | Door handle - outside - Scratch(es) - Smart repair |

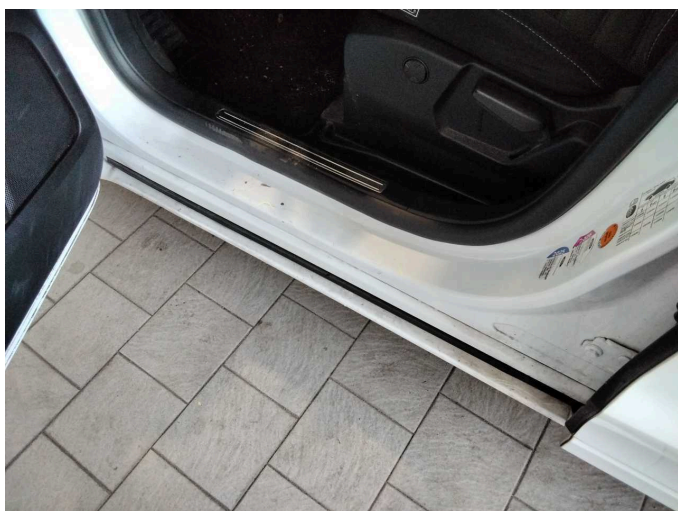
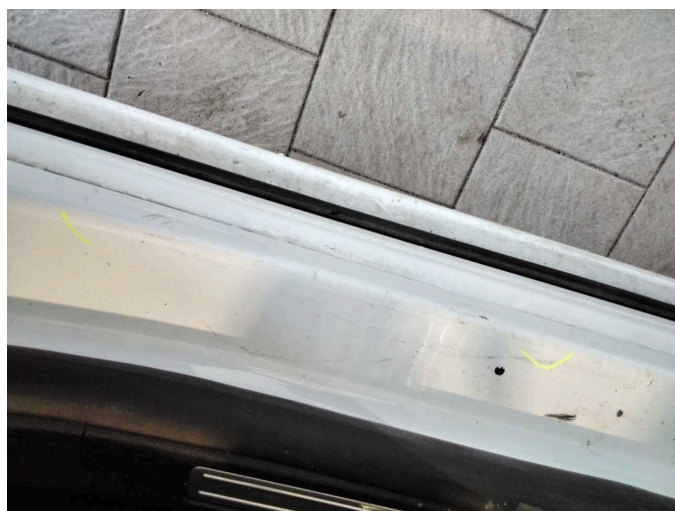
**Damage 4:** Sill - left side: Sill - Scratch(es) - Smart repair

| No. | Component group | Description |
|---|---|---|
| 4 | Sill - left side | Sill - Scratch(es) - Smart repair |

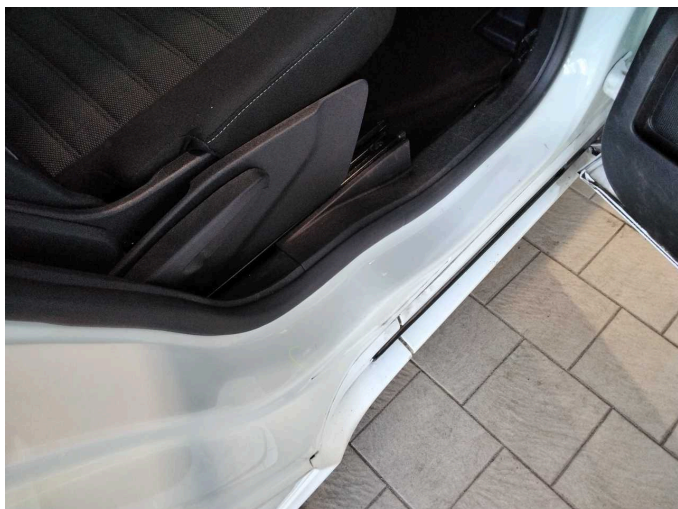
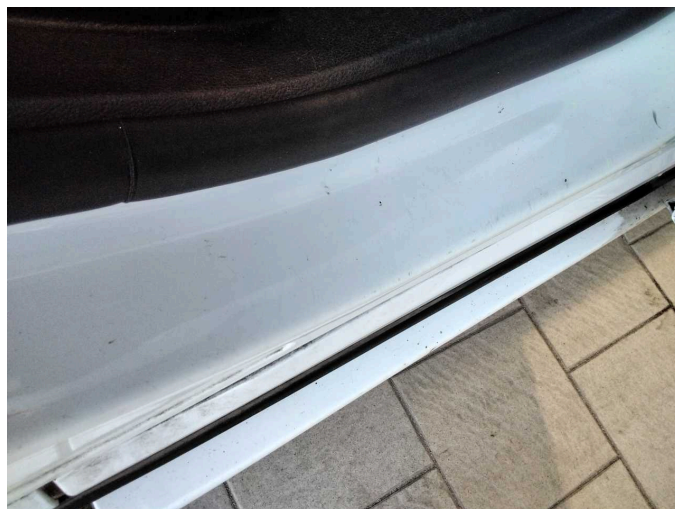
**Damage 5:** Side panel - rear right side: Sill - Scratch(es) - Smart repair

| No. | Component group | Description |
|---|---|---|
| 5 | Side panel - rear right side | Sill - Scratch(es) - Smart repair |

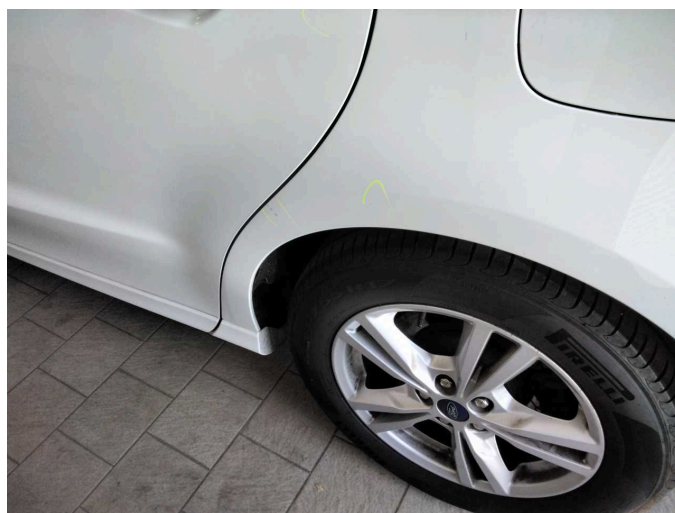
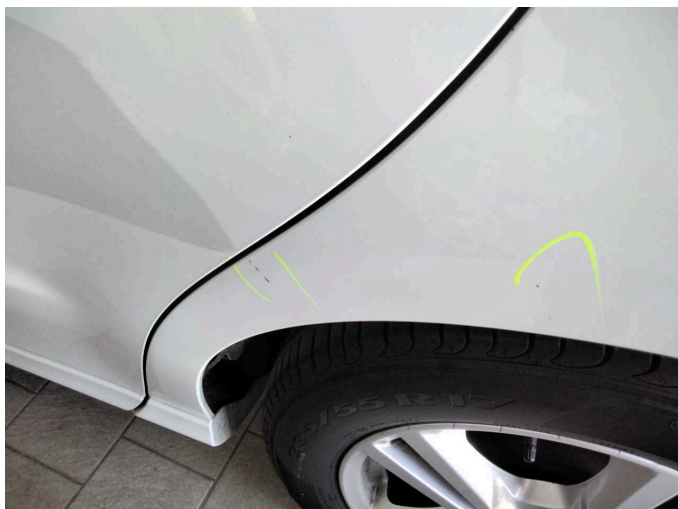
**Damage 7:** Side panel - rear left side: Side panel - Scratch(es) - Smart repair

| No. | Component group | Description |
|---|---|---|
| 7 | Side panel - rear left side | Side panel - Scratch(es) - Smart repair |

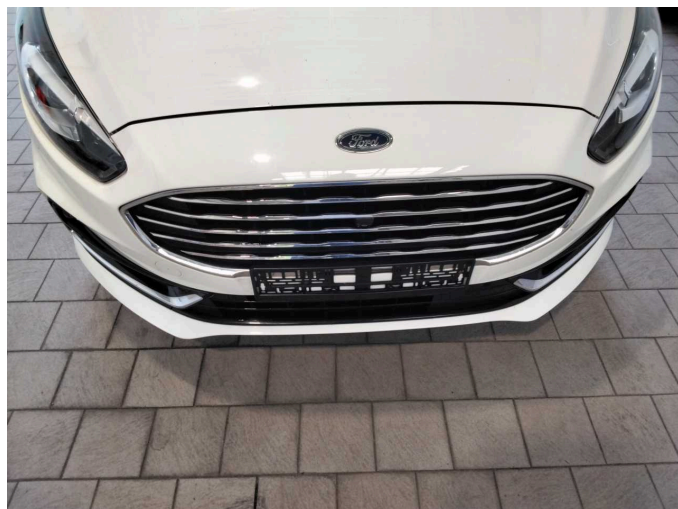
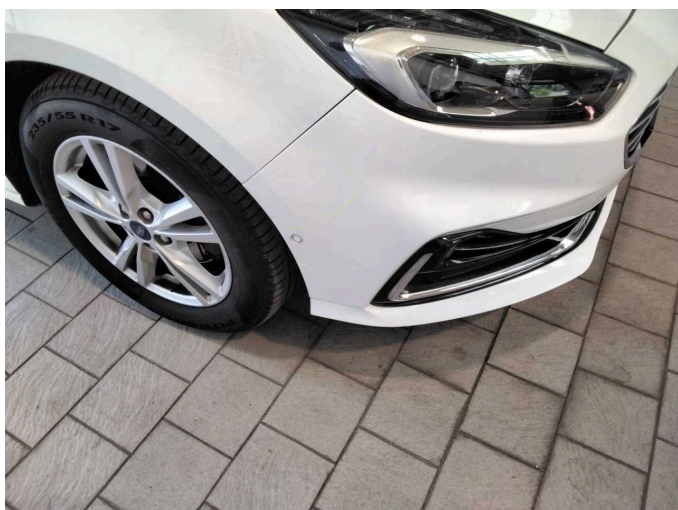
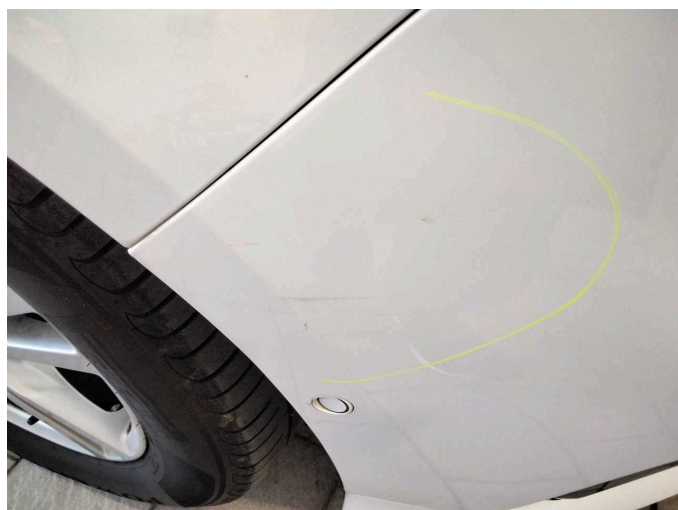
**Damage 8:** Front bumper: Front bumper - Scratch(es) - Smart repair

| No. | Component group | Description |
|---|---|---|
| 8 | Front bumper | Front bumper - Scratch(es) - Smart repair |

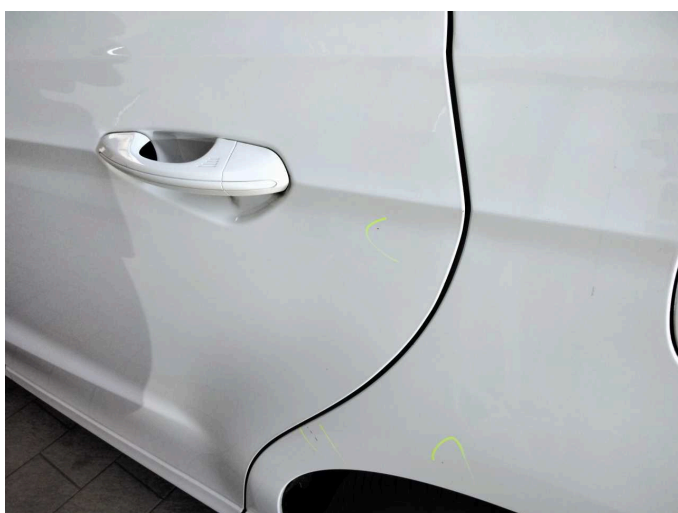
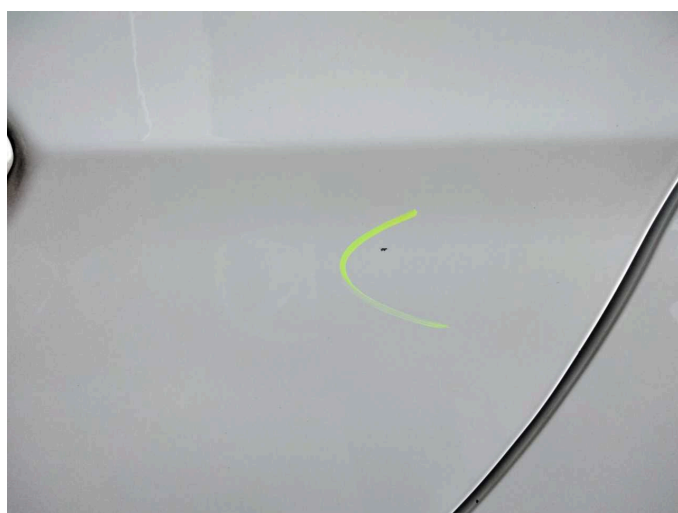
**Damage 9:** Door - rear left side: Door - Scratch(es) - Smart repair

| No. | Component group | Description |
|---|---|---|
| 9 | Door - rear left side | Door - Scratch(es) - Smart repair |

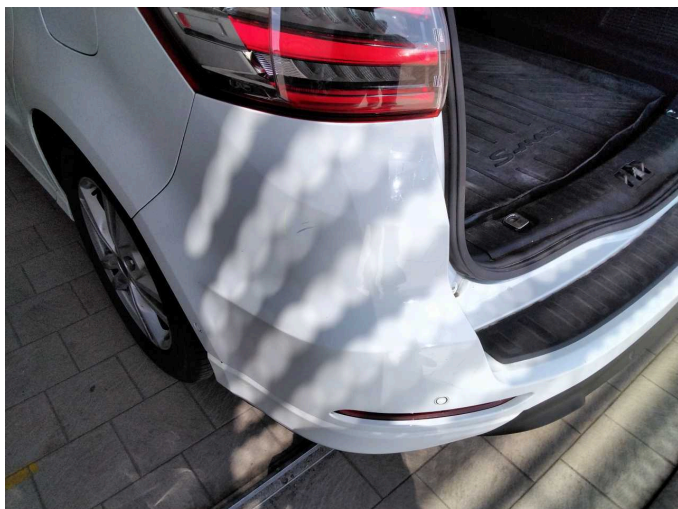
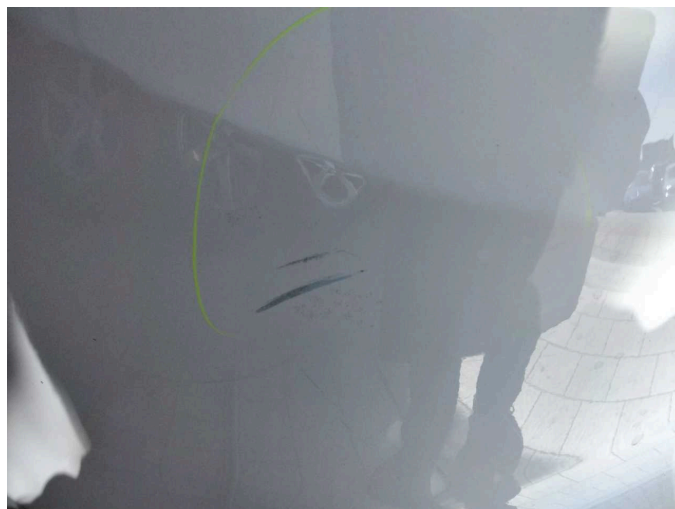
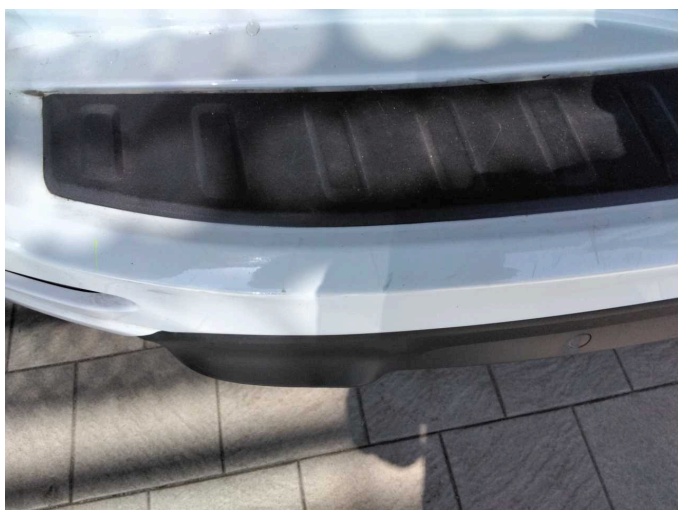
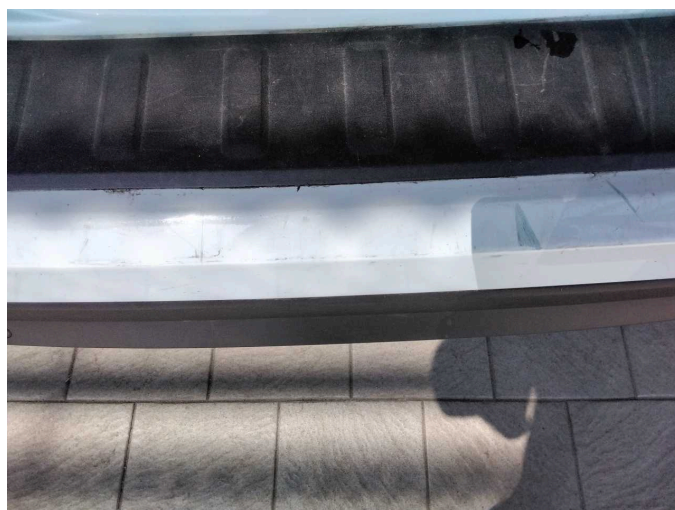
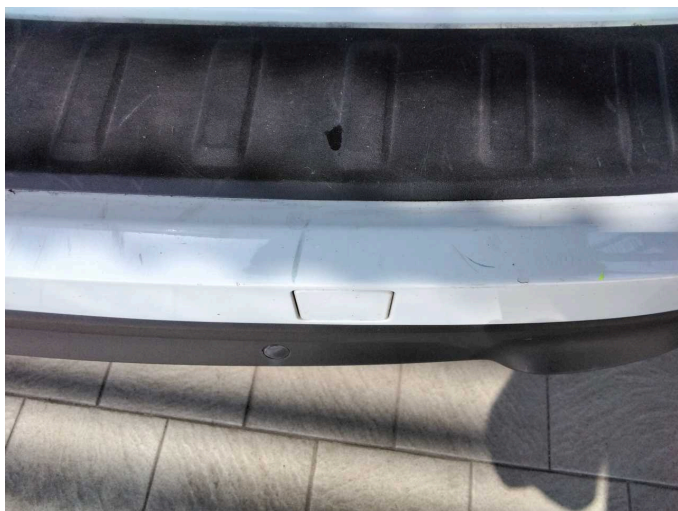
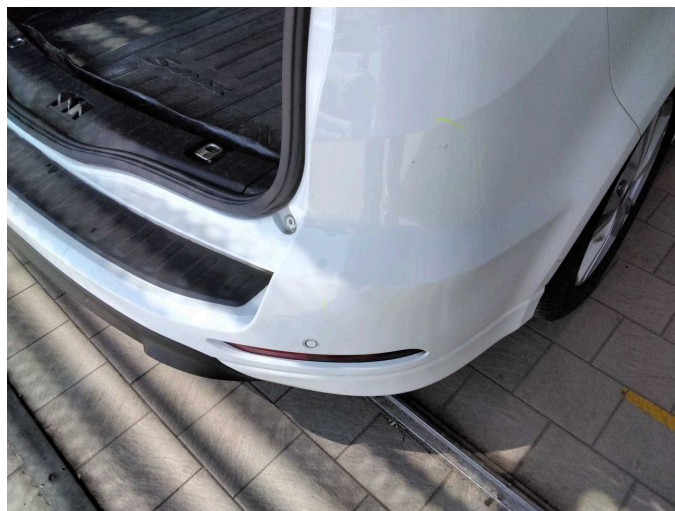
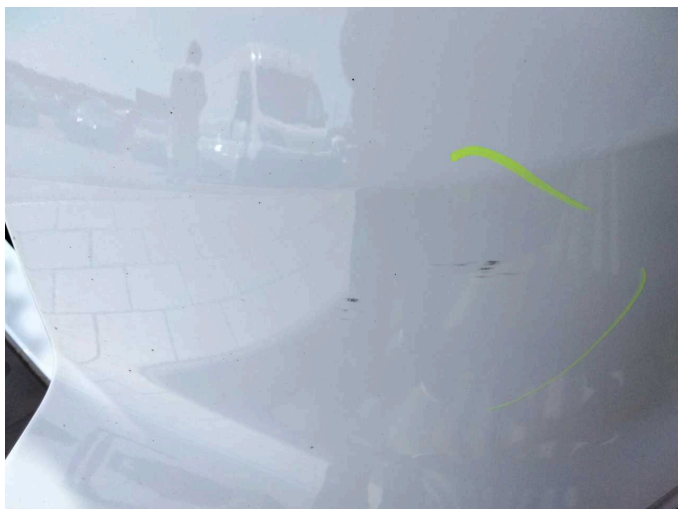
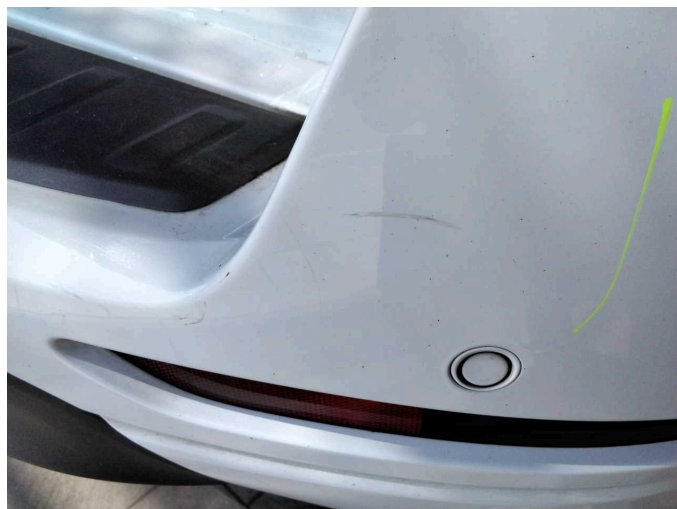
**Damage 10:** Rear bumper: Rear bumper - Scratch(es) - Paint

| No. | Component group | Description |
|---|---|---|
| 10 | Rear bumper | Rear bumper - Scratch(es) - Paint |

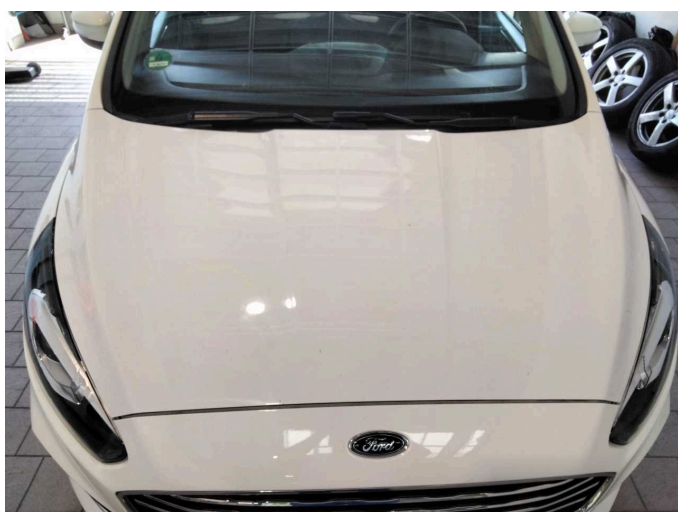
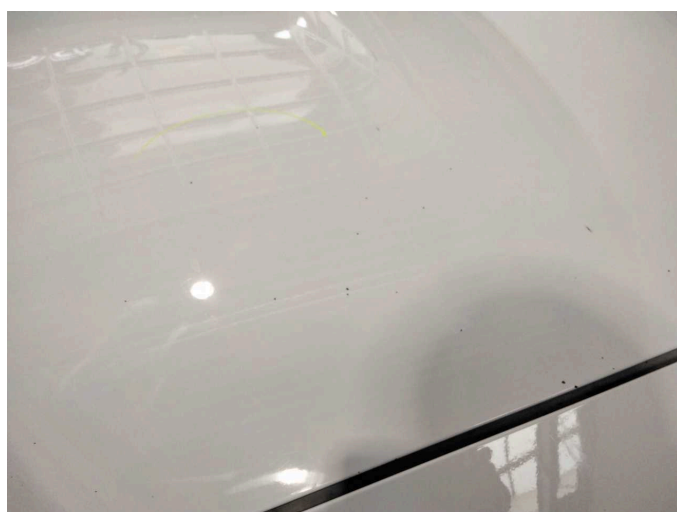
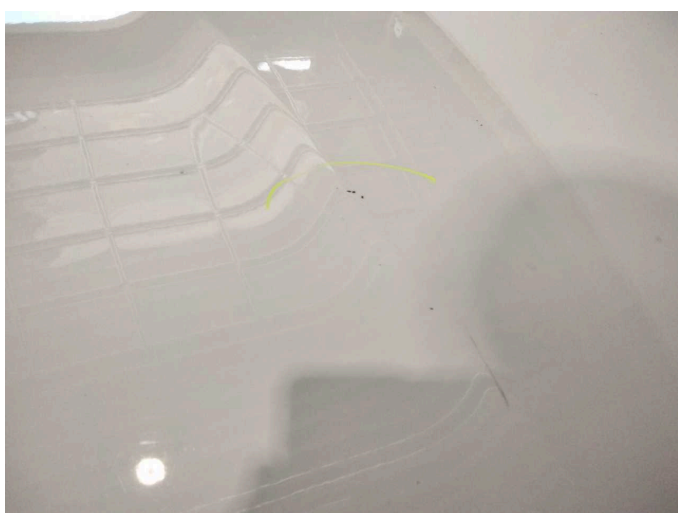
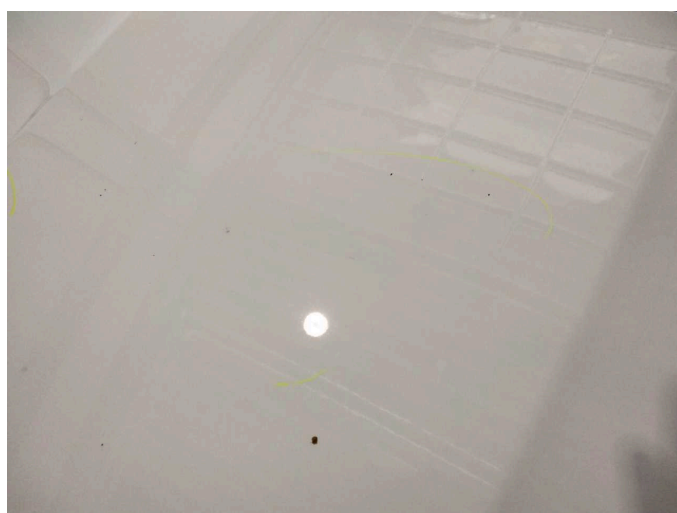
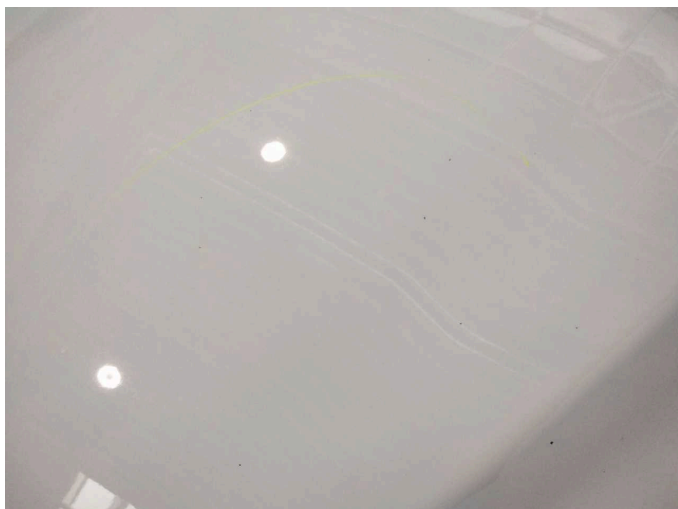
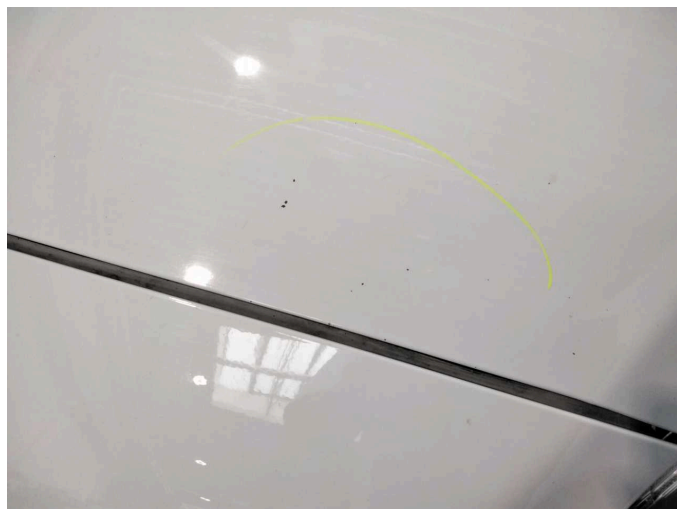
**Damage 11:** Bonnet: Bonnet - Stone chips - Paint

| No. | Component group | Description |
|---|---|---|
| 11 | Bonnet | Bonnet - Stone chips - Paint |

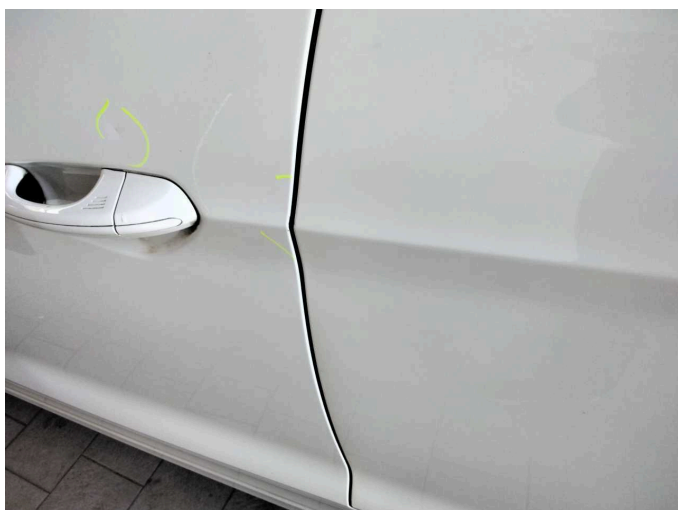
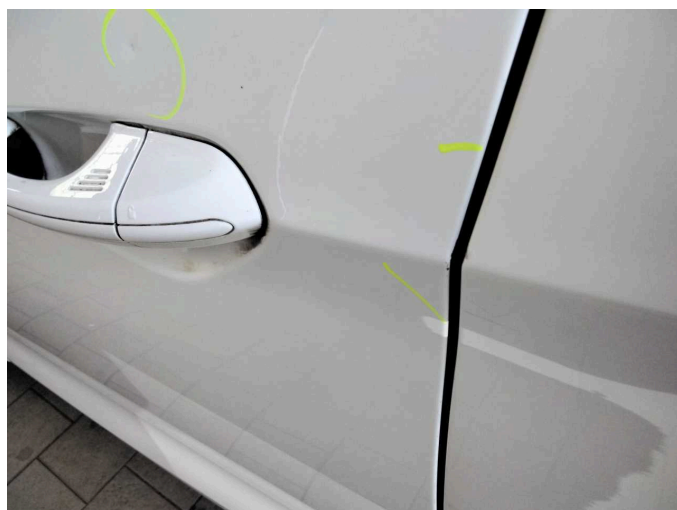
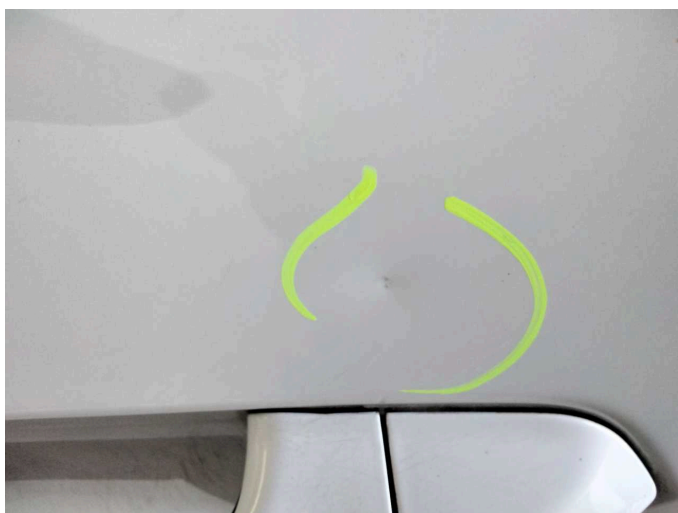
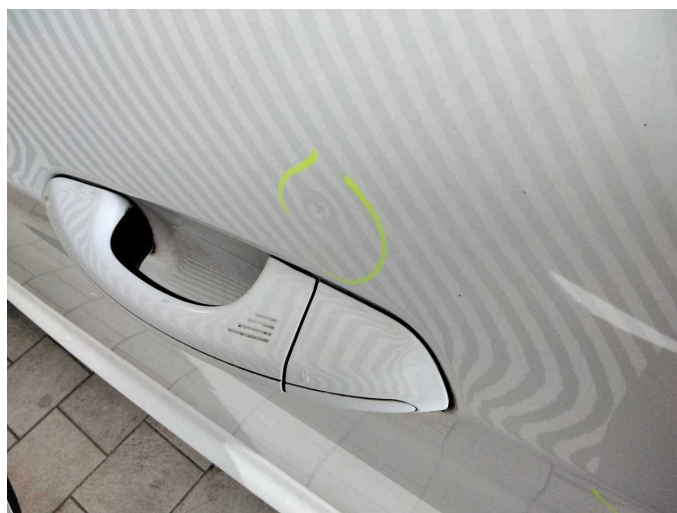
**Damage 12:** Door - front left side: Door - Dent / paintcoat damage - Paint

| No. | Component group | Description |
|---|---|---|
| 12 | Door - front left side | Door - Dent / paintcoat damage - Paint |

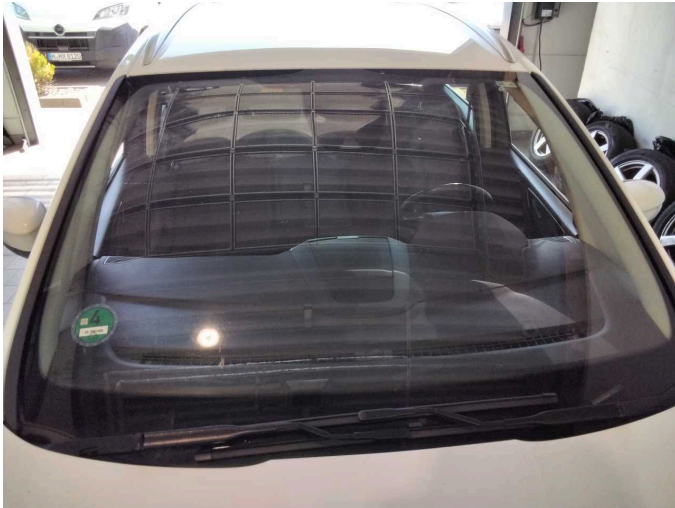
| No. | Component group | Description |
|---|---|---|
| 1 | Vehicle glazing | Windscreen - Stone chips - No deduction |

**Wear and tear 1:** Vehicle glazing: Windscreen - Stone chips - No deduction

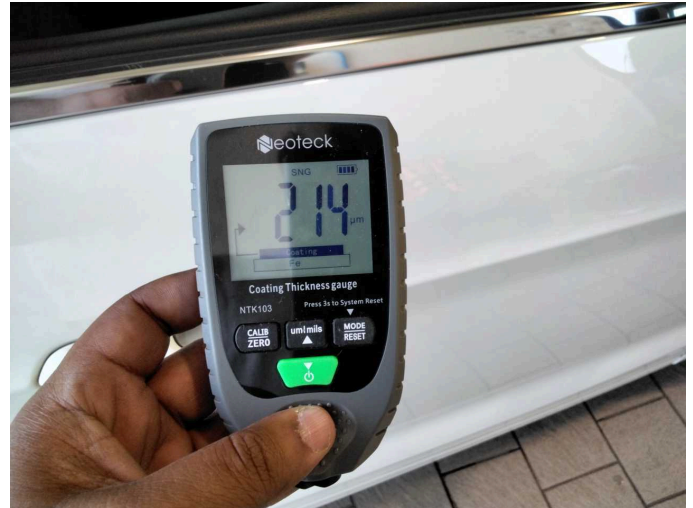
| 1 | Side panel - rear right side, Door - front right side, Professionally carried out, Invoice of repair done Non-existent |

**Repainting 1:** Side panel - rear right side, Door - front right side

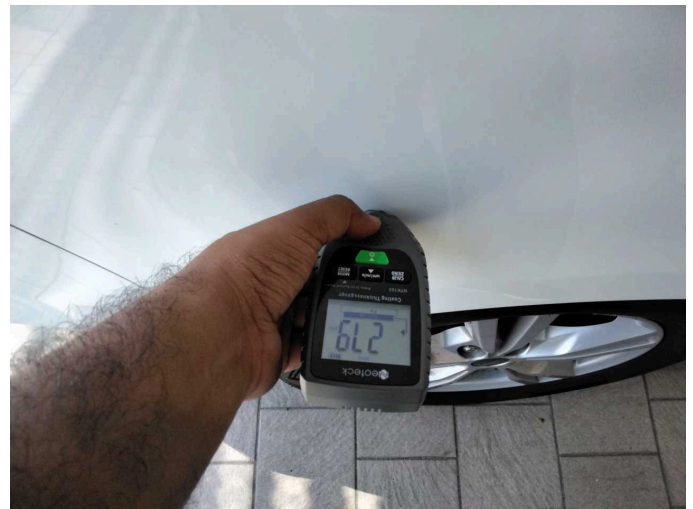
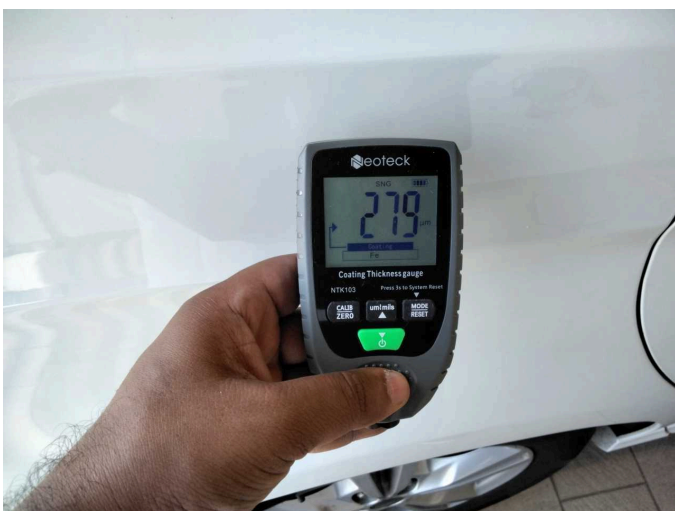
| Side panel - rear right side | 279 µm | Door - front right side | 214 µm |

**Side panel - rear right side:** 279 µm

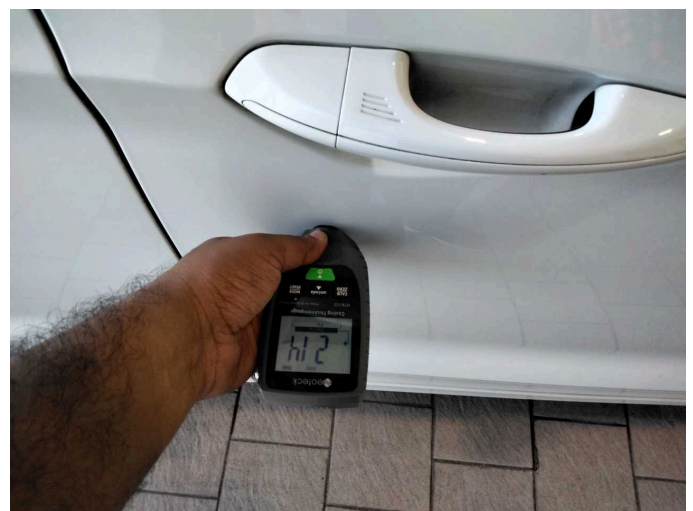
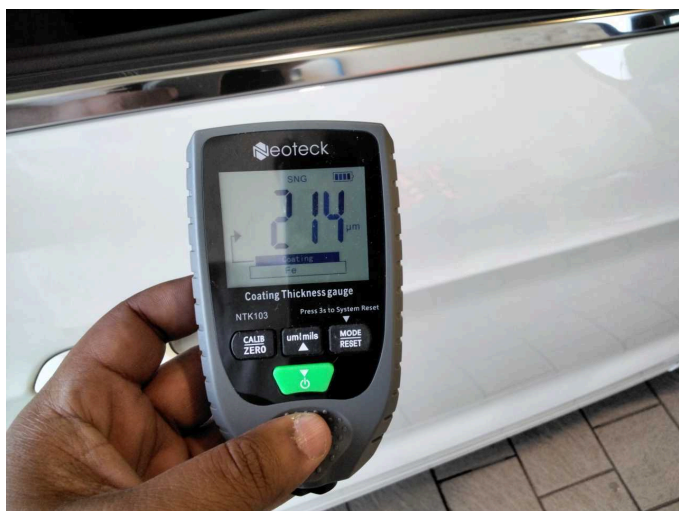
**Door - front right side:** 214 µm

Door - front right side: 214 µm
