Expertise

Protocol number: 46531928  
Order No. / Reference: 26689386  
Inspection date: 13 Jul 2026

Manufacturer: Ford

Model: Focus Turnier 1.0 EcoBoost Hybrid COOL&CONNECT

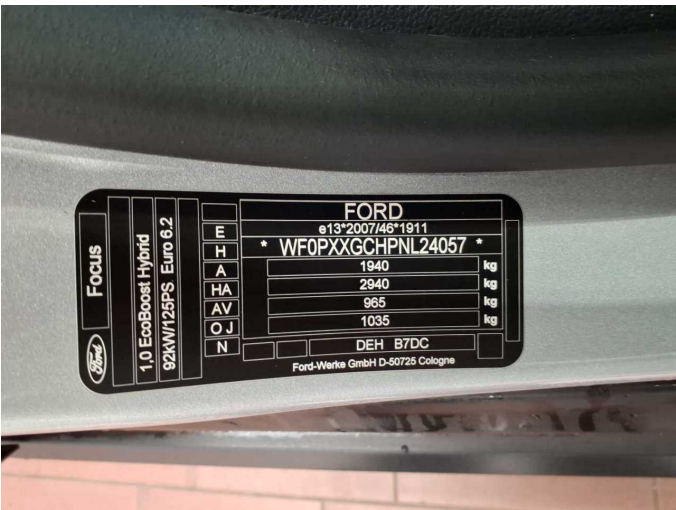
| VIN comparison | The vehicle identification number (VIN) was read from the vehicle and its conformity with the submitted documents was confirmed by the undersigned during the inspection. |

Figure 11: VIN

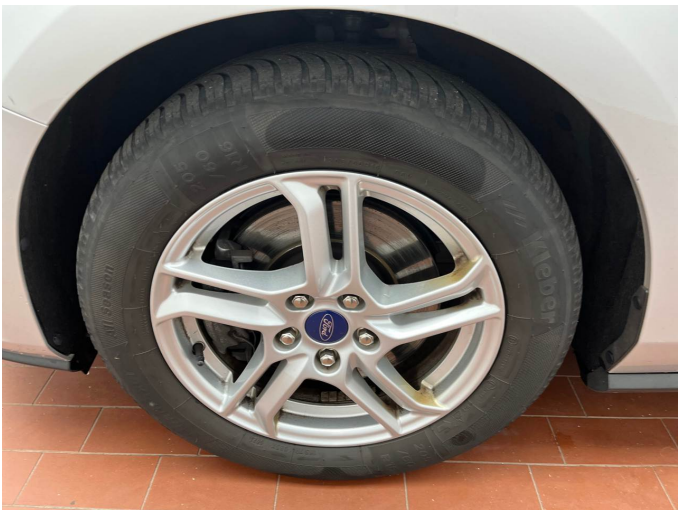
| # | Tyre size | Type of tyre | Manufacturer | Tread depth |
|---|---|---|---|---|
| 1) | 205/60 R16 96V | All-season tyres on Light alloy | Kleber | 4mm / 4mm |
| 2) | 205/60 R16 96V | All-season tyres on Light alloy | Kleber | 4mm / 4mm |

Figure 12: Mounted tyres

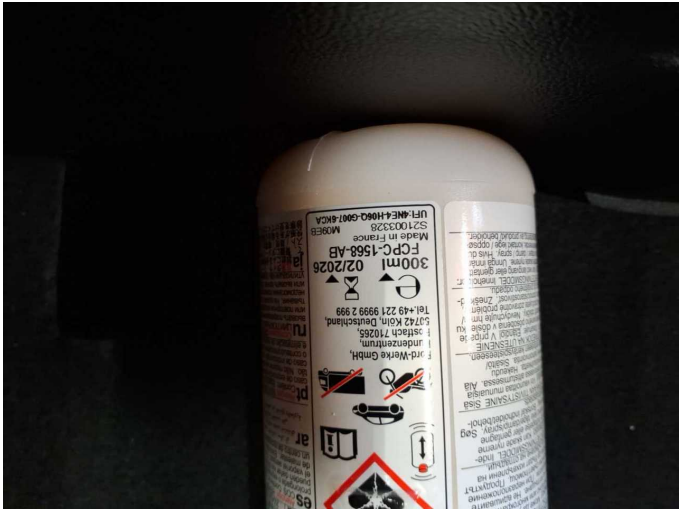
Damage 1: Equipment: Tirefit filler - Due - Replace

| No. | Component group | Description |
|---|---|---|
| 1 | Equipment | Tirefit filler - Due - Replace |

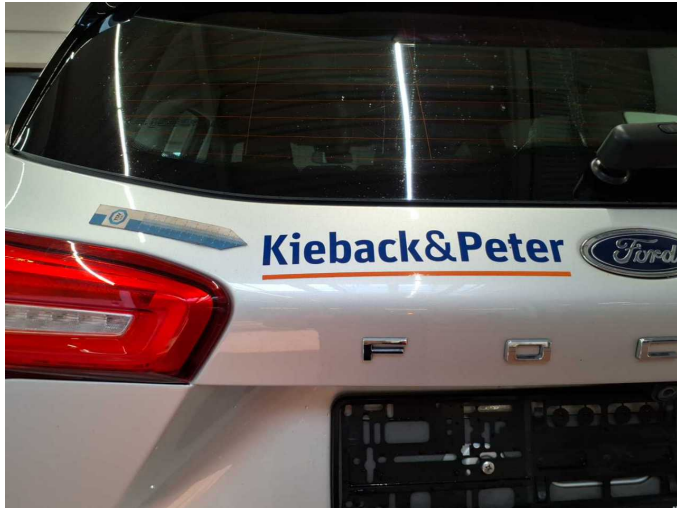
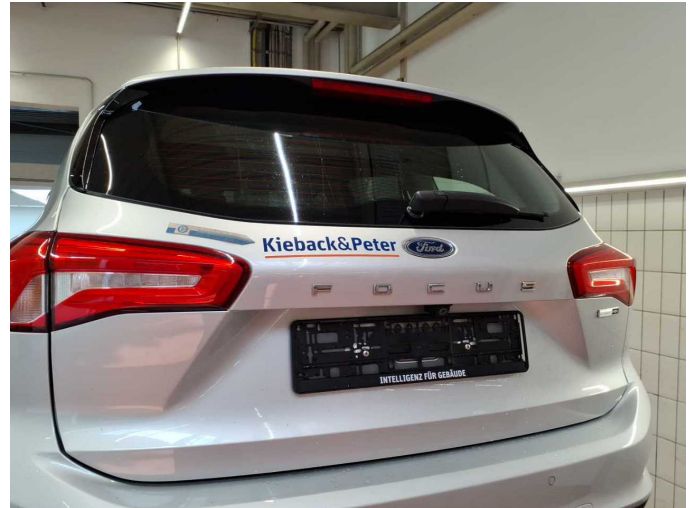
**Damage 2:** Boot lid / rear door: Boot lid - Glued / labelled - De-glue / neutralise

| No. | Component group | Description |
|---|---|---|
| 2 | Boot lid / rear door | Boot lid - Glued / labelled - De-glue / neutralise |

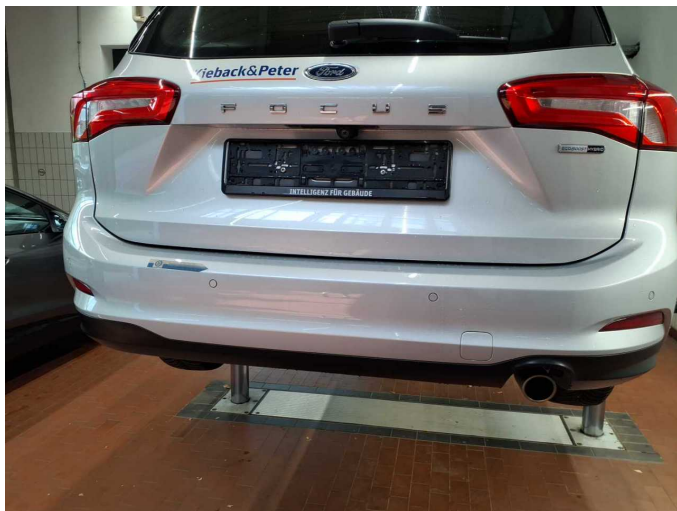
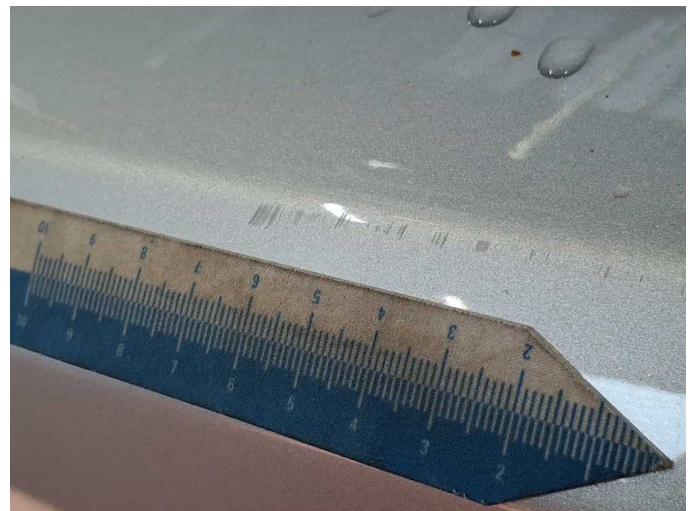
**Damage 3:** Rear bumper: Rear bumper - Scratch(es) - Smart repair

| No. | Component group | Description |
|---|---|---|
| 3 | Rear bumper | Rear bumper - Scratch(es) - Smart repair |

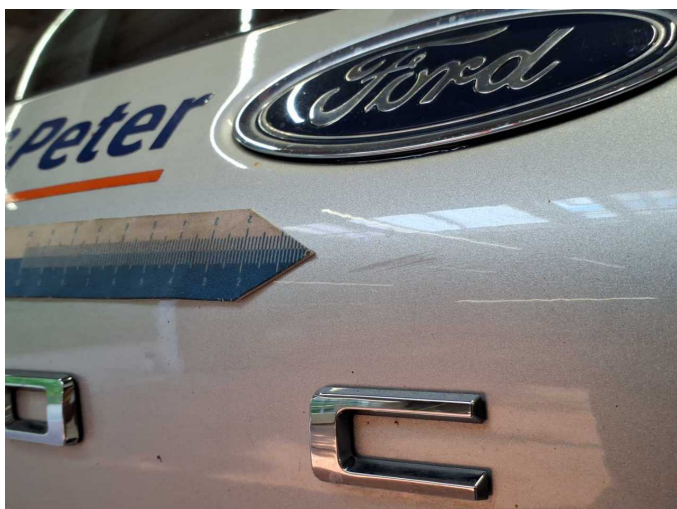
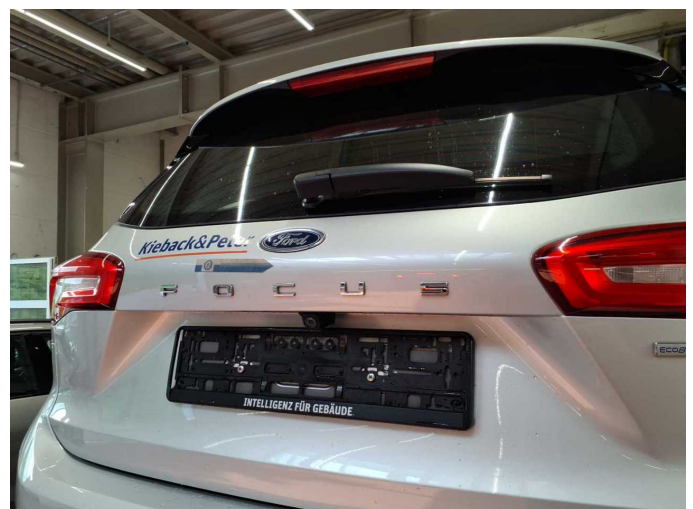
**Damage 4:** Boot lid / rear door: Boot lid - Scratch(es) - Smart repair

| No. | Component group | Description |
|---|---|---|
| 4 | Boot lid / rear door | Boot lid - Scratch(es) - Smart repair |

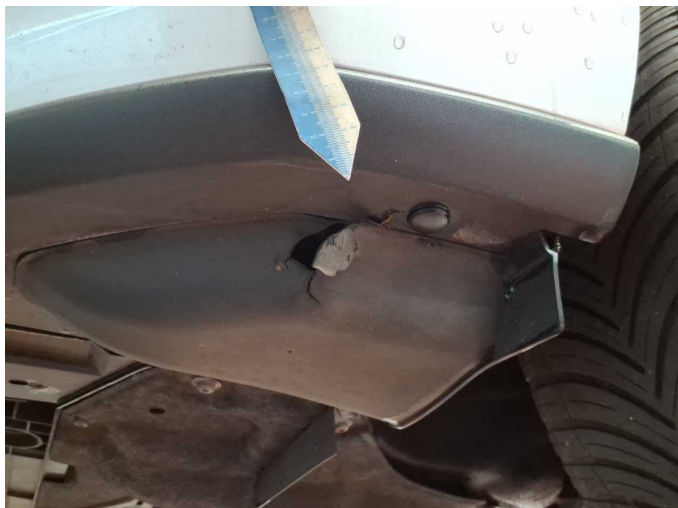
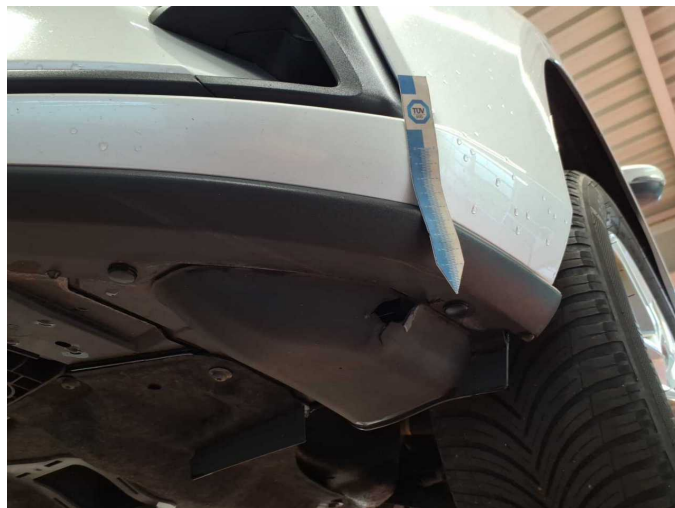
**Damage 5:** Body: Underbody panelling - Broken / torn - Replace

| No. | Component group | Description |
|---|---|---|
| 5 | Body | Underbody panelling - Broken / torn - Replace |

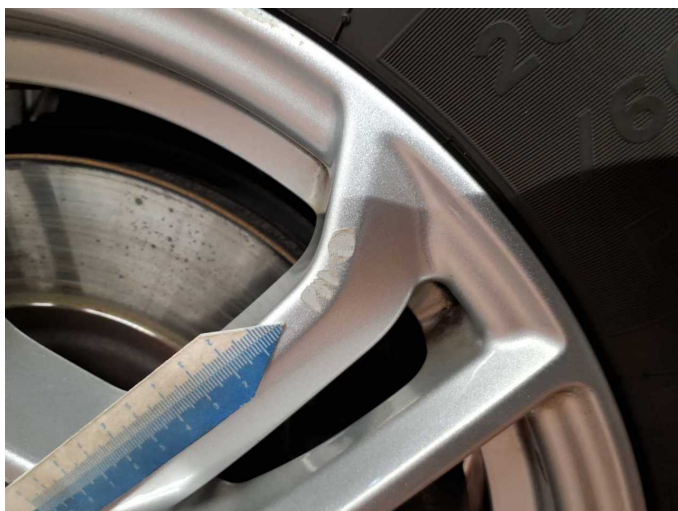
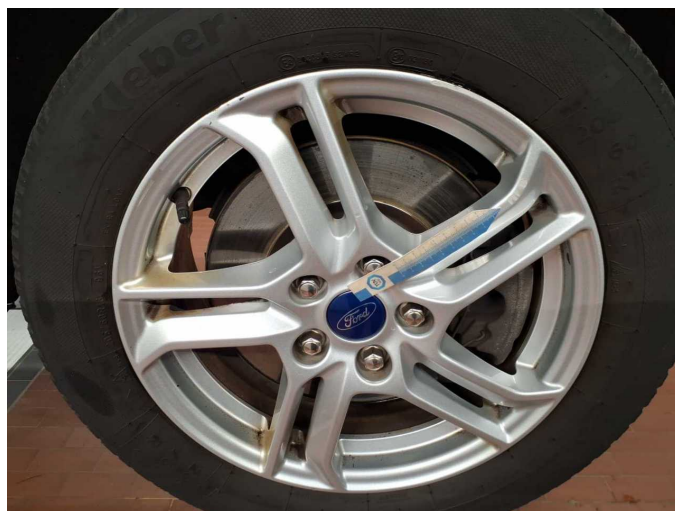
**Damage 6:** Wheel / tyres: Alloy rim - front right side - Scratch(es) - Loss in value

| No. | Component group | Description |
|---|---|---|
| 6 | Wheel / tyres | Alloy rim - front right side - Scratch(es) - Loss in value |

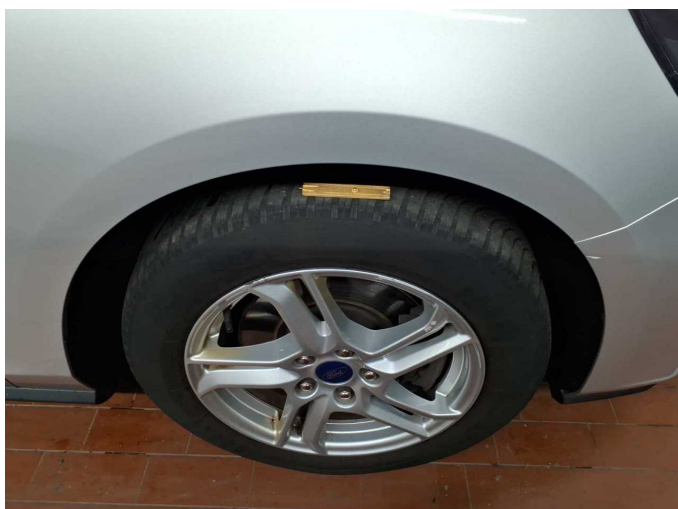
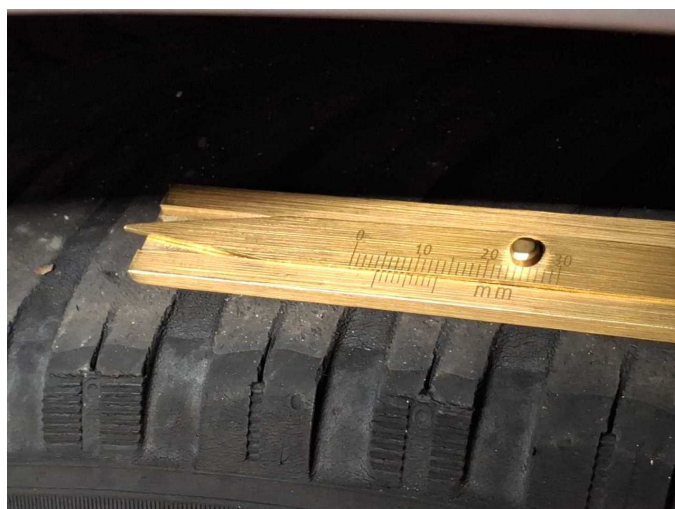
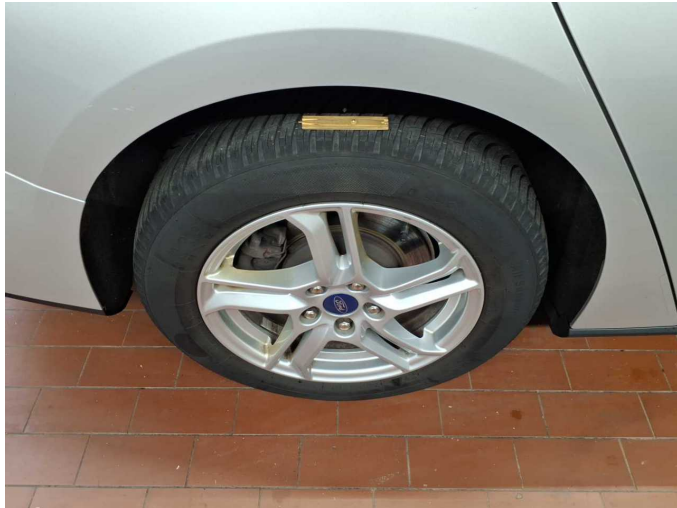
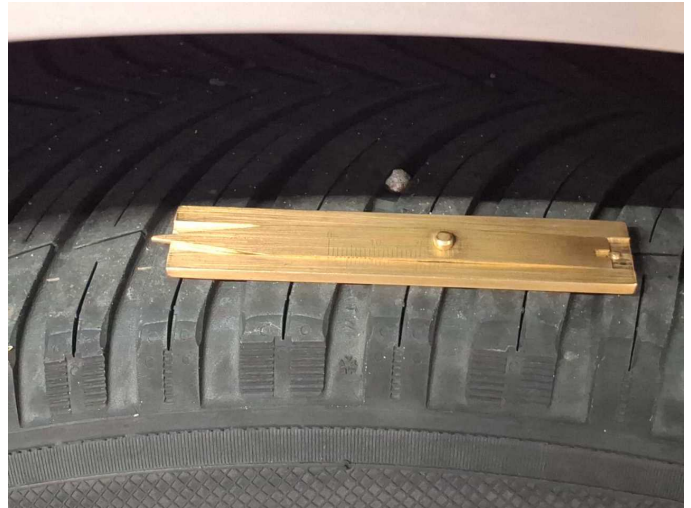
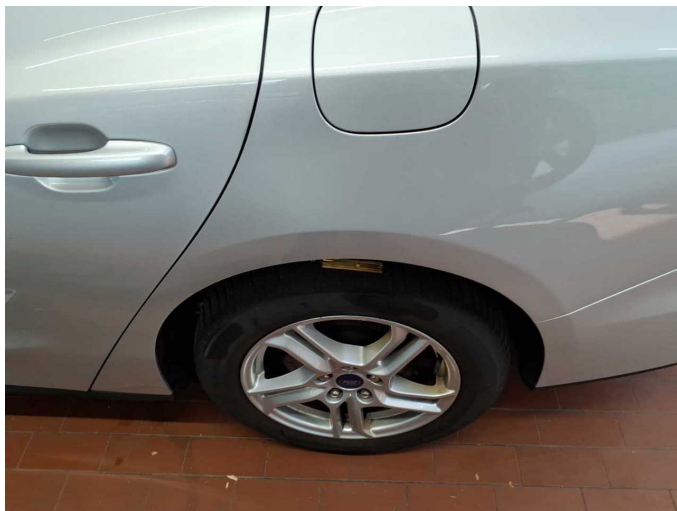
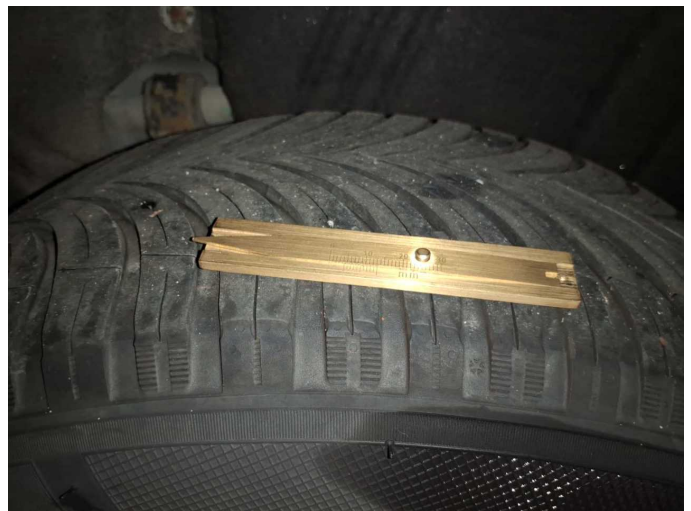
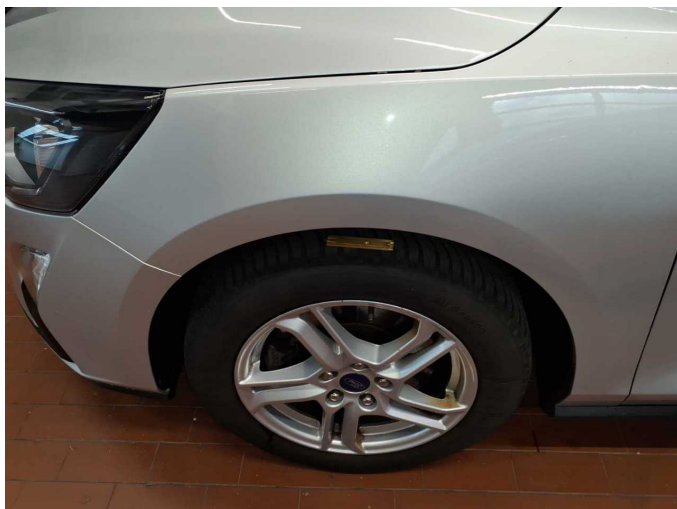
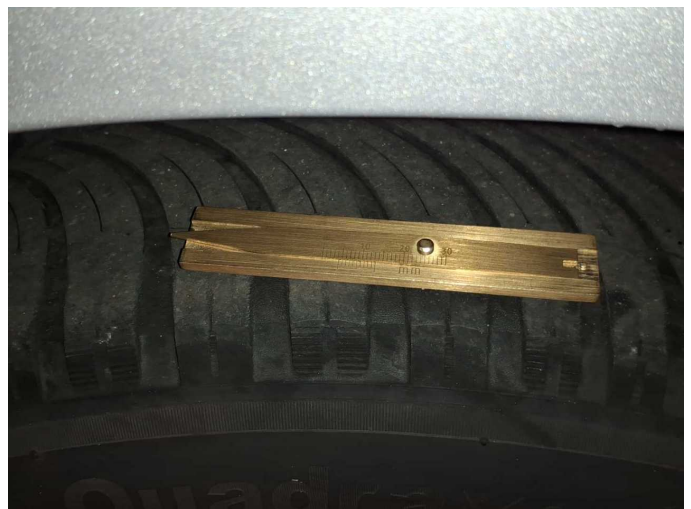
**Damage 7:** Wheel / tyres: Tyres - complete set (4mm) - Does not meet the leasing specifications - Replace

| No. | Component group | Description |
|---|---|---|
| 7 | Wheel / tyres | Tyres - complete set (4mm) - Does not meet the leasing specifications - Replace |

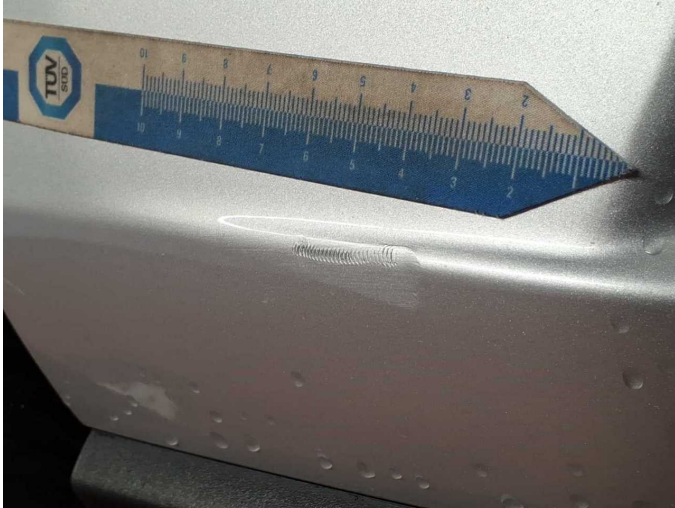
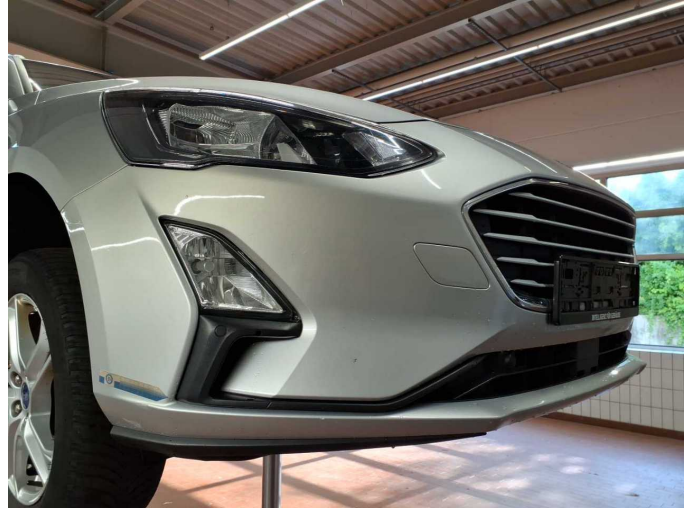
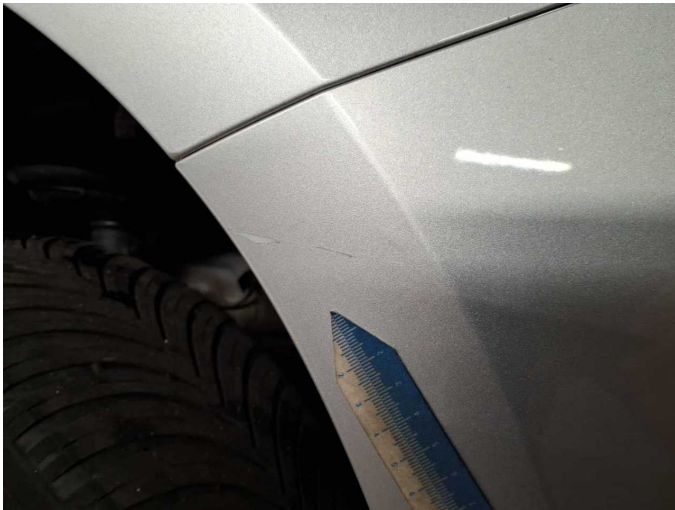
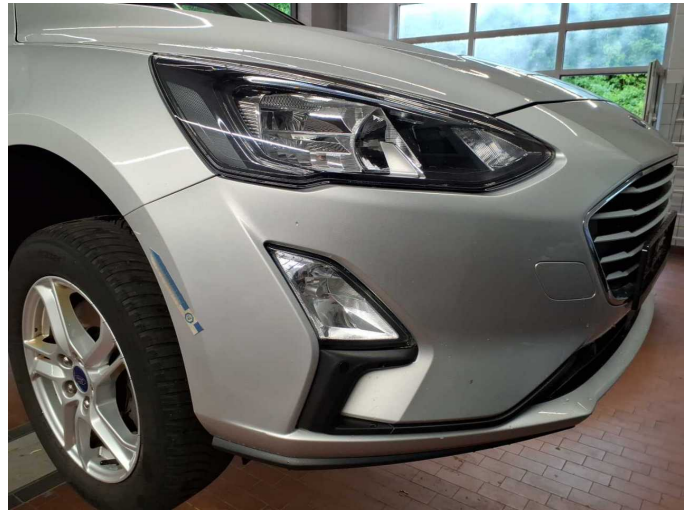
**Damage 8:** Front bumper: Front bumper - Scratch(es) - Paint

| No. | Component group | Description |
|---|---|---|
| 8 | Front bumper | Front bumper - Scratch(es) - Paint |

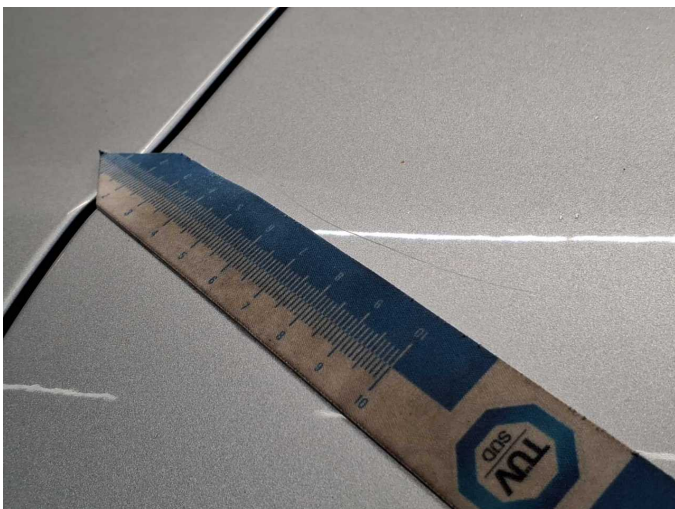
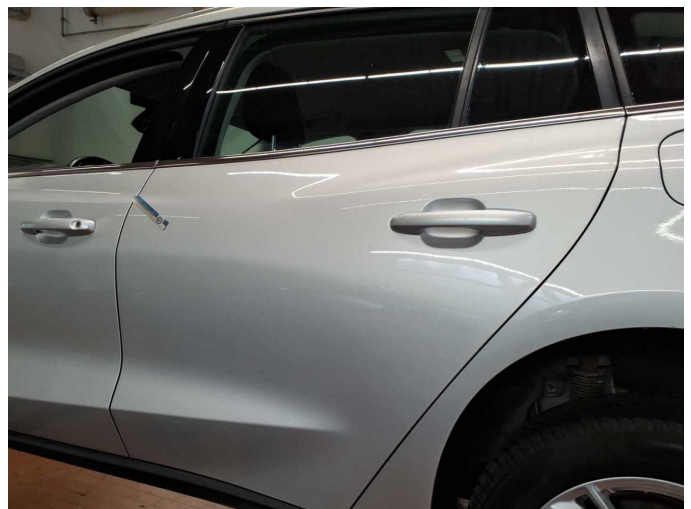
**Damage 9:** Door - rear left side: Door - Scratch(es) - Paint

| No. | Component group | Description |
|---|---|---|
| 9 | Door - rear left side | Door - Scratch(es) - Paint |

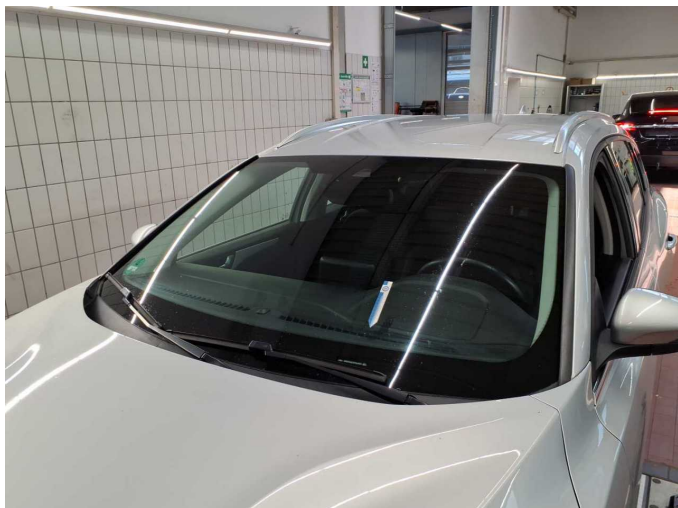
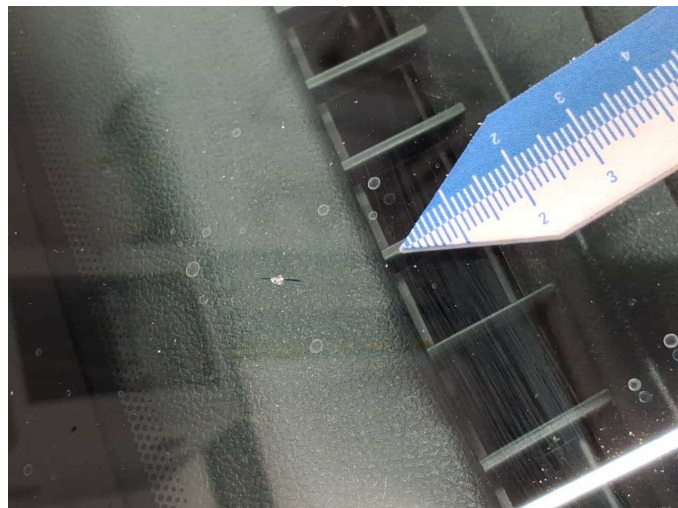
**Damage 10:** Vehicle glazing: Windscreen - Stone chips - Replace

| No. | Component group | Description |
|---|---|---|
| 10 | Vehicle glazing | Windscreen - Stone chips - Replace |

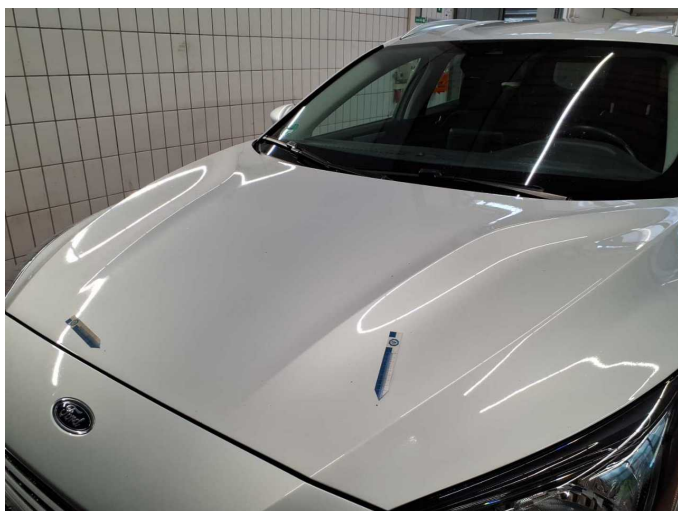
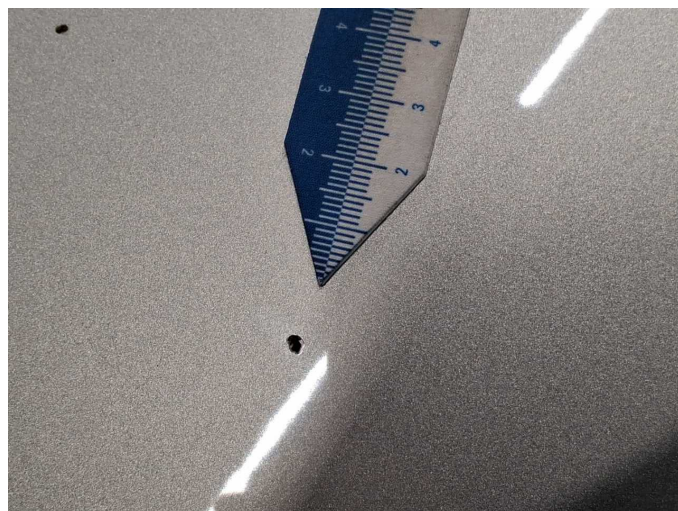
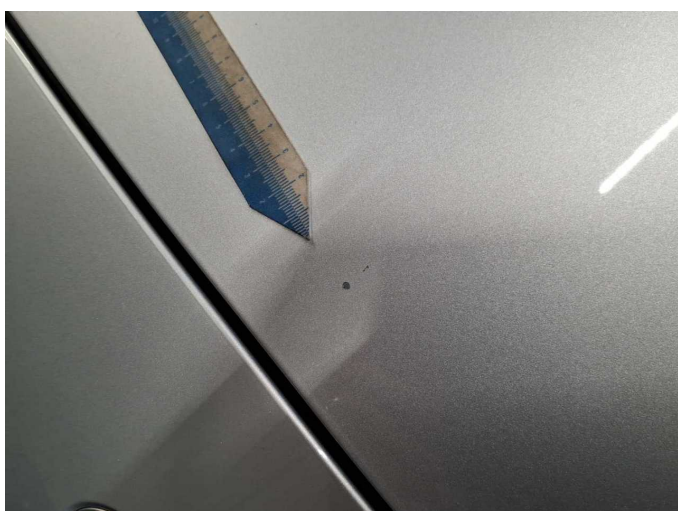
**Wear and tear 2:** Bonnet: Bonnet - Stone chips - No deduction

| No. | Component group | Description |
|---|---|---|
| 2 | Bonnet | Bonnet - Stone chips - No deduction |

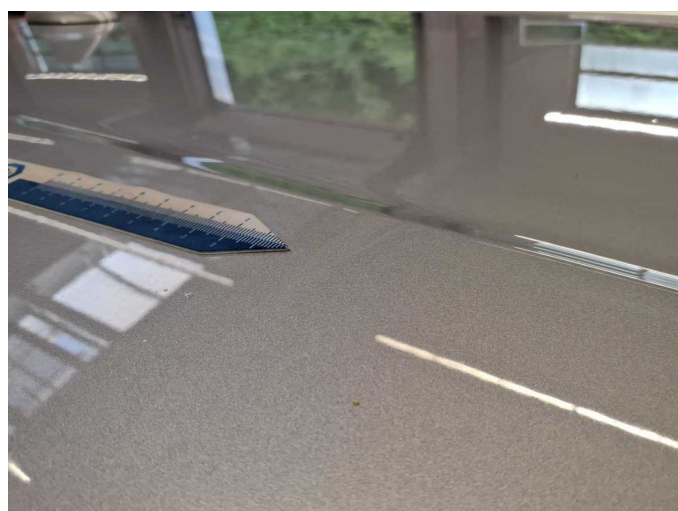
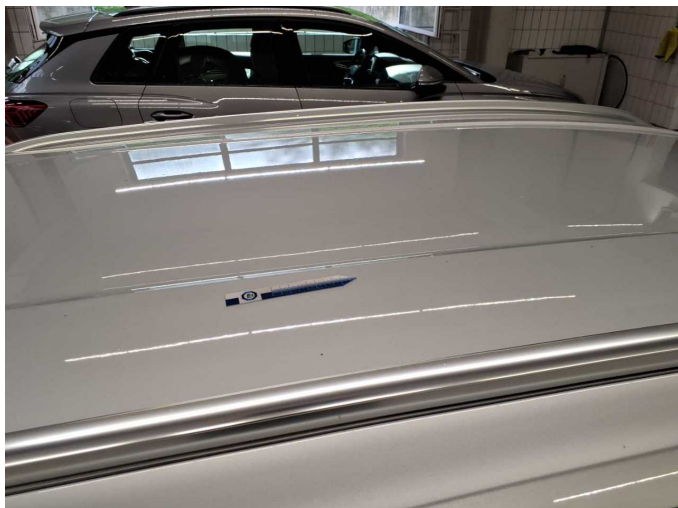
**Wear and tear 3:** Roof: Roof - Scratch(es) - No deduction

| No. | Component group | Description |
|---|---|---|
| 3 | Roof | Roof - Scratch(es) - No deduction |

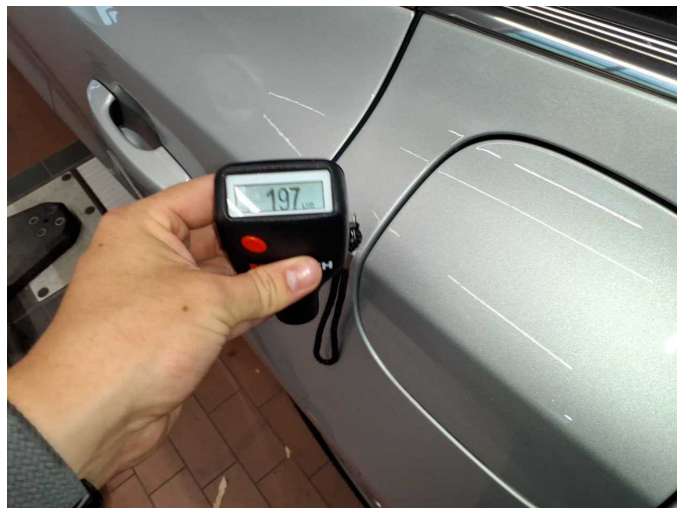
| No. | Repainting |
|---|---|
| 1 | Side panel - rear left side, Professionally carried out, Invoice of repair done Non-existent |

| Side panel - rear left side | 197 µm |

**Repainting 1:** Side panel - rear left side
