Expertise

Protocol number: 46411247  
Order No. / Reference: 26521502  
Inspection date: 8 Jul 2026

Manufacturer: Volvo

Model: XC40 Recharge 69 kWh Single Motor Core

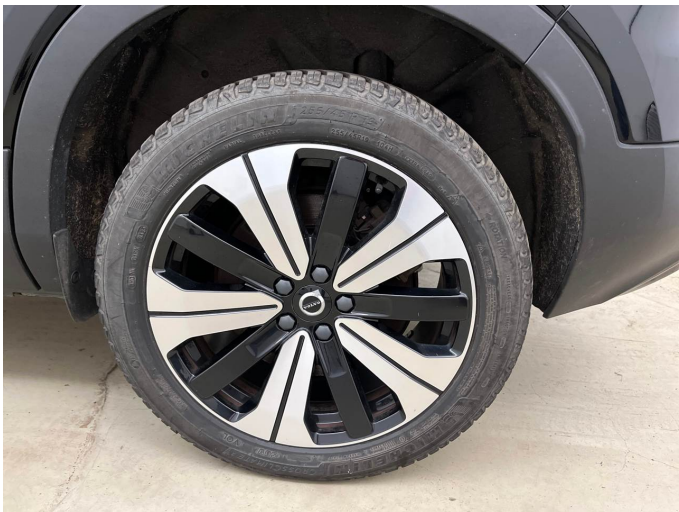
Figure 12: Mounted tyres

| # | Tyre size | Type of tyre | Manufacturer | Tread depth |
|---|---|---|---|---|
| 1) | 235/50 R19 103H | All-season tyres on Light alloy | Michelin | 4mm / 4mm |
| 2) | 255/45 R19 104H | All-season tyres on Light alloy | Michelin | 6mm / 6mm |

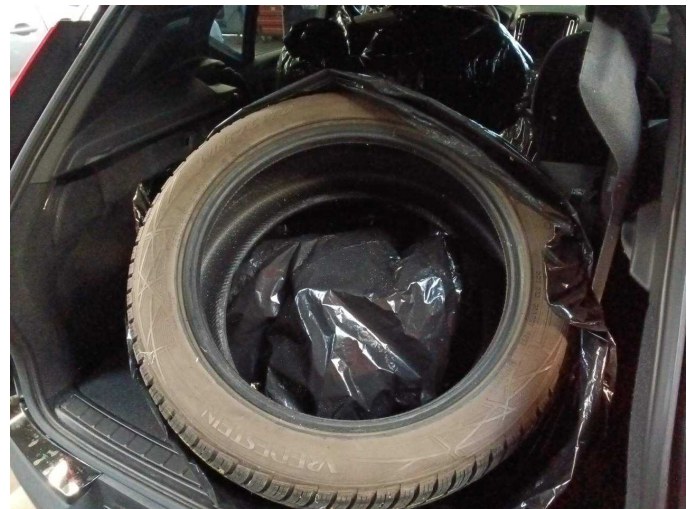
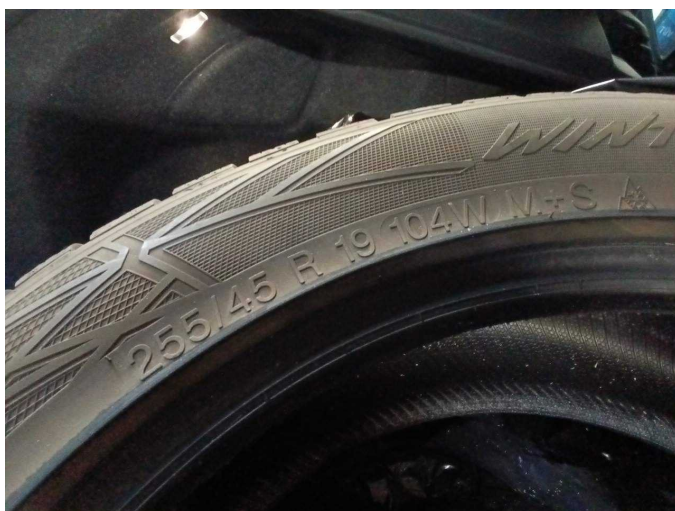
Figure 16: Additional tyres

| # | Tyre size | Type of tyre | Manufacturer | Tread depth |
|---|---|---|---|---|
| 1) | 235/50 R19 103V | Winter tyres (Without wheel rim) | Vredestein | 5mm / 5mm |
| 2) | 255/45 R19 104W | Winter tyres (Without wheel rim) | Vredestein | 7mm / 7mm |

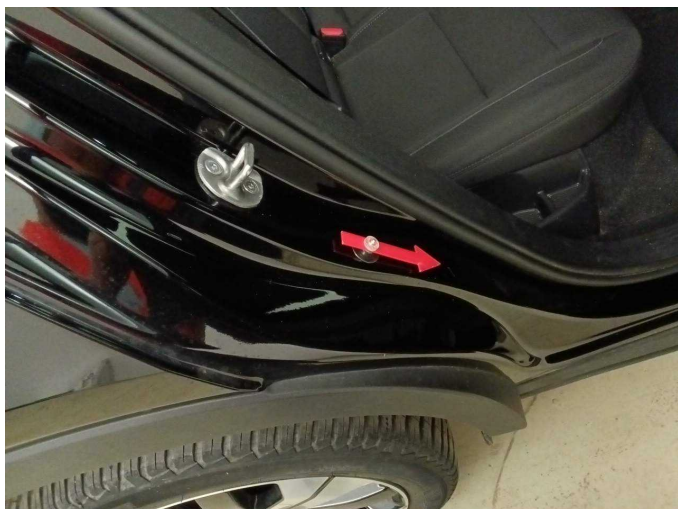
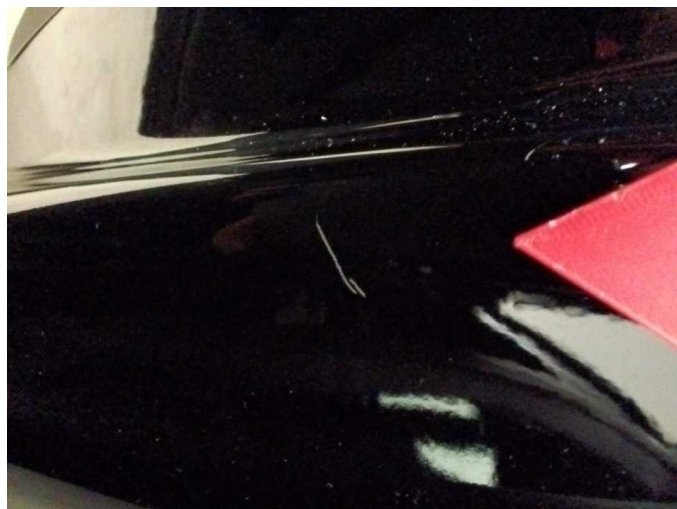
**Damage 2:** Side panel - rear right side: Sill - Scratch(es) - Smart repair

| No. | Component group | Description |
|---|---|---|
| 2 | Side panel - rear right side | Sill - Scratch(es) - Smart repair |

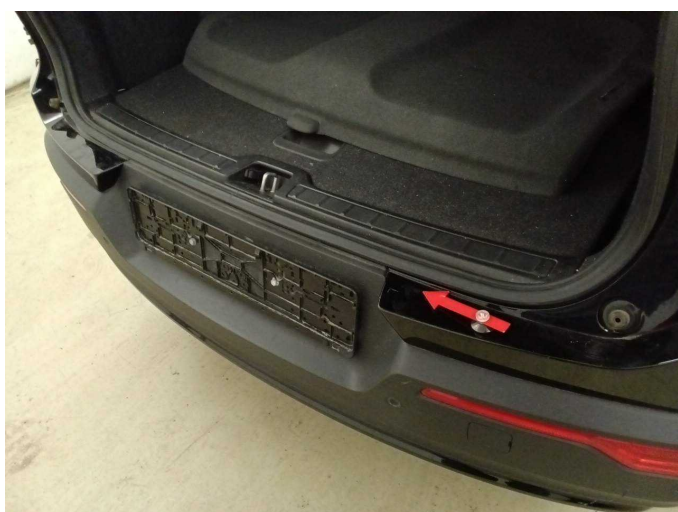
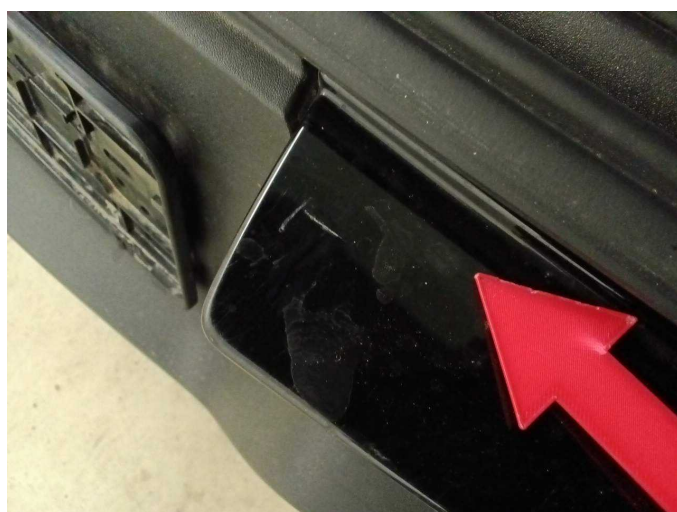
**Damage 3:** Rear bumper: Rear bumper - Scratch(es) - Smart repair

| No. | Component group | Description |
|---|---|---|
| 3 | Rear bumper | Rear bumper - Scratch(es) - Smart repair |

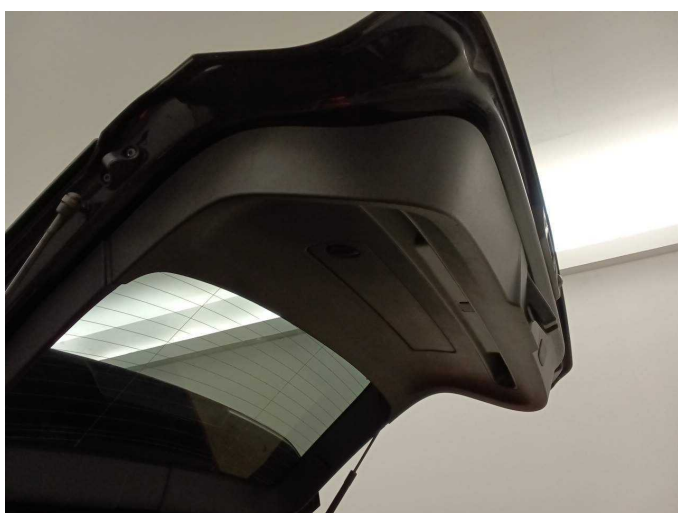
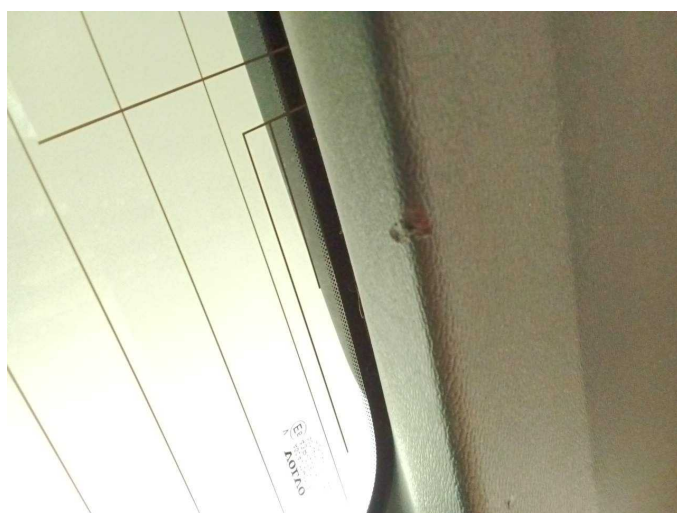
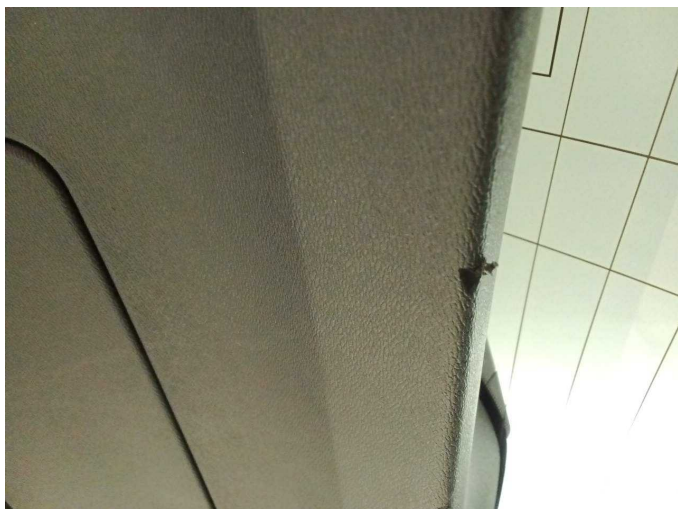
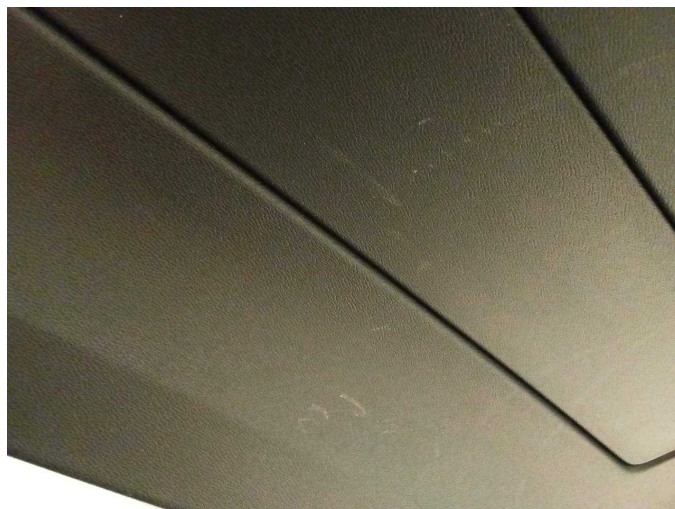
**Damage 4:** Trim / covers: Boot lid - interior trim - Scratched - Replace

| No. | Component group | Description |
|---|---|---|
| 4 | Trim / covers | Boot lid - interior trim - Scratched - Replace |

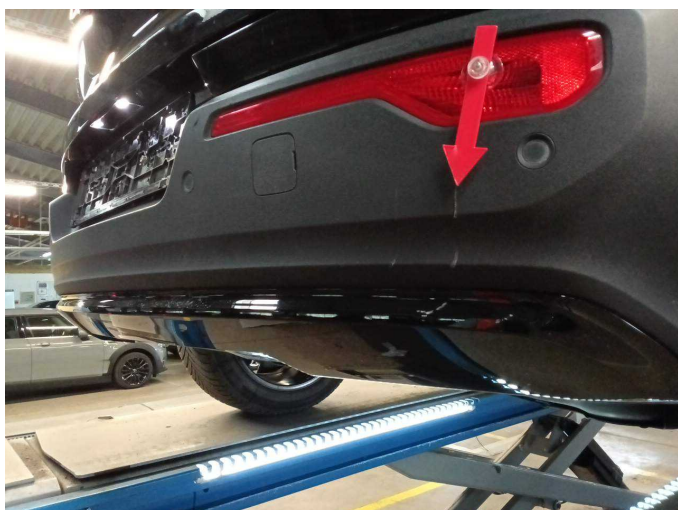
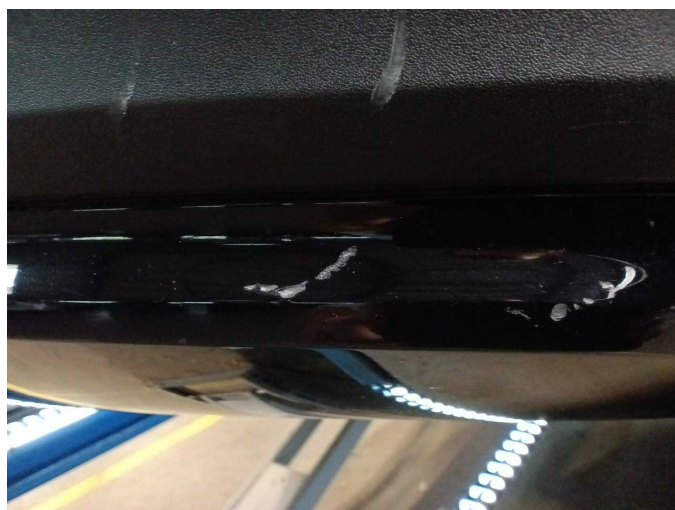
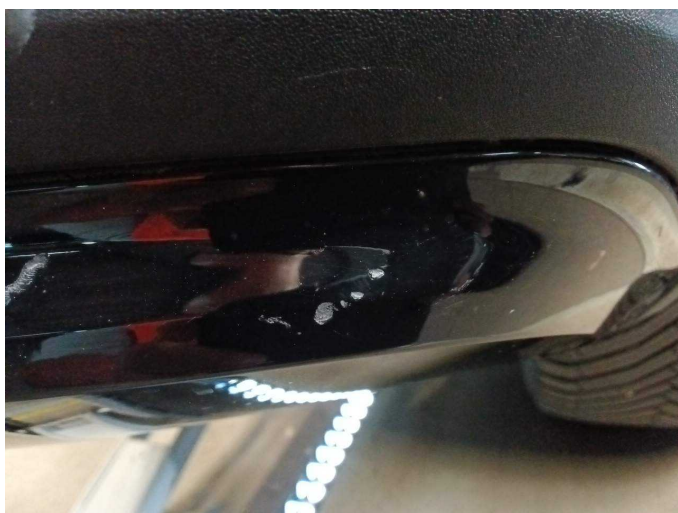
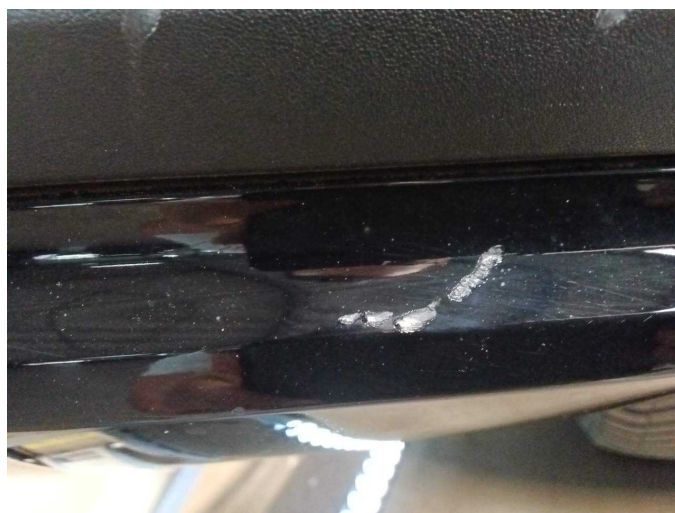
**Damage 5:** Rear bumper: Spoiler - Scratch(es) - Paint

| No. | Component group | Description |
|---|---|---|
| 5 | Rear bumper | Spoiler - Scratch(es) - Paint |

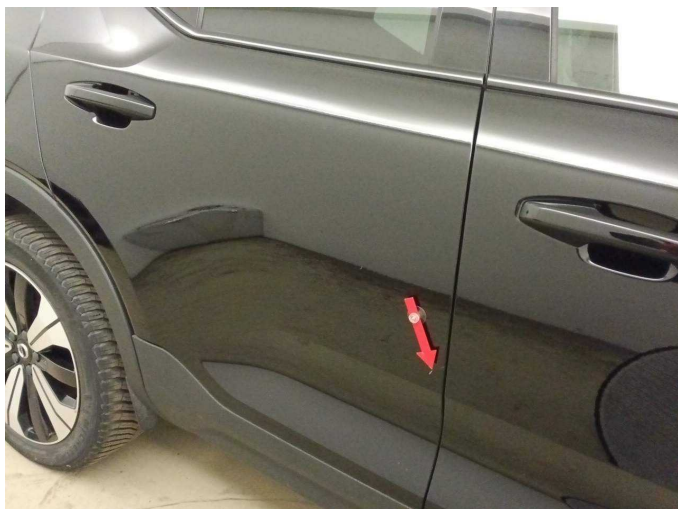
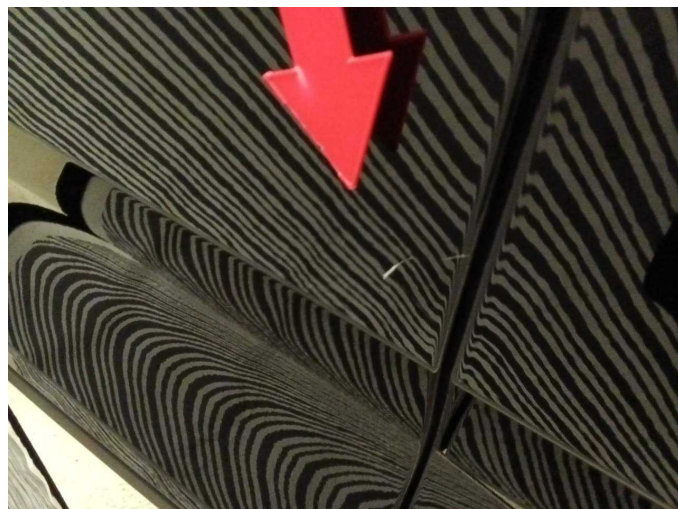
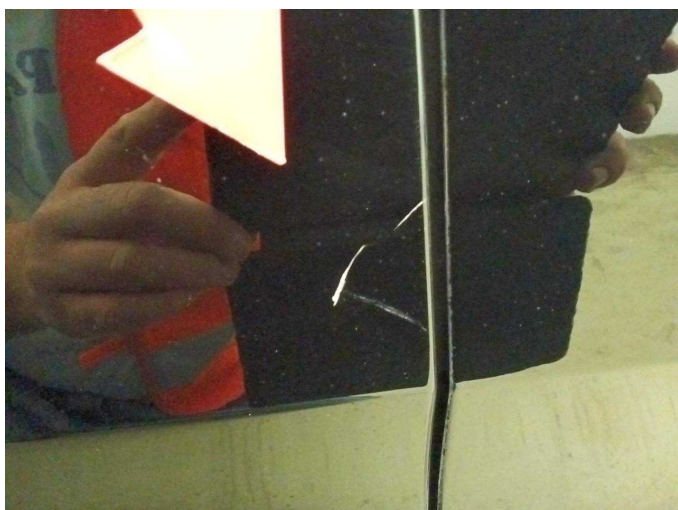
**Damage 6:** Door - rear right side: Door - Dent / paintcoat damage - Repair and paint

| No. | Component group | Description |
|---|---|---|
| 6 | Door - rear right side | Door - Dent / paintcoat damage - Repair and paint |

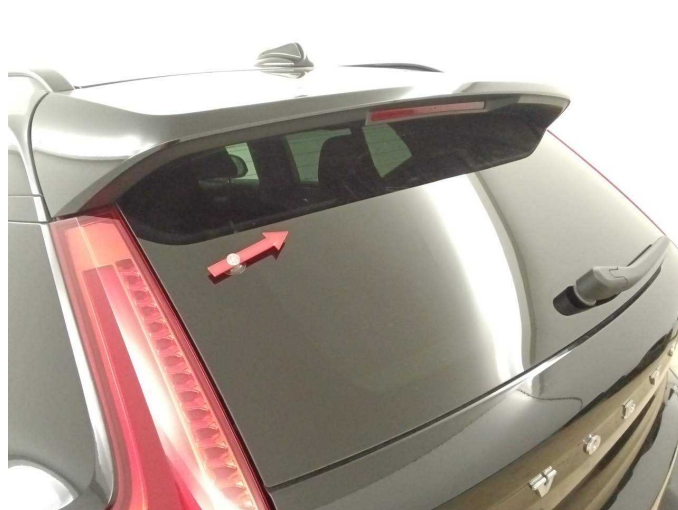
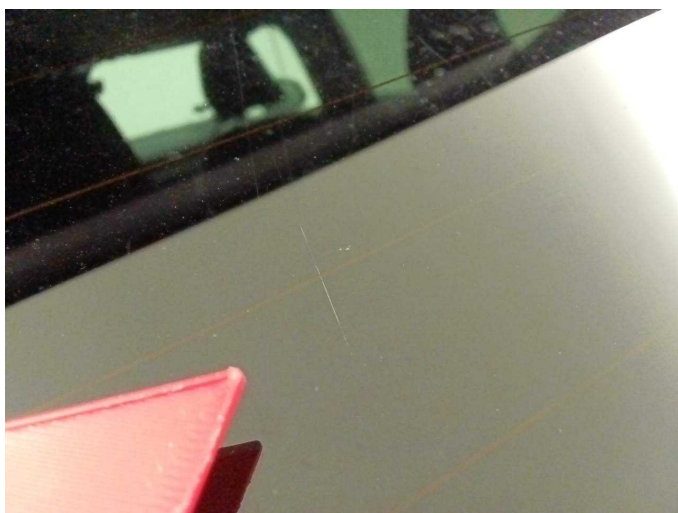
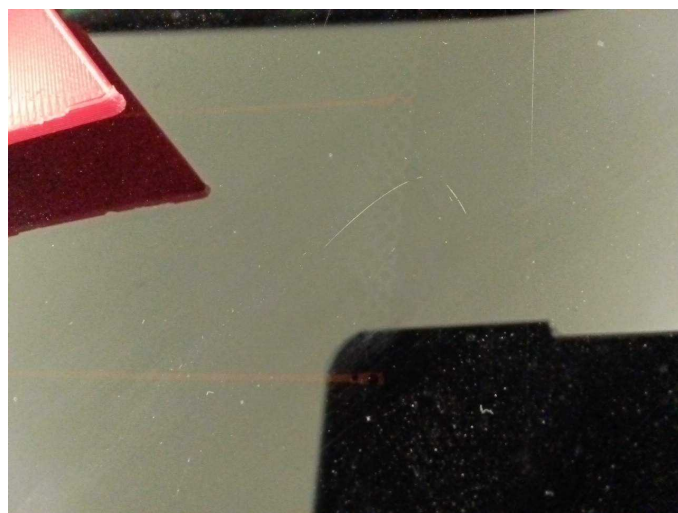
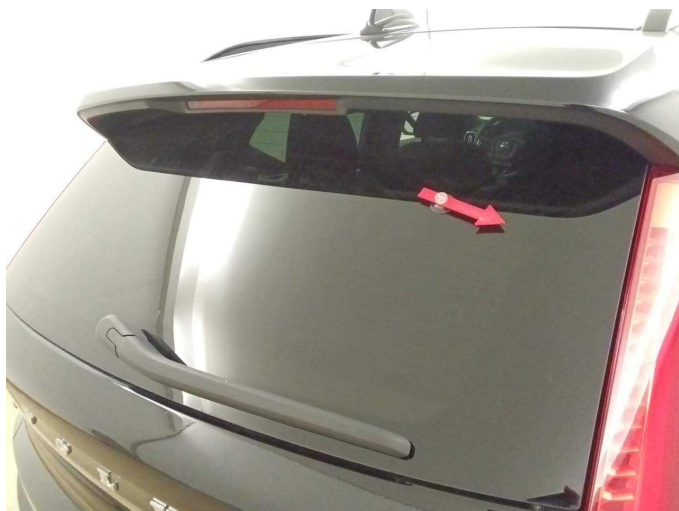
**Damage 7:** Vehicle glazing: Rear window - Scratch(es) - Replace

| No. | Component group | Description |
|---|---|---|
| 7 | Vehicle glazing | Rear window - Scratch(es) - Replace |

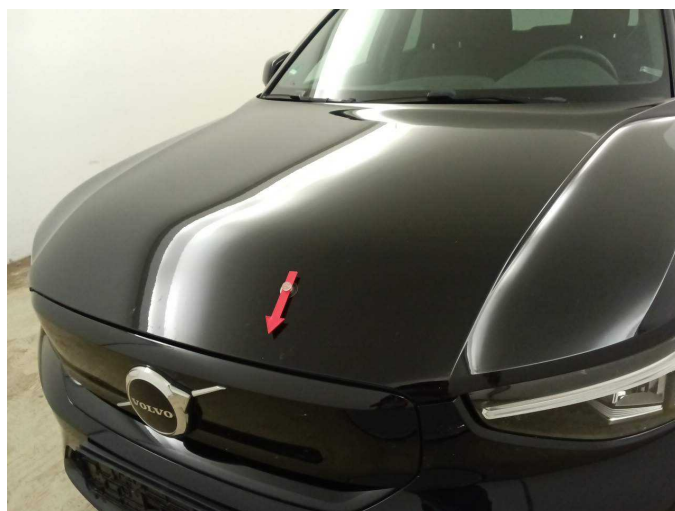
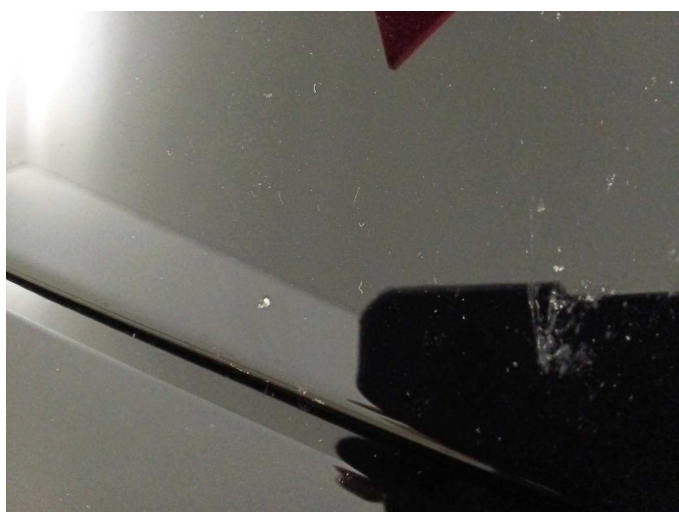
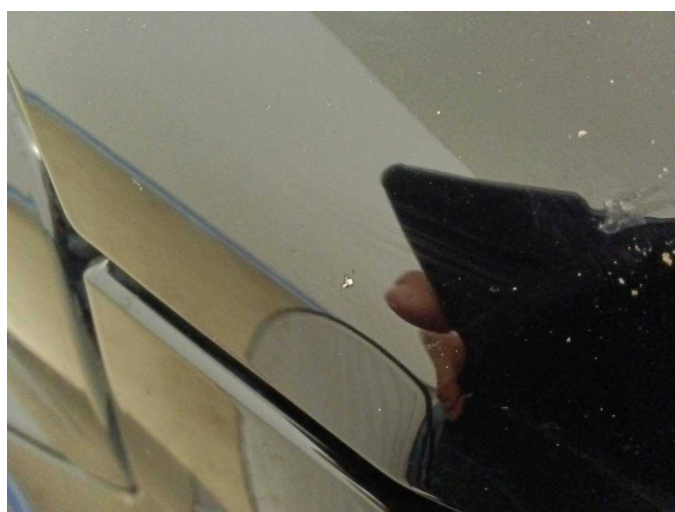
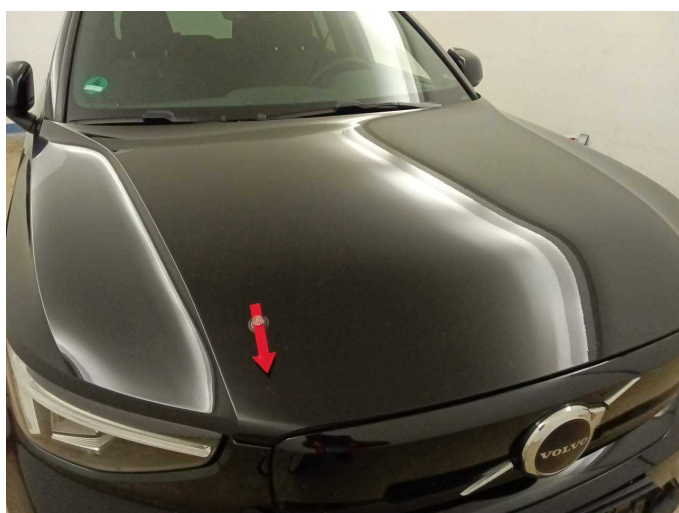
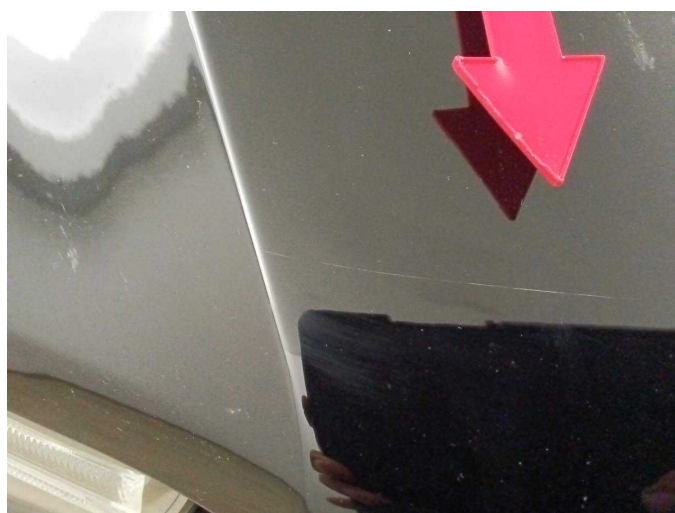
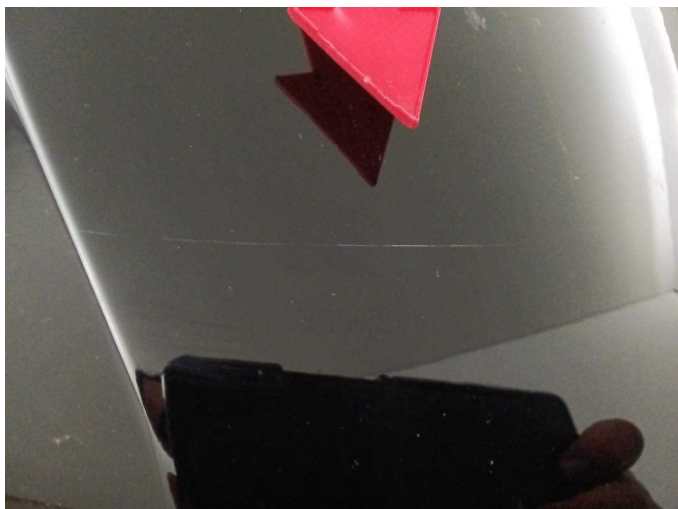
**Damage 8:** Bonnet: Bonnet - Scratch(es) - Paint

| No. | Component group | Description |
|---|---|---|
| 8 | Bonnet | Bonnet - Scratch(es) - Paint |

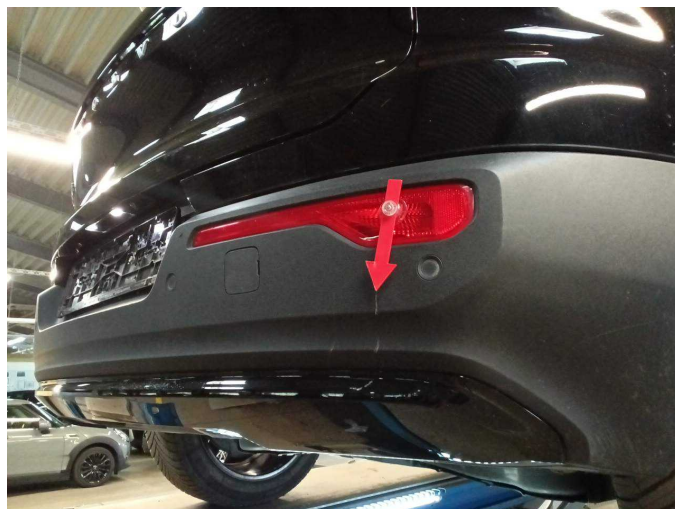
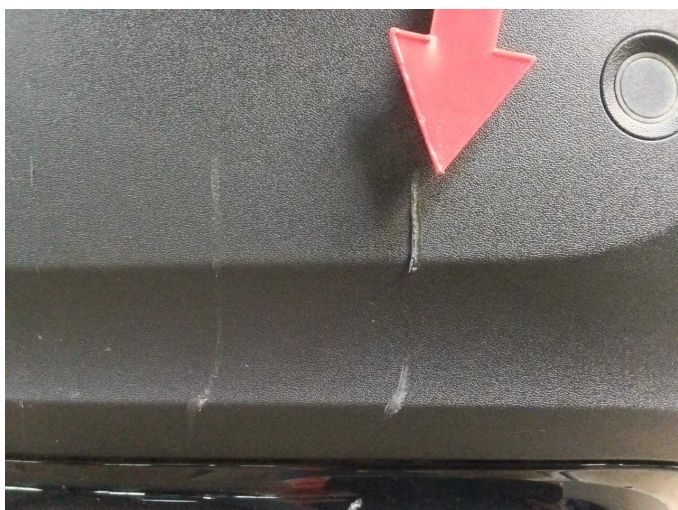
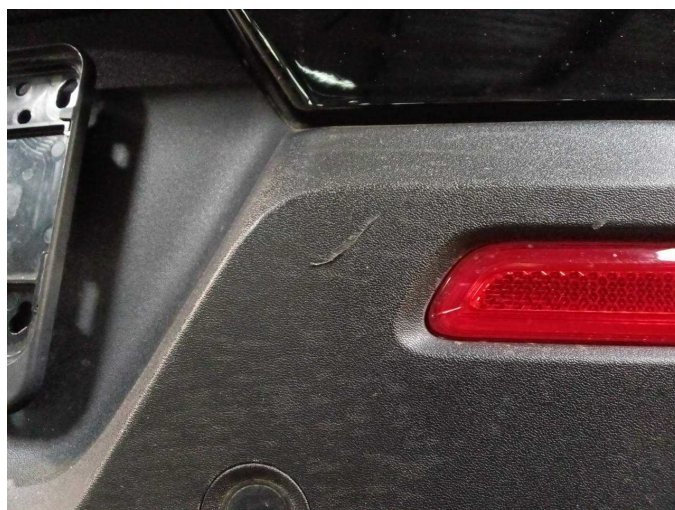
**Damage 9:** Rear bumper: Rear bumper - Scratched - Replace

| No. | Component group | Description |
|---|---|---|
| 9 | Rear bumper | Rear bumper - Scratched - Replace |

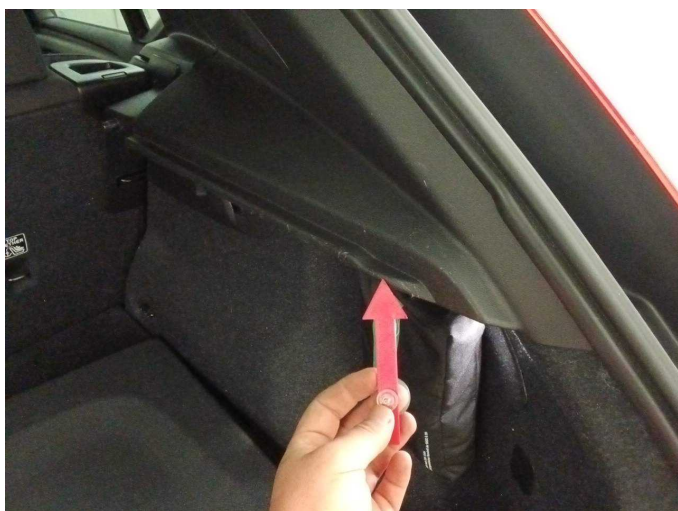
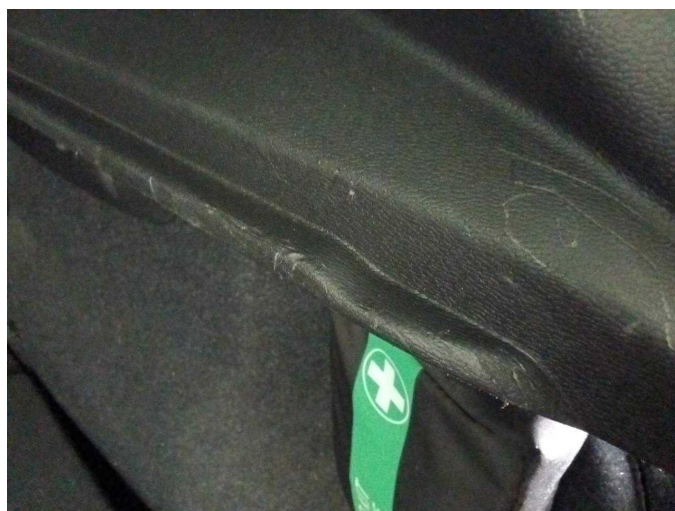
| No. | Component group | Description |
|---|---|---|
| 1 | Trim / covers | Boot lining - Scratched - No deduction |

**Wear and tear 1:** Trim / covers: Boot lining - Scratched - No deduction
