Expertise

Protocol number: 45755894  
Order No. / Reference: 26361894  
Inspection date: 2 Jun 2026

Manufacturer: Seat

Model: Tarraco 2.0 TDI SCR DSG FR

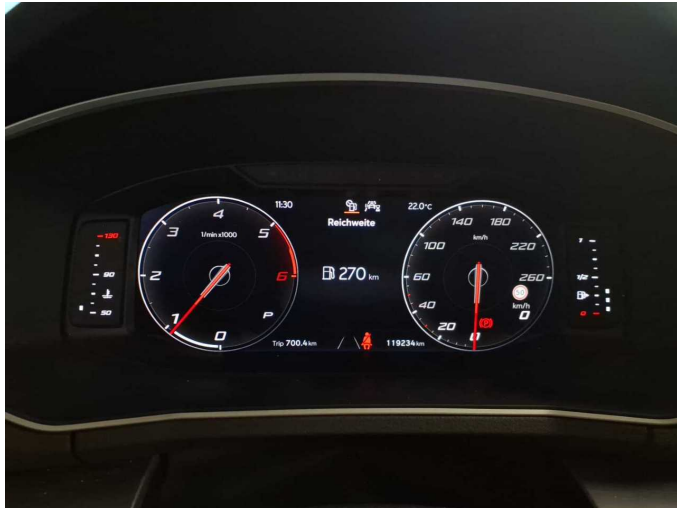
**Figure 7: Instrument cluster**

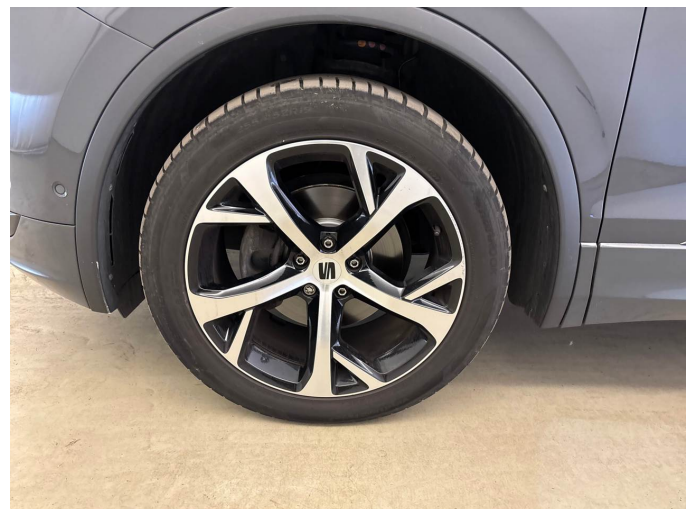
| Tyres | | | | |
|---|---|---|---|---|
| 1) | 255/45 R19 104Y | Summer tyres on Light alloy | Hankook | 5mm / 5mm |

**Figure 12: Mounted tyres**

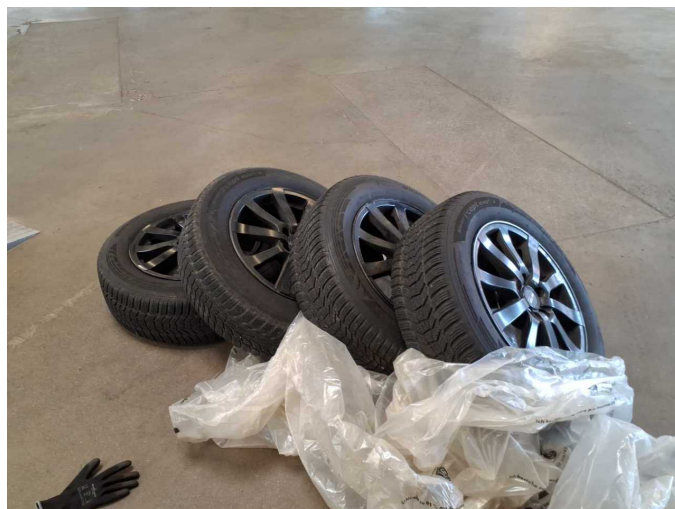
| Tyres | | | | |
|---|---|---|---|---|
| 1) | 215/65 R17 99V | Winter tyres on Light alloy | Hankook | 5mm / 5mm |

Figure 14: Additional tyres

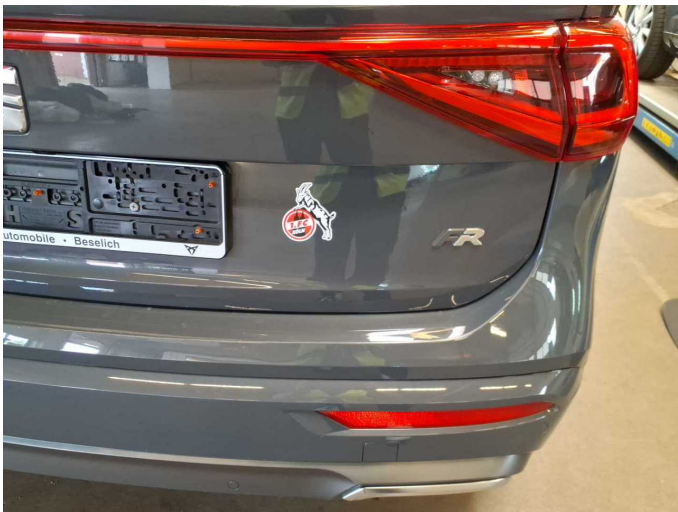
| No. | Component group | Description |
|---|---|---|
| 1 | Boot lid / rear door | Boot lid - Glued / labelled - De-glue / neutralise |

Damage 1: Boot lid / rear door: Boot lid - Glued / labelled - De-glue / neutralise

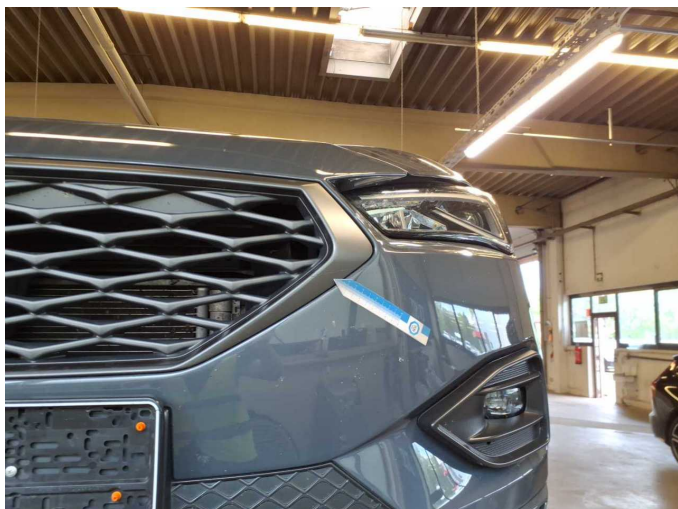
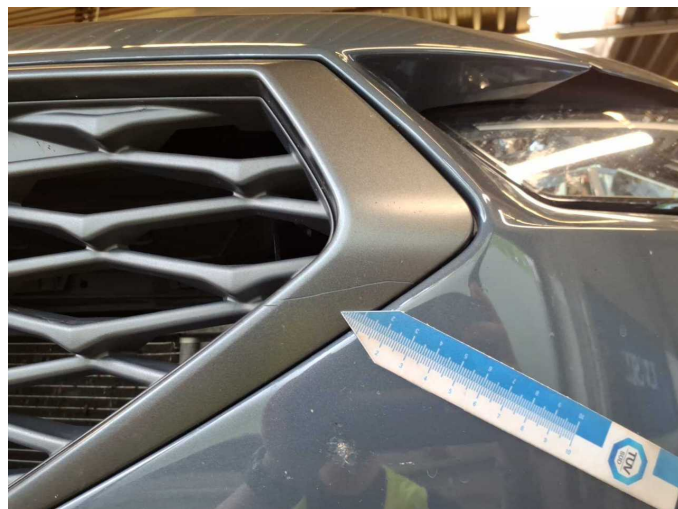
| No. | Component group | Description |
|---|---|---|
| 2 | Front structure | Grille - Scratch(es) - Smart repair |

**Damage 2:** Front structure: Grille - Scratch(es) - Smart repair

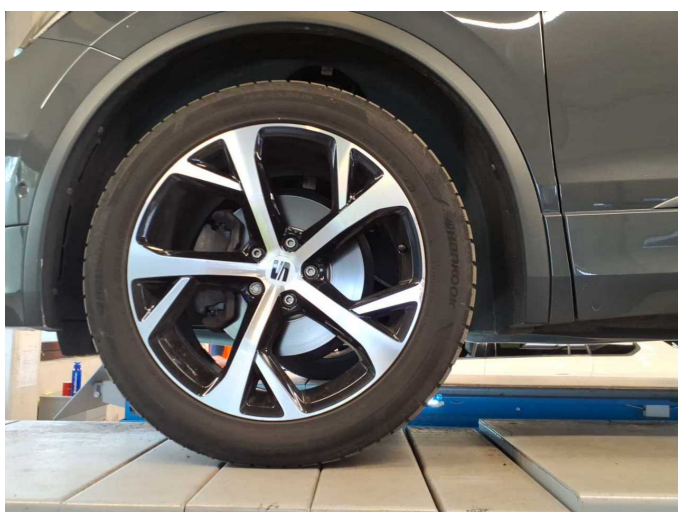
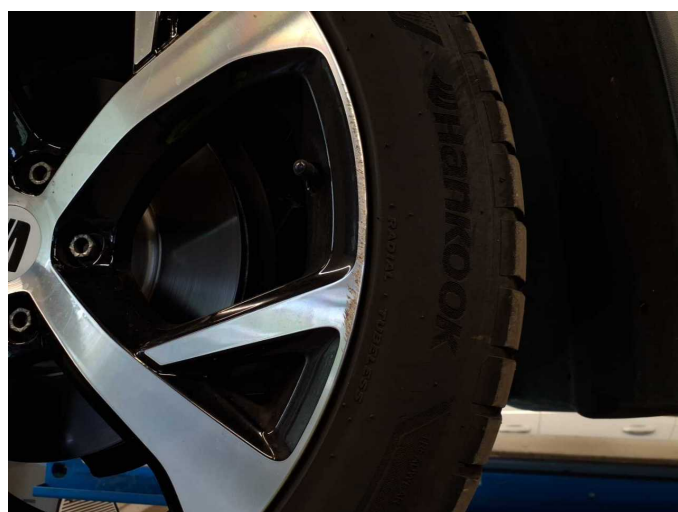
| No. | Component group | Description |
|---|---|---|
| 4 | Wheel / tyres | Alloy rim - front left side - Scratch(es) - Loss in value |

**Damage 4:** Wheel / tyres: Alloy rim - front left side - Scratch(es) - Loss in value

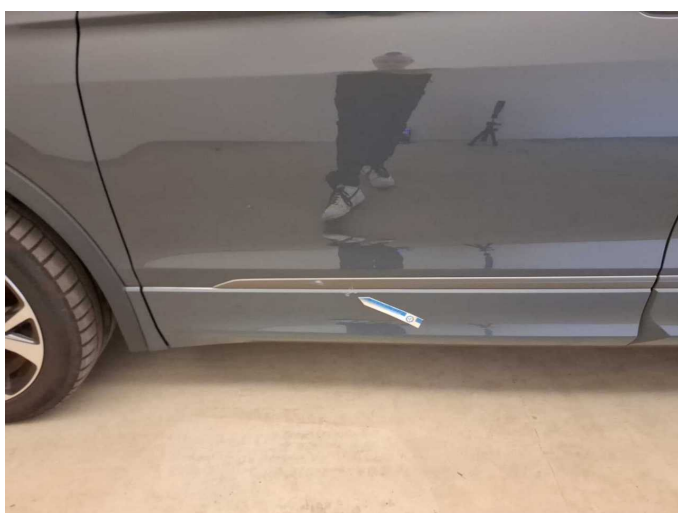
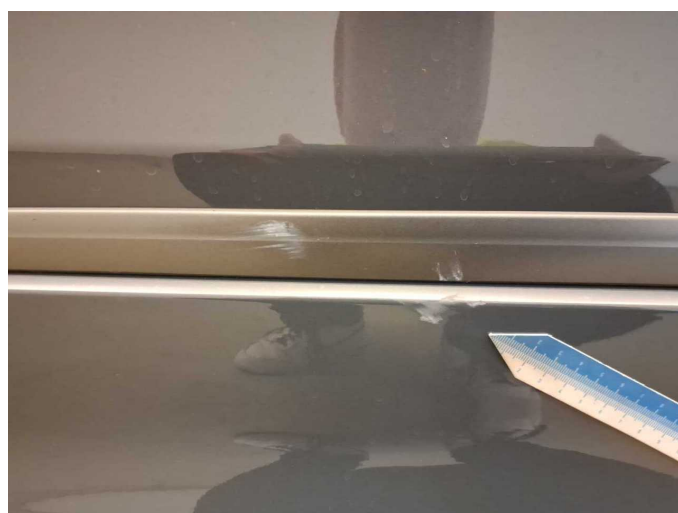
| No. | Component group | Description |
|---|---|---|
| 5 | Door - front left side | Door - Scratch(es) - Paint |

**Damage 5:** Door - front left side: Door - Scratch(es) - Paint

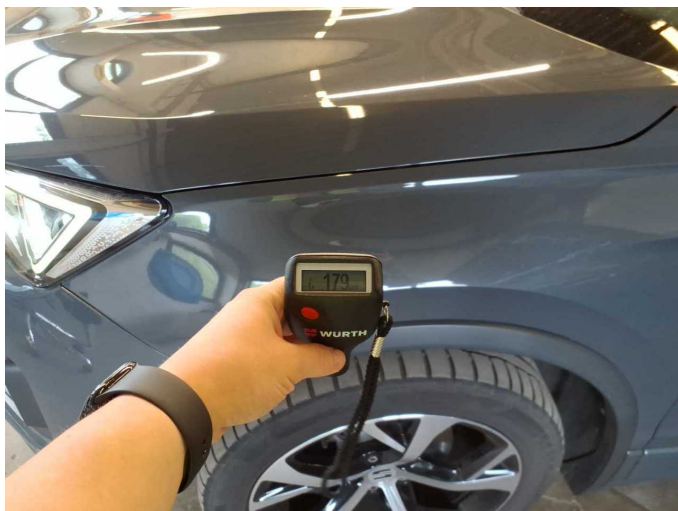
- 1 Mudguard - left side, Professionally carried out, Invoice of repair done Non-existent

Mudguard - left side 179 µm

**Repainting 1:** Mudguard - left side
