Expertise

Protocol number: 46146956
Order No. / Reference: 26512066
Inspection date: 24 Jun 2026

Manufacturer: Audi

Model: A3 40 TFSIe Sportback S tronic

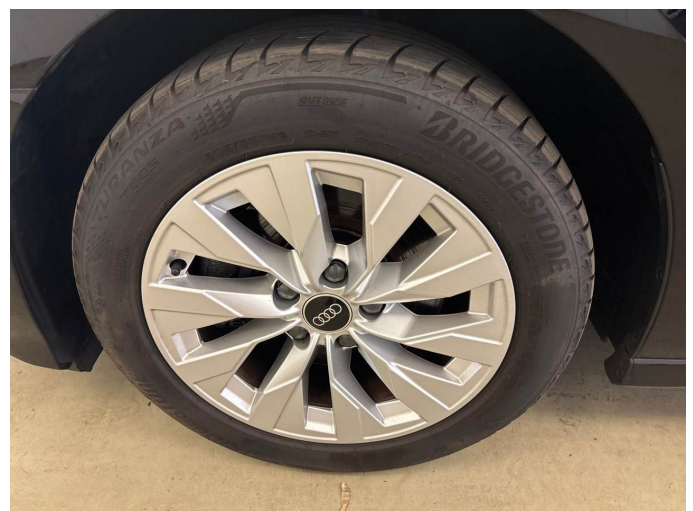
Figure 12: Mounted tyres

#	Tyre size	Type of tyre	Manufacturer	Tread depth
1)	205/55 R16 94V	Summer tyres on Light alloy	Bridgestone	5mm / 5mm
2)	205/55 R16 94V	Summer tyres on Light alloy	Bridgestone	5mm / 5mm

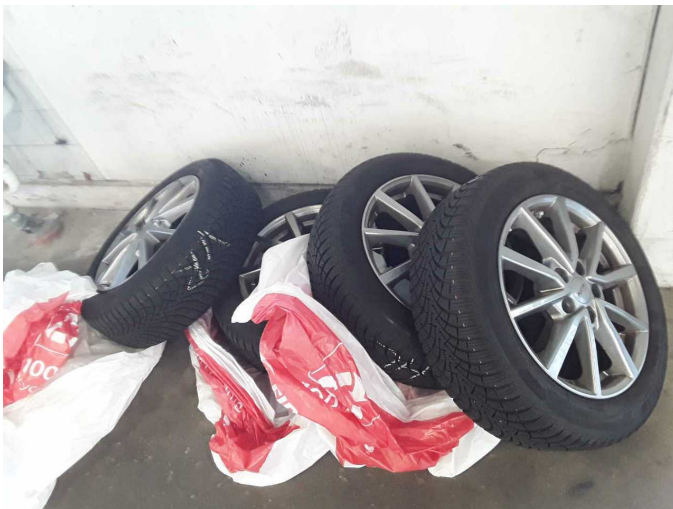
Figure 15: Additional tyres

#	Tyre size	Type of tyre	Manufacturer	Tread depth
1)	205/55 R16 94H	Winter tyres on Light alloy	Goodyear	6mm / 6mm
2)	205/55 R16 94H	Winter tyres on Light alloy	Goodyear	5mm / 5mm

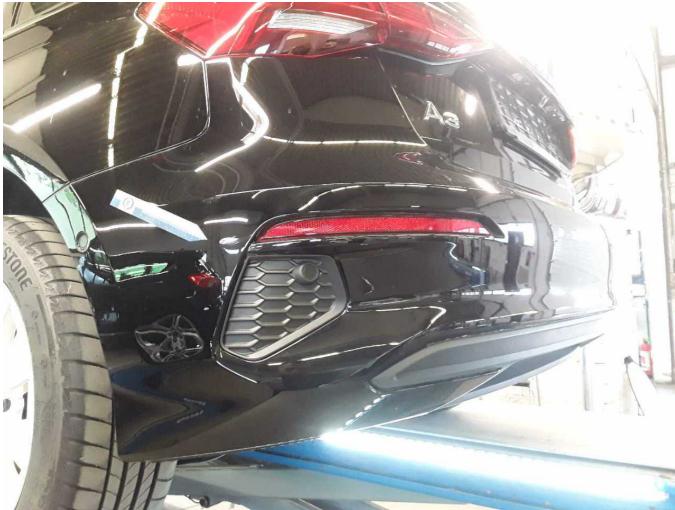
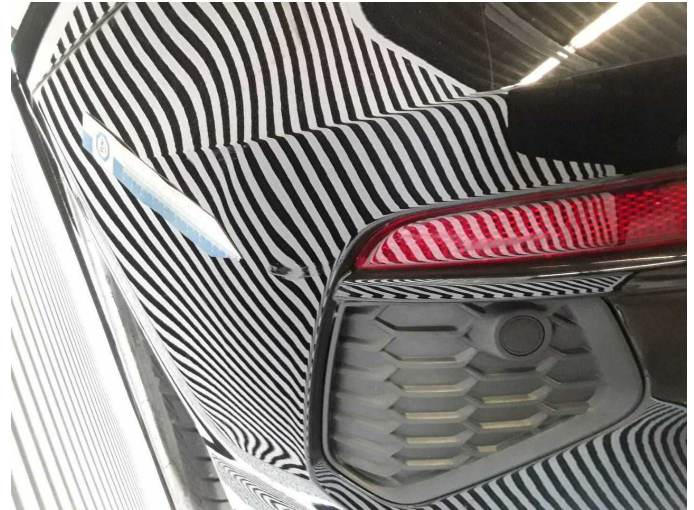
Damage 1: Rear bumper: Rear bumper - Dent / paintcoat damage - Repair and paint

No.	Component group	Description
1	Rear bumper	Rear bumper - Dent / paintcoat damage - Repair and paint
2	Vehicle glazing	Windscreen (Rissbildung) - Stone chips - Replace

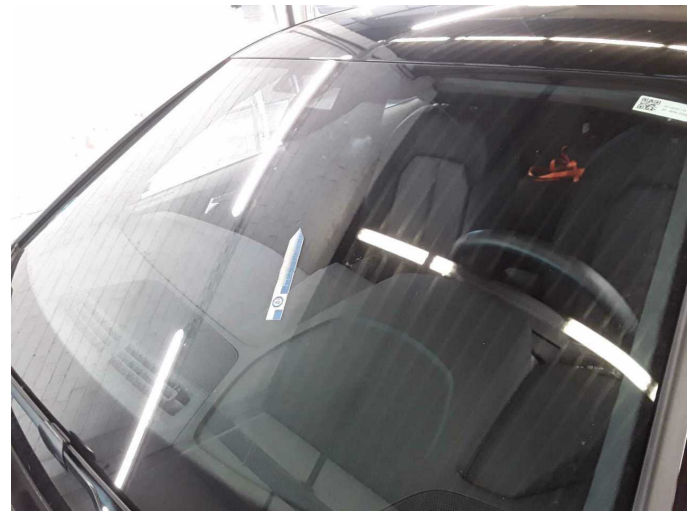
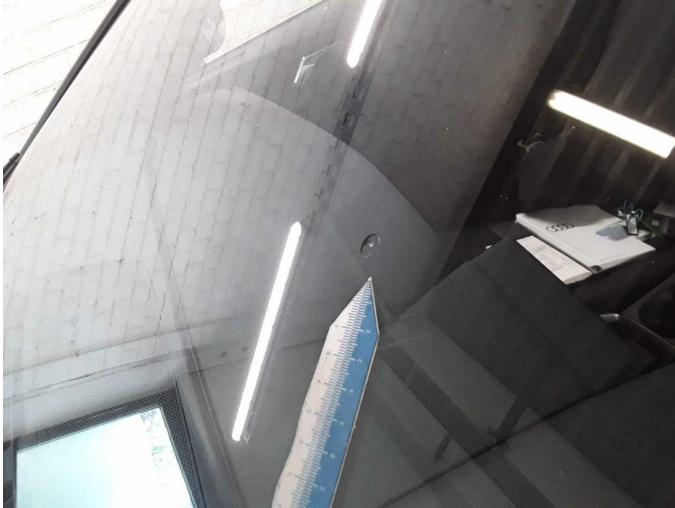
Damage 2: Vehicle glazing: Windscreen (Rissbildung) - Stone chips - Replace

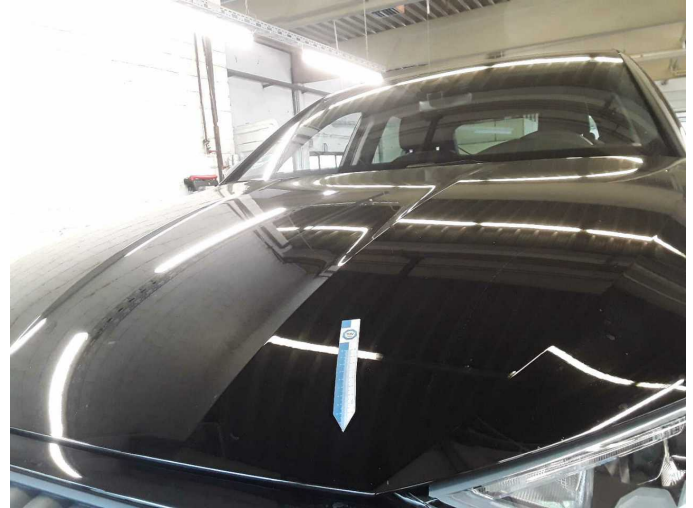
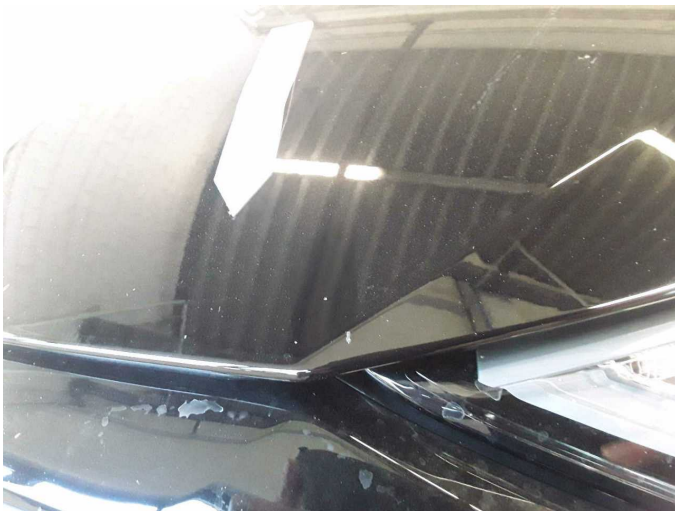
Wear and tear 1: Bonnet: Bonnet - Stone chips - No deduction

No.	Component group	Description
1	Bonnet	Bonnet - Stone chips - No deduction
2	Front bumper	Front bumper - Stone chips - No deduction

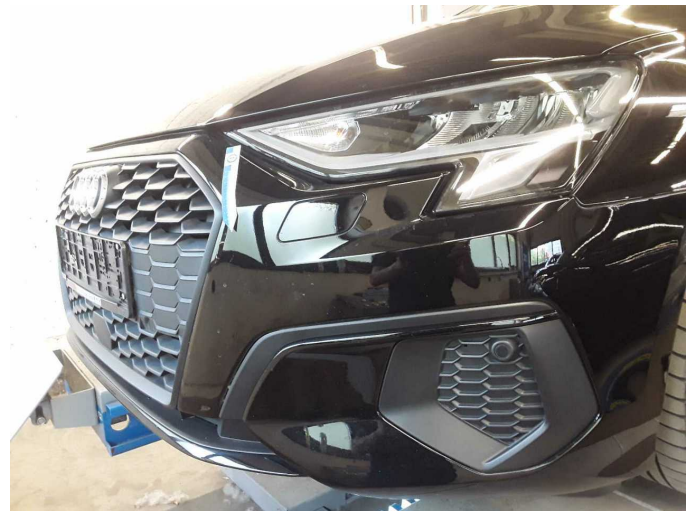
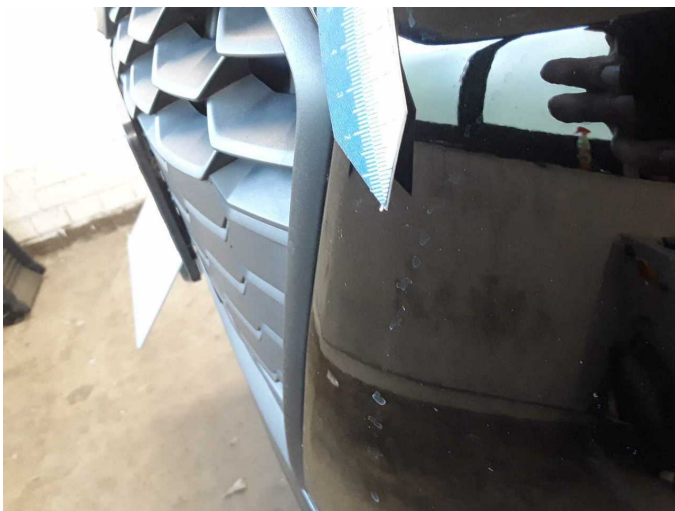
Wear and tear 2: Front bumper: Front bumper - Stone chips - No deduction
