Expertise

Protocol number: 46012306  
Order No. / Reference: 26530217  
Inspection date: 18 Jun 2026

Manufacturer: Skoda  
VIN: TMBJH7NP1P7028323

Model: Superb Combi 2.0 TDI DSG Style

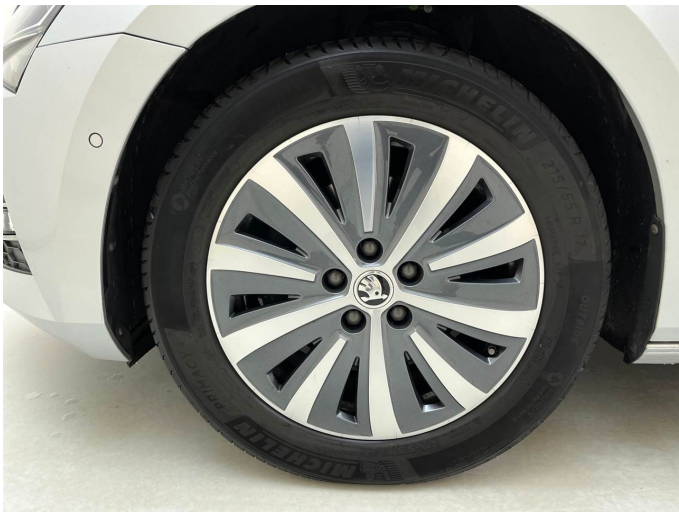
| # | Tyre size | Type of tyre | Manufacturer | Tread depth |
|---|---|---|---|---|
| 1) | 215/55 R17 94V | Summer tyres on Light alloy | Michelin | 4mm / 4mm |
| 2) | 215/55 R17 94V | Summer tyres on Light alloy | Michelin | 6mm / 6mm |

Figure 12: Mounted tyres

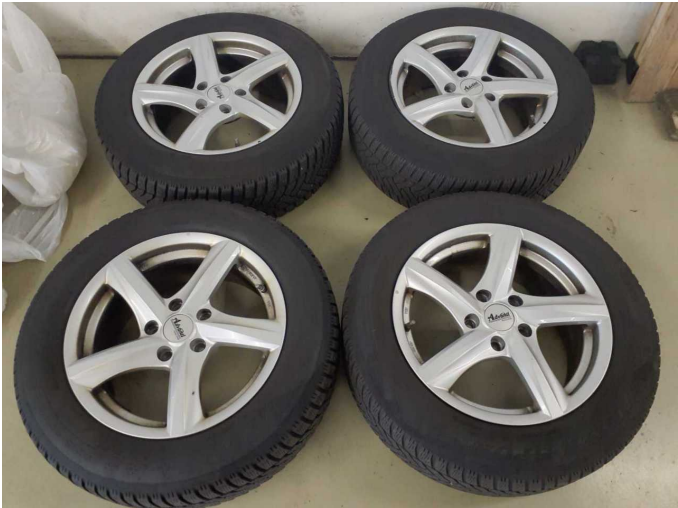
| # | Tyre size | Type of tyre | Manufacturer | Tread depth |
|---|---|---|---|---|
| 1) | 215/60 R16 95H | Winter tyres on Light alloy | Dunlop | 4mm / 4mm |
| 2) | 215/60 R16 95H | Winter tyres on Light alloy | Dunlop | 8mm / 8mm |

Figure 16: Additional tyres

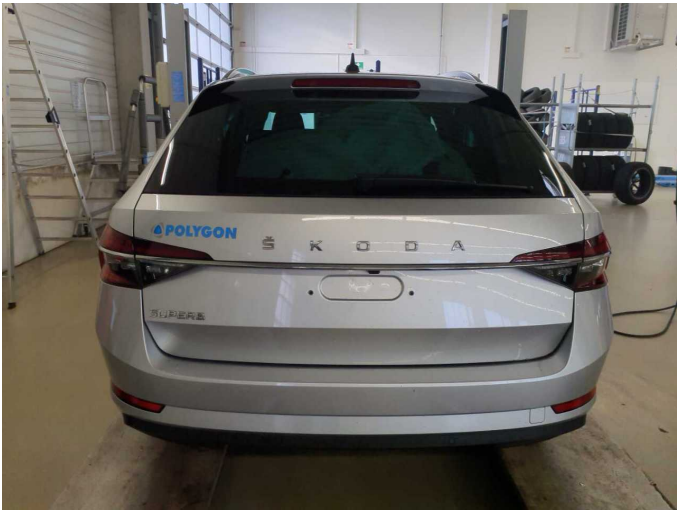
Damage 1: Boot lid / rear door: Boot lid - Glued / labelled - De-glue / neutralise

| No. | Component group | Description |
|---|---|---|
| 1 | Boot lid / rear door | Boot lid - Glued / labelled - De-glue / neutralise |

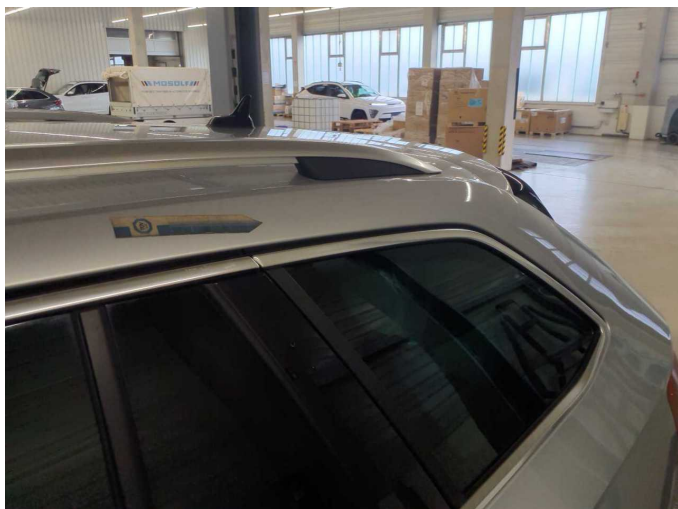
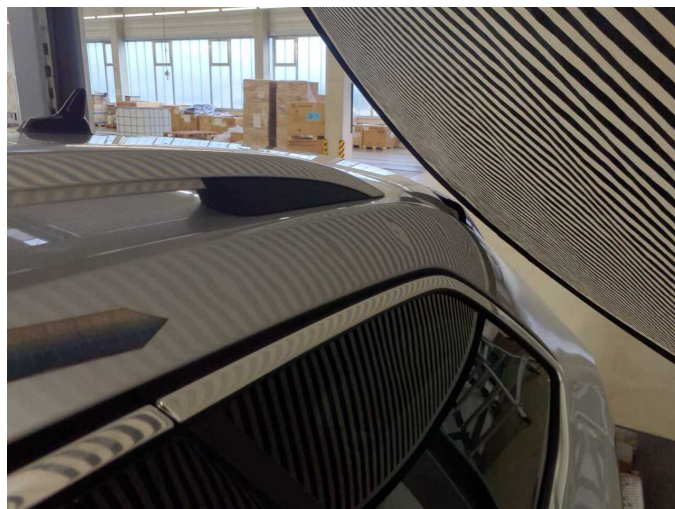
**Damage 2:** Roof: Roof rail - left side - dent(s) - Smart repair

| No. | Component group | Description |
|---|---|---|
| 2 | Roof | Roof rail - left side - dent(s) - Smart repair |

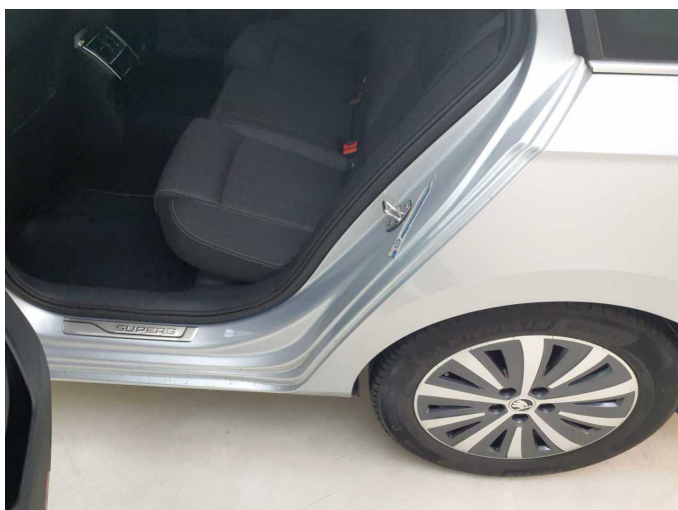
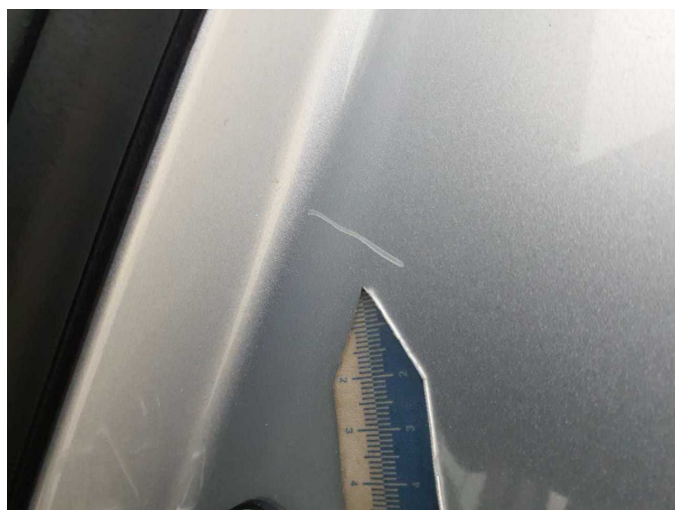
**Damage 3:** Side panel - rear left side: Sill - Scratch(es) - Smart repair

| No. | Component group | Description |
|---|---|---|
| 3 | Side panel - rear left side | Sill - Scratch(es) - Smart repair |

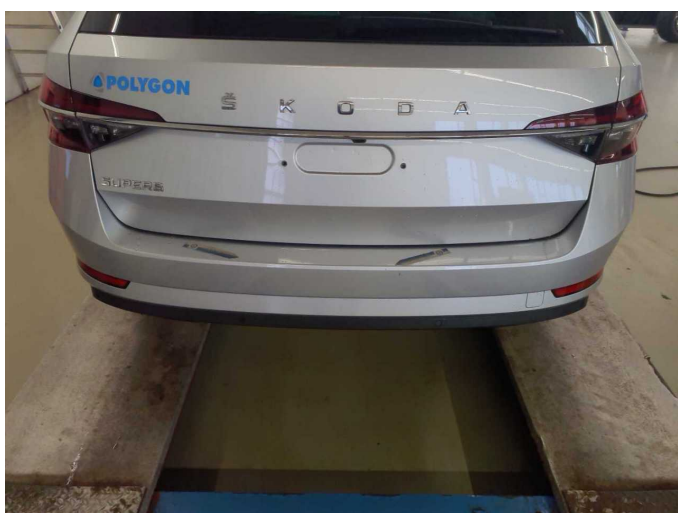
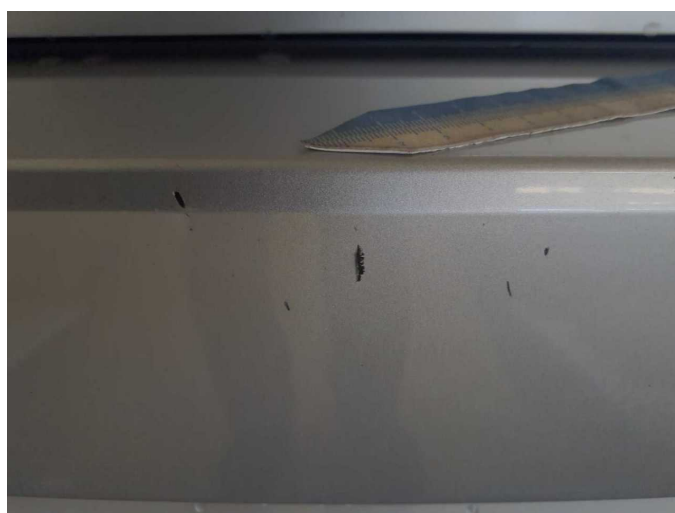
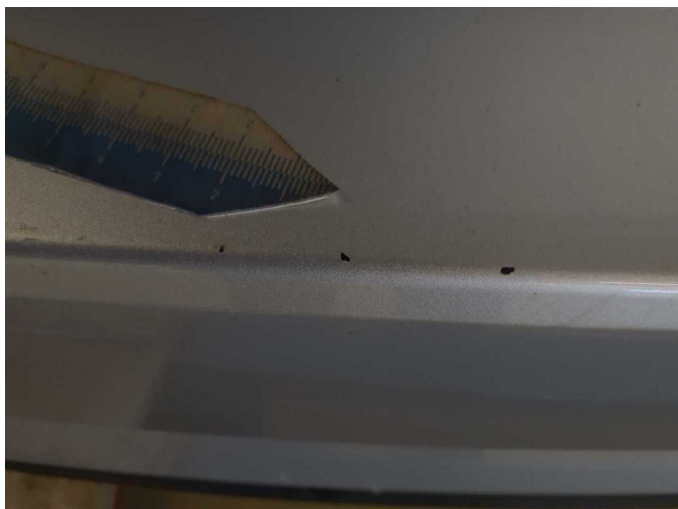
**Damage 4:** Rear bumper: Rear bumper - Scratch(es) - Paint

| No. | Component group | Description |
|---|---|---|
| 4 | Rear bumper | Rear bumper - Scratch(es) - Paint |

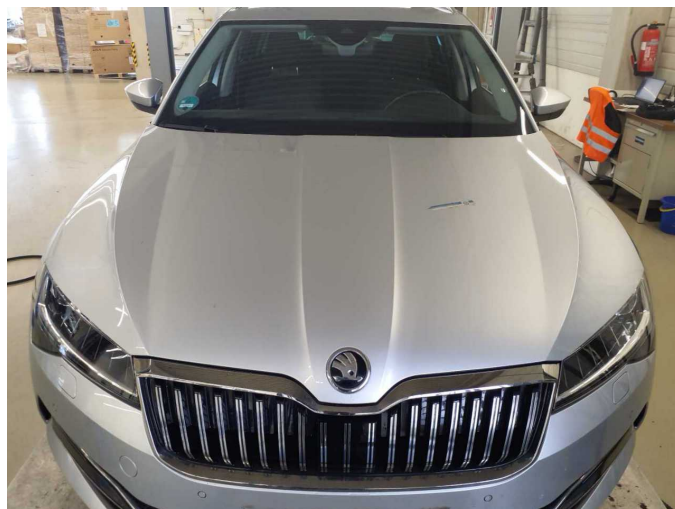
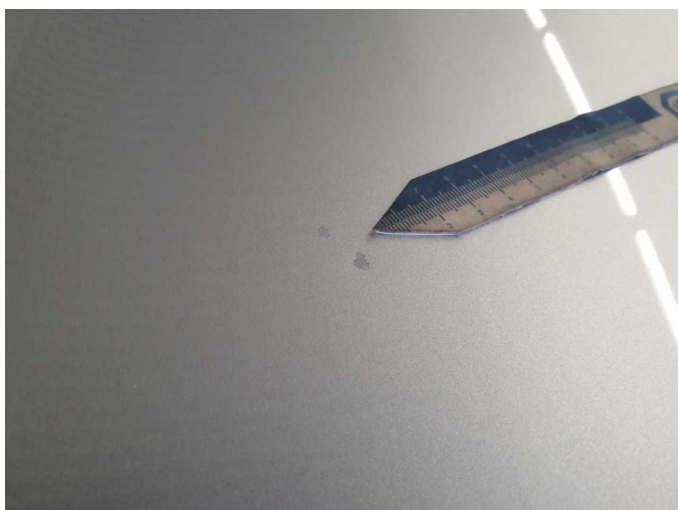
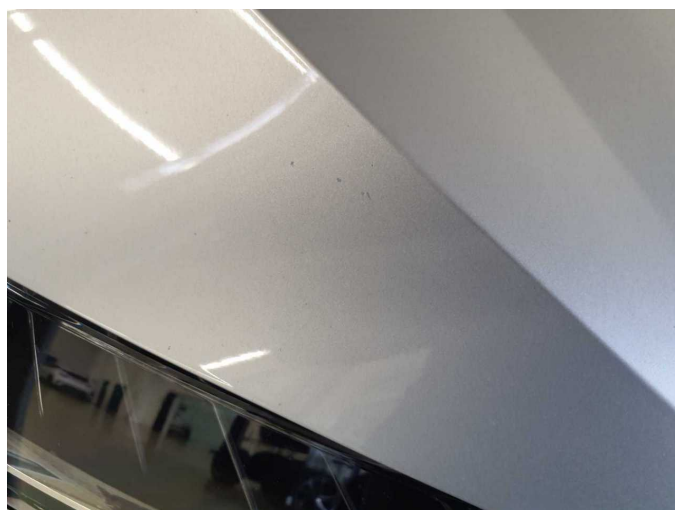
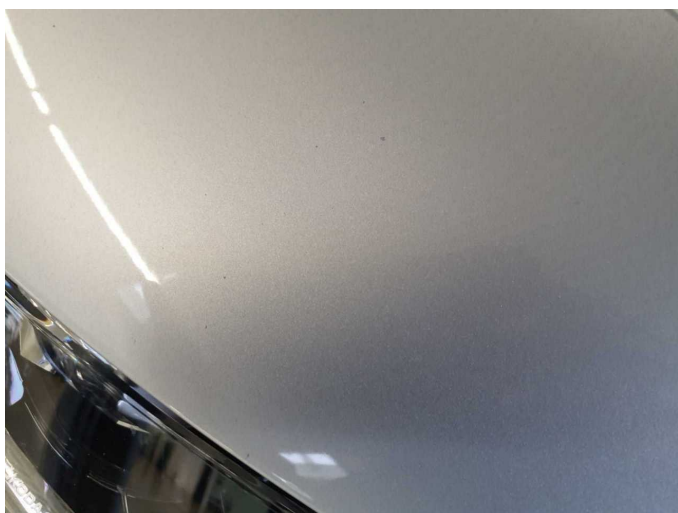
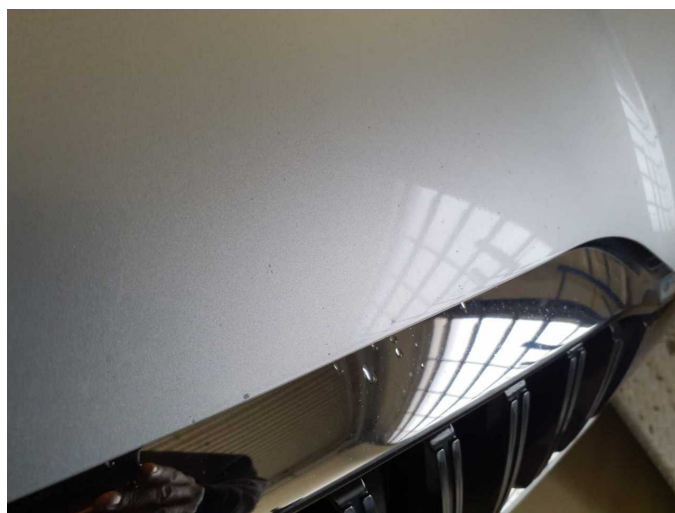
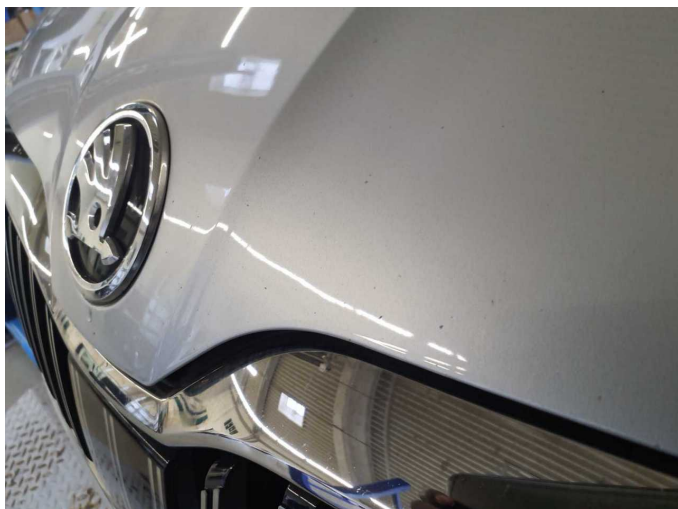
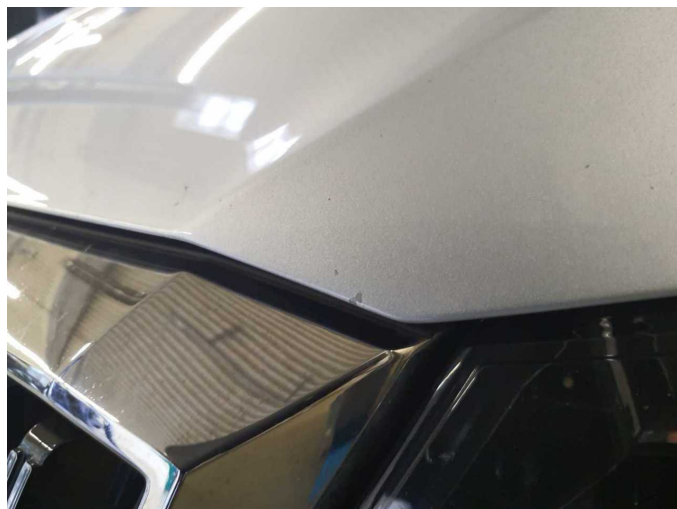
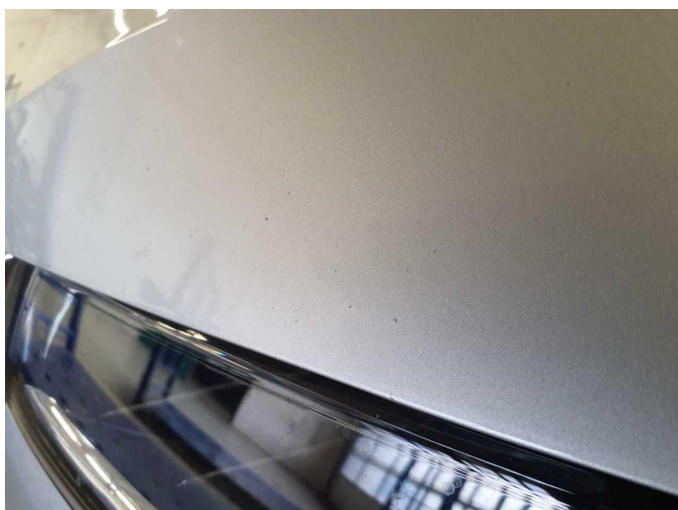
**Damage 5:** Bonnet: Bonnet - Stone chips - Paint

| No. | Component group | Description |
|---|---|---|
| 5 | Bonnet | Bonnet - Stone chips - Paint |

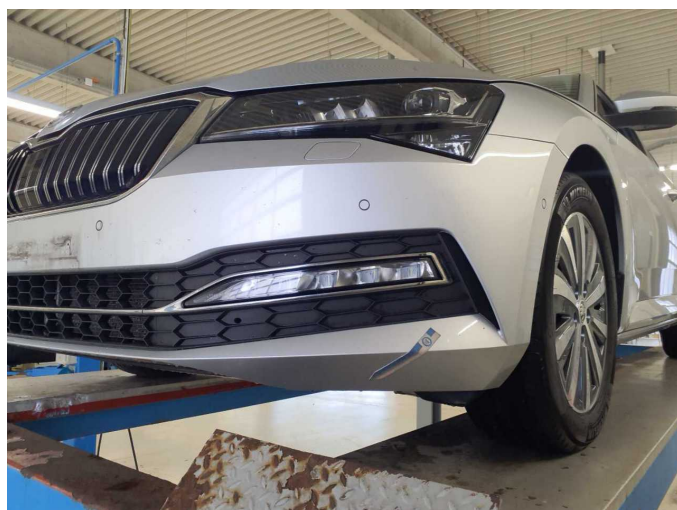
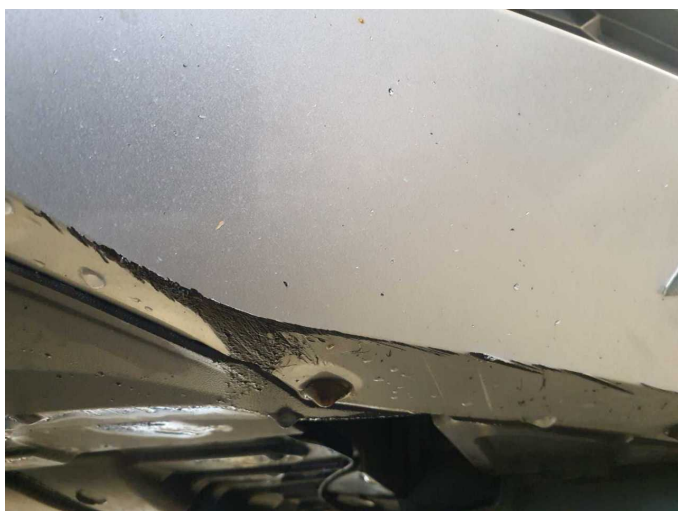
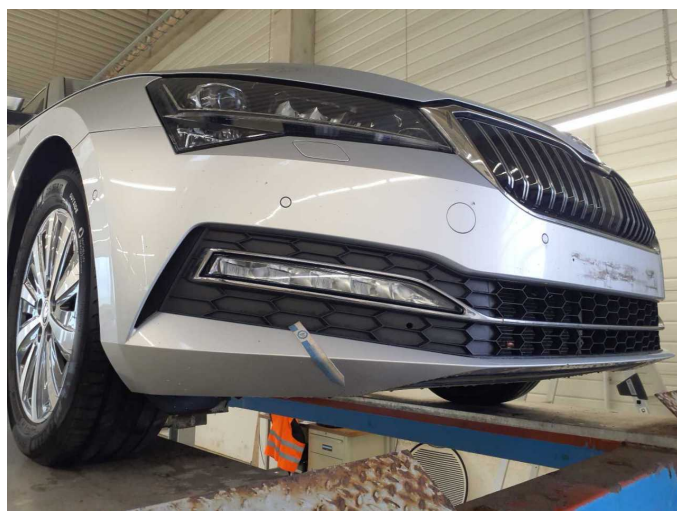
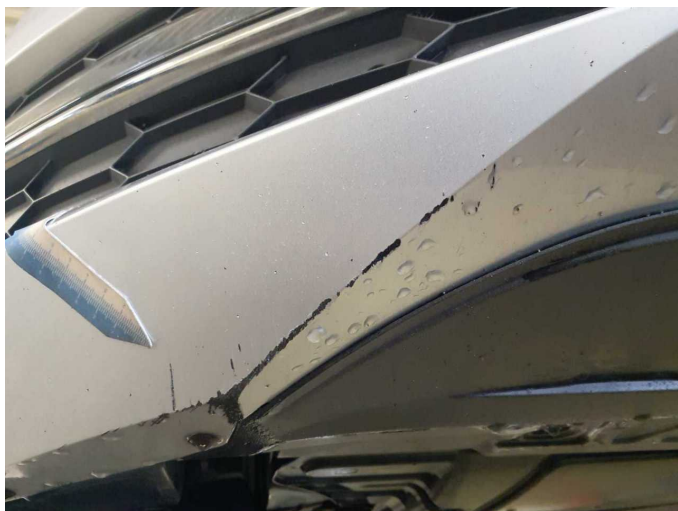
**Damage 6:** Front bumper: Front bumper - Scratch(es) - Paint

| No. | Component group | Description |
|---|---|---|
| 6 | Front bumper | Front bumper - Scratch(es) - Paint |
