Expertise

Protocol number: 46841656  
Order No. / Reference: 26687945  
Inspection date: 31 Jul 2026

Manufacturer: Polestar

Model: 2 Single Motor 78kWh

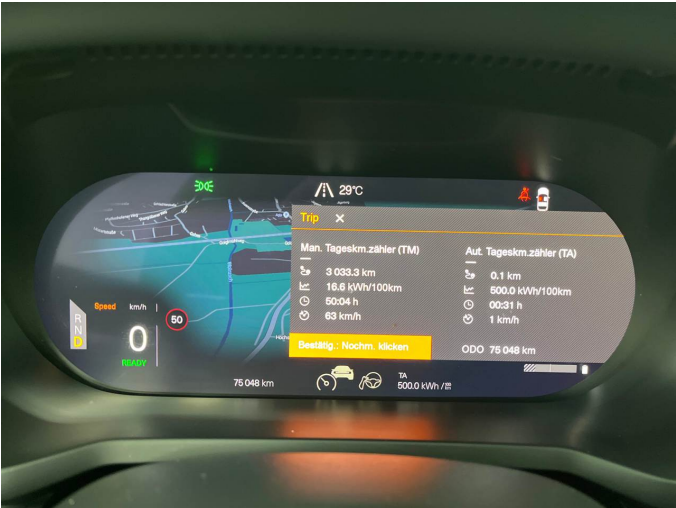
| Vehicle details | |
|---|---|
| Mileage (Read) | 75,048 km |

Figure 7: Instrument cluster

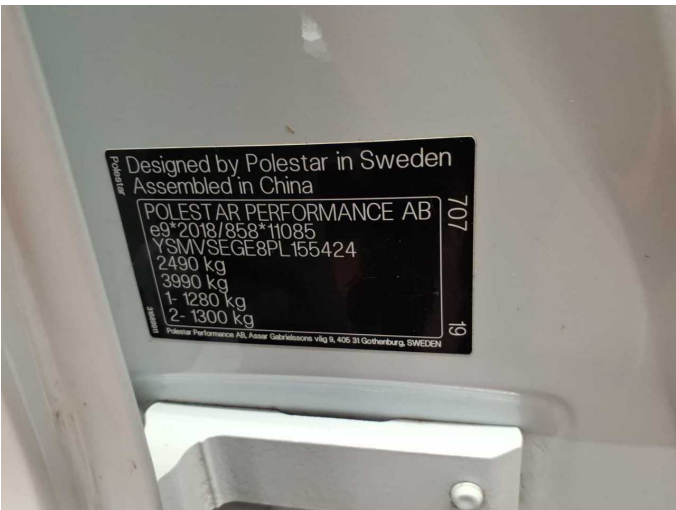
| VIN comparison | The vehicle identification number (VIN) was read from the vehicle and its conformity with the submitted documents was confirmed by the undersigned during the inspection. |

Figure 11: VIN

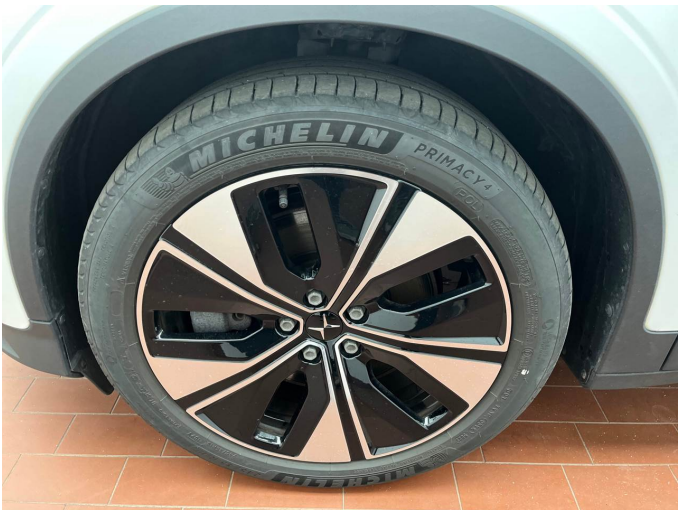
| # | Tyre size | Type of tyre | Manufacturer | Tread depth |
|---|---|---|---|---|
| 1) | 245/45 R19 102V | Summer tyres on Light alloy | Michelin | 5mm / 5mm |
| 2) | 245/45 R19 102V | Summer tyres on Light alloy | Michelin | 6mm / 6mm |

Figure 12: Mounted tyres

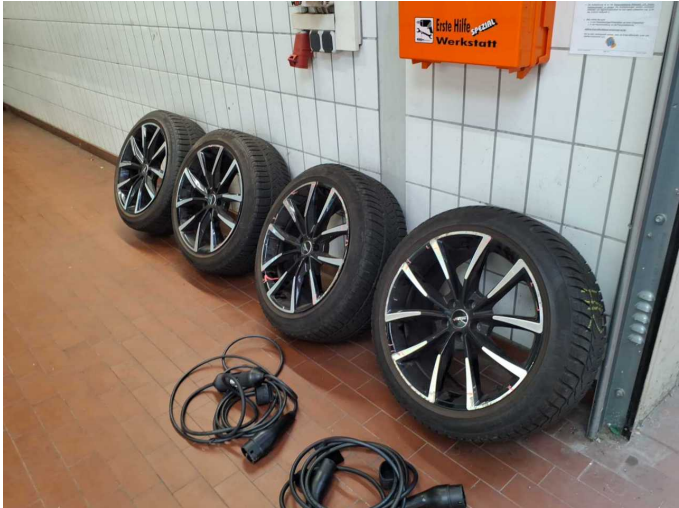
| # | Tyre size | Type of tyre | Manufacturer | Tread depth |
|---|---|---|---|---|
| 1) | 245/45 R19 102V | Winter tyres on Light alloy | Pirelli | 5mm / 5mm |
| 2) | 245/45 R19 102V | Winter tyres on Light alloy | Pirelli | 6mm / 6mm |

| No. | Component group | Description |
|---|---|---|
| 1 | 2nd wheel set | 3 alloy rims (Hoher Materialabtrag) - Scratched - No deduction |

Figure 16: Additional tyres

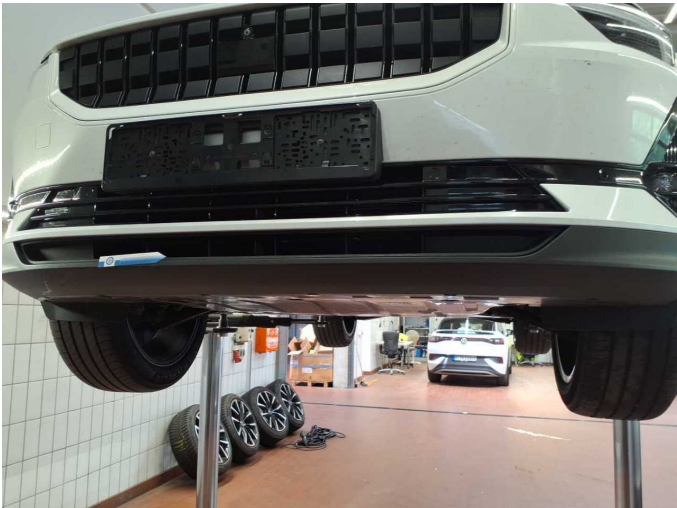
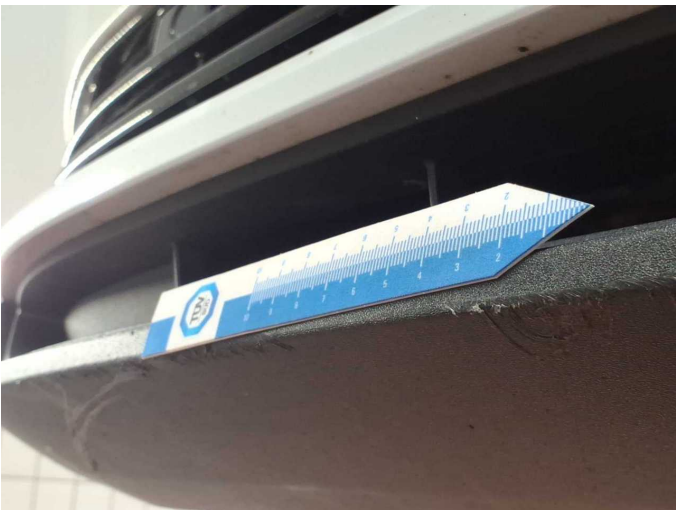
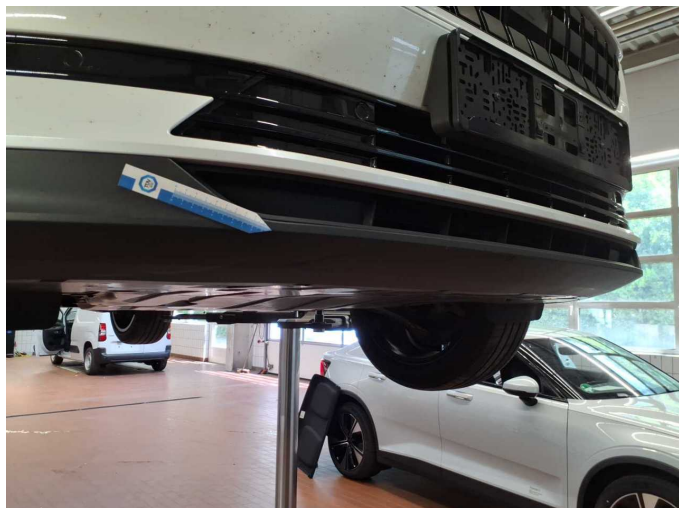
Damage 1: Front bumper: Spoiler - Scratch(es) - Replace

**Damage 1:** Front bumper: Spoiler - Scratch(es) - Replace

| No. | Component group | Description |
|---|---|---|
| 1 | Front bumper | Spoiler - Scratch(es) - Replace |

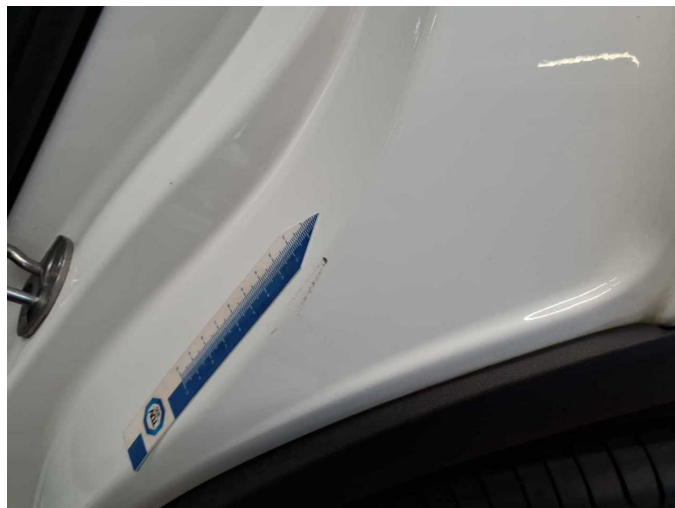
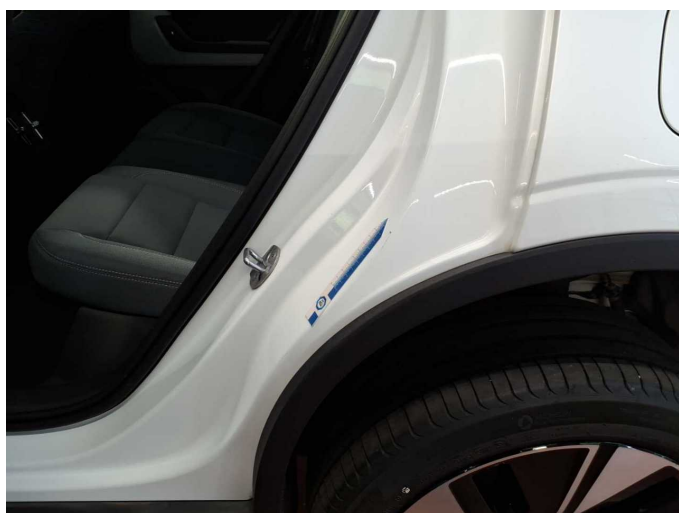
**Damage 2:** Side panel - rear left side: Sill - Scratch(es) - Smart repair

| No. | Component group | Description |
|---|---|---|
| 2 | Side panel - rear left side | Sill - Scratch(es) - Smart repair |

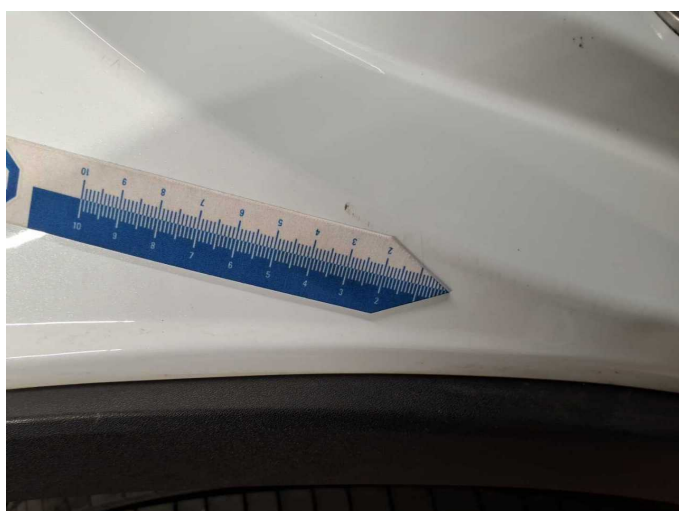
**Damage 3:** Side panel - rear right side: Sill - Dent / paintcoat damage - Smart repair

| No. | Component group | Description |
|---|---|---|
| 3 | Side panel - rear right side | Sill - Dent / paintcoat damage - Smart repair |

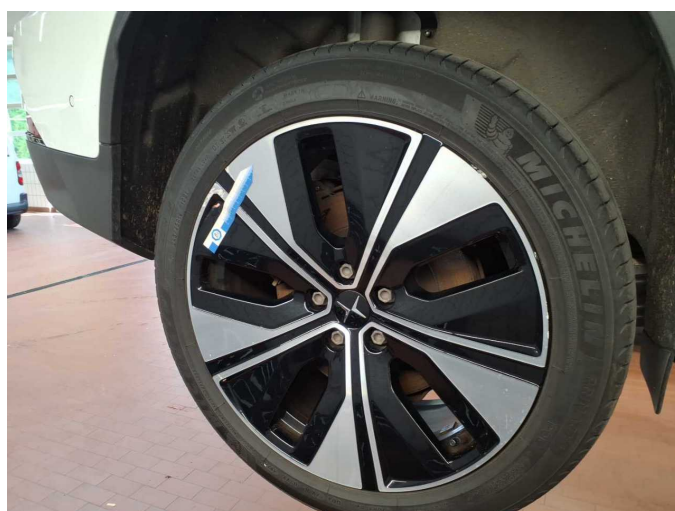
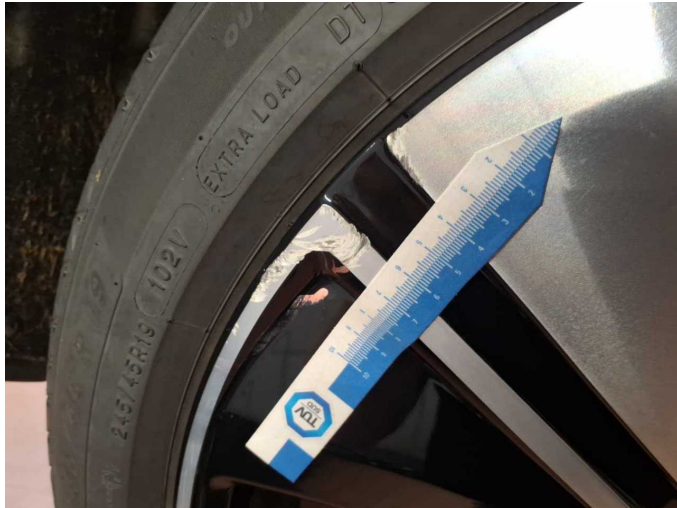
**Damage 4:** Wheel / tyres: Alloy rim - rear right side - Scratched - Replace

| No. | Component group | Description |
|---|---|---|
| 4 | Wheel / tyres | Alloy rim - rear right side - Scratched - Replace |

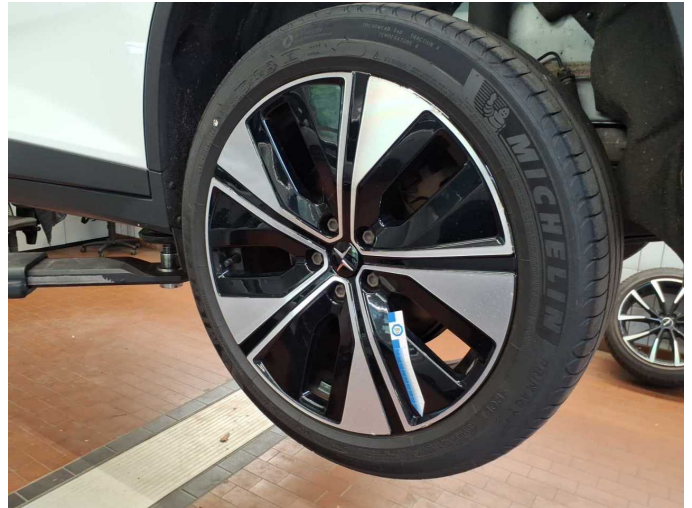
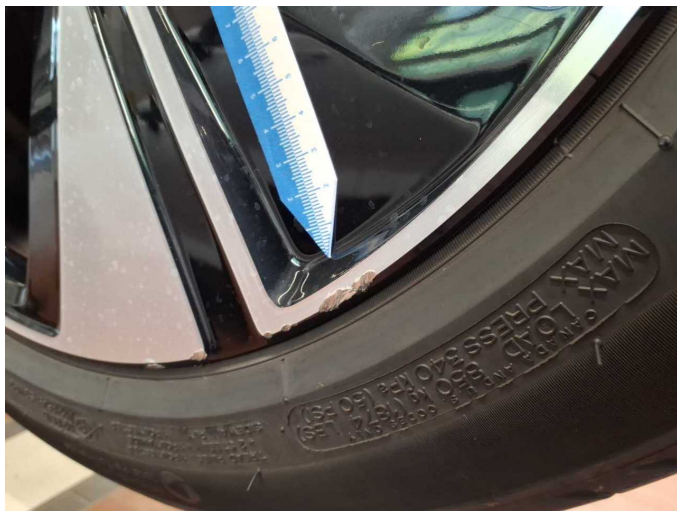
**Damage 5:** Wheel / tyres: Alloy rim - rear left side - Scratched - Replace

| No. | Component group | Description |
|---|---|---|
| 5 | Wheel / tyres | Alloy rim - rear left side - Scratched - Replace |

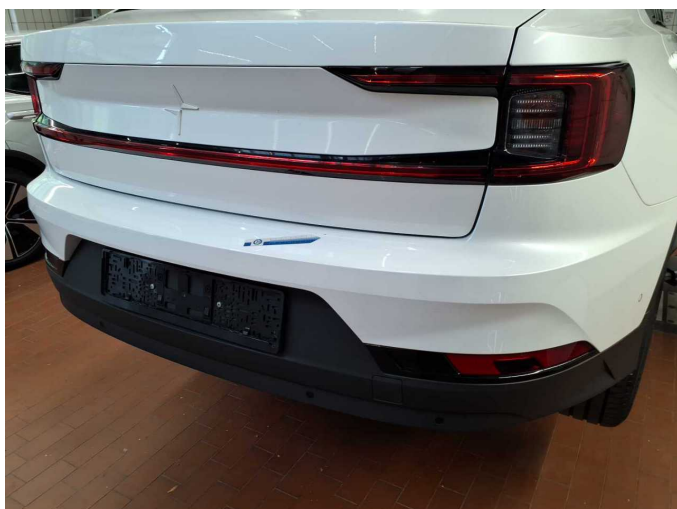
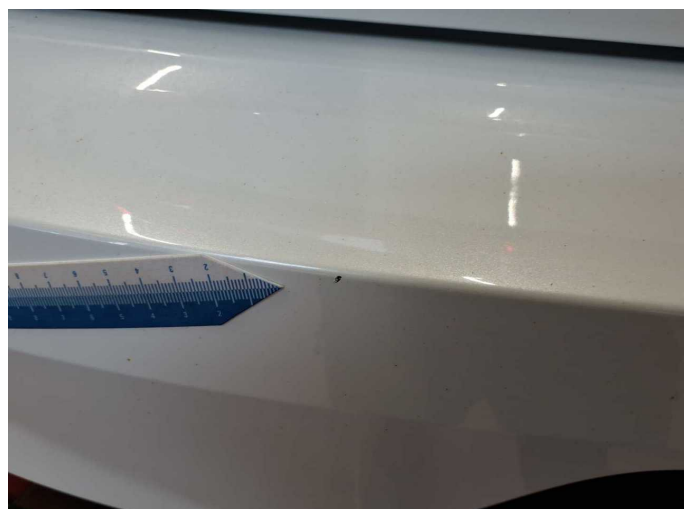
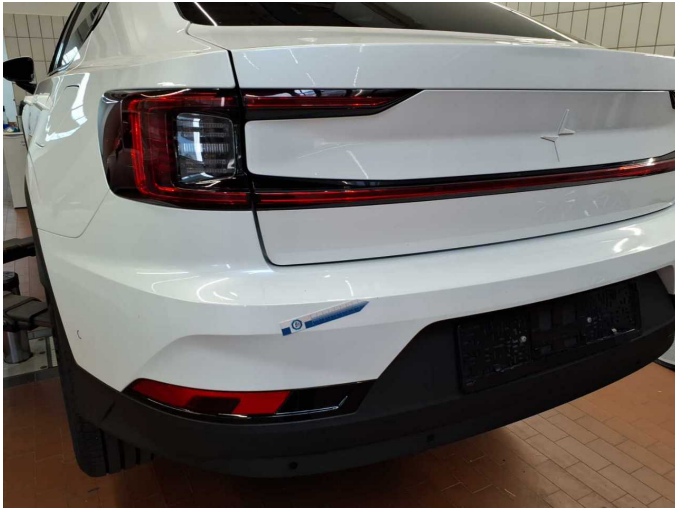
**Damage 6:** Rear bumper: Rear bumper - Scratch(es) - Paint

| No. | Component group | Description |
|---|---|---|
| 6 | Rear bumper | Rear bumper - Scratch(es) - Paint |
