Protocol number: 46128322
Order No. / Reference: 26512278
Inspection date: 23 Jun 2026

Manufacturer: Mercedes-Benz

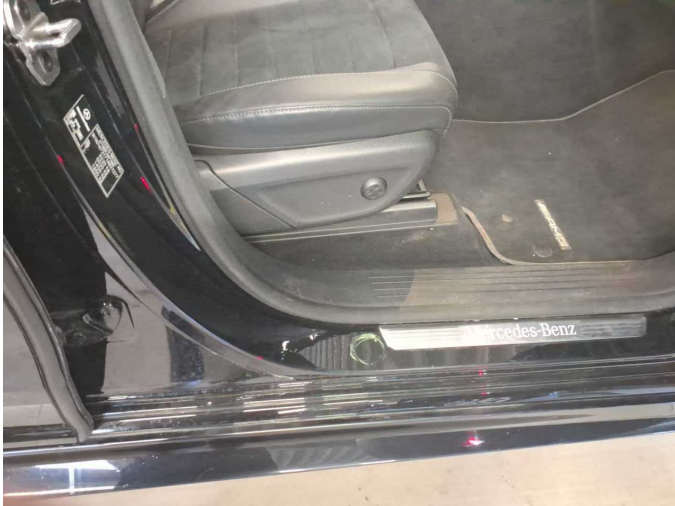
Damage 1: Sill - right side: Sill - dent(s) - Smooth repair work

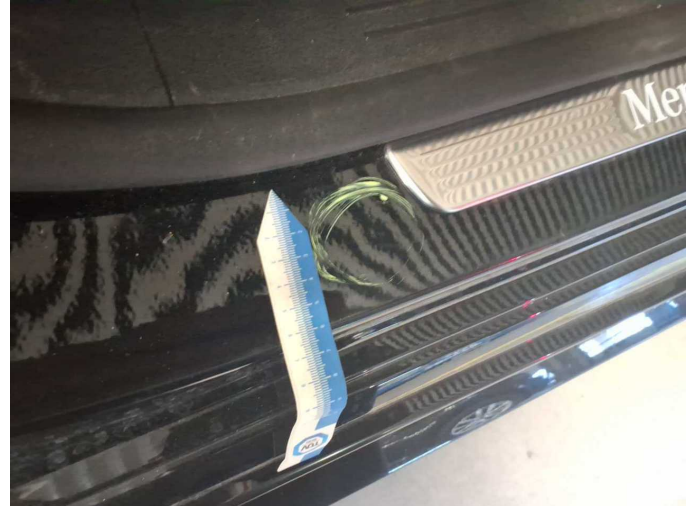
Damage 1: Sill - right side: Sill - dent(s) - Smooth repair work

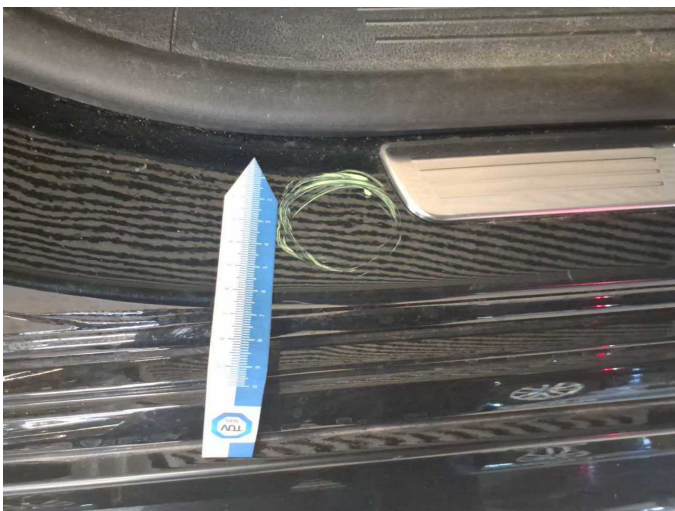
Damage 1: Sill - right side: Sill - dent(s) - Smooth repair work

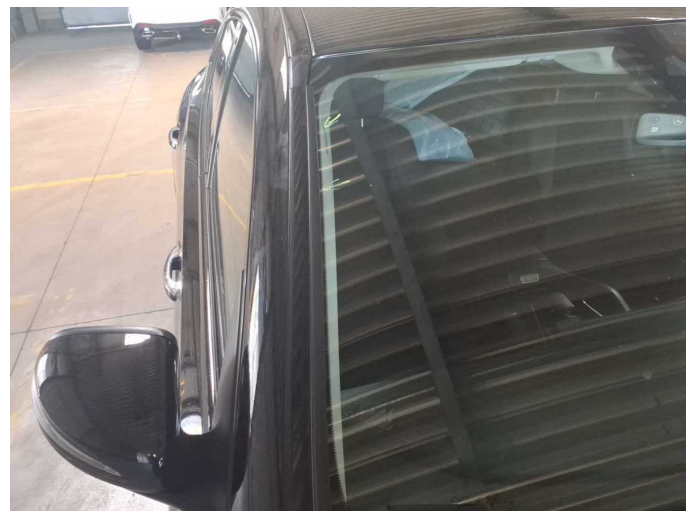
Damage 2: Body: A-pillar - left side (Verkleidung außen) - Damaged - Replace

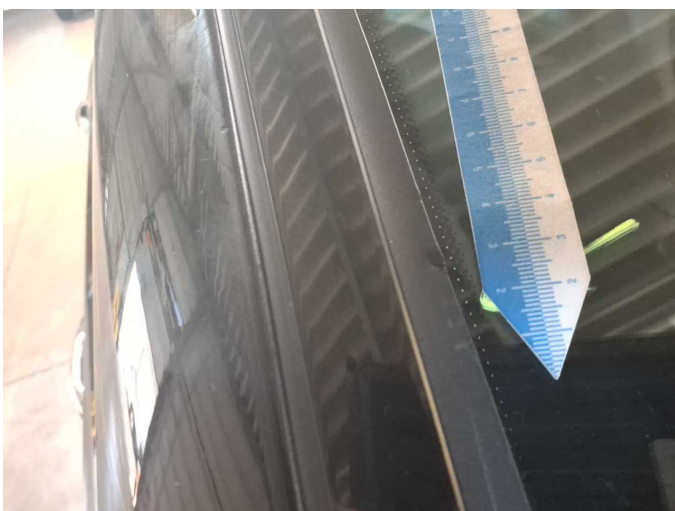
Damage 2: Body: A-pillar - left side (Verkleidung außen) - Damaged - Replace

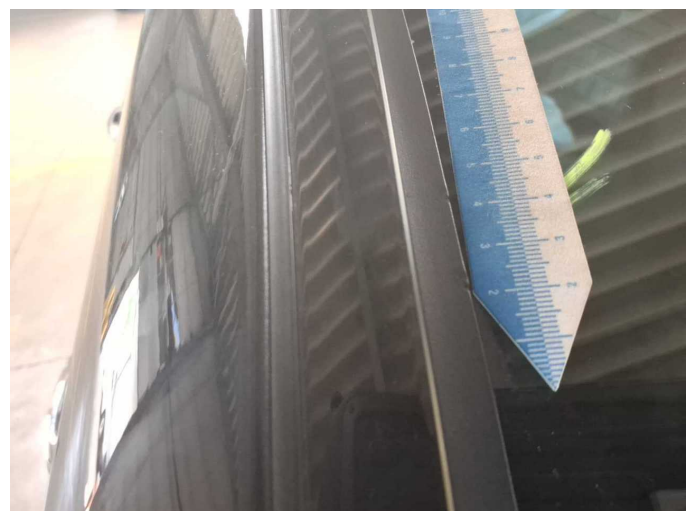
Damage 2: Body: A-pillar - left side (Verkleidung außen) - Damaged - Replace

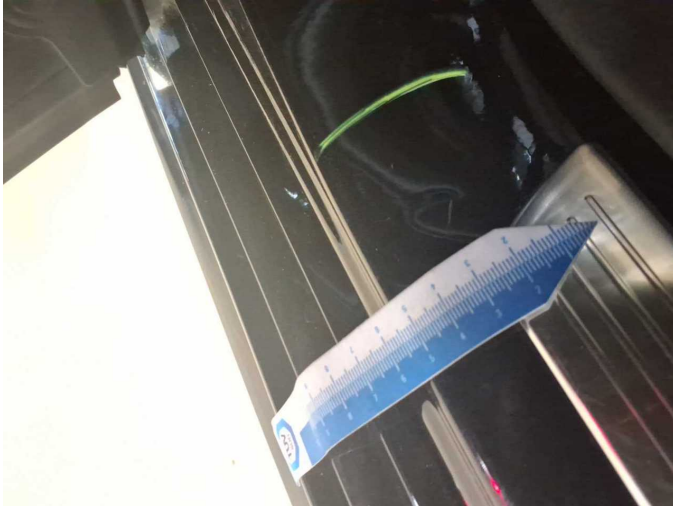
Damage 3: Side panel - rear left side: Sill - Dent / paintcoat damage - Smart repair

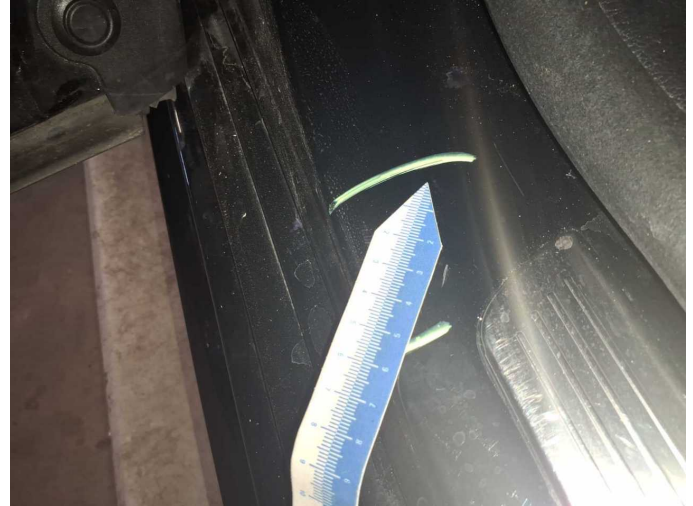
Damage 3: Side panel - rear left side: Sill - Dent / paintcoat damage - Smart repair

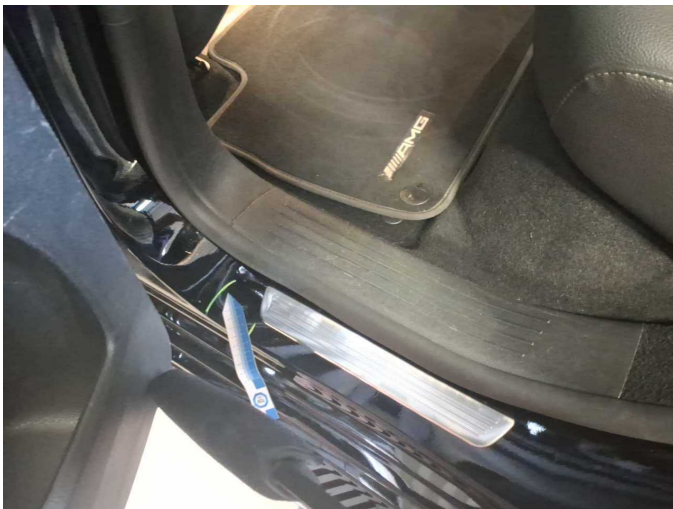
Damage 3: Side panel - rear left side: Sill - Dent / paintcoat damage - Smart repair

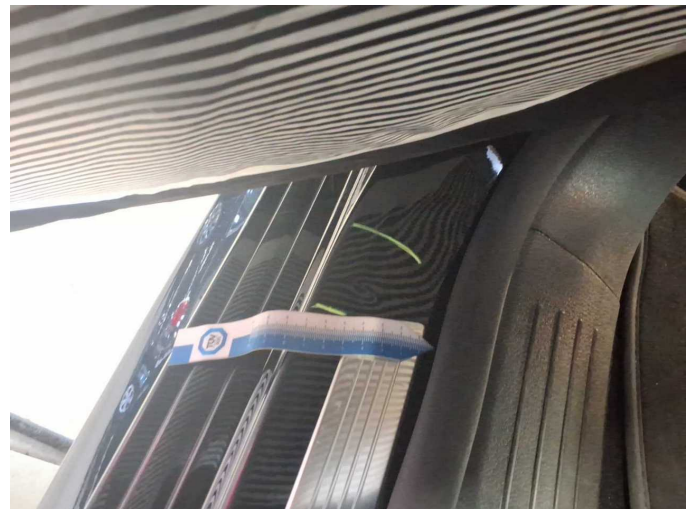
Damage 3: Side panel - rear left side: Sill - Dent / paintcoat damage - Smart repair

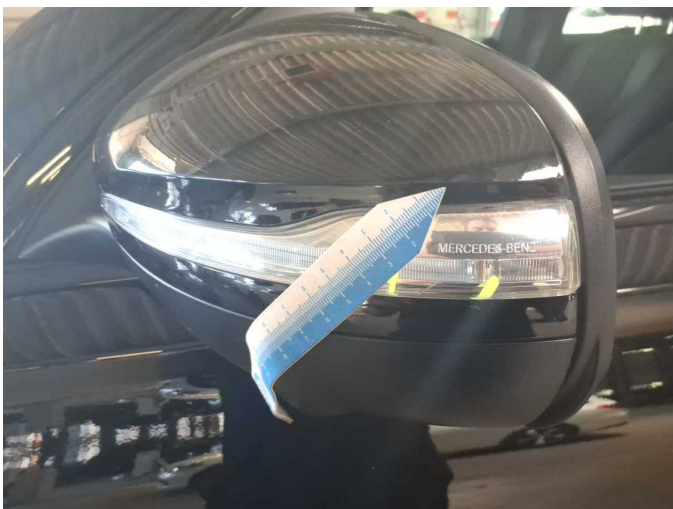
Wear and tear 1: Indicator - front: Mirror - left side - Scratch(es) - No deduction

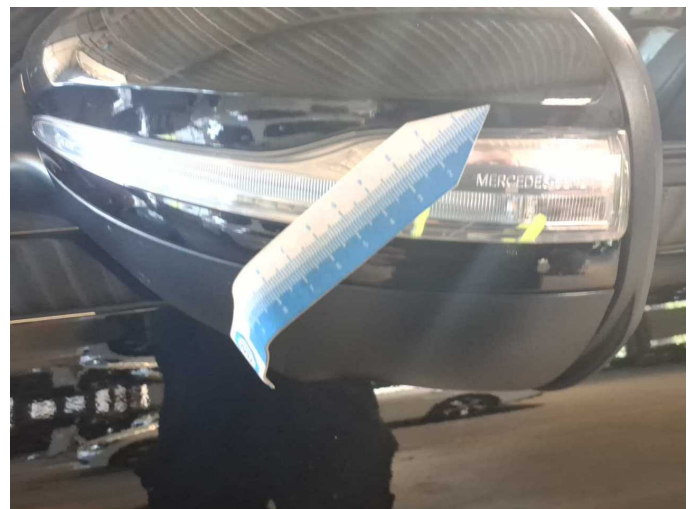
Wear and tear 1: Indicator - front: Mirror - left side - Scratch(es) - No deduction

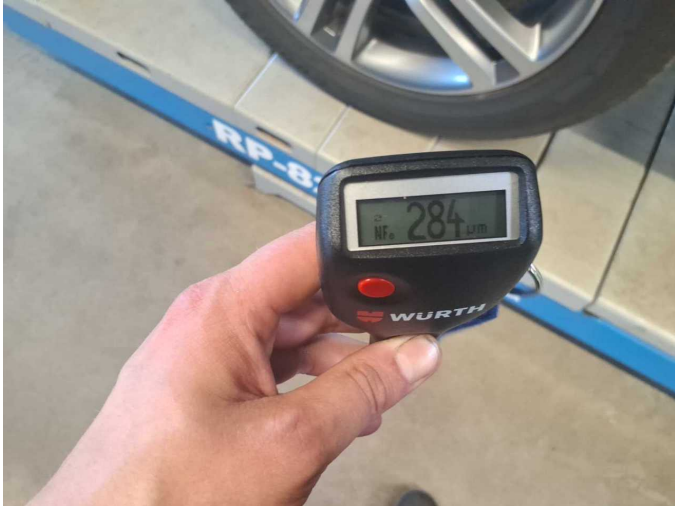
Repainting 1: Mudguard - left side
