Expertise

Protocol number: 46594087  
Order No. / Reference: 26651511  
Inspection date: 17 Jul 2026

Manufacturer: Mercedes-Benz

Model: C 220 d T 9G-TRONIC Avantgarde

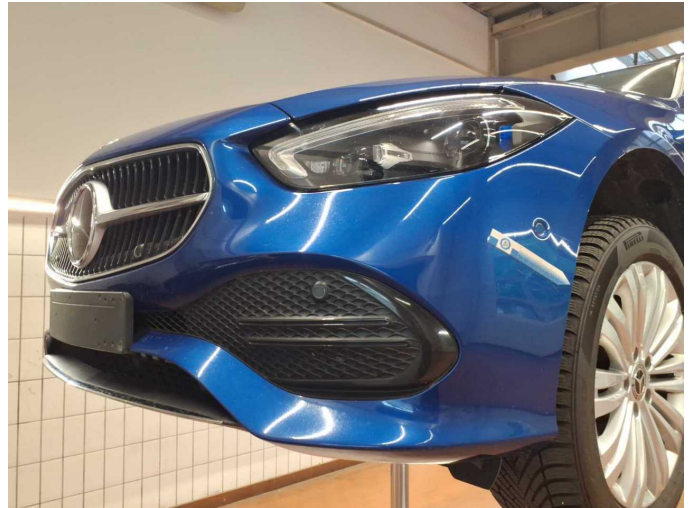
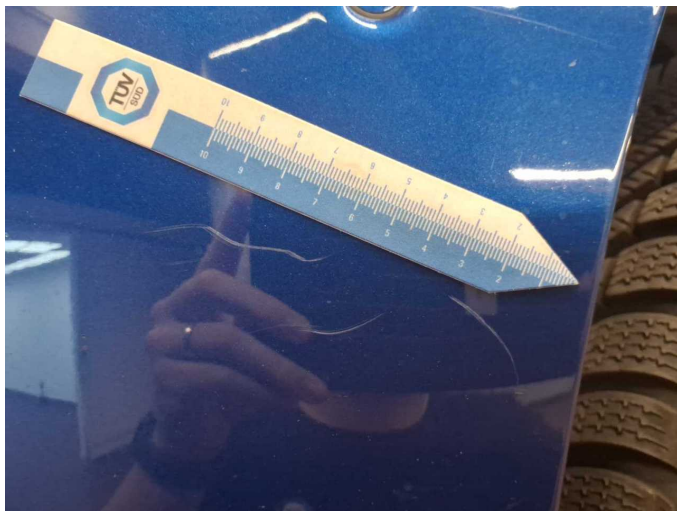
| No. | Component group | Description |
|---|---|---|
| 2 | Front bumper | Front bumper - Scratch(es) - Smart repair |

**Damage 2:** Front bumper: Front bumper - Scratch(es) - Smart repair

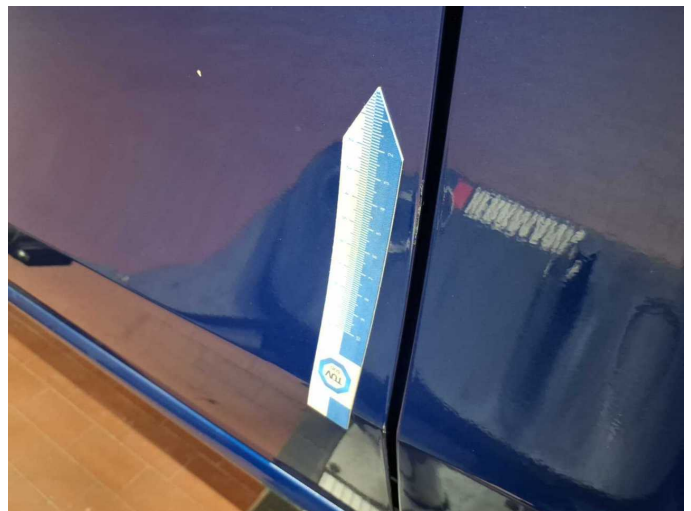
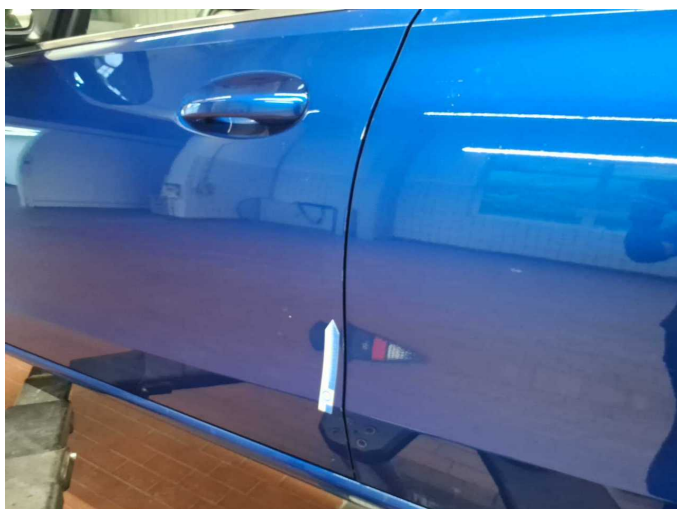
| No. | Component group | Description |
|---|---|---|
| 3 | Door - front left side | Door edge - Scratch(es) - Smart repair |

**Damage 3:** Door - front left side: Door edge - Scratch(es) - Smart repair

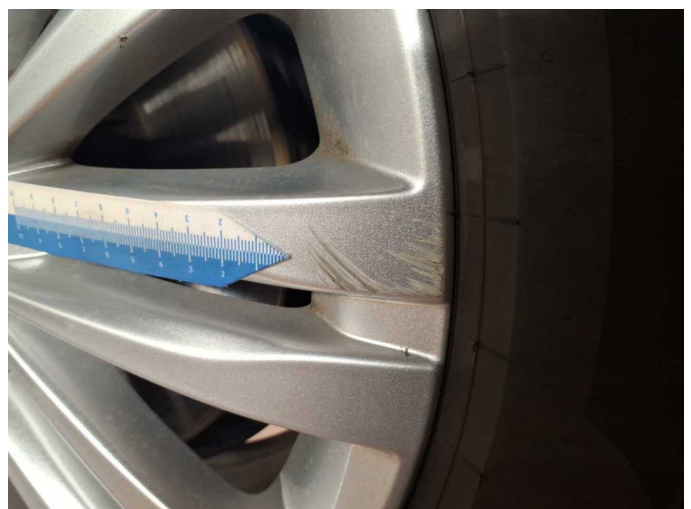
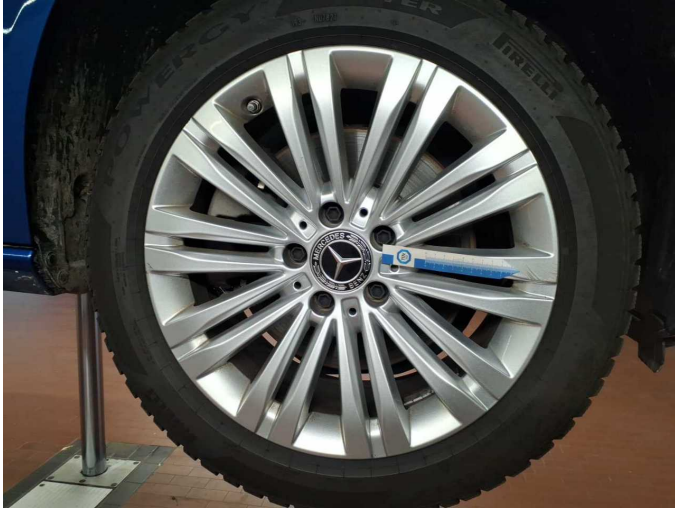
| No. | Component group | Description |
|---|---|---|
| 4 | Wheel / tyres | Alloy rim - front right side - Scratched - Loss in value |

**Damage 4:** Wheel / tyres: Alloy rim - front right side - Scratched - Loss in value

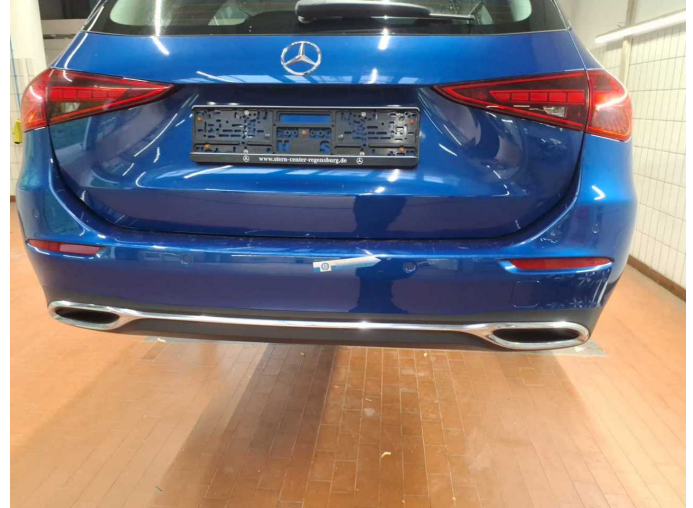
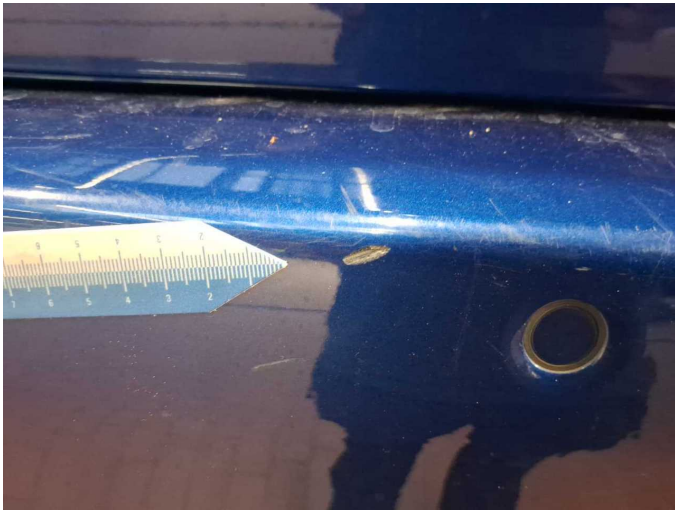
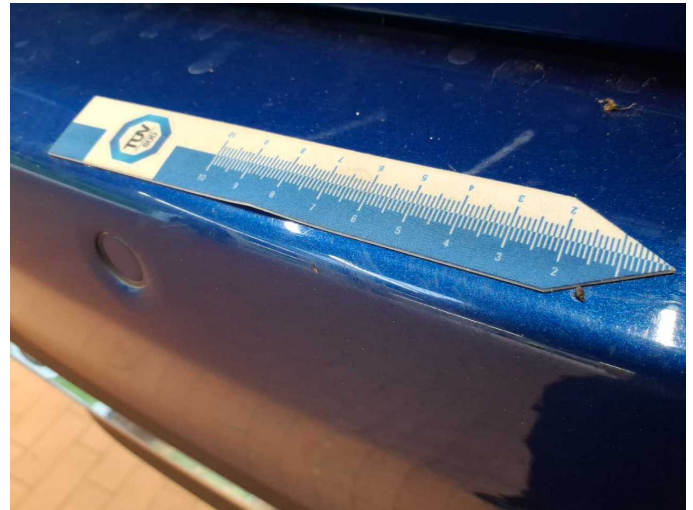
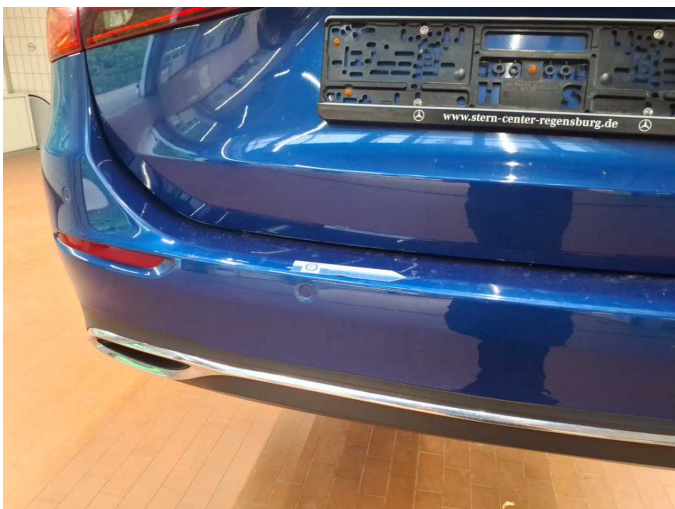
| No. | Component group | Description |
|---|---|---|
| 5 | Rear bumper | Rear bumper - Scratch(es) - Paint |

**Damage 5:** Rear bumper: Rear bumper - Scratch(es) - Paint

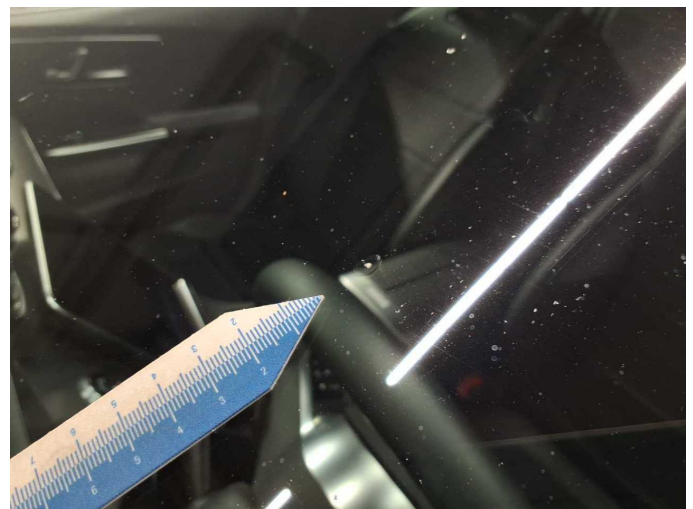
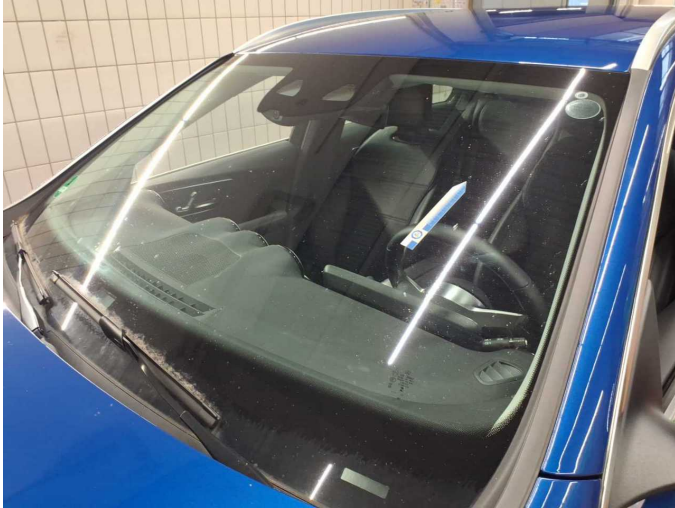
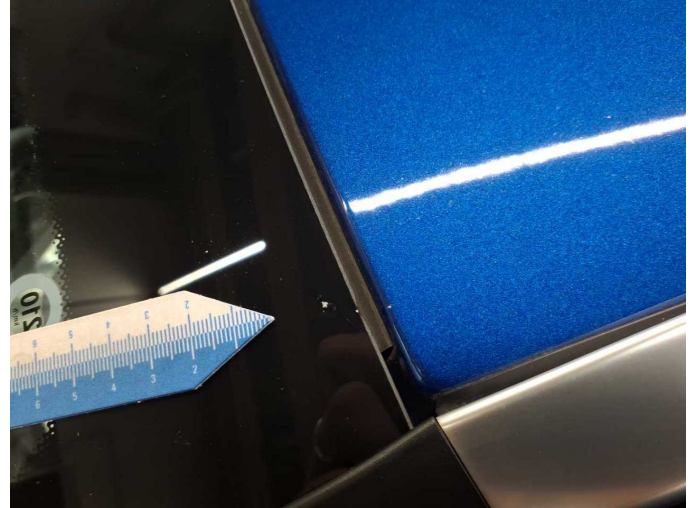
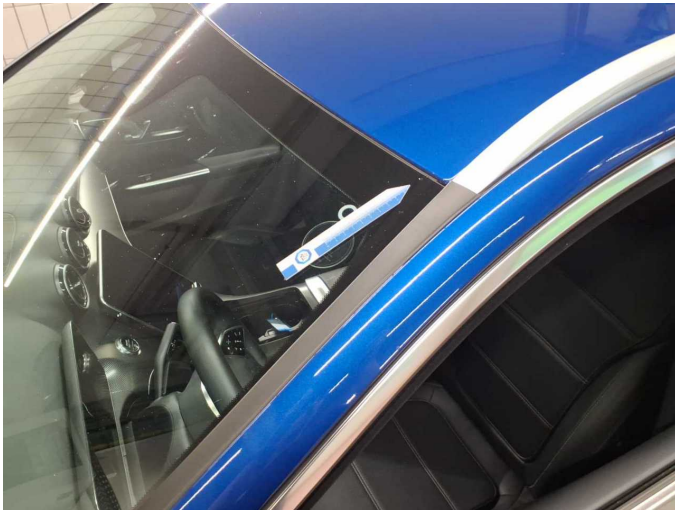
| No. | Component group | Description |
|---|---|---|
| 6 | Vehicle glazing | Windscreen - Stone chips - Replace |

**Damage 6:** Vehicle glazing: Windscreen - Stone chips - Replace

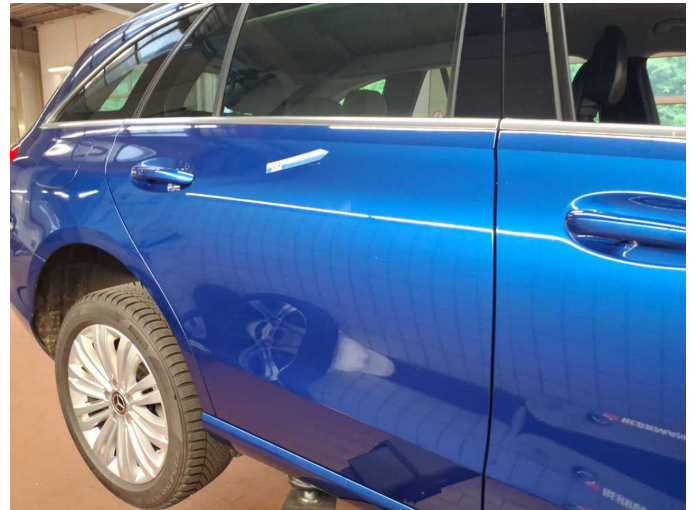
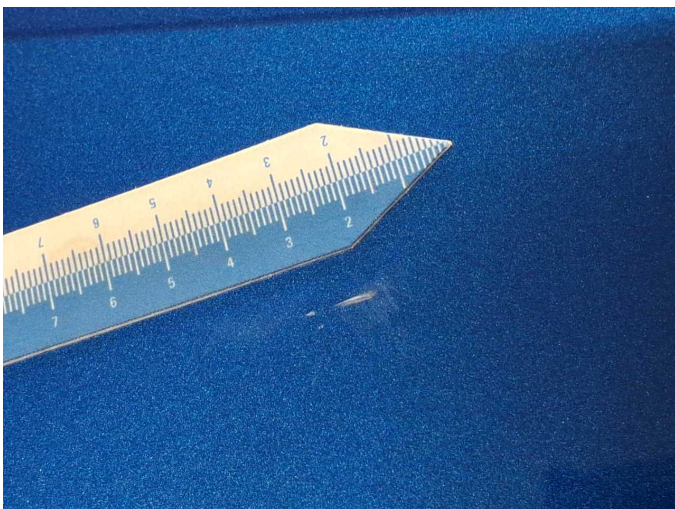
| No. | Component group | Description |
|---|---|---|
| 1 | Door - rear right side | Door - Scratch(es) - No deduction |

**Wear and tear 1:** Door - rear right side: Door - Scratch(es) - No deduction

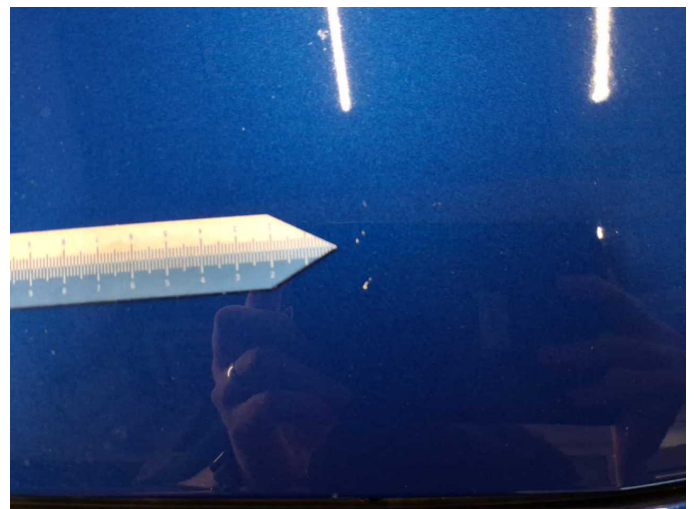
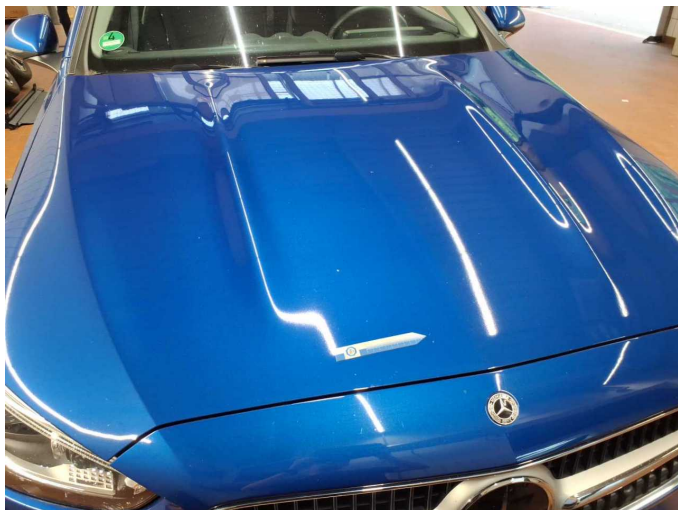
| No. | Component group | Description |
|---|---|---|
| 2 | Bonnet | Bonnet - Stone chips - No deduction |

**Wear and tear 2:** Bonnet: Bonnet - Stone chips - No deduction
