Expertise

Protocol number: 46192327  
Order No. / Reference: 26540128  
Inspection date: 23 Jun 2026

Manufacturer: Volkswagen

Model: Tiguan 2.0 TDI SCR DSG URBAN SPORT

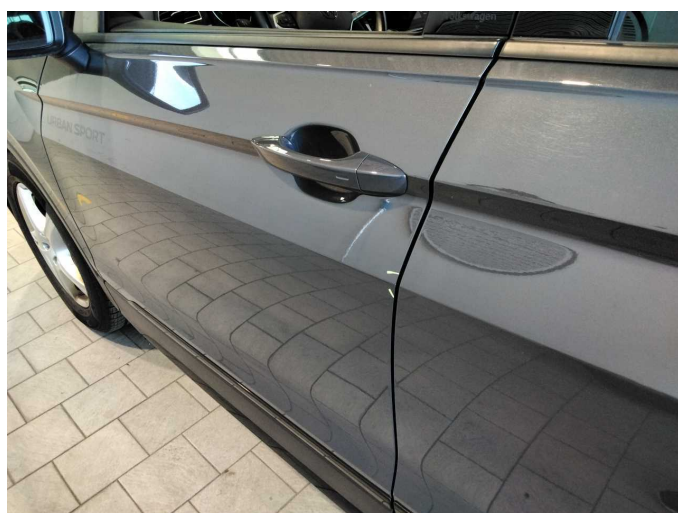
Damage 1: Door - front left side: Door edge - Scratch(es) - Smart repair

| No. | Component group | Description |
|---|---|---|
| 1 | Door - front left side | Door edge - Scratch(es) - Smart repair |

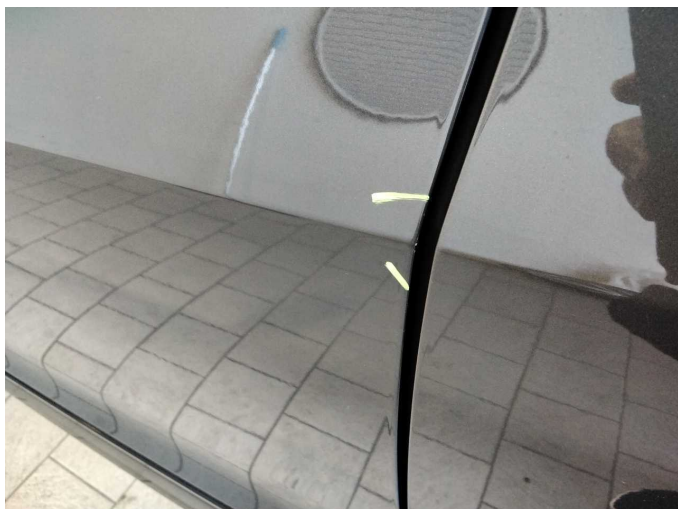
**Damage 1:** Door - front left side: Door edge - Scratch(es) - Smart repair

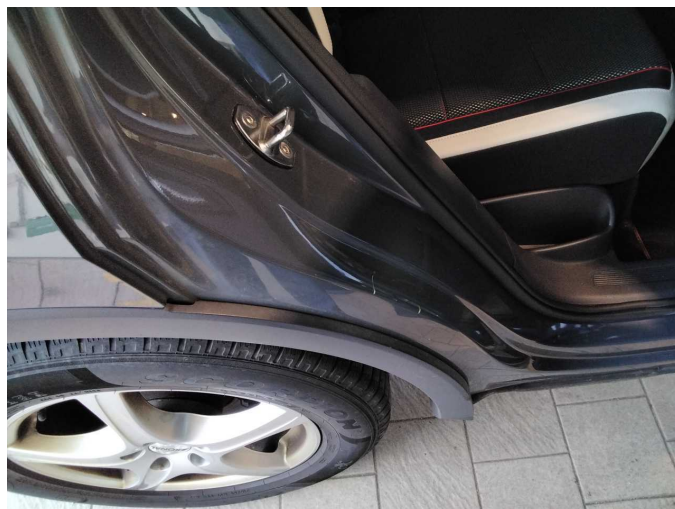
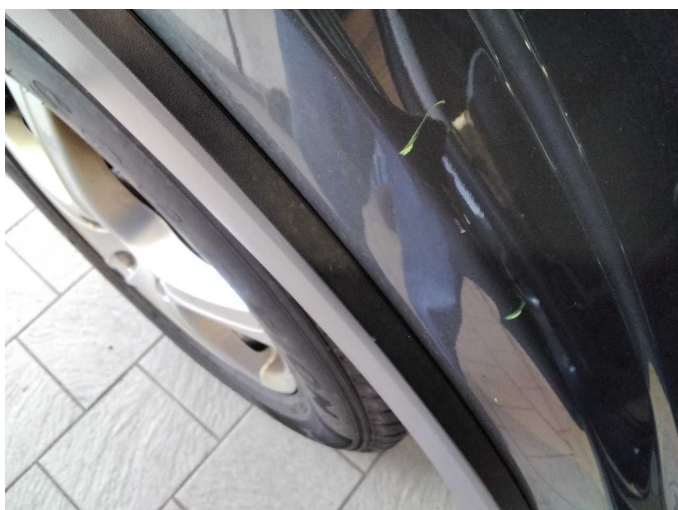
**Damage 2:** Body: C-pillar - right side - Scratch(es) - Smart repair

| No. | Component group | Description |
|---|---|---|
| 2 | Body | C-pillar - right side - Scratch(es) - Smart repair |

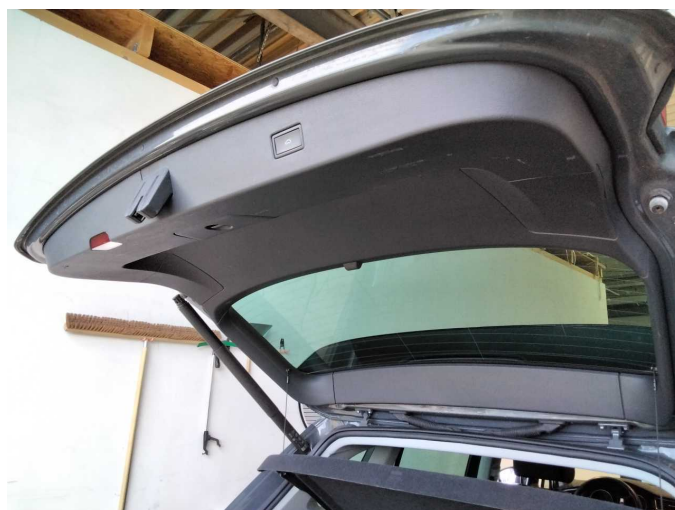
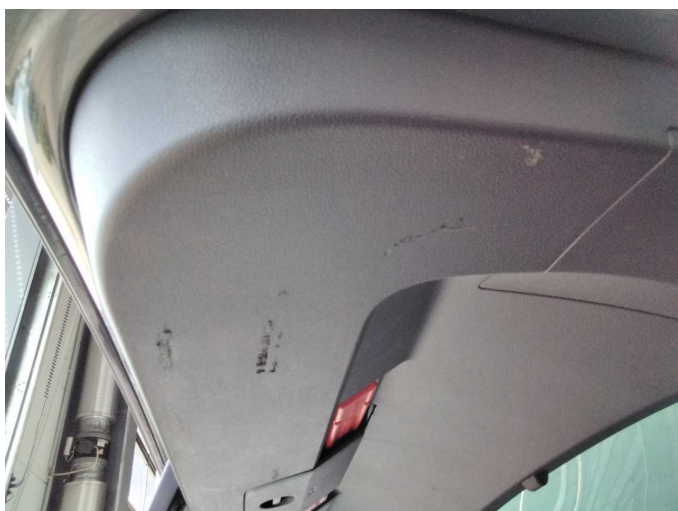
**Damage 3:** Trim / covers: Boot lid - interior trim - Scratch(es) - Replace

| No. | Component group | Description |
|---|---|---|
| 3 | Trim / covers | Boot lid - interior trim - Scratch(es) - Replace |

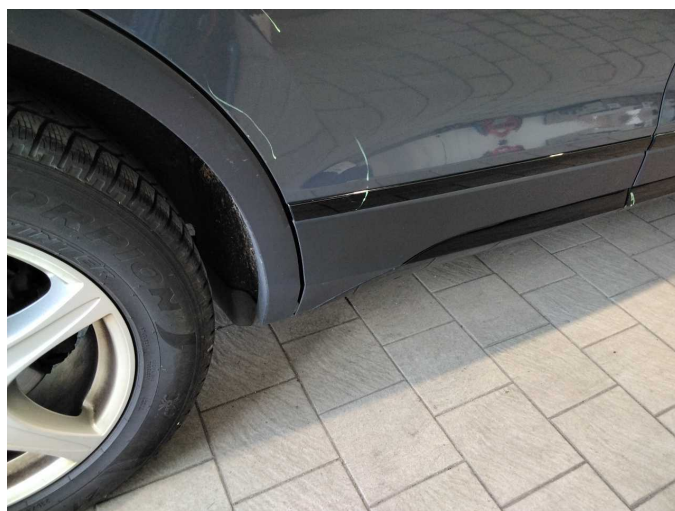
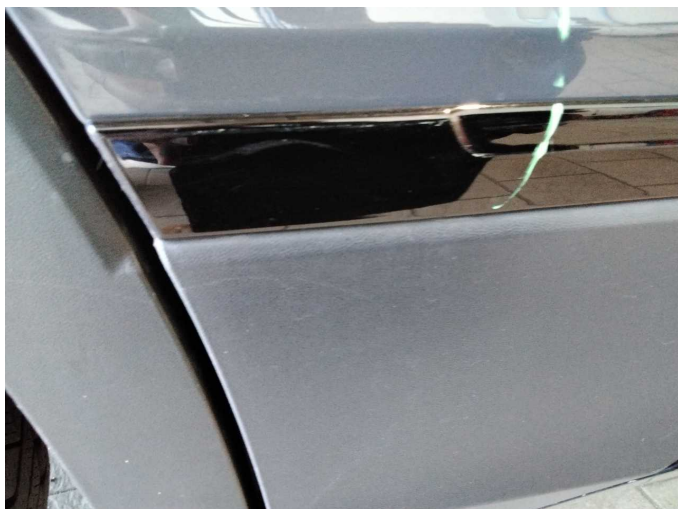
**Damage 4:** Door - rear right side: Brightware - lower - Scratch(es) - Replace

| No. | Component group | Description |
|---|---|---|
| 4 | Door - rear right side | Brightware - lower - Scratch(es) - Replace |

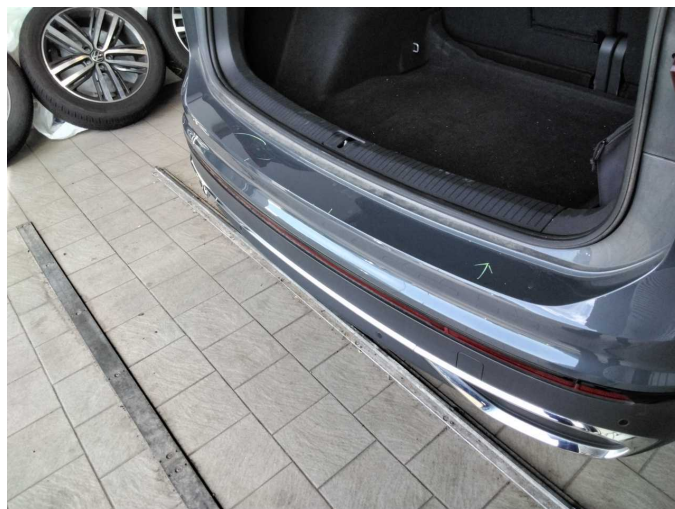
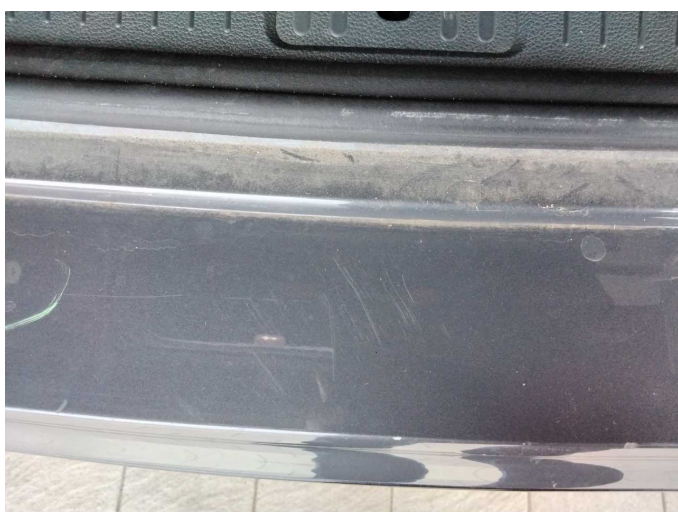
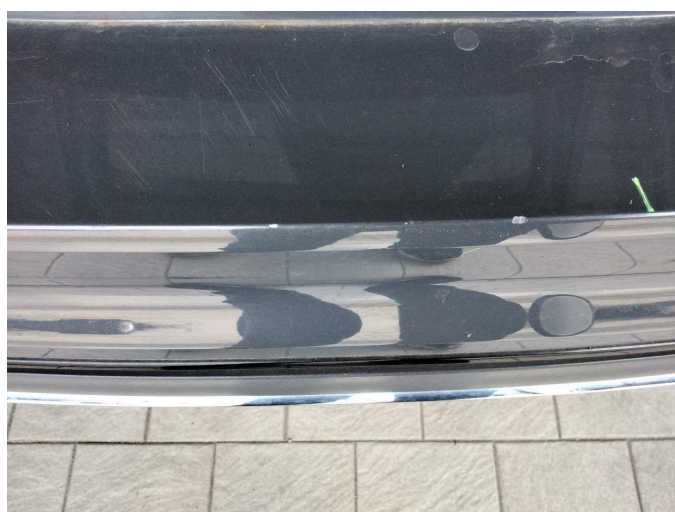
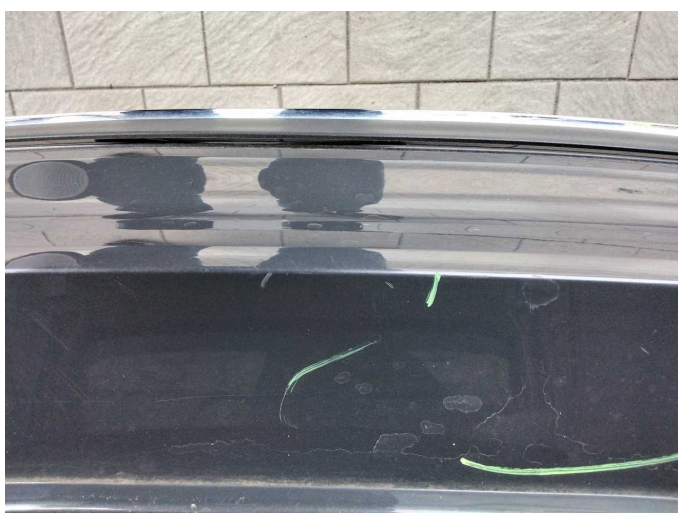
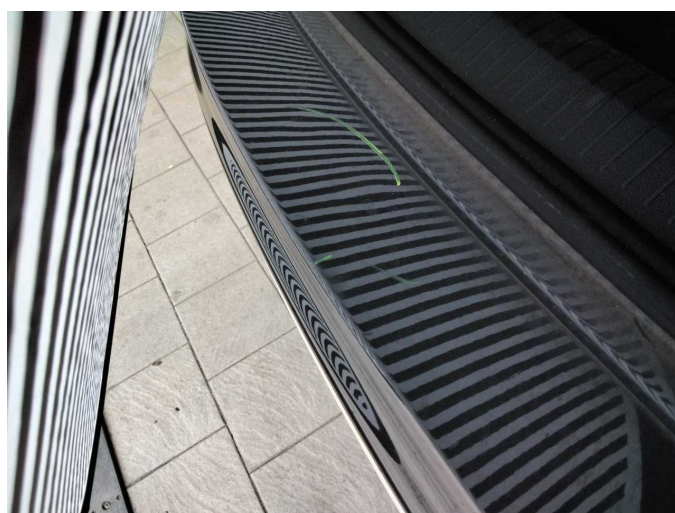
**Damage 5:** Rear bumper: Rear bumper - Dent / paintcoat damage - Repair and paint

| No. | Component group | Description |
|---|---|---|
| 5 | Rear bumper | Rear bumper - Dent / paintcoat damage - Repair and paint |

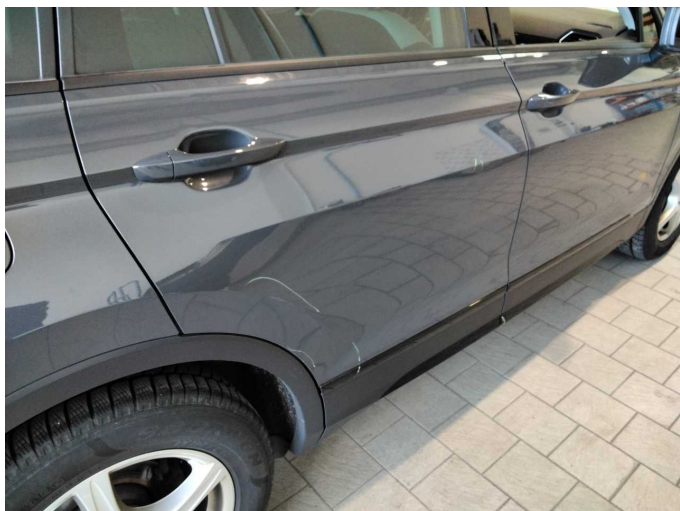
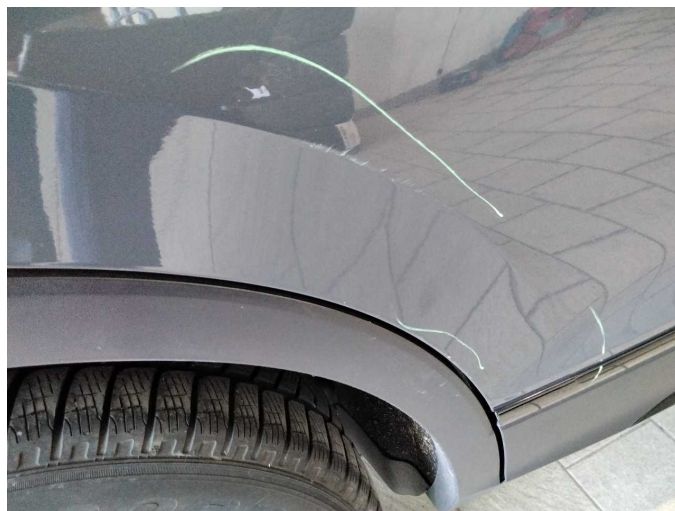
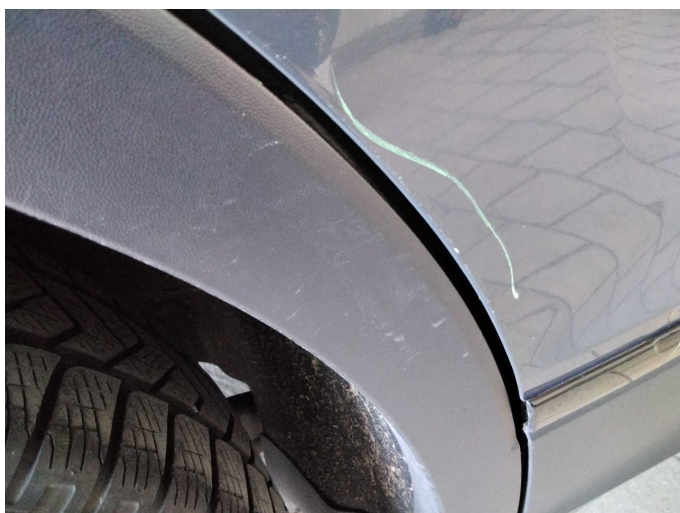
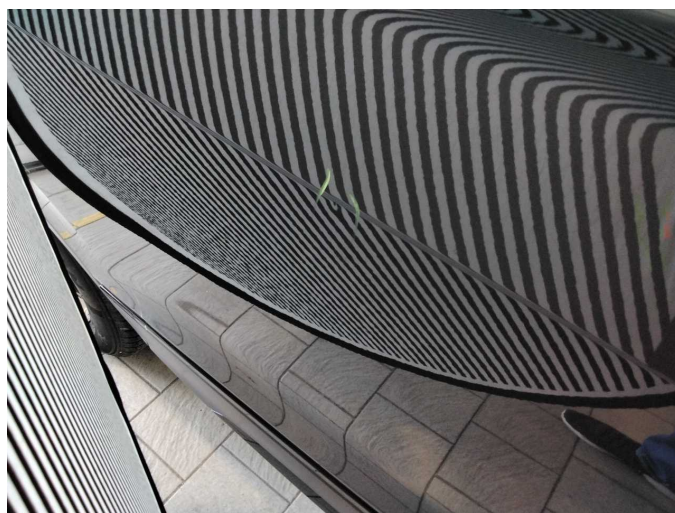
**Damage 6:** Door - rear right side: Door - Dent / paintcoat damage - Repair and paint

| No. | Component group | Description |
|---|---|---|
| 6 | Door - rear right side | Door - Dent / paintcoat damage - Repair and paint |

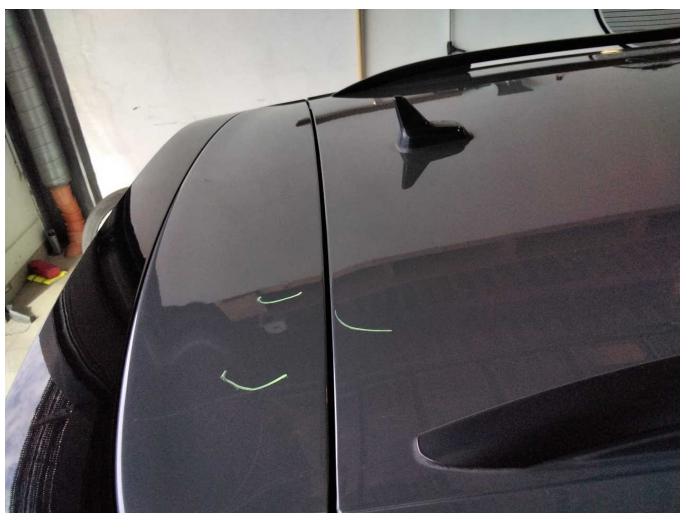
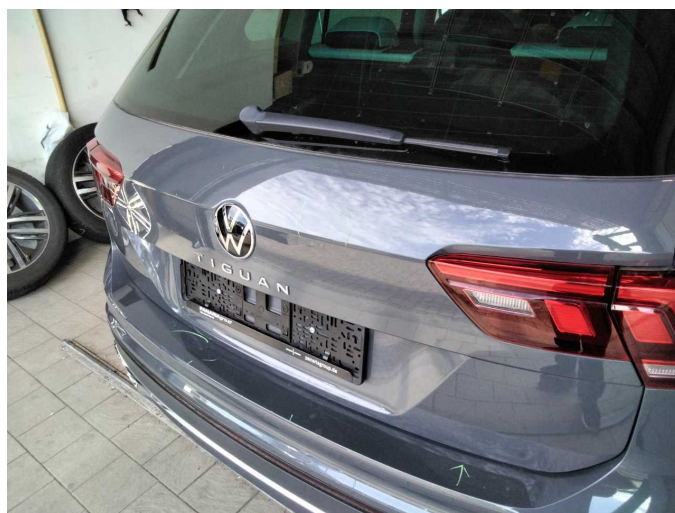
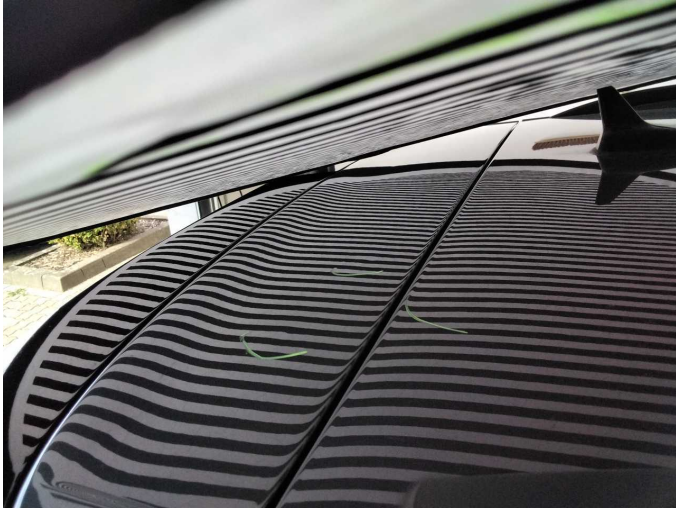
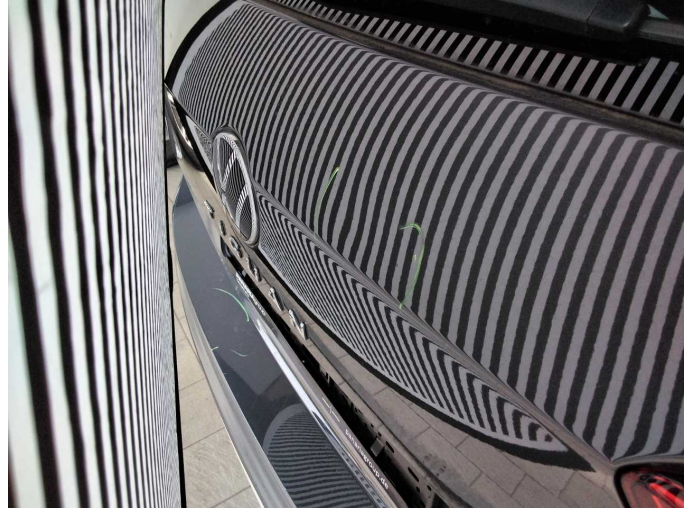
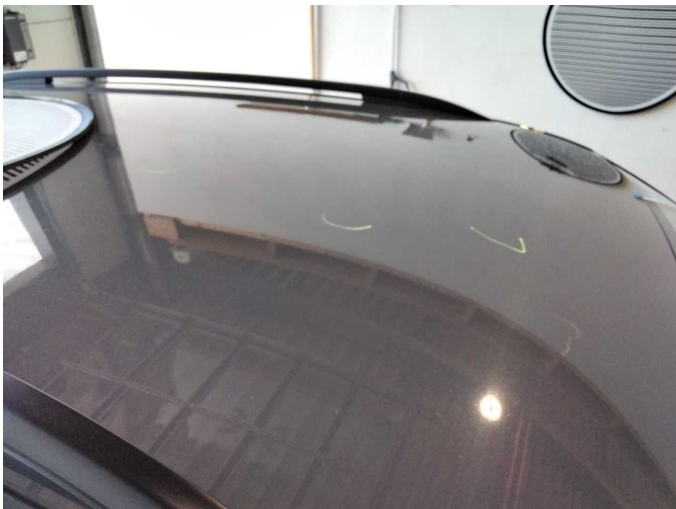
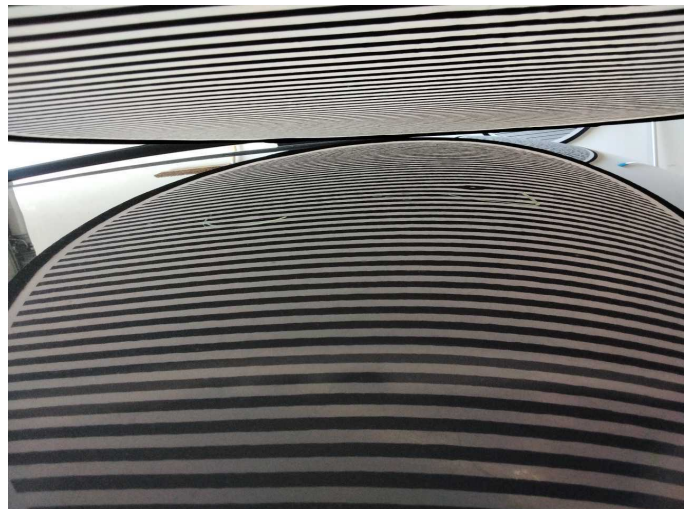
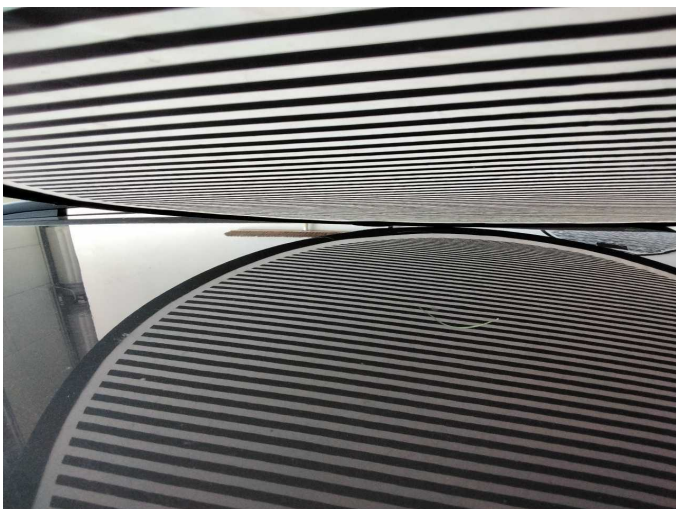
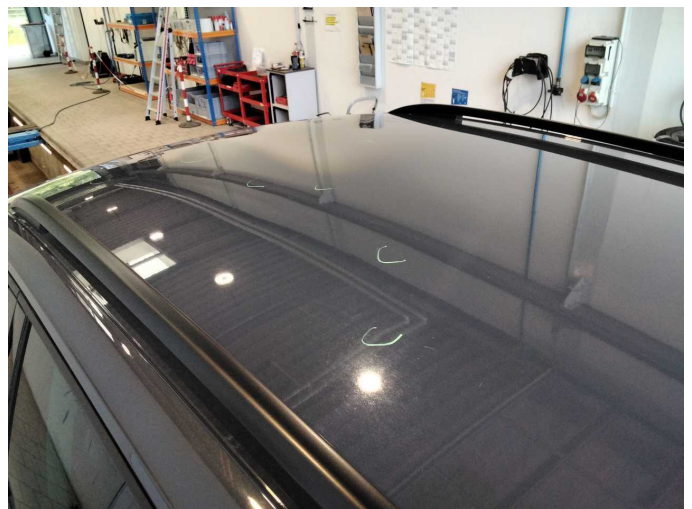
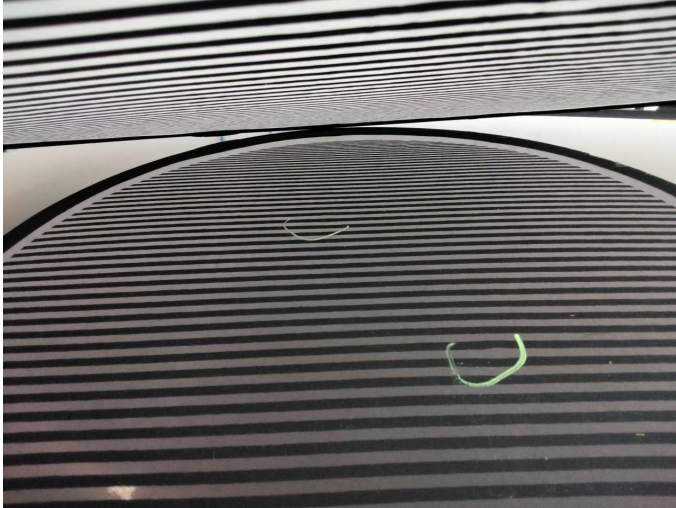
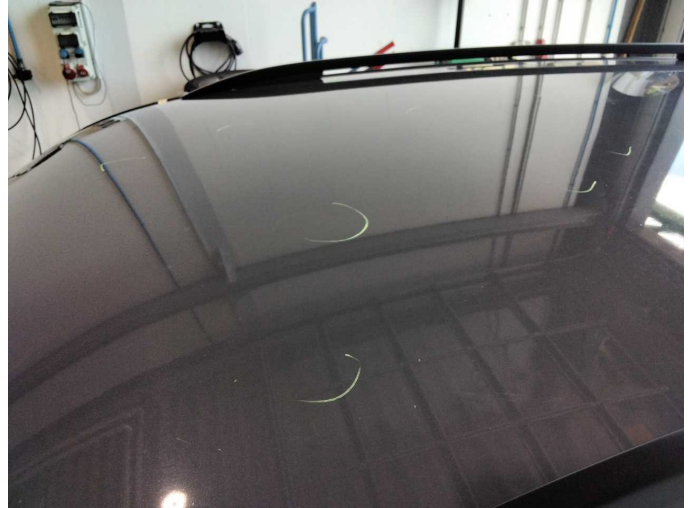
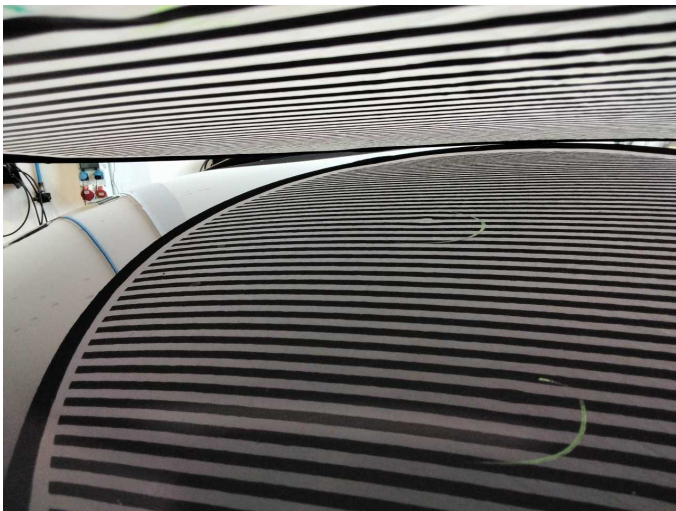
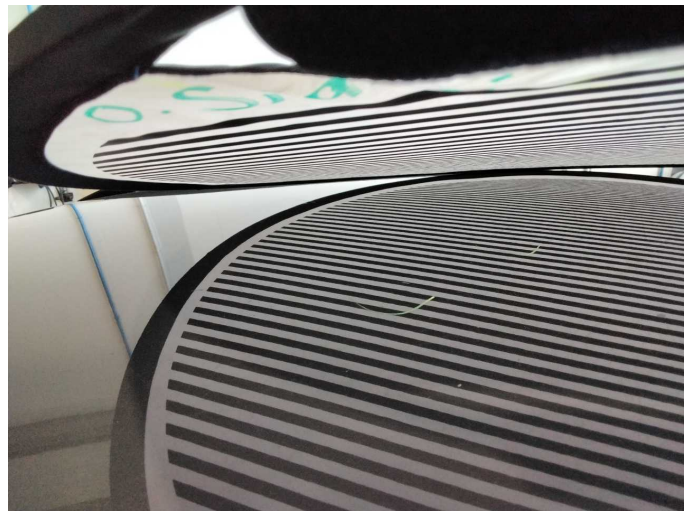
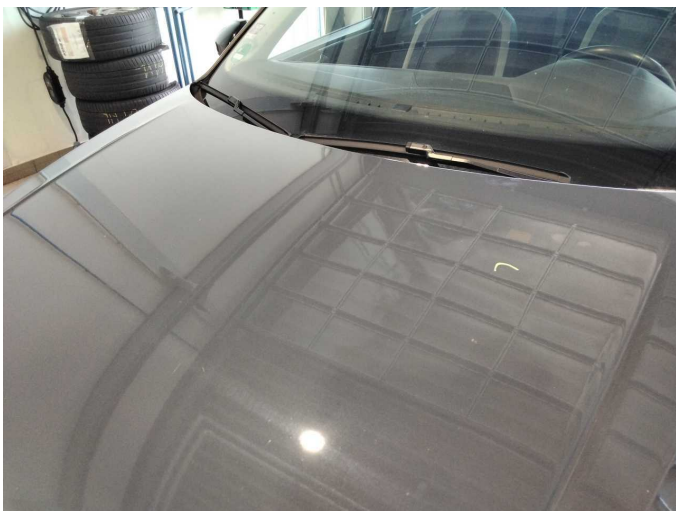
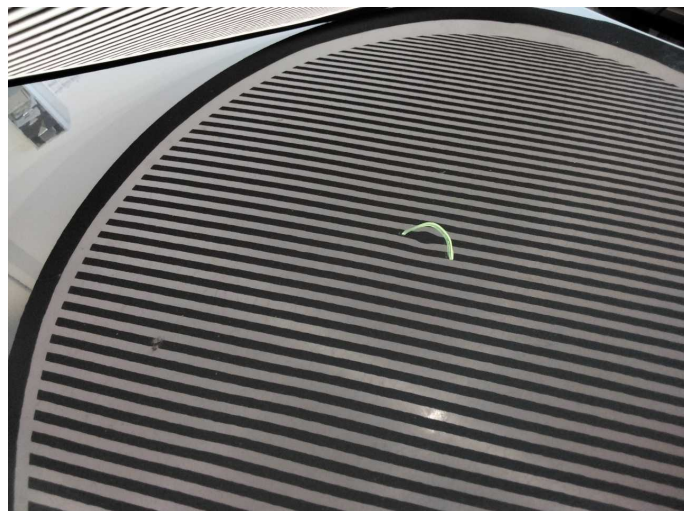
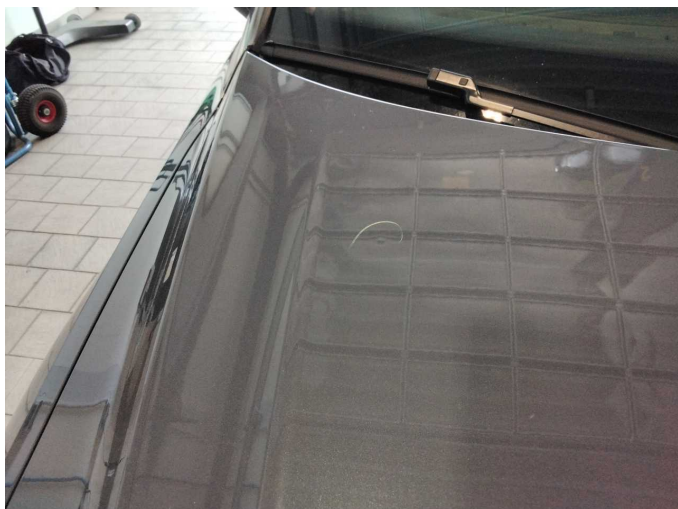
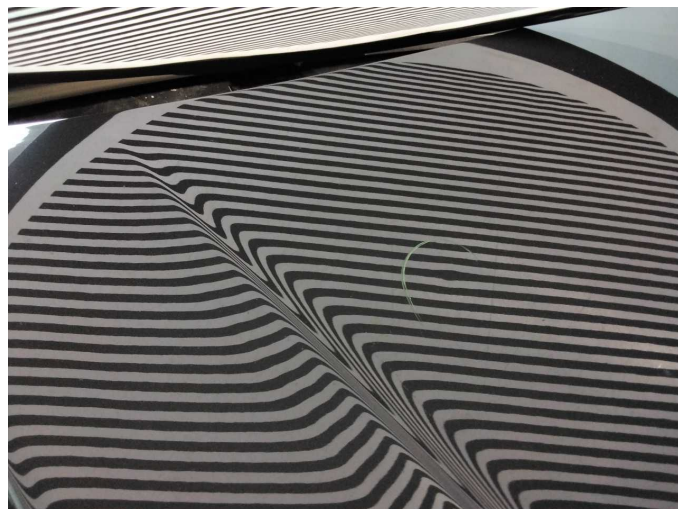
**Damage 7:** Body: Body - Damage by hail - repair according to calculation

| No. | Component group | Description |
|---|---|---|
| 7 | Body | Body - Damage by hail - repair according to calculation |

Der kalkulierte Hagelschaden wurde nach bestem Wissen und Gewissen unter eingeschränkten Besichtigungsbedingung im demontagefreien Zustand erstellt. Es können aufgrund verdeckter Beschädigung, Mehrkosten und somit Abweichung der für den Schaden ausgewiesenen Reparaturkosten nicht ausgeschlossen werden.

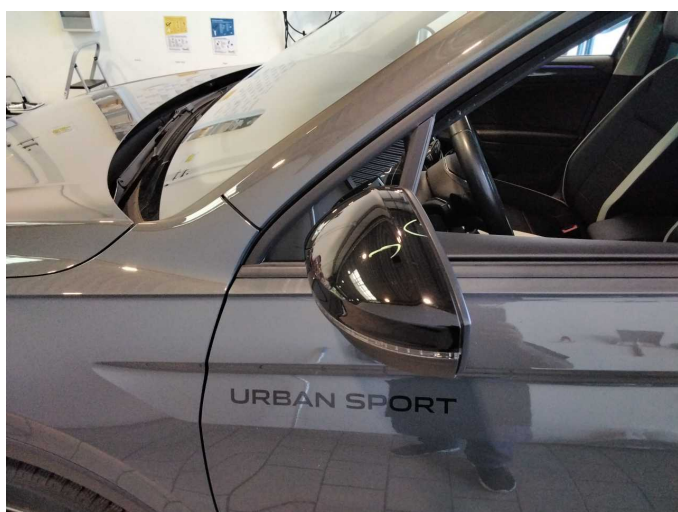
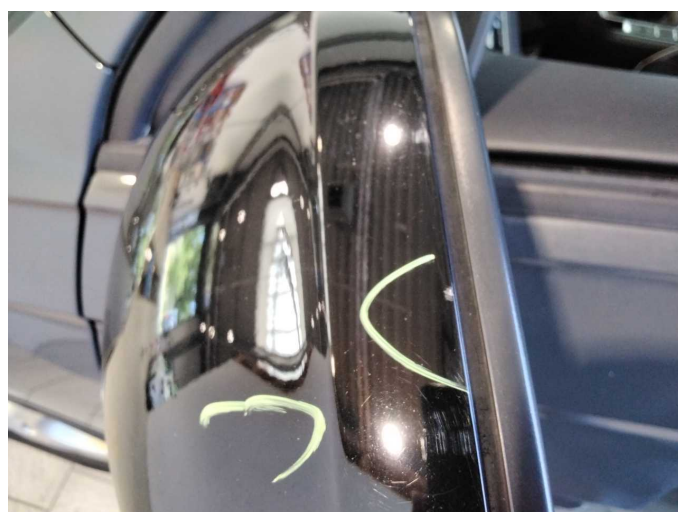
**Wear and tear 1:** Wing mirror - left side: Cap - Scratch(es) - No deduction

| No. | Component group | Description |
|---|---|---|
| 1 | Wing mirror - left side | Cap - Scratch(es) - No deduction |

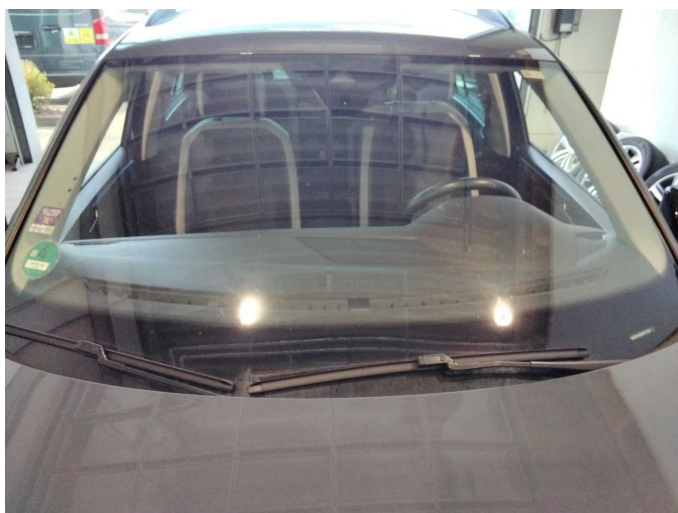
**Wear and tear 2:** Vehicle glazing: Windscreen - Stone chips - No deduction

| No. | Component group | Description |
|---|---|---|
| 2 | Vehicle glazing | Windscreen - Stone chips - No deduction |

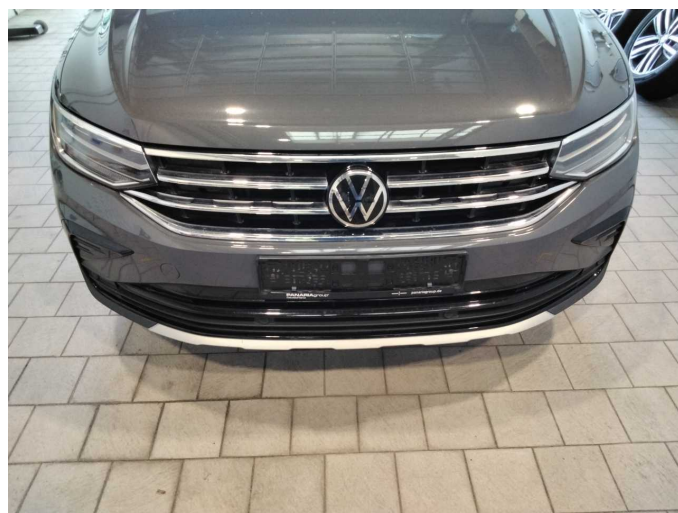
**Wear and tear 3:** Front bumper: Front bumper - Stone chips - No deduction

| No. | Component group | Description |
|---|---|---|
| 3 | Front bumper | Front bumper - Stone chips - No deduction |

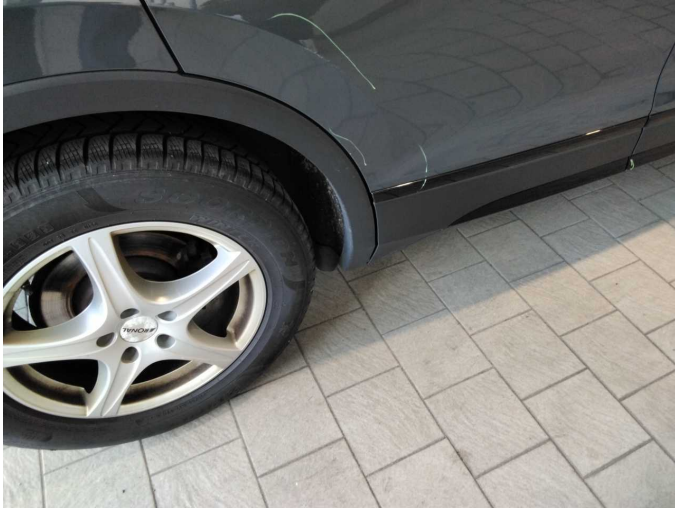
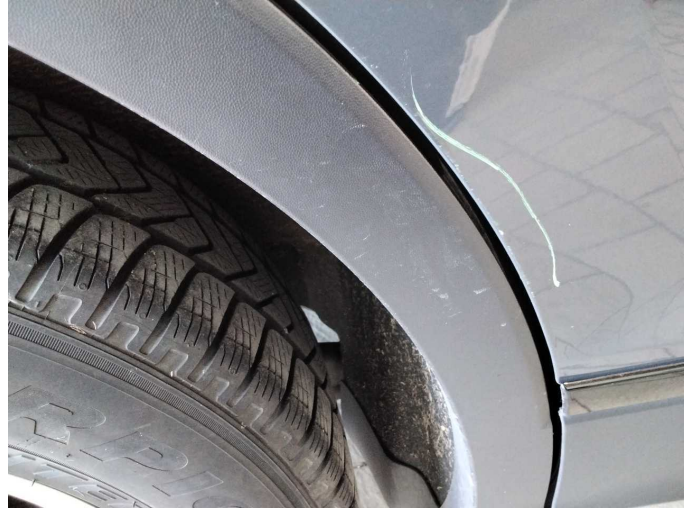
**Wear and tear 5:** Side panel - rear right side: Wheel well extension -  
Scratch(es) - No deduction

| No. | Component group | Description |
|---|---|---|
| 5 | Side panel - rear right side | Wheel well extension - Scratch(es) - No deduction |
