Expertise

Protocol number: 46595336  
Order No. / Reference: 26657597  
Inspection date: 20 Jul 2026

Manufacturer: Volkswagen

Model: Passat Variant 1.4 TSI Plug-In-Hybrid DSG GTE

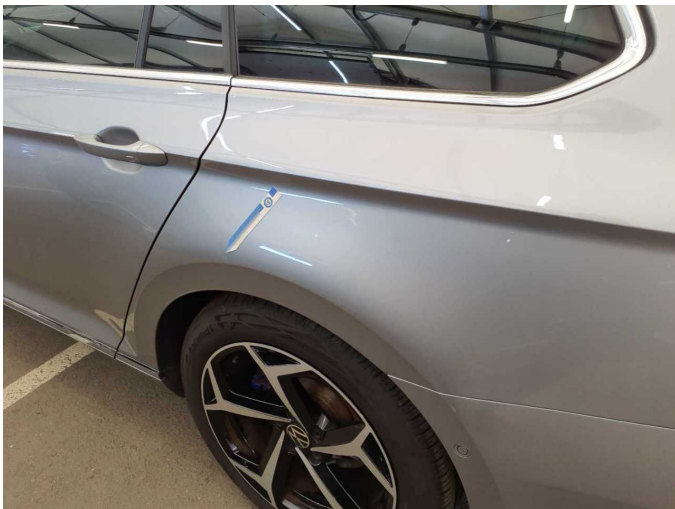
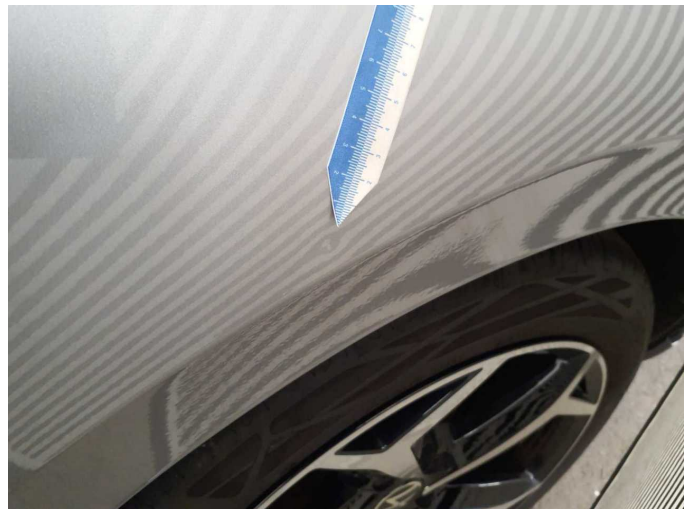
| No. | Component group | Description |
|---|---|---|
| 1 | Side panel - rear left side | Side panel - dent(s) - Smart repair |

**Damage 1:** Side panel - rear left side: Side panel - dent(s) - Smart repair

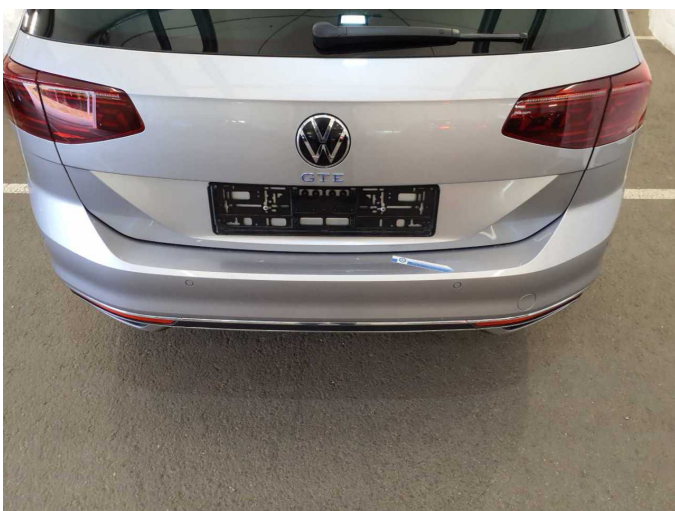
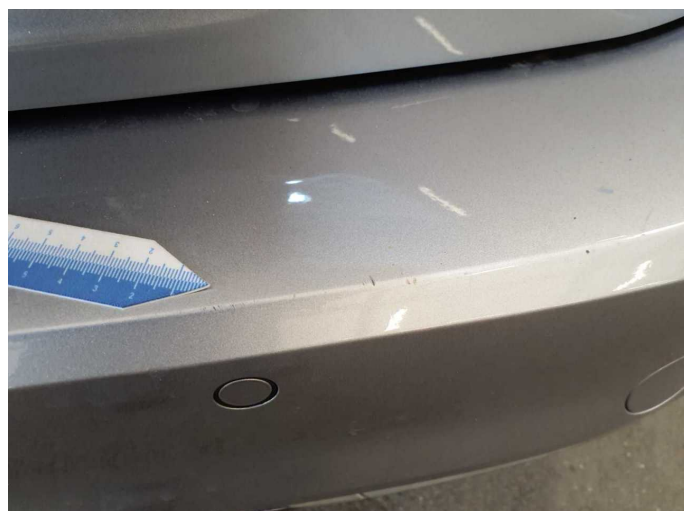
| No. | Component group | Description |
|---|---|---|
| 2 | Rear bumper | Rear bumper - Scratch(es) - Smart repair |

**Damage 2:** Rear bumper: Rear bumper - Scratch(es) - Smart repair

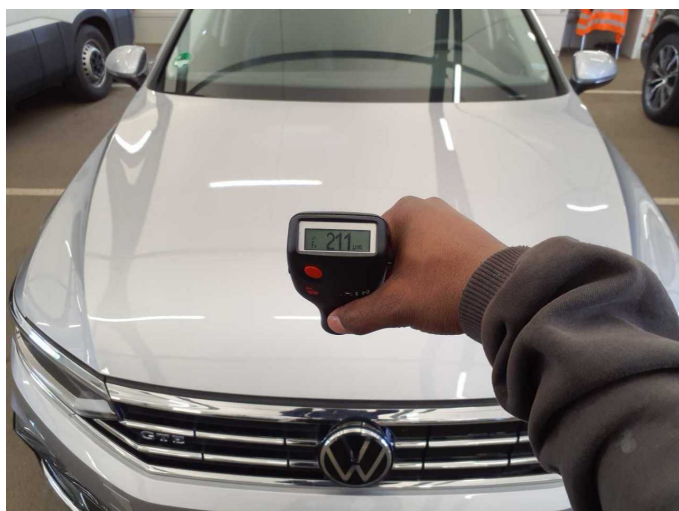
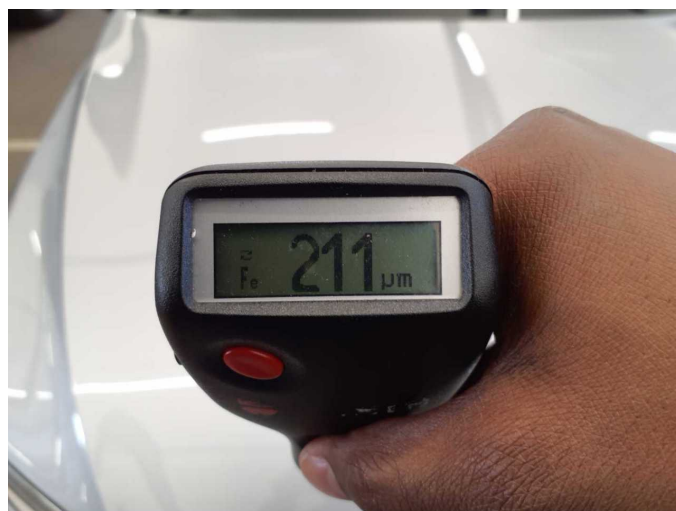
- 1 Bonnet, Professionally carried out, Invoice of repair done Non-existent

Bonnet 211 µm |

**Repainting 1: Bonnet**
