Expertise

Protocol number: 46572196  
Order No. / Reference: 26656952  
Inspection date: 15 Jul 2026

Manufacturer: Mercedes-Benz  
VIN: W1N4M1EB3PW272533

Model: GLB 220 d 8G-DCT AMG Line

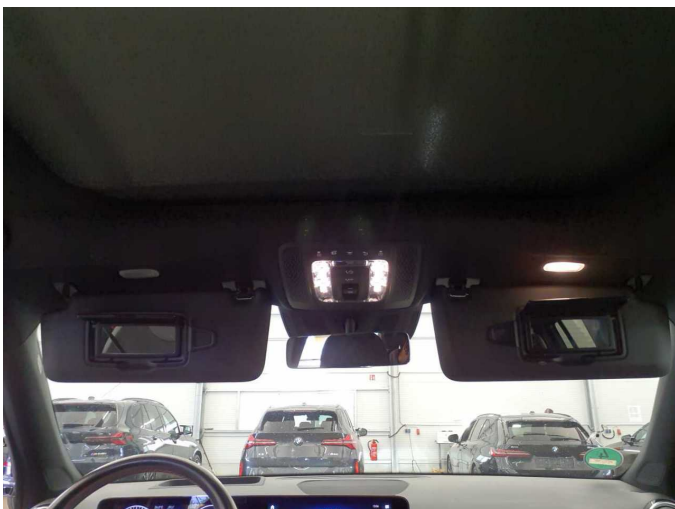
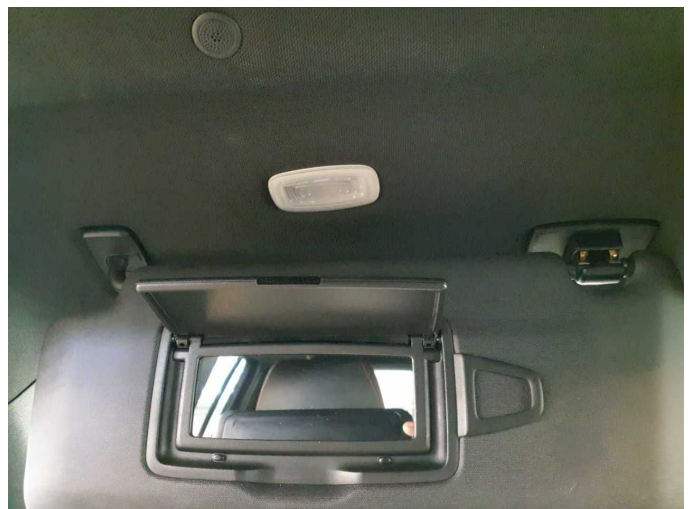
| No. | Component group | Description |
|---|---|---|
| 1 | Interior | Sun visor - left side (Licht) - Non-operational - Replace |

**Damage 1:** Interior: Sun visor - left side (Licht) - Non-operational - Replace

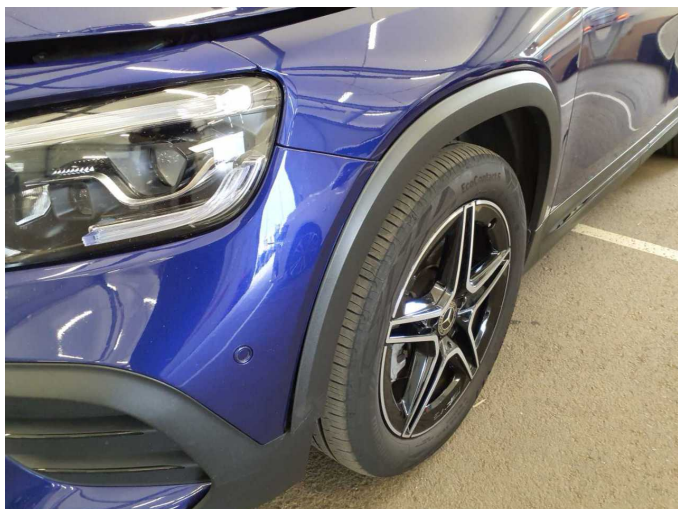
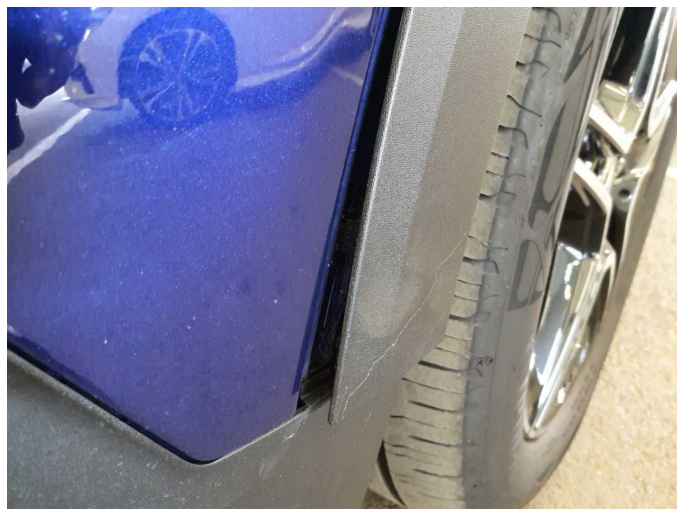
| No. | Component group | Description |
|---|---|---|
| 2 | Mudguard - left side | Wheel well extension - Malposition - Un- / install |

**Damage 2:** Mudguard - left side: Wheel well extension - Malposition - Un- / install

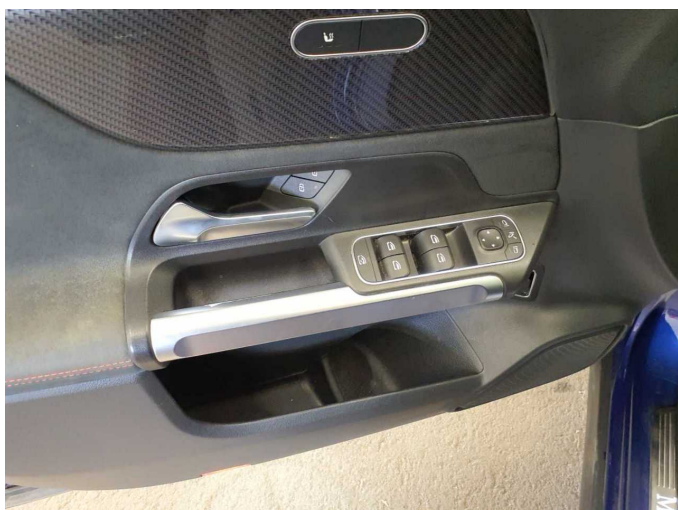
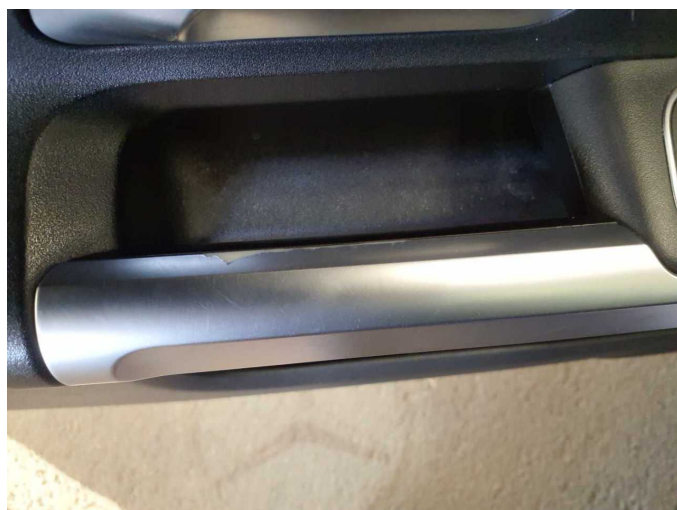
| No. | Component group | Description |
|---|---|---|
| 3 | Door - front left side | Door handle - inside - Abrasion - Loss in value |

**Damage 3:** Door - front left side: Door handle - inside - Abrasion - Loss in value

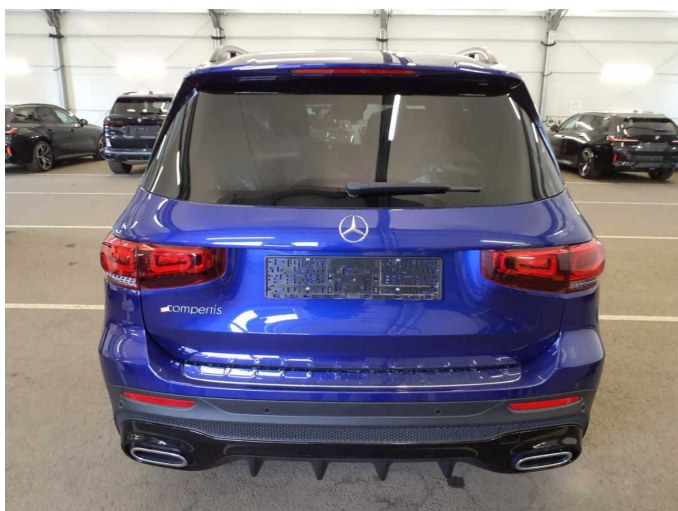
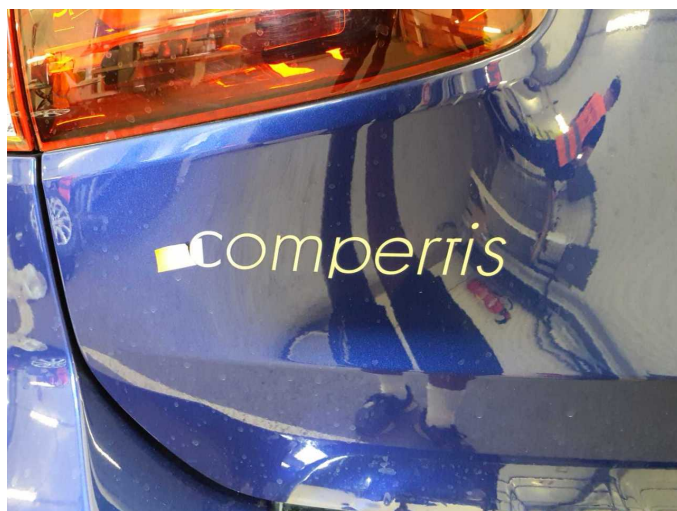
| No. | Component group | Description |
|---|---|---|
| 4 | Boot lid / rear door | Boot lid - Glued / labelled - De-glue / neutralise |

**Damage 4:** Boot lid / rear door: Boot lid - Glued / labelled - De-glue / neutralise

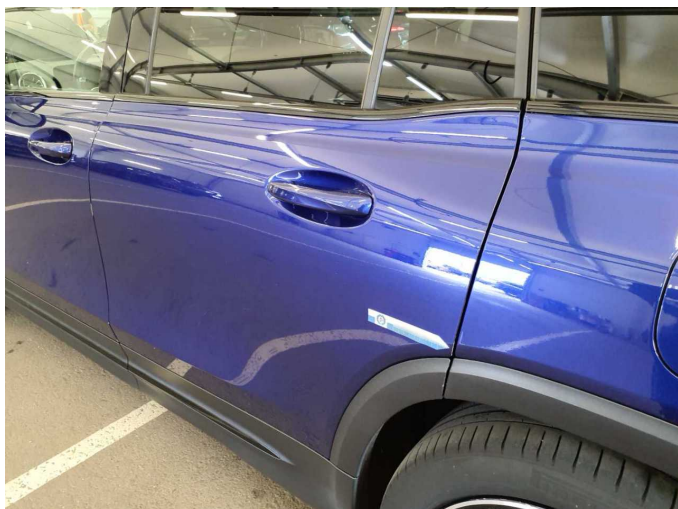
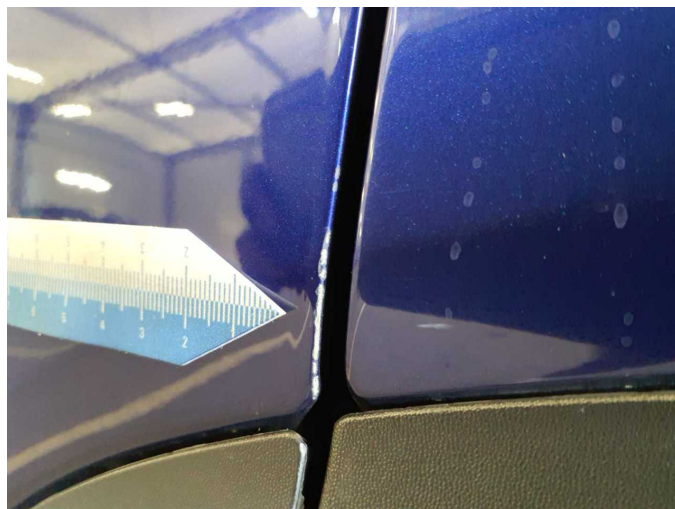
| No. | Component group | Description |
|---|---|---|
| 5 | Door - rear left side | Door edge - Scratch(es) - Smart repair |

**Damage 5:** Door - rear left side: Door edge - Scratch(es) - Smart repair

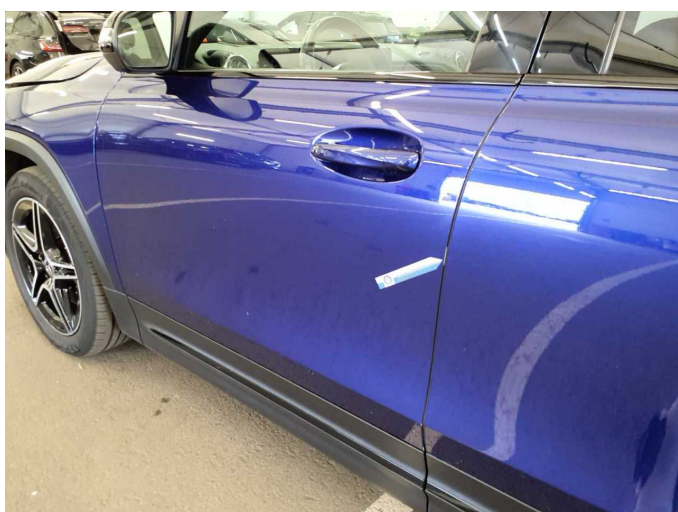
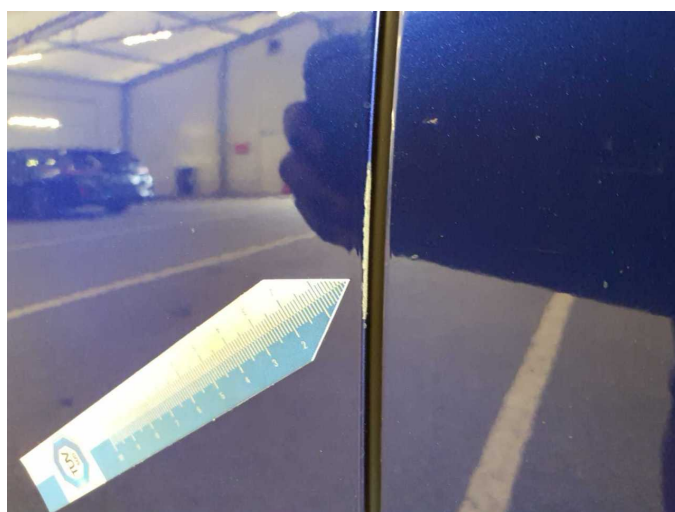
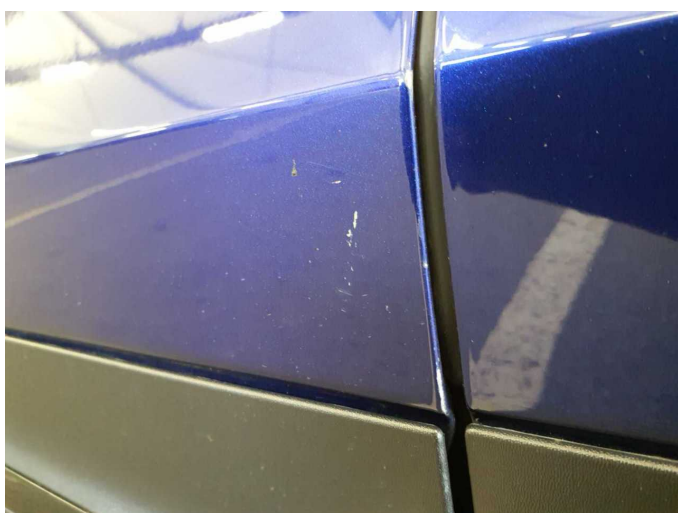
| No. | Component group | Description |
|---|---|---|
| 6 | Door - front left side | Door edge - Scratch(es) - Smart repair |

**Damage 6:** Door - front left side: Door edge - Scratch(es) - Smart repair

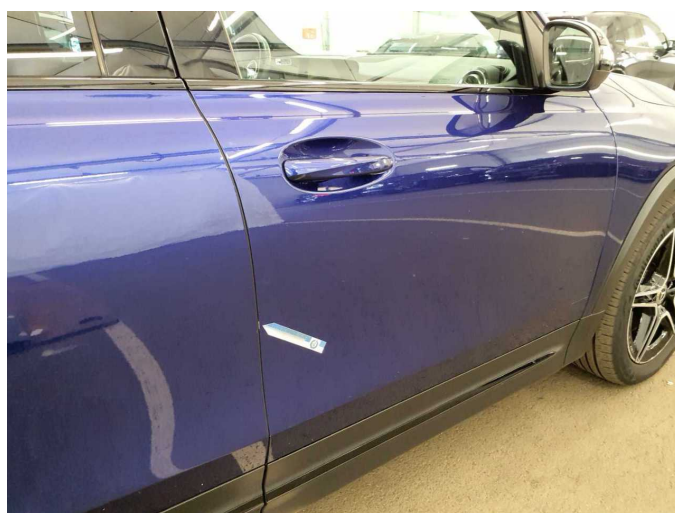
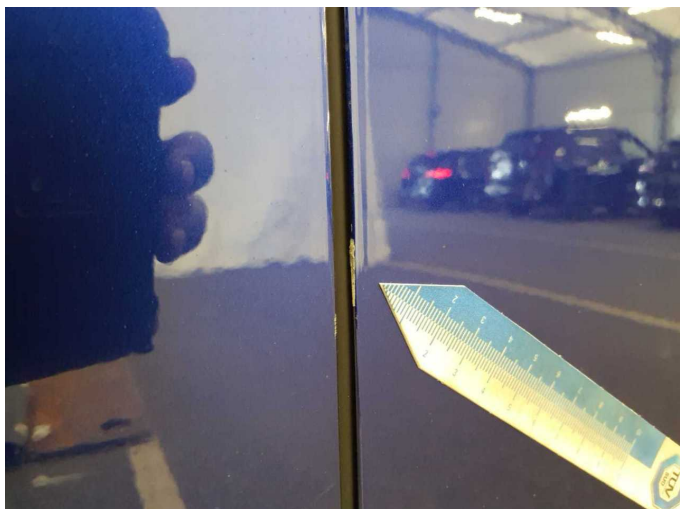
| No. | Component group | Description |
|---|---|---|
| 7 | Door - front right side | Door edge - Scratch(es) - Smart repair |

**Damage 7:** Door - front right side: Door edge - Scratch(es) - Smart repair

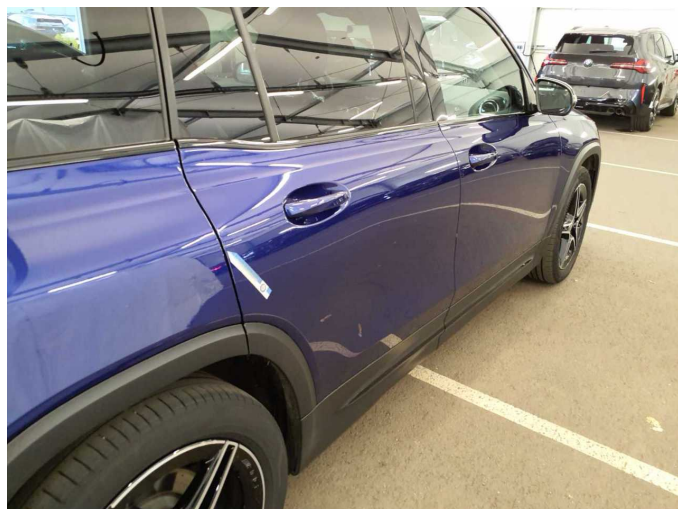
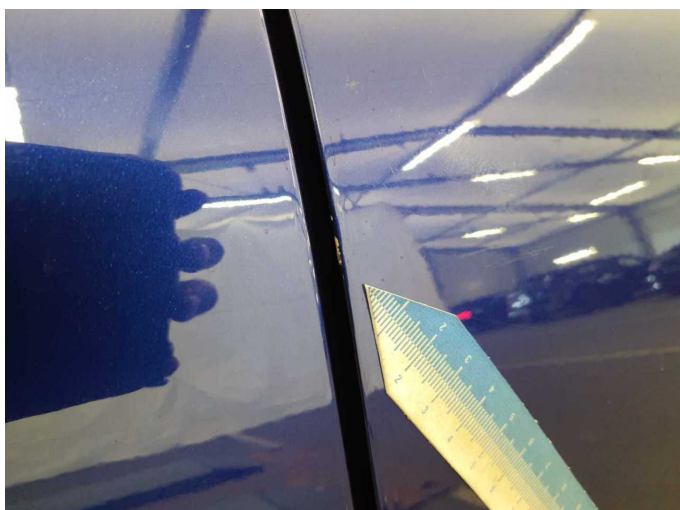
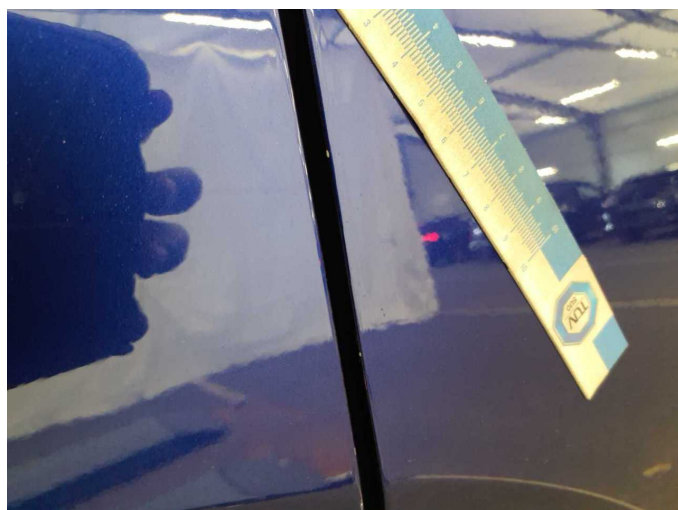
| No. | Component group | Description |
|---|---|---|
| 8 | Door - rear right side | Door edge - Scratch(es) - Smart repair |

**Damage 8:** Door - rear right side: Door edge - Scratch(es) - Smart repair

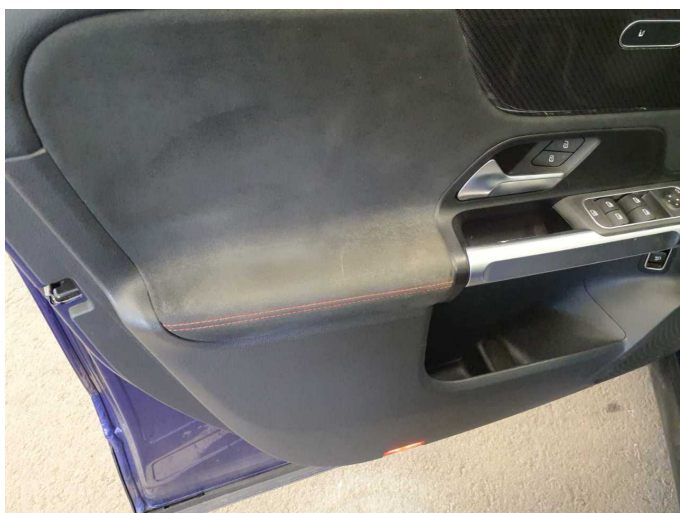
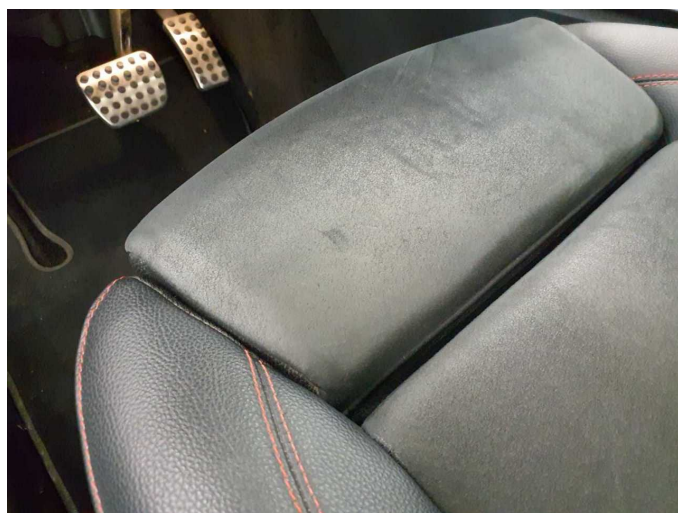
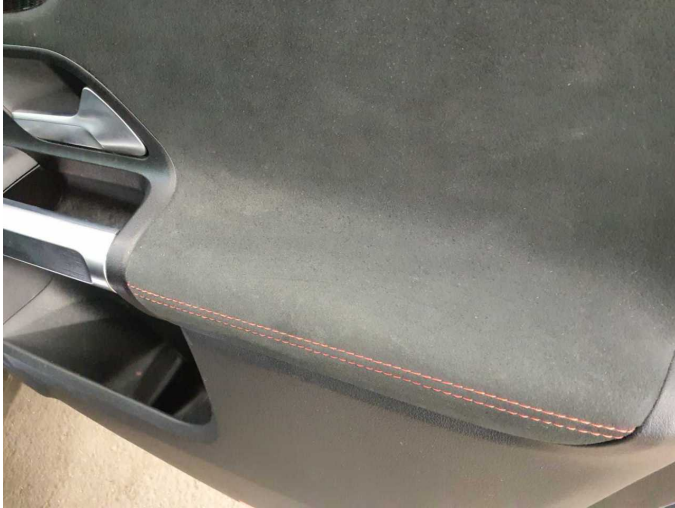
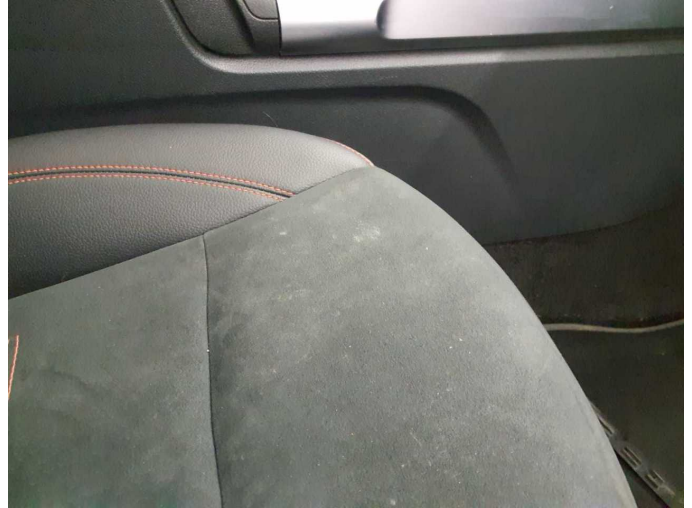
| No. | Component group | Description |
|---|---|---|
| 9 | Interior | Interior (Alcantara) - Soiled - Clean |

**Damage 9:** Interior: Interior (Alcantara) - Soiled - Clean

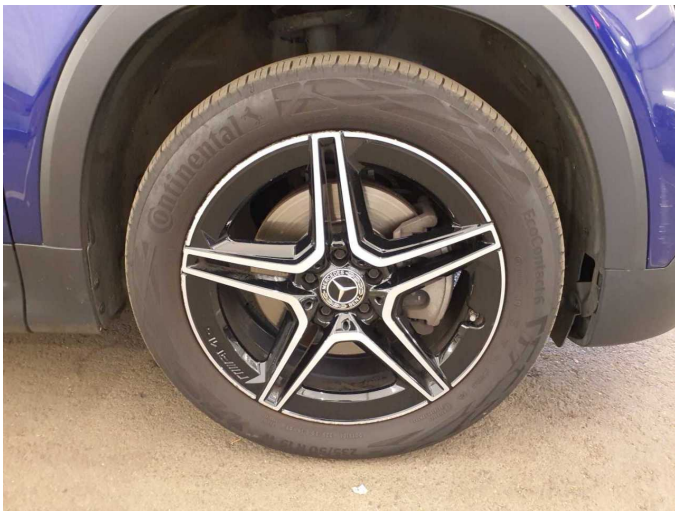
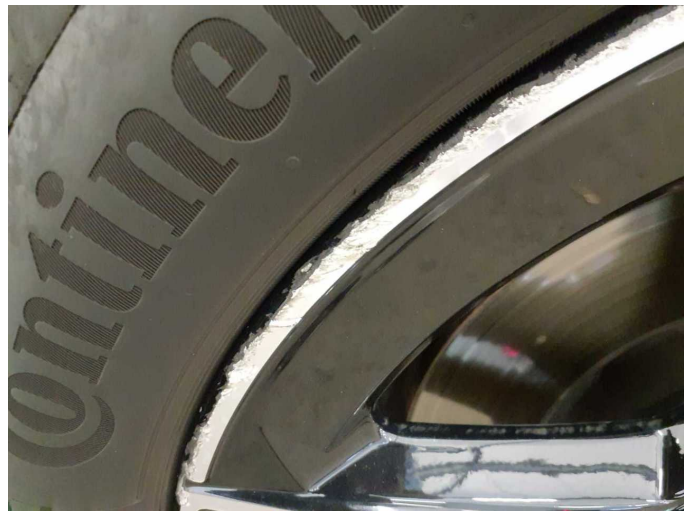
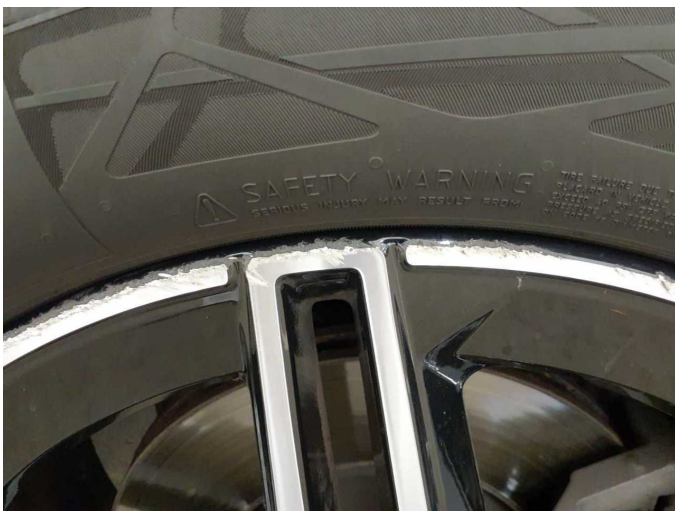
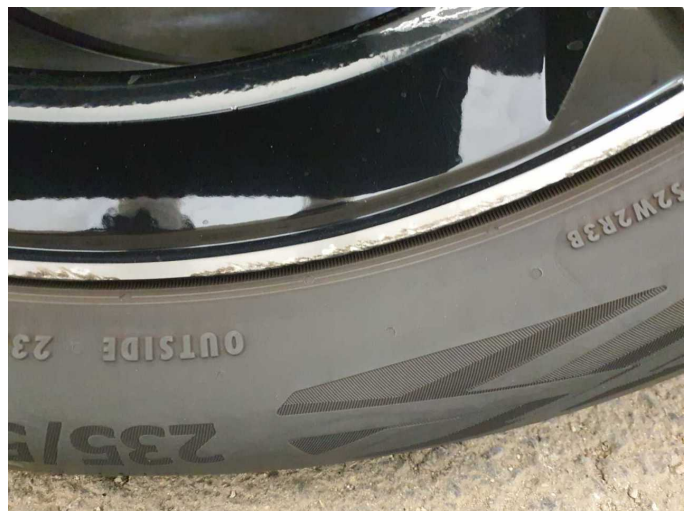
| No. | Component group | Description |
|---|---|---|
| 11 | Wheel / tyres | Alloy rim - front right side - Scratched - Replace |

**Damage 11:** Wheel / tyres: Alloy rim - front right side - Scratched - Replace

| No. | Component group | Description |
|---|---|---|
| 10 | Front axle | Axles / undercarriage (wegen der beschädigten Felge) - Specify findings - Measure |

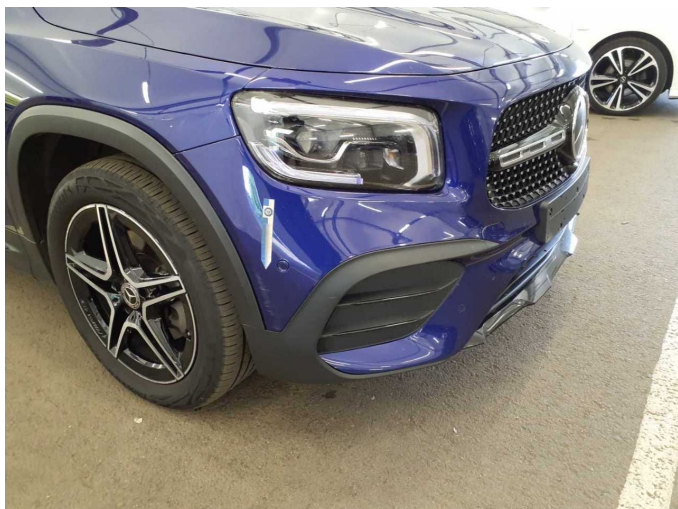
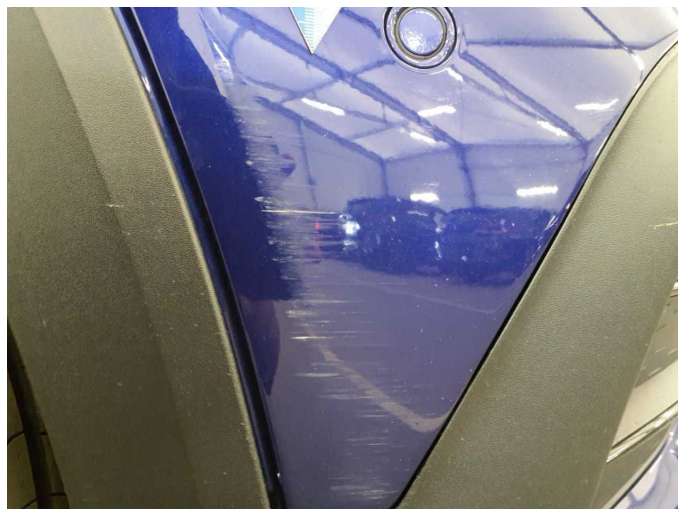
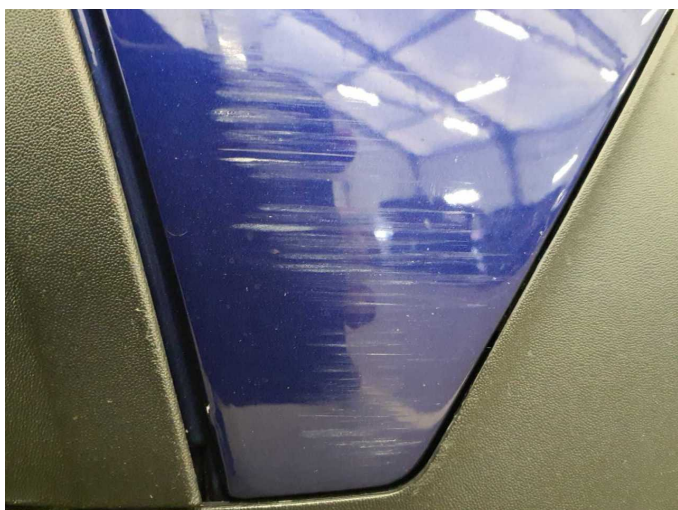
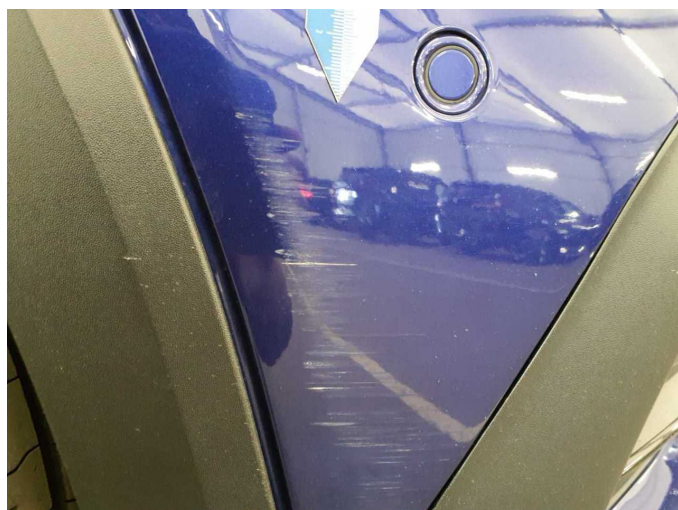
| No. | Component group | Description |
|---|---|---|
| 12 | Front bumper | Front bumper - Scratch(es) - Paint |

**Damage 12:** Front bumper: Front bumper - Scratch(es) - Paint

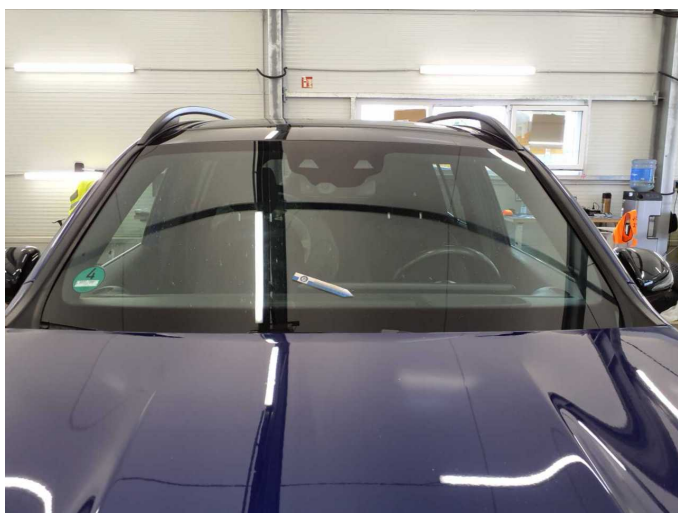
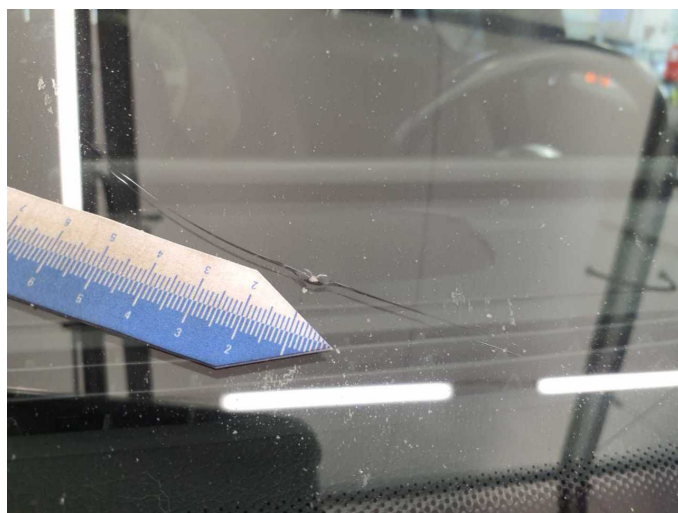
| No. | Component group | Description |
|---|---|---|
| 13 | Vehicle glazing | Windscreen with lane departure assistant - Broken / torn - repair according to calculation |

**Damage 13:** Vehicle glazing: Windscreen with lane departure assistant - Broken / torn - repair according to calculation

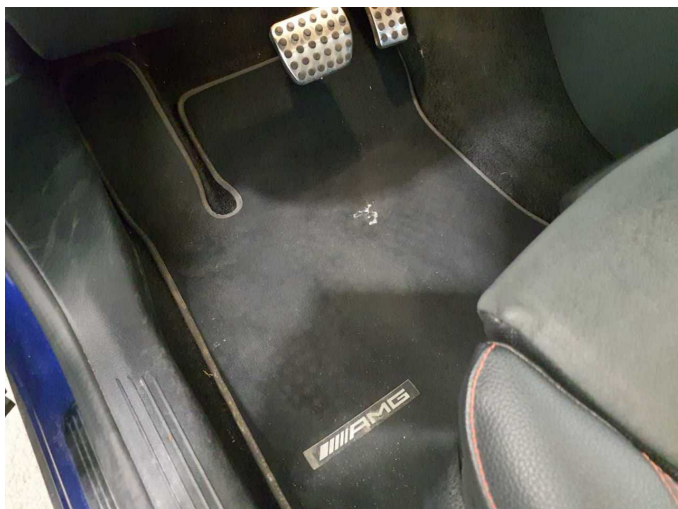
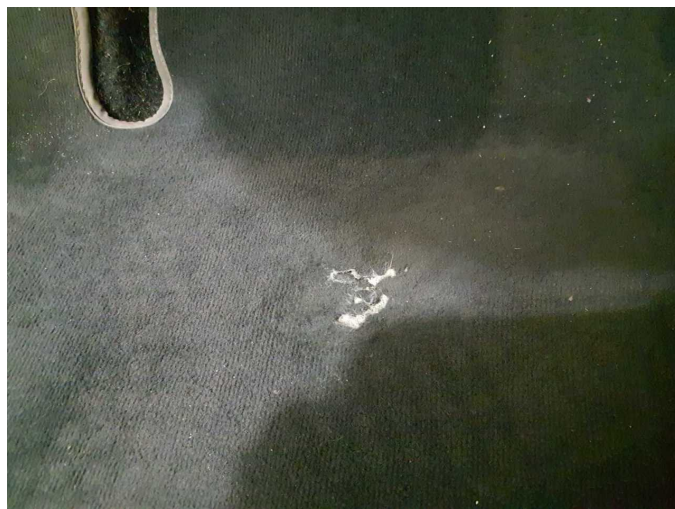
| No. | Component group | Description |
|---|---|---|
| 1 | Trim / covers | Floor mats - Holes - No deduction |

**Wear and tear 1:** Trim / covers: Floor mats - Holes - No deduction
