Expertise

Protocol number: 46380454  
Order No. / Reference: 26345381-1  
Inspection date: 7 Jul 2026

Manufacturer: Mercedes-Benz  
VIN: W1N2539531V282007

Model: GLC 300 e 4Matic 9G-TRONIC

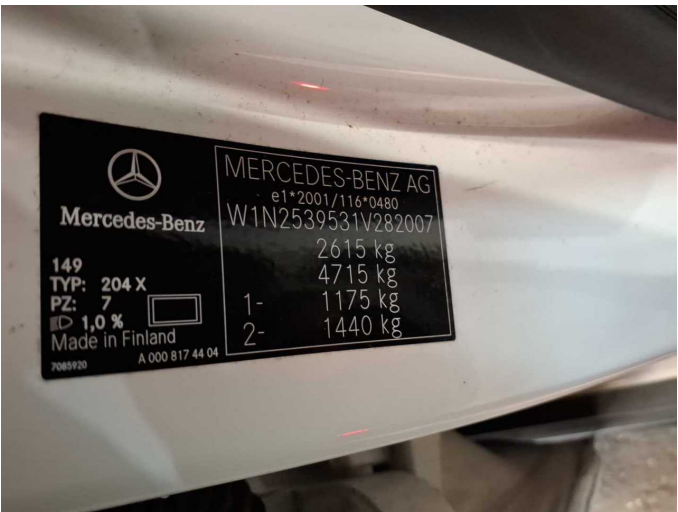
Figure 11: VIN

| VIN comparison | The vehicle identification number (VIN) was read from the vehicle and its conformity with the submitted documents was confirmed by the undersigned during the inspection. |

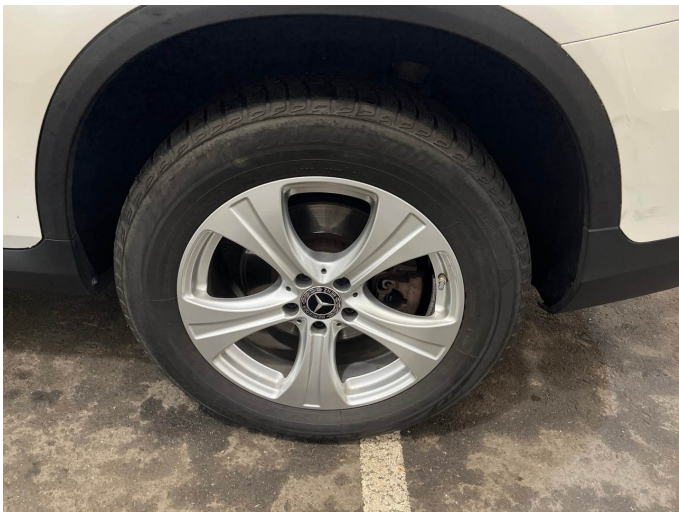
Figure 12: Mounted tyres

| # | Tyre size | Type of tyre | Manufacturer | Tread depth |
|---|---|---|---|---|
| 1) | 235/60 R18 103H | Winter tyres on Light alloy | Bridgestone | 5mm / 5mm |
| 2) | 235/60 R18 103H | Winter tyres on Light alloy | Bridgestone | 4mm / 4mm |

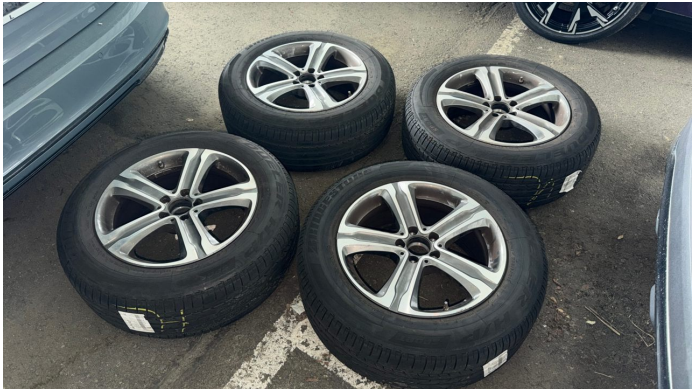
Figure 16: Additional tyres

| # | Tyre size | Type of tyre | Manufacturer | Tread depth |
|---|---|---|---|---|
| 1) | 235/60 R18 103W | Summer tyres on Light alloy | Bridgestone | 5mm / 5mm |
| 2) | 235/60 R18 103W | Summer tyres on Light alloy | Bridgestone | 5mm / 5mm |

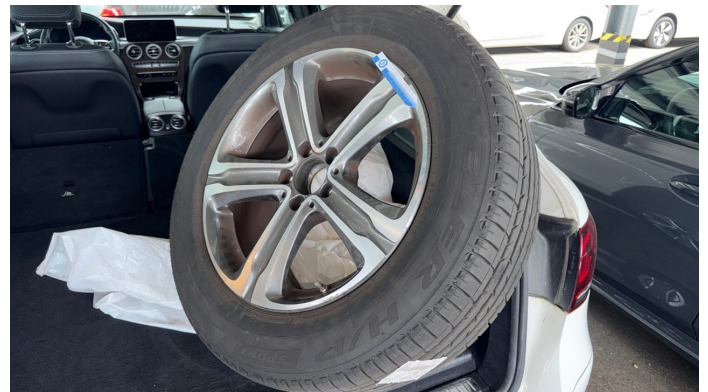
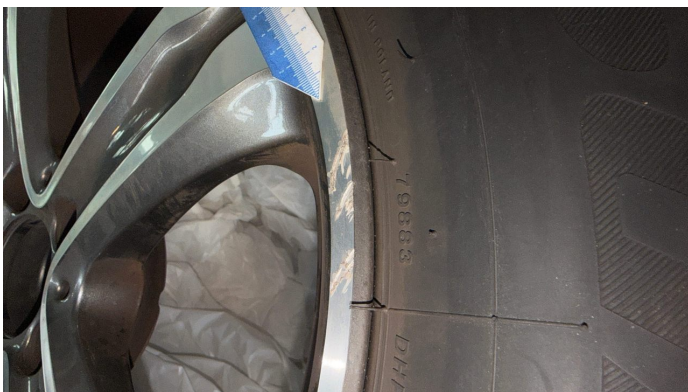
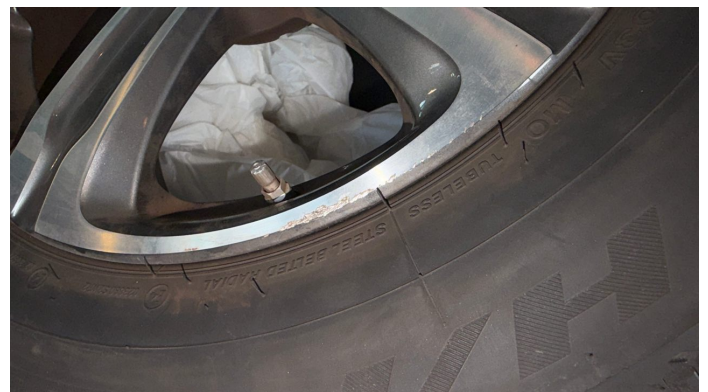
**Damage 2:** 2nd wheel set: 1 alloy rim - Scratched - Loss in value

| No. | Component group | Description |
|---|---|---|
| 2 | 2nd wheel set | 1 alloy rim - Scratched - Loss in value |

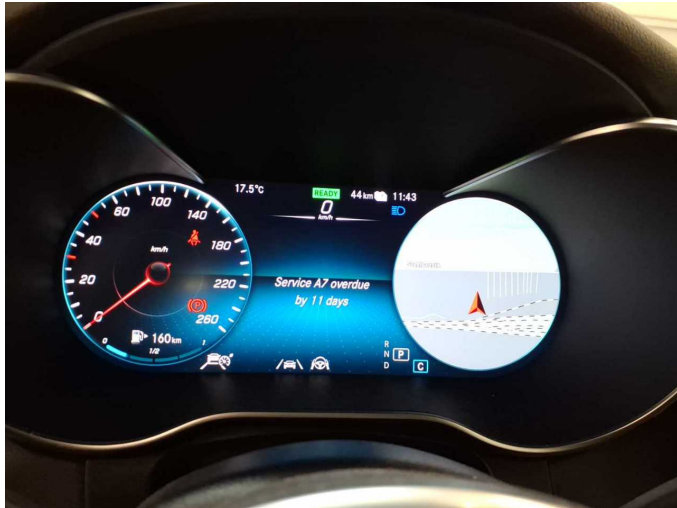
**Damage 3:** Misc.: Inspection / maintenance - Due - Perform

| No. | Component group | Description |
|---|---|---|
| 3 | Misc. | Inspection / maintenance - Due - Perform |

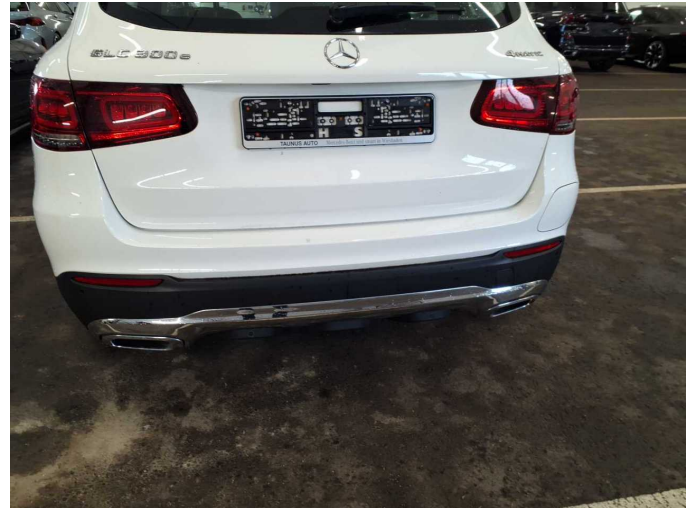
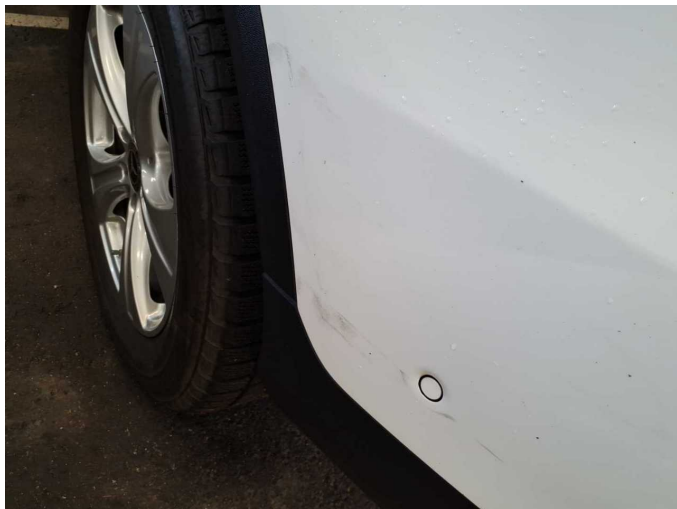
**Damage 4:** Rear bumper: Rear bumper - Scratched - Repair and paint

| No. | Component group | Description |
|---|---|---|
| 4 | Rear bumper | Rear bumper - Scratched - Repair and paint |
