Expertise

Protocol number: 46660730  
Order No. / Reference: 26712677  
Inspection date: 23 Jul 2026

Manufacturer: Mercedes-Benz

Model: GLE 350 de 4Matic 9G-TRONIC

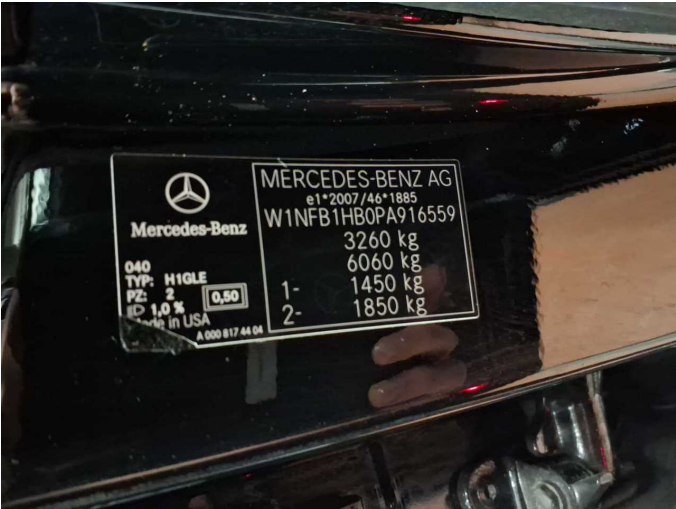
Figure 11: VIN

| VIN comparison | The vehicle identification number (VIN) was read from the vehicle and its conformity with the submitted documents was confirmed by the undersigned during the inspection. |

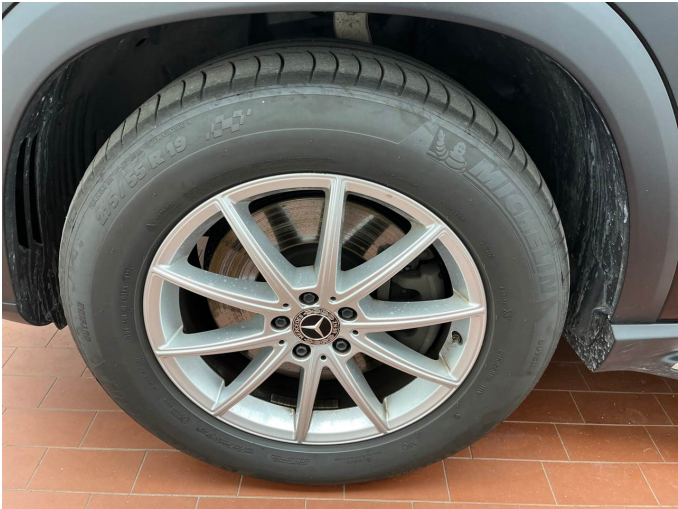
Figure 12: Mounted tyres

| # | Tyre size | Type of tyre | Manufacturer | Tread depth |
|---|---|---|---|---|
| 1) | 275/55 R19 111W | Summer tyres on Light alloy | Michelin | 5mm / 5mm |
| 2) | 275/55 R19 111W | Summer tyres on Light alloy | Michelin | 5mm / 5mm |

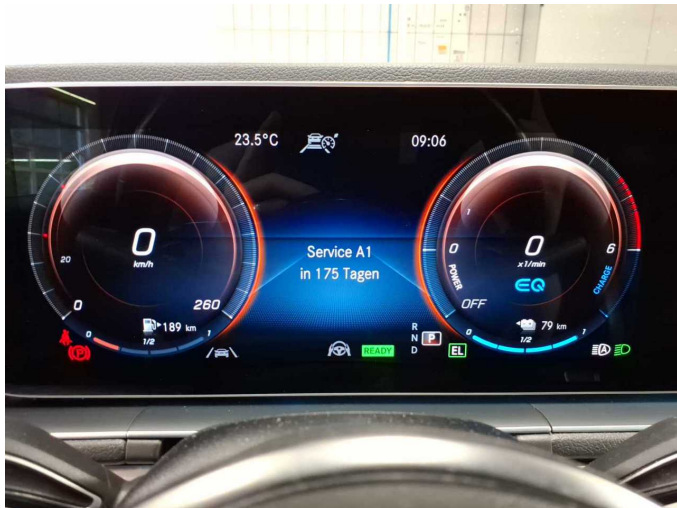
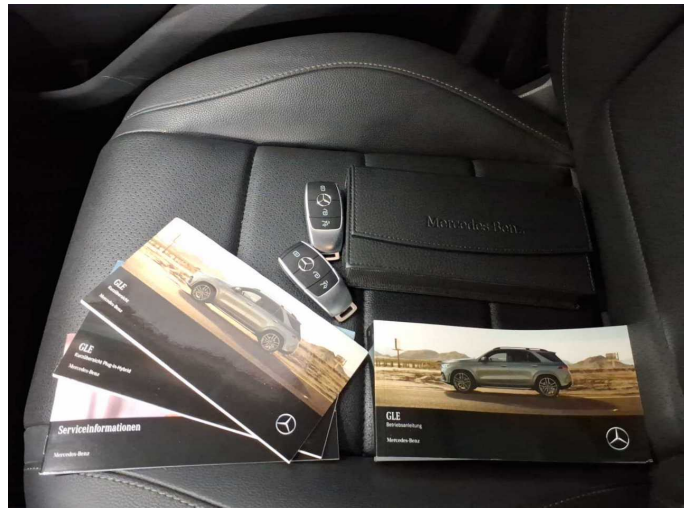
Figure 13: Documents

| Documents submitted | At the time of the inspection, the vehicle registration certificate Part 2 (title) was available, but the vehicle registration certificate Part 1 (document) was not. (Copy) |

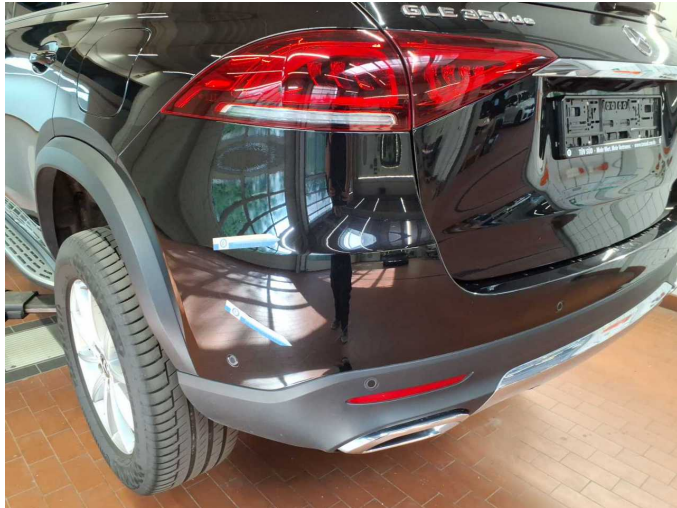
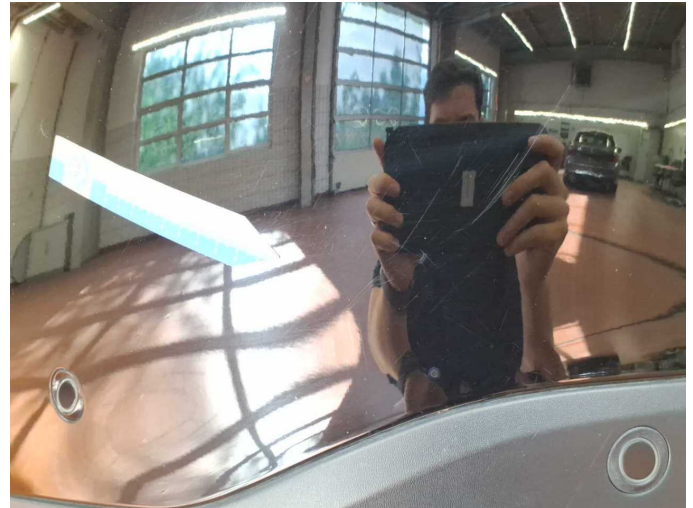
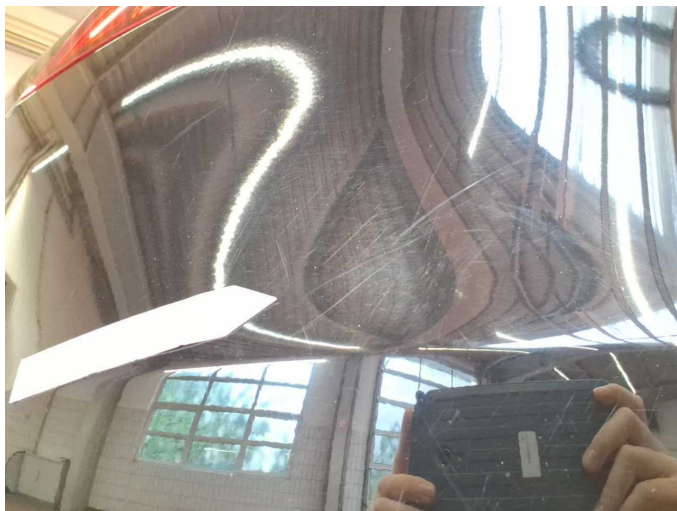
**Damage 1:** Rear bumper: Rear bumper - Scratch(es) - Paint

| No. | Component group | Description |
|---|---|---|
| 1 | Rear bumper | Rear bumper - Scratch(es) - Paint |
