Expertise

Protocol number: 46532419  
Order No. / Reference: 26620654  
Inspection date: 15 Jul 2026

| Manufacturer: Opel | Model: Insignia Sports Tourer 2.0 Diesel Aut. Elegance |
| VIN: W0VZT8EP8M1024281 | |

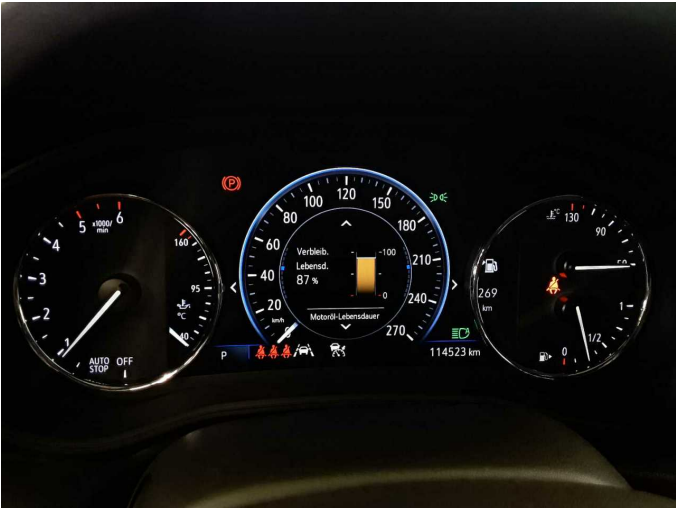
Figure 7: Instrument cluster

| Manufacturer / Type / Model / Equipment | |
|---|---|
| Mileage (Read) | 114,523 km |

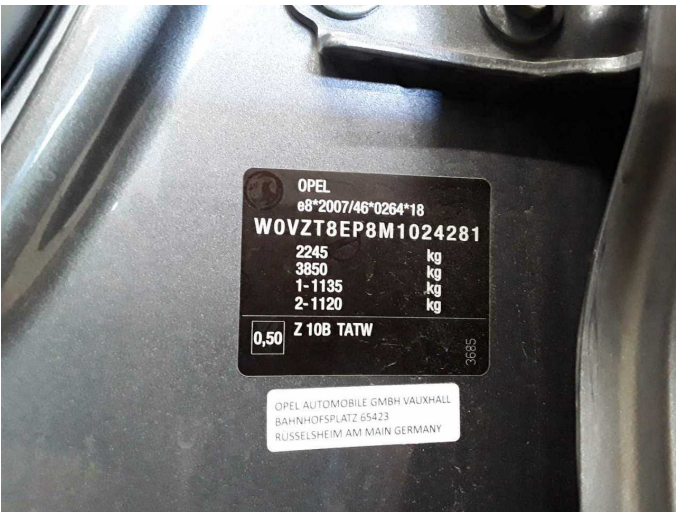
Figure 11: VIN

| VIN comparison | The vehicle identification number (VIN) was read from the vehicle and its conformity with the submitted documents was confirmed by the undersigned during the inspection. |

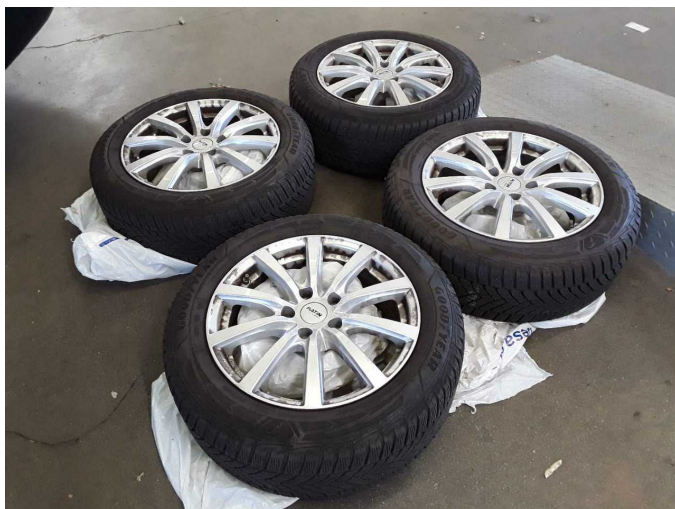
Figure 17: Additional tyres

| # | Tyre size | Type of tyre | Manufacturer | Tread depth |
|---|---|---|---|---|
| 1) | 225/55 R17 97H | Winter tyres on Light alloy | Goodyear | 5mm / 5mm |
| 2) | 225/55 R17 97H | Winter tyres on Light alloy | Goodyear | 6mm / 6mm |

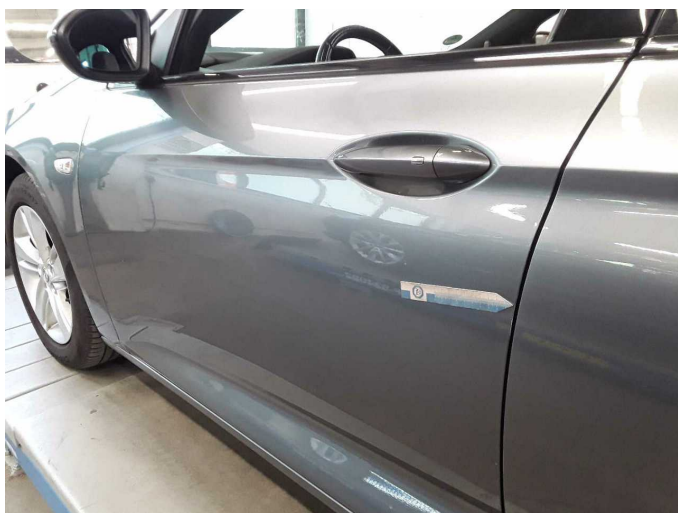
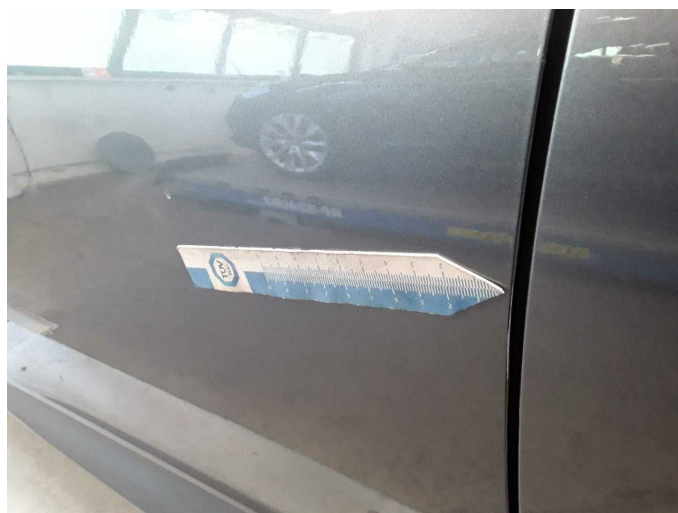
Damage 1: Door - front left side: Door - Scratch(es) - Smart repair

| No. | Component group | Description |
|---|---|---|
| 1 | Door - front left side | Door - Scratch(es) - Smart repair |

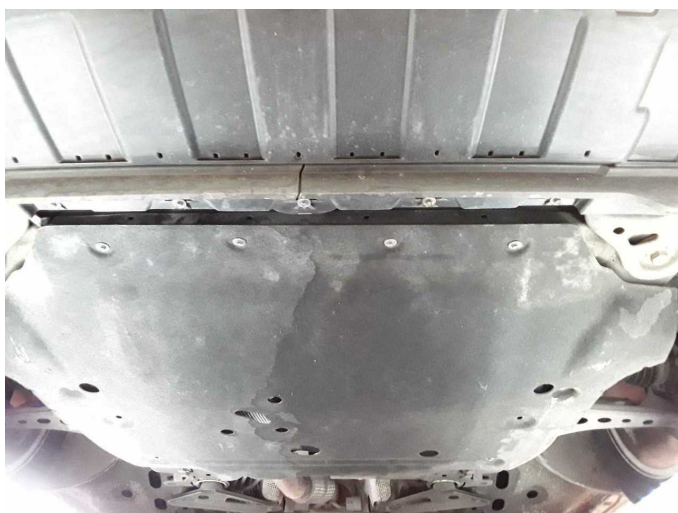
Damage 2: Engine: Engine - Leaking - Diagnosed and repair if necessary

| No. | Component group | Description |
|---|---|---|
| 2 | Engine | Engine - Leaking - Diagnosed and repair if necessary |

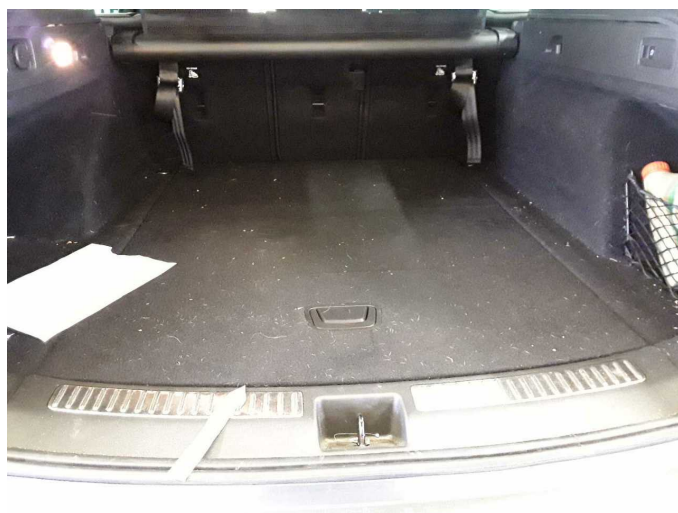
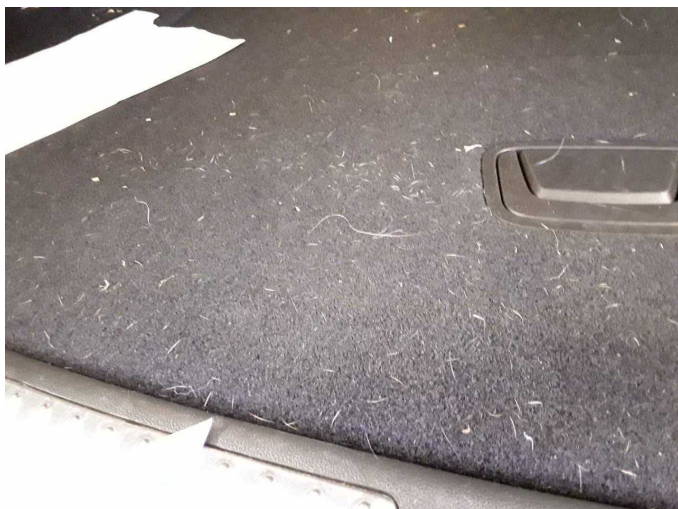
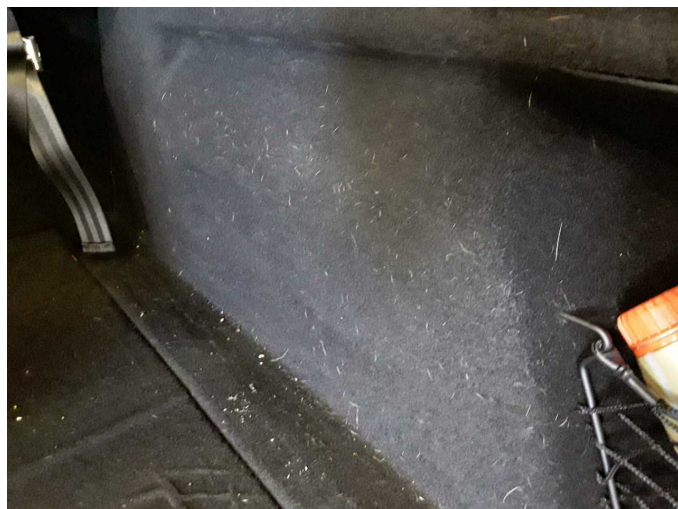
Damage 3: Interior: Interior (Hundehaare) - Soiled - Conditioning

**Damage 3:** Interior: Interior (Hundehaare) - Soiled - Conditioning

| No. | Component group | Description |
|---|---|---|
| 3 | Interior | Interior (Hundehaare) - Soiled - Conditioning |

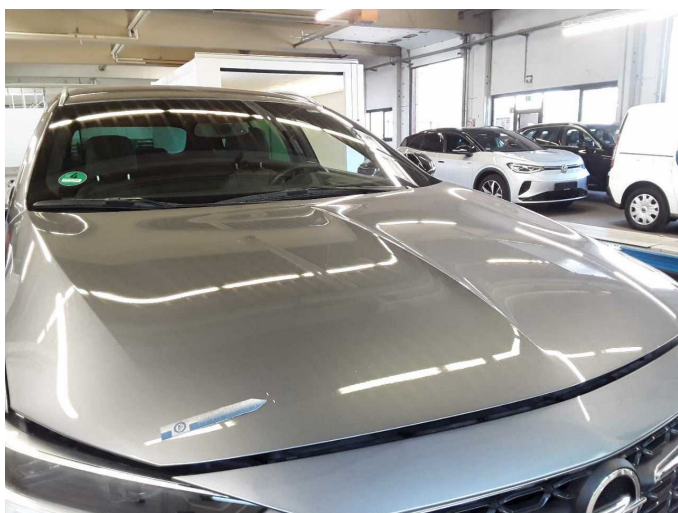
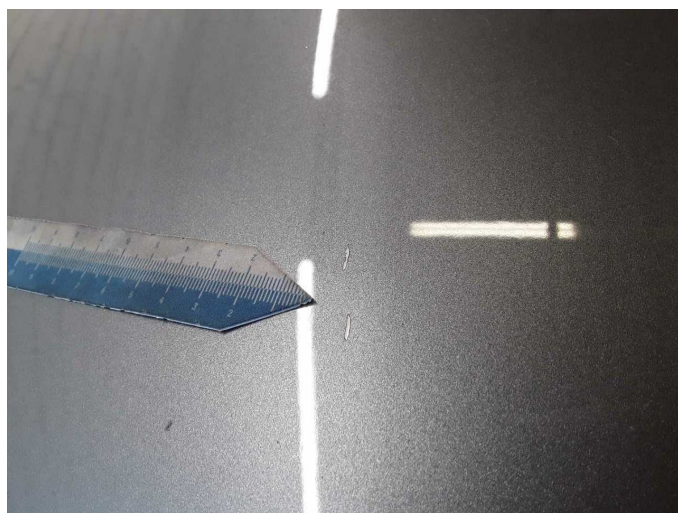
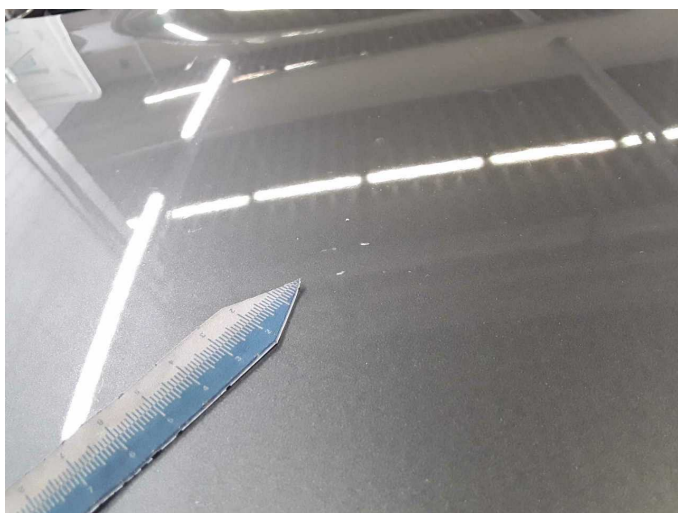
**Damage 4:** Bonnet: Bonnet - Scratch(es) - Paint

| No. | Component group | Description |
|---|---|---|
| 4 | Bonnet | Bonnet - Scratch(es) - Paint |
