Expertise

Protocol number: 46288423  
Order No. / Reference: 26638861  
Inspection date: 2 Jul 2026

Manufacturer: Ford

Model: Transit Connect 240 L1 Autm. Trend

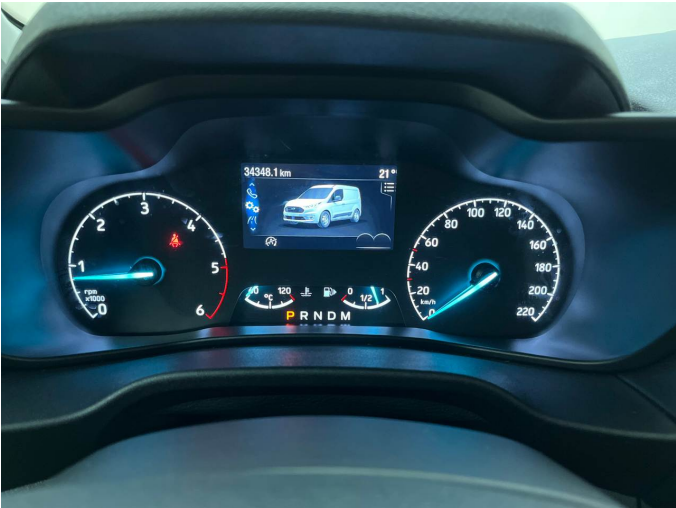
Figure 7: Instrument cluster

| Mileage (Read) | 34,348 km |

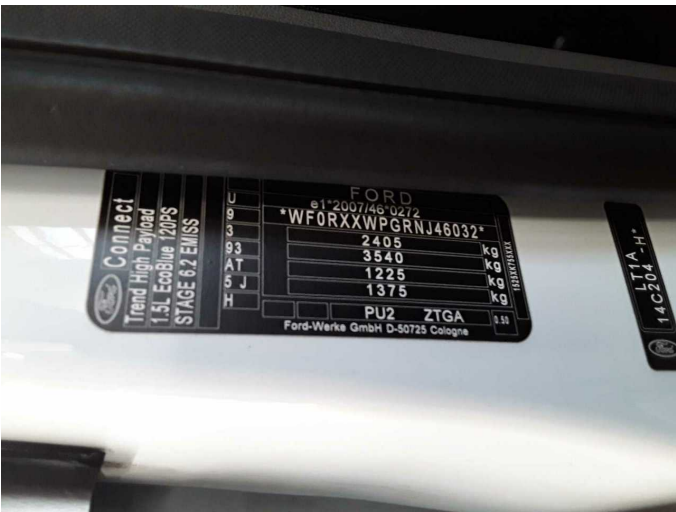
Figure 11: VIN

| VIN comparison | The vehicle identification number (VIN) was read from the vehicle and its conformity with the submitted documents was confirmed by the undersigned during the inspection. |

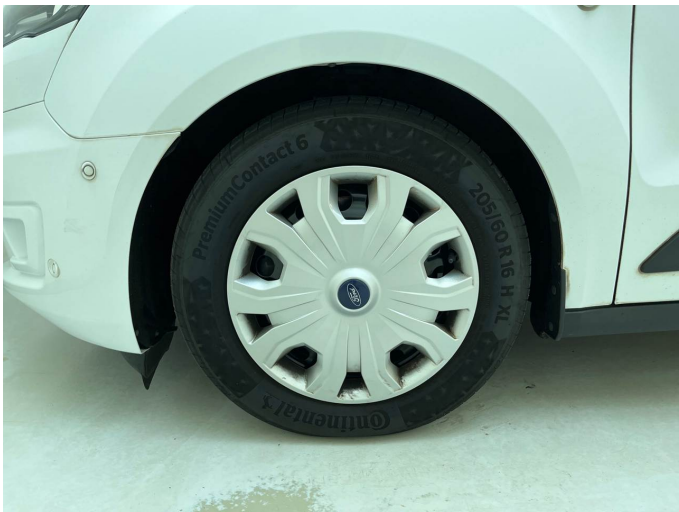
Figure 12: Mounted tyres

| # | Tyre size | Type of tyre | Manufacturer | Tread depth |
|---|---|---|---|---|
| 1) | 205/60 R16 96H | Summer tyres on Steel rim with wheel cover | Continental | 6mm / 6mm |
| 2) | 205/60 R16 96H | Summer tyres on Steel rim with wheel cover | Continental | 7 mm |
| | 205/60 R16 96H | Summer tyres on Steel | Continental | 7 mm |

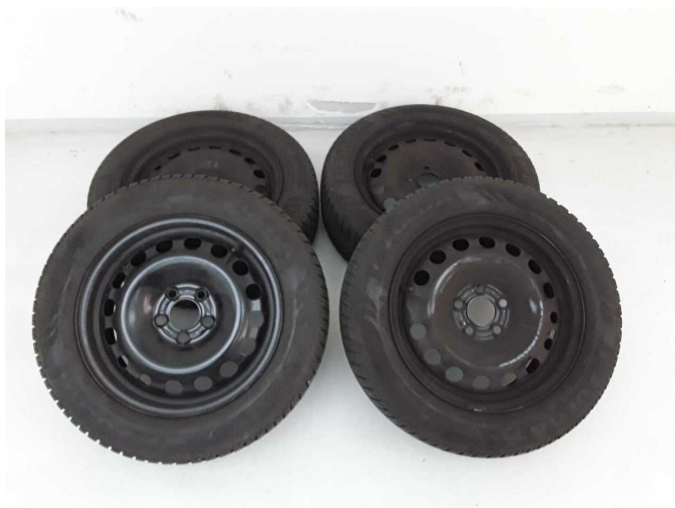
Figure 15: Additional tyres

| # | Tyre size | Type of tyre | Manufacturer | Tread depth |
|---|---|---|---|---|
| 1) | 205/60 R16 96H | Winter tyres on Steel | Fulda | 6mm / 6mm |
| 2) | 205/60 R16 96H | Winter tyres on Steel | Fulda | 8mm / 8mm |

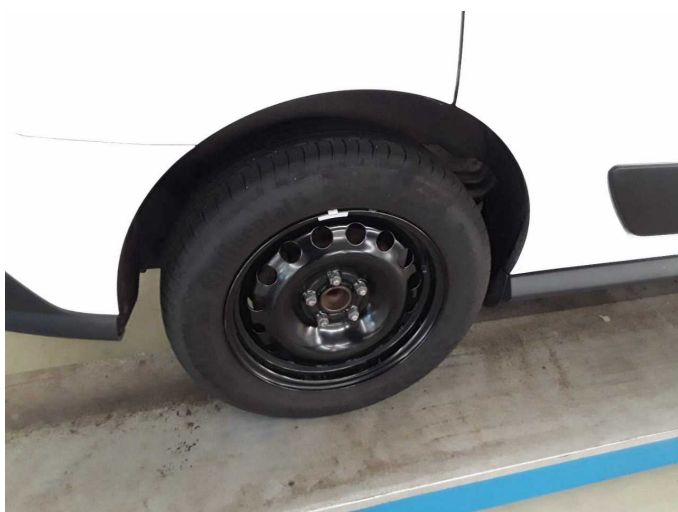
| No. | Component group | Description |
|---|---|---|
| 1 | Wheel / tyres | Wheel cover - rear right side - Missing - Replace |

**Damage 1:** Wheel / tyres: Wheel cover - rear right side - Missing - Replace

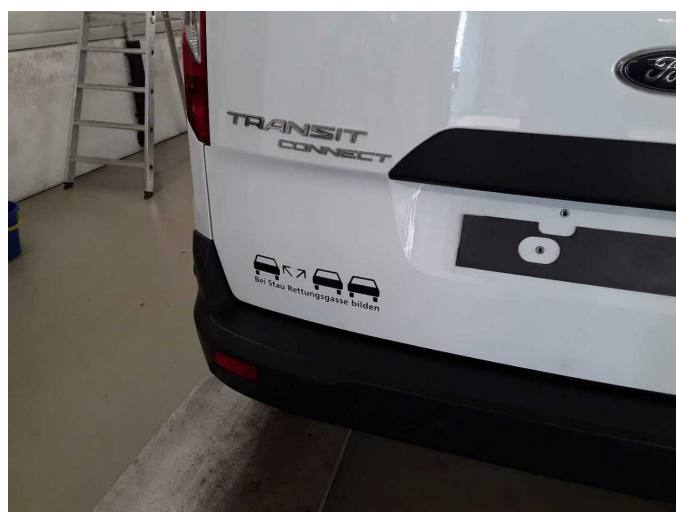
| No. | Component group | Description |
|---|---|---|
| 2 | Body | Body (Zusatzkosten können entstehen) - Glued / labelled - De-glue / neutralise |

**Damage 2:** Body: Body (Zusatzkosten können entstehen) - Glued / labelled - De-glue / neutralise

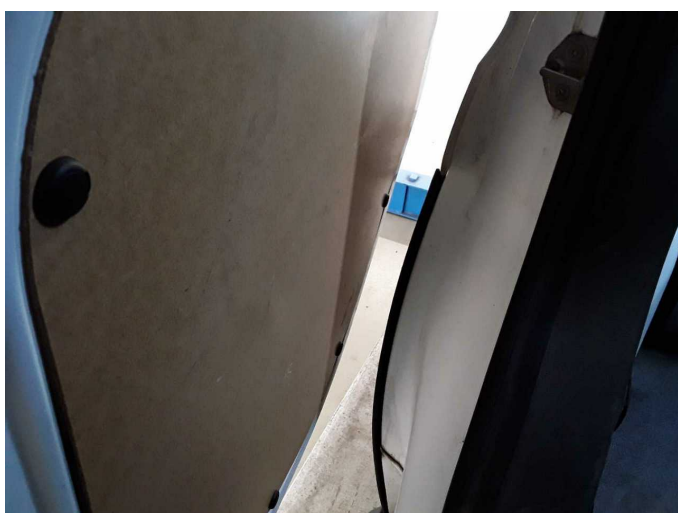
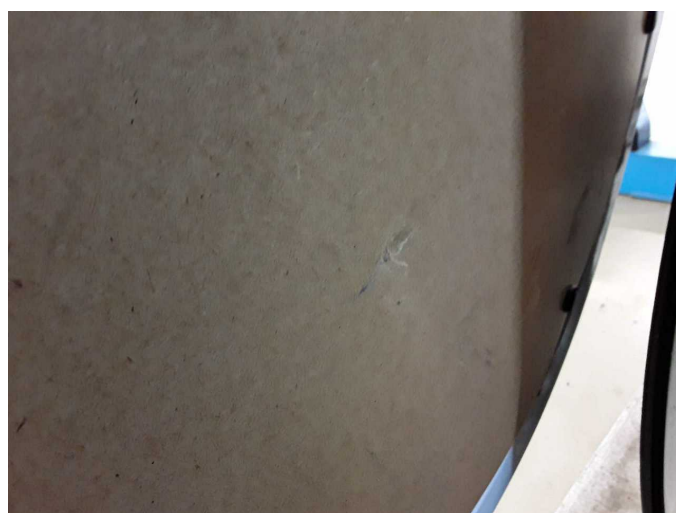
| No. | Component group | Description |
|---|---|---|
| 3 | Sliding door, right | Trim hard fibre - lower - Broken / torn - Replace |

**Damage 3:** Sliding door, right: Trim hard fibre - lower - Broken / torn - Replace

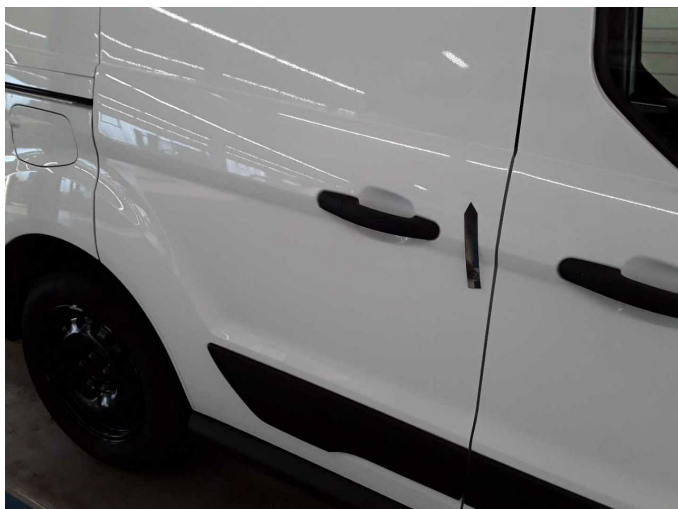
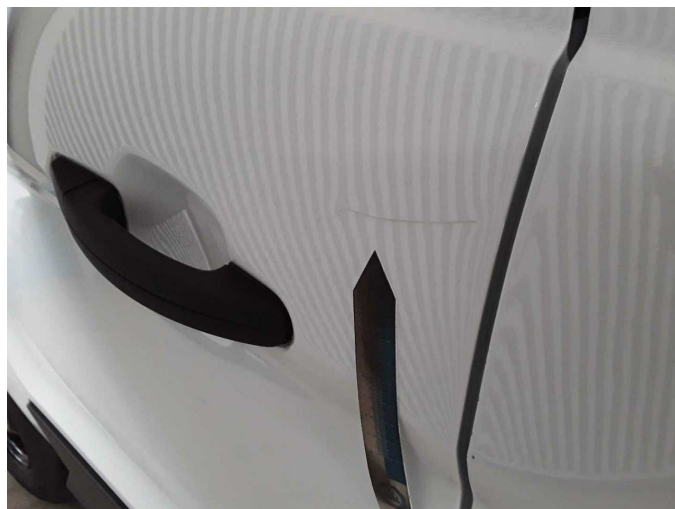
| No. | Component group | Description |
|---|---|---|
| 4 | Sliding door, right | Sliding door - Dent / paintcoat damage - Smart repair |

**Damage 4:** Sliding door, right: Sliding door - Dent / paintcoat damage - Smart repair

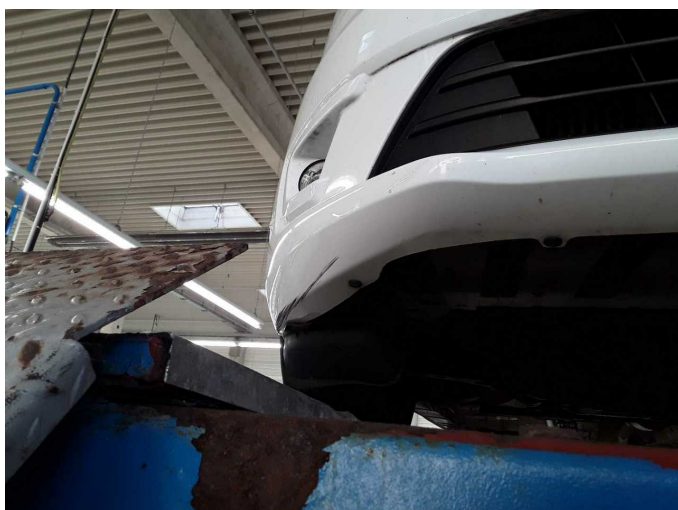
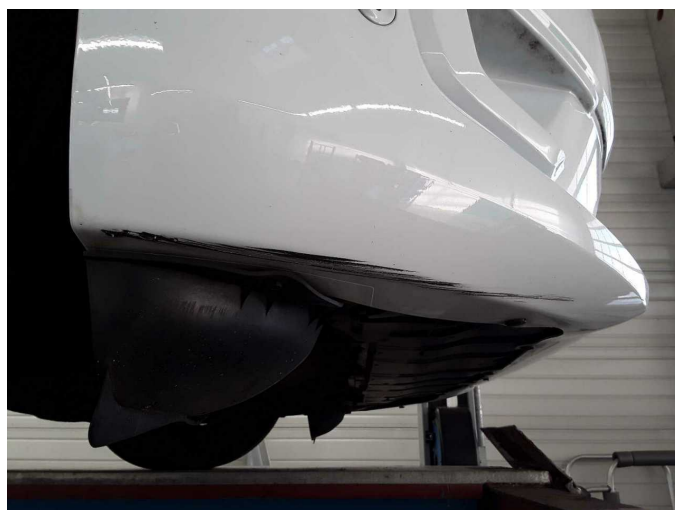
| No. | Component group | Description |
|---|---|---|
| 5 | Front bumper | Bumper with Parktronic - Scratch(es) - Paint |

**Damage 5:** Front bumper: Bumper with Parktronic - Scratch(es) - Paint
