# INSPECTION REPORT

**End of contract**

| License plate | 2CEL153 |
| Make | BMW 320e Touring |

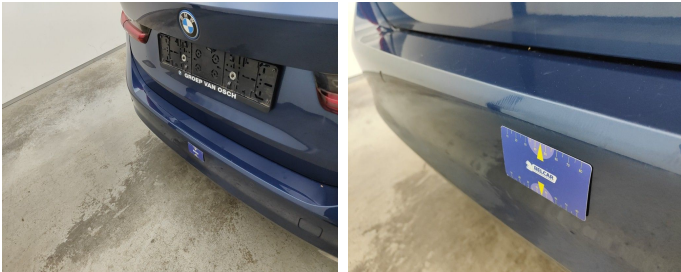
Bumper Rear // Polish-scratch

| Damages | Type | Acceptable |
|---|---|---|
| 136 | Bumper Rear // Polish | Y |

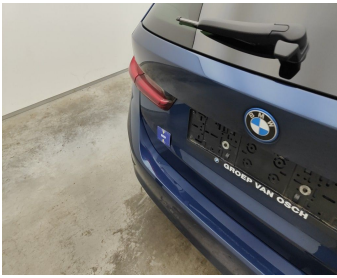
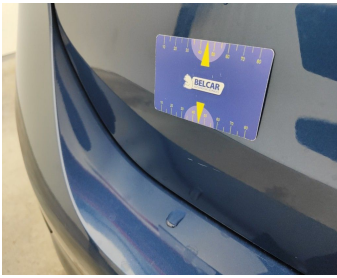
Rear Bonnet // Painting-scratch

| Damages | Type | Acceptable |
|---|---|---|
| 153 | Rear Bonnet // Painting | Y |

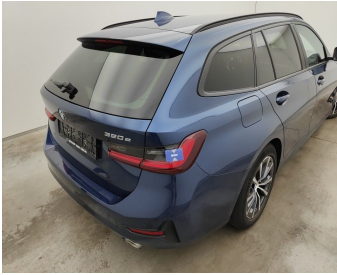
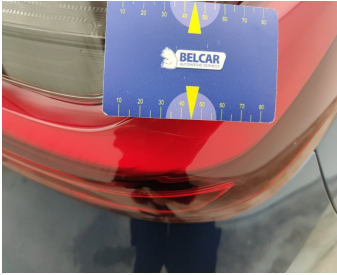
Light / Rear Right / Replace-scratch

| Damages | Type | Acceptable |
|---|---|---|
| 174 | Light / Rear Right / Replace | Y |

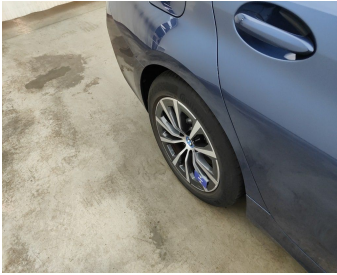
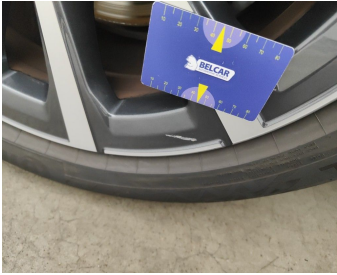
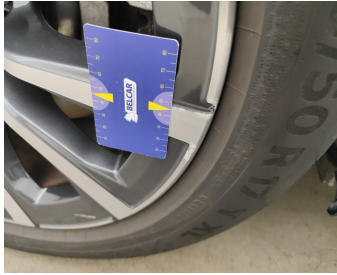
Wheel Two Tone Rear Right // Repair-scratch

| Damages | Type | Acceptable |
|---|---|---|
| 330 | Wheel Two Tone Rear Right // Repair | N |

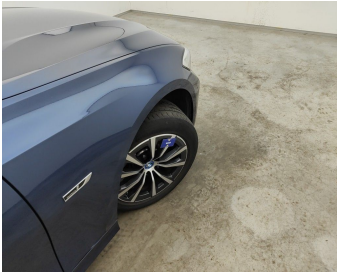
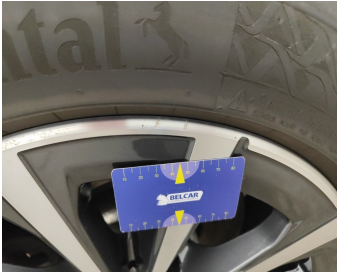
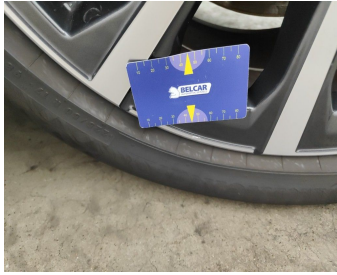
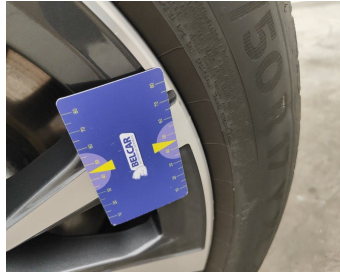
Wheel Two Tone Front Right // Repair-scratch

| Damages | Type | Acceptable |
|---|---|---|
| 340 | Wheel Two Tone Front Right // Repair | N |

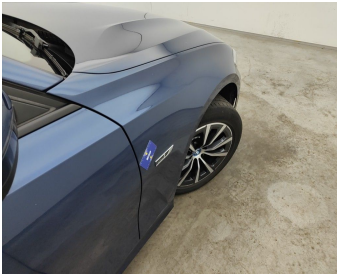
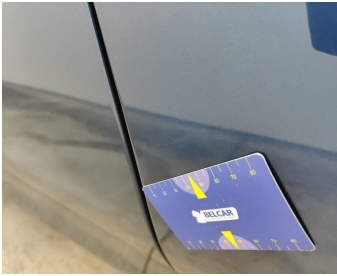
Wing Front right // Polish-scratch

| Damages | Type | Acceptable |
|---|---|---|
| 236 | Wing Front right // Polish | Y |

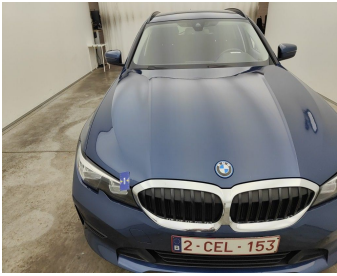
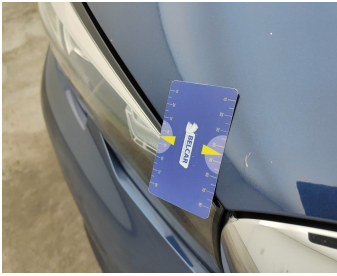
Front Bonnet // Painting-scratch

| Damages | Type | Acceptable |
|---|---|---|
| 32 | Front Bonnet // Painting | Y |

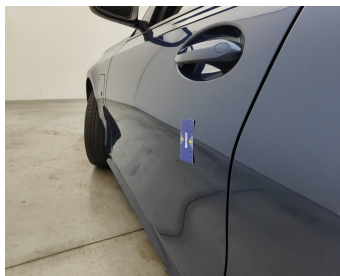
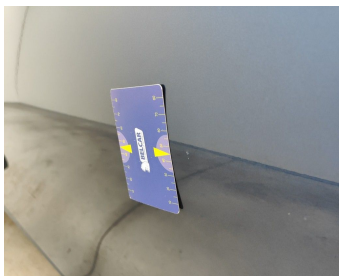
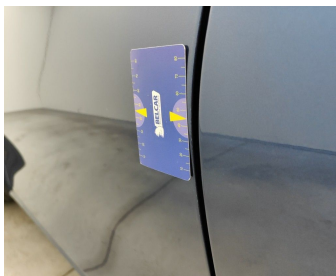
Door Front Left // Painting-scratch

| Damages | Type | Acceptable |
|---|---|---|
| 83 | Door Front Left // Painting | Y |

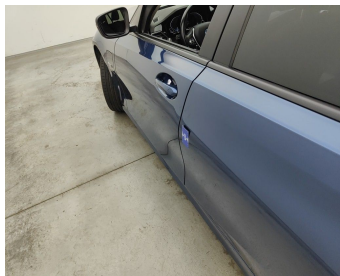
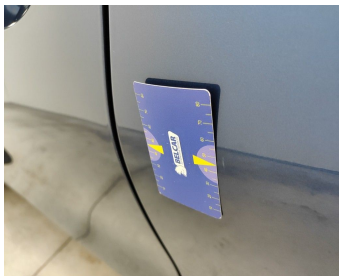
Door Rear Left // Painting-scratch

| Damages | Type | Acceptable |
|---|---|---|
| 103 | Door Rear Left // Painting | Y |

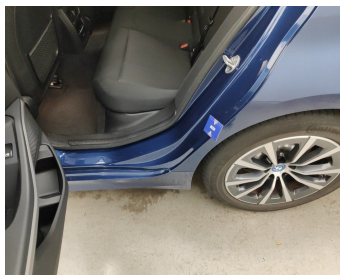
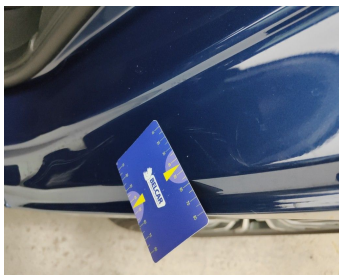
Rocker Panel Left // Painting-scratch

| Damages | Type | Acceptable |
|---|---|---|
| 92 | Rocker Panel Left // Painting | Y |

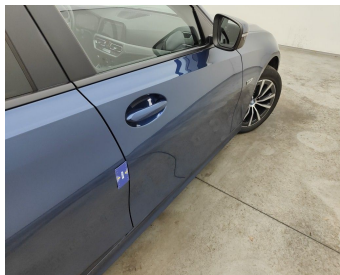
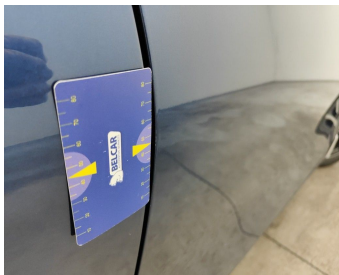
Door Front Right // Smart Repair Small-scratch

| Damages | Type | Acceptable |
|---|---|---|
| 210 | Door Front Right // Smart Repair Small | Y |

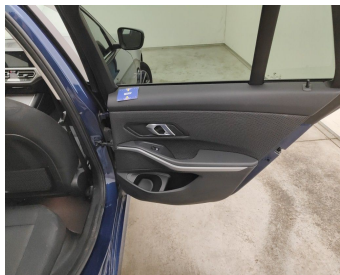
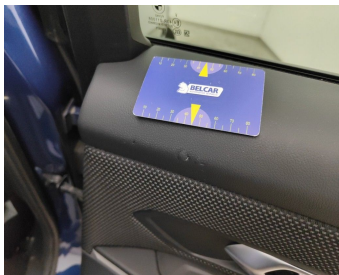
Rear Right Door Interior Coating // Repair-scratch

| Damages | Type | Acceptable |
|---|---|---|
| 641 | Rear Right Door Interior Coating // Repair | N |

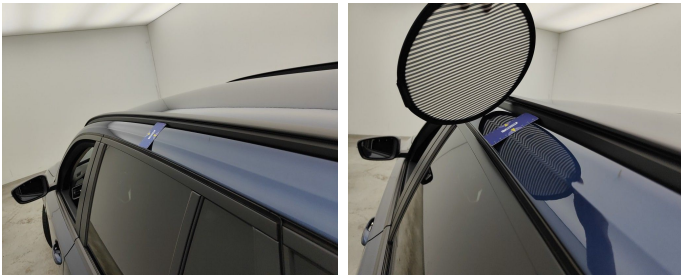
Roof // Smart Repair Medium-dent

| Damages | Type | Acceptable |
|---|---|---|
| 161 | Roof // Smart Repair Medium | Y |

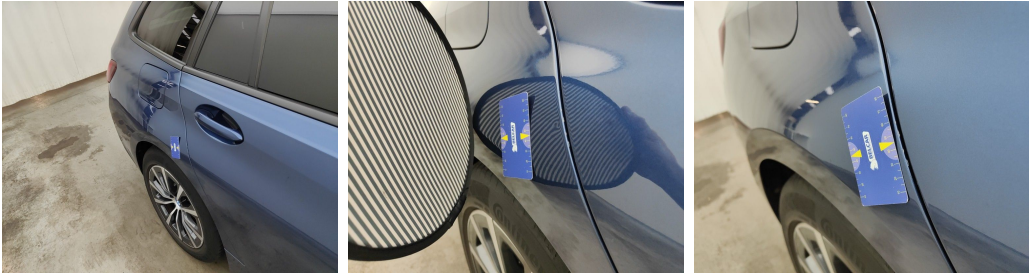
Wing Rear Right // Smart Repair Small-dent

| Damages | Type | Acceptable |
|---|---|---|
| 180 | Wing Rear Right // Smart Repair Small | Y |

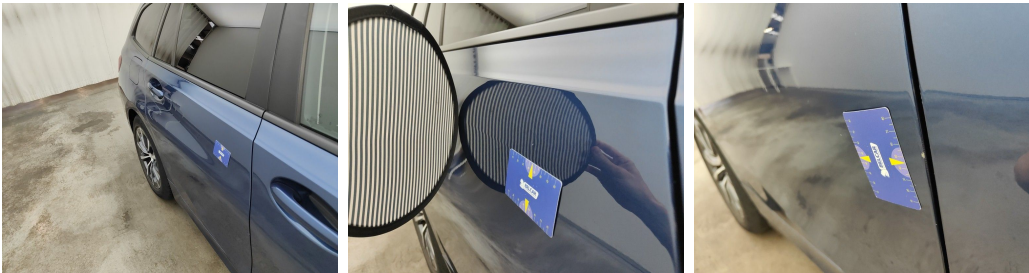
Door Rear Right // Repair & Painting-scratch + dent

| Damages | Type | Acceptable |
|---|---|---|
| 194 | Door Rear Right // Repair & Painting | Y |

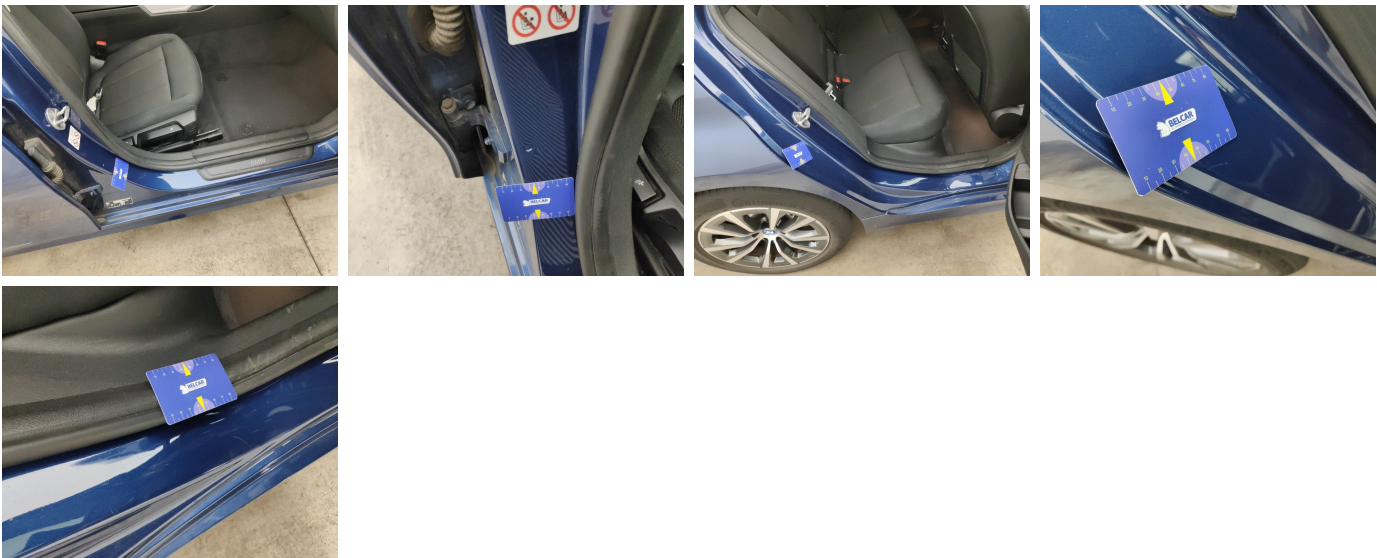
Rocker Panel Right // Smart Repair Medium-scratch + dent

| Damages | Type | Acceptable |
|---|---|---|
| 201 | Rocker Panel Right // Smart Repair Medium | Y |

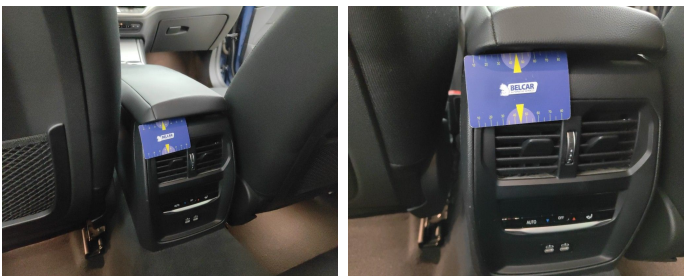
Dashboard / Ventilation Outlet / Replace-cracked

| Damages | Type | Acceptable |
|---|---|---|
| 568 | Dashboard / Ventilation Outlet / Replace | N |

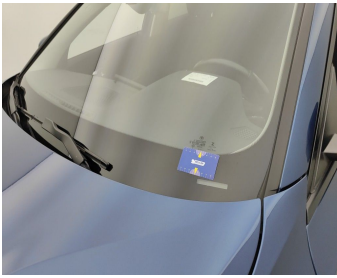
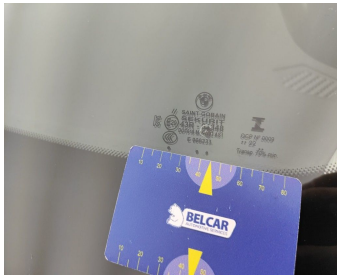
Windshield // Repair-glass damage

| Damages | Type | Acceptable |
|---|---|---|
| 40 | Windshield // Repair | Y |

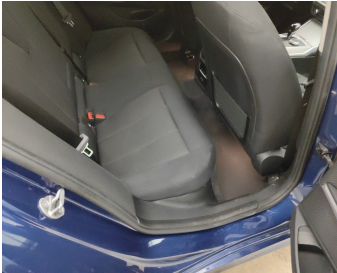
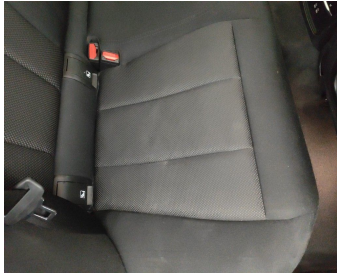
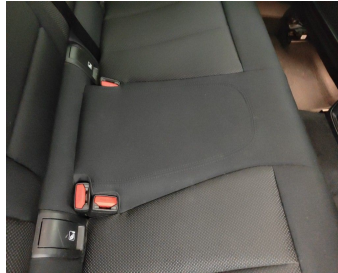
Interior Cleaning // Small-stain

| Damages | Type | Acceptable |
|---|---|---|
| 860 | Interior Cleaning // Small | N |

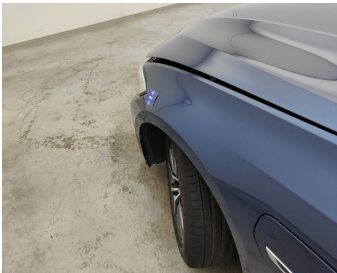
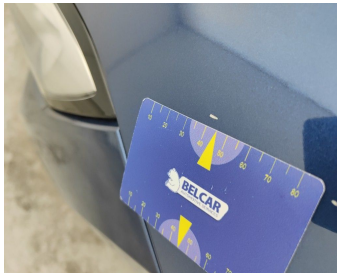
Wing Front Left // Painting-stone chipping

| Damages | Type | Acceptable |
|---|---|---|
| 63 | Wing Front Left // Painting | N |
