## Expertise

Protocol number: 45082297  
Order No. / Reference: 26165932  
Inspection date: 20 Apr 2026

Manufacturer: Volvo

Model: XC60 B4 D AWD Geartronic Momentum Pro

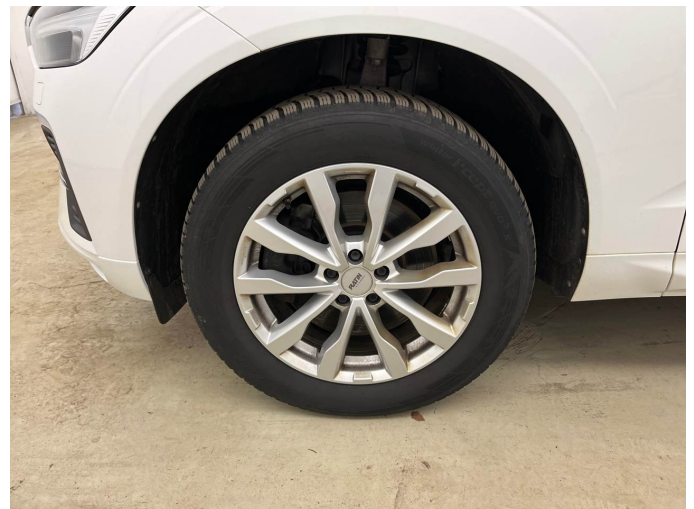
Figure 12: Mounted tyres

#	Tyre size	Type of tyre	Manufacturer	Tread depth
1)	235/60 R18 107H	Winter tyres on Light alloy	Hankook	3mm / 3mm
2)	235/60 R18 107H	Winter tyres on Light alloy	Hankook	5mm / 5mm

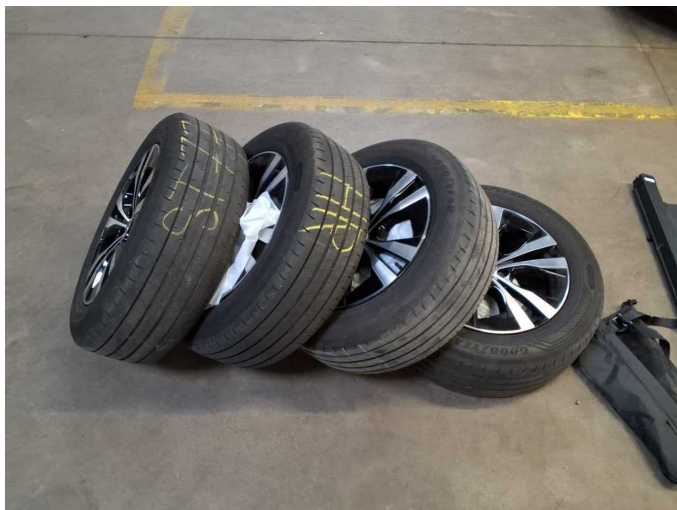
Figure 15: Additional tyres

#	Tyre size	Type of tyre	Manufacturer	Tread depth
1)	235/60 R18 107V	Summer tyres on Light alloy	Goodyear	3mm / 3mm
2)	235/60 R18 107V	Summer tyres on Light alloy	Goodyear	4mm / 4mm

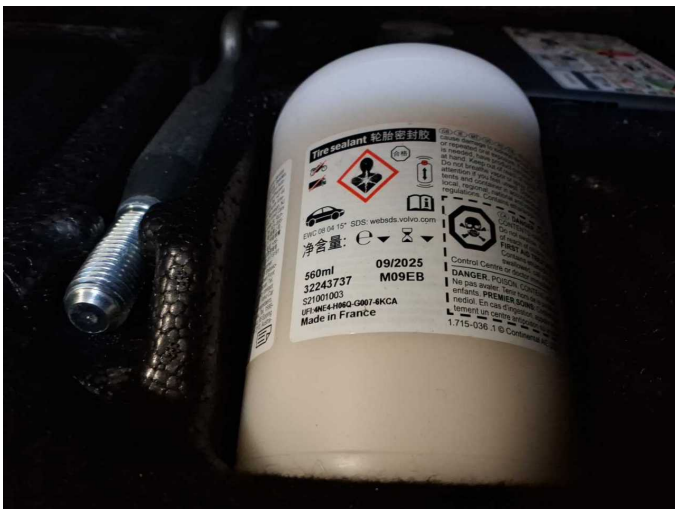
Damage 1: Equipment: Tirefit filler - Expired - Replace

No.	Component group	Description
1	Equipment	Tirefit filler - Expired - Replace
2	Wheel / tyres	Pressure sensor (Reifendruck) - Functional / admissibility - Perform diagnosis
3	Door - rear right side	Door handle - inside - Deformed - Smart repair

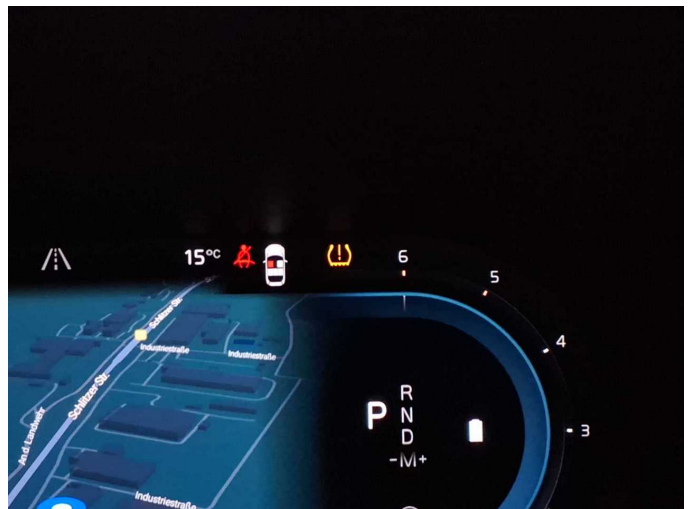
Damage 2: Wheel / tyres: Pressure sensor (Reifendruck) - Functional / admissibility - Perform diagnosis

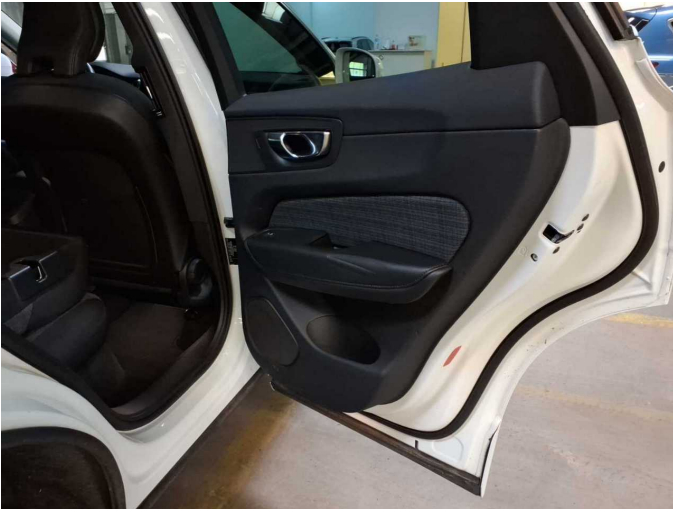
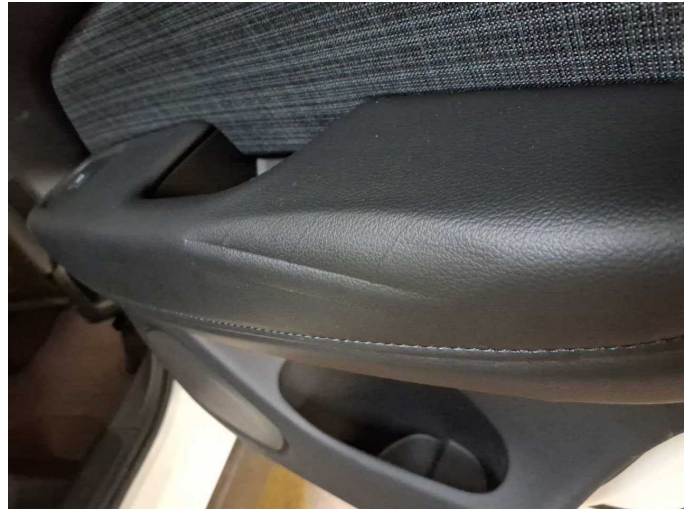
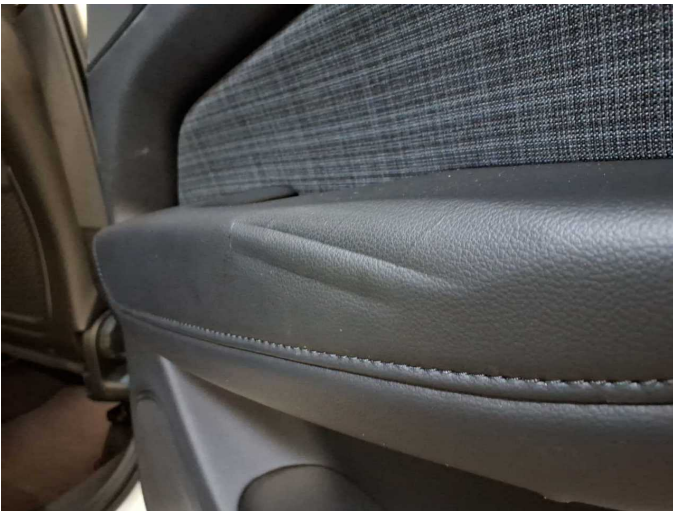
**Damage 3:** Door - rear right side: Door handle - inside - Deformed - Smart repair

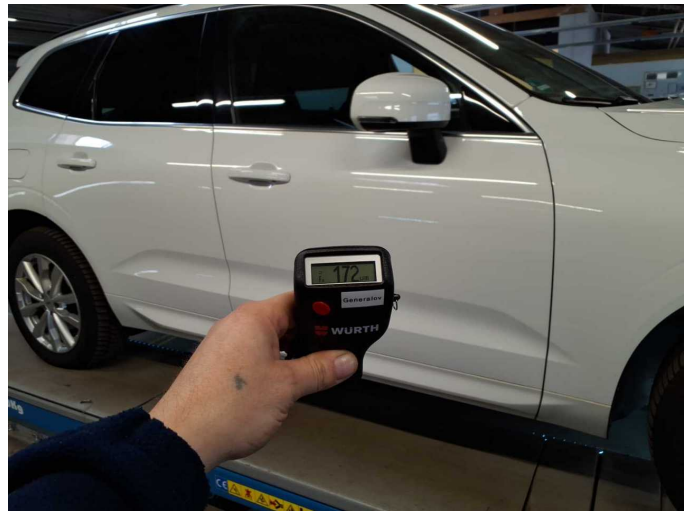
**Repainting 1:** Door - front right side

No.	Repainting
1	Door - front right side, Professionally carried out, Invoice of repair done Non-existent

Door - front right side	172 µm
-------------------------	--------
