Expertise

Protocol number: 46475470  
Order No. / Reference: 26572969  
Inspection date: 13 Jul 2026

Manufacturer: Volkswagen

Model: ID. BUZZ PRO LR

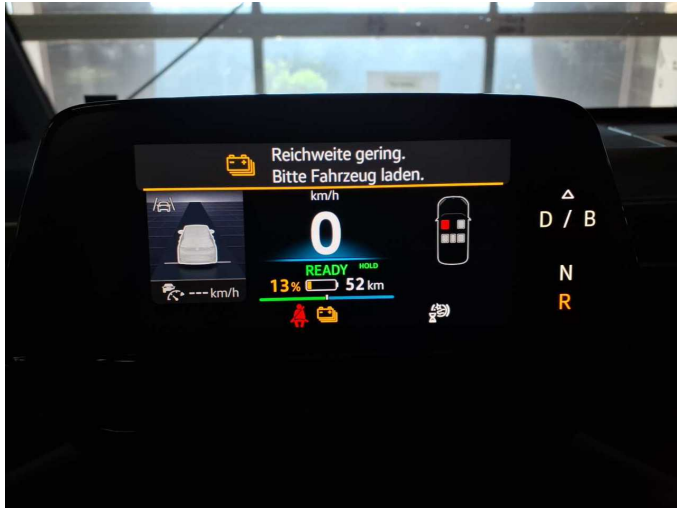
| Vehicle details | |
|---|---|
| Mileage (Read) | 18,176 km |

Figure 7: Instrument cluster

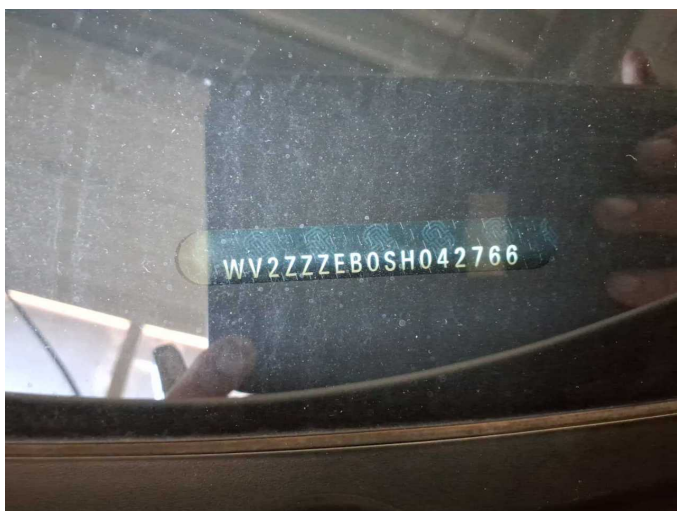
| VIN comparison | The vehicle identification number (VIN) was read from the vehicle and its conformity with the submitted documents was confirmed by the undersigned during the inspection. |

Figure 11: VIN

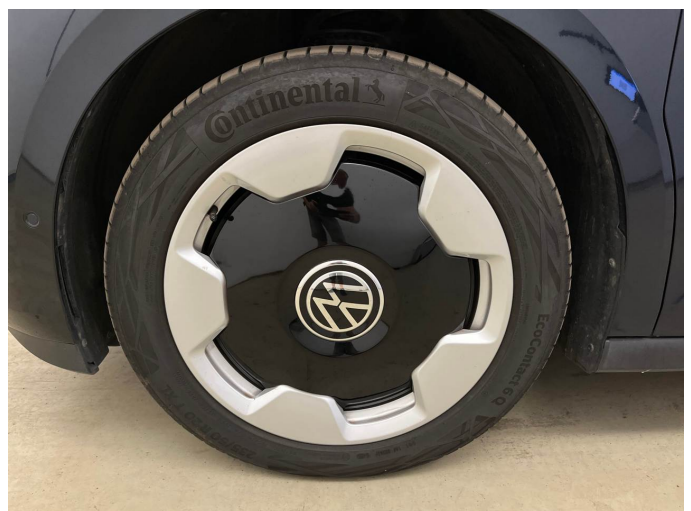
| # | Tyre size | Type of tyre | Manufacturer | Tread depth |
|---|---|---|---|---|
| 1) | 235/50 R20 104T | Summer tyres on Light alloy | Continental | 5mm / 5mm |
| 2) | 265/45 R20 108T | Summer tyres on Light alloy | Continental | 6mm / 6mm |

Figure 12: Mounted tyres

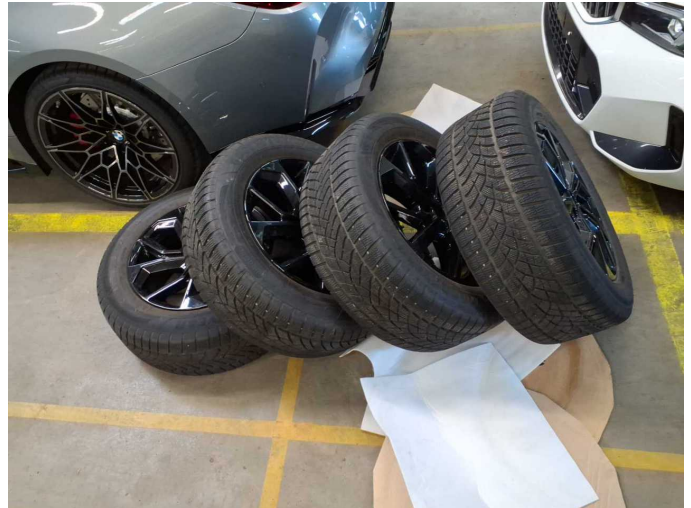
| # | Tyre size | Type of tyre | Manufacturer | Tread depth |
|---|---|---|---|---|
| 1) | 235/60 R18 103T | Winter tyres on Light alloy | Goodyear | 7mm / 7mm |
| 2) | 255/55 R18 105T | Winter tyres on Light alloy | Goodyear | 7mm / 7mm |

Figure 14: Additional tyres

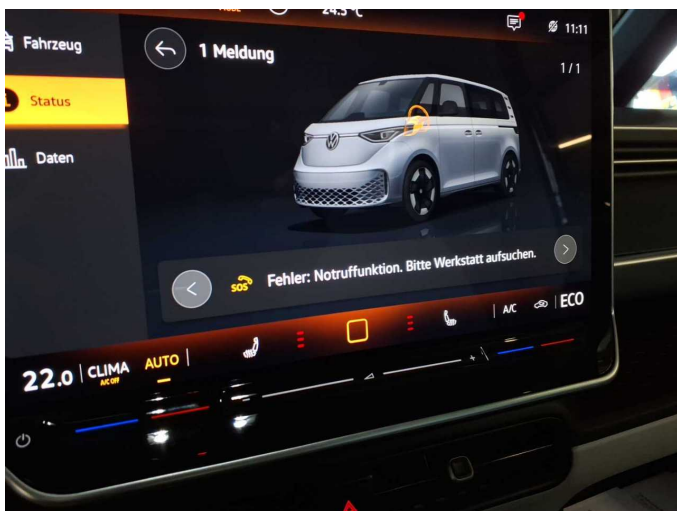
| No. | Component group | Description |
|---|---|---|
| 1 | Electronic systems | Electronic systems (SOS) - Functional / admissibility - Perform diagnosis |

**Damage 1:** Electronic systems: Electronic systems (SOS) - Functional / admissibility - Perform diagnosis

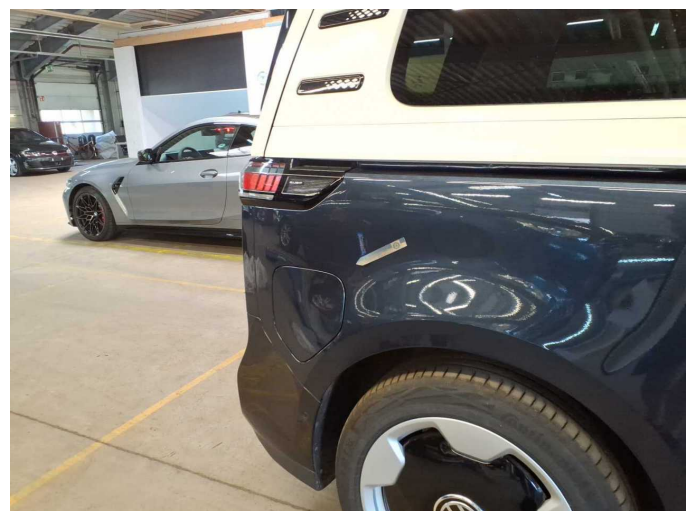
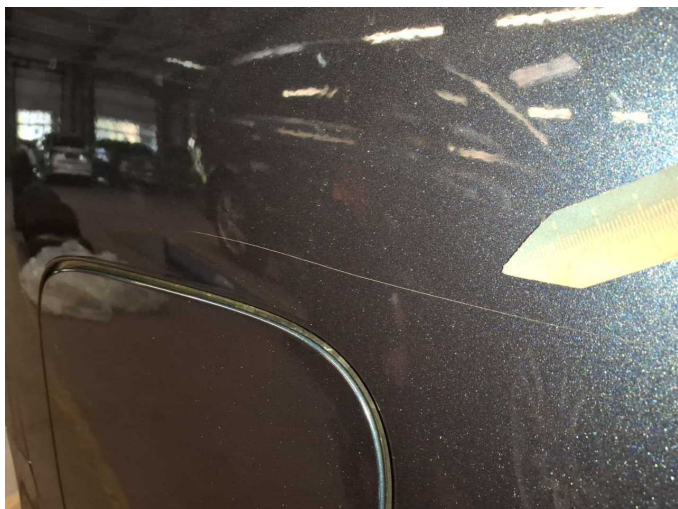
| No. | Component group | Description |
|---|---|---|
| 2 | Side panel - rear right side | Side panel - Scratch(es) - Smart repair |

**Damage 2:** Side panel - rear right side: Side panel - Scratch(es) - Smart repair
