Expertise

Protocol number: 46917837  
Order No. / Reference: 26754529  
Inspection date: 4 Aug 2026

Manufacturer: Volkswagen

Model: Passat Variant 2.0 TDI SCR DSG 4Motion Business

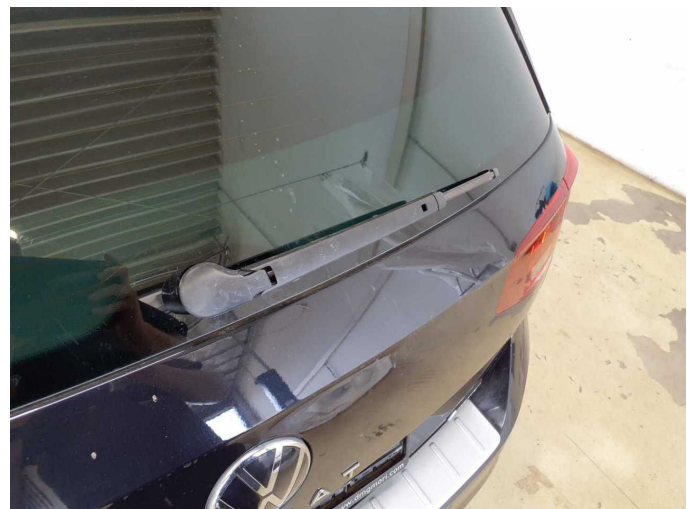
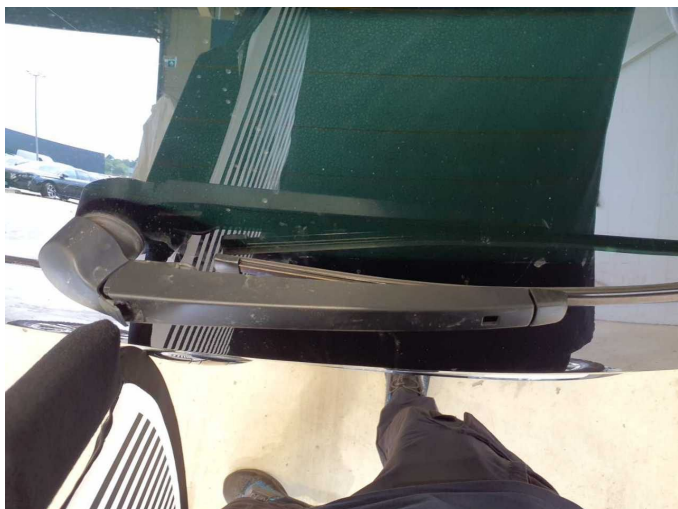
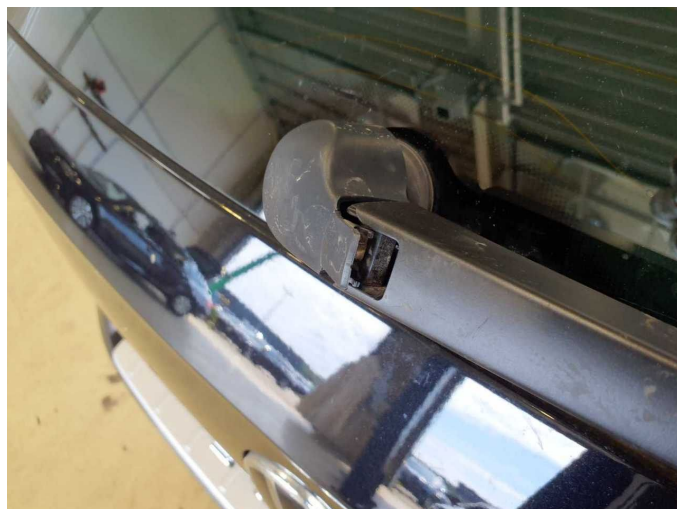
| No. | Component group | Description |
|---|---|---|
| 2 | Screen cleaning | Wiper arm - rear (Inklusive Wischerblatt) - Broken / torn - Replace |

**Damage 2:** Screen cleaning: Wiper arm - rear (Inklusive Wischerblatt) - Broken / torn - Replace

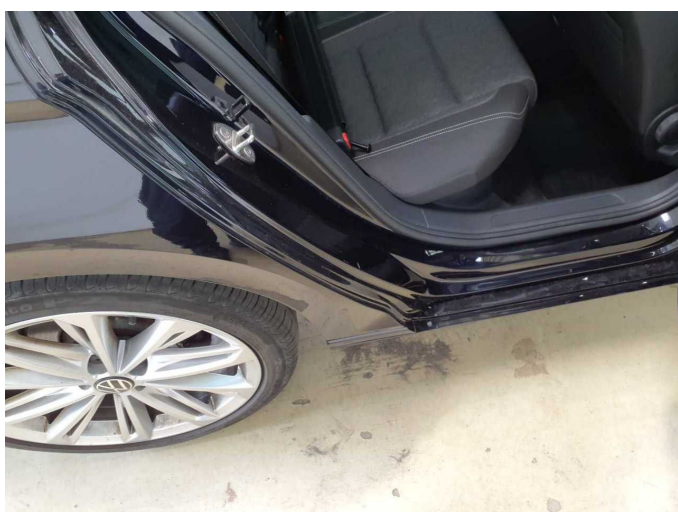
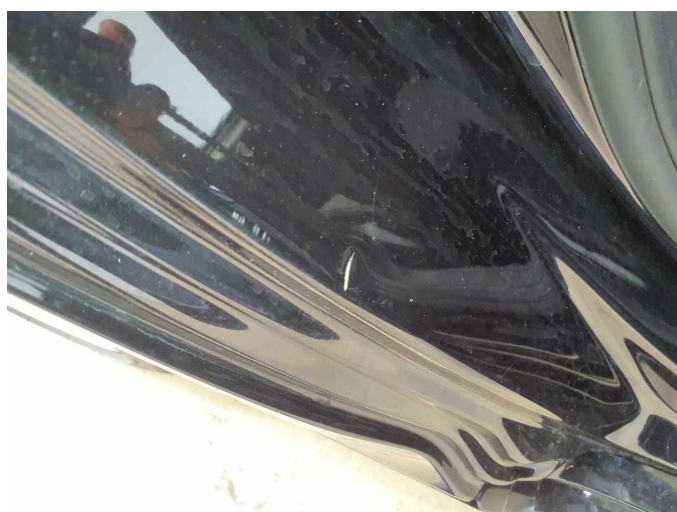
| No. | Component group | Description |
|---|---|---|
| 3 | Side panel - rear right side | Sill - Dent / paintcoat damage - Smart repair |

**Damage 3:** Side panel - rear right side: Sill - Dent / paintcoat damage - Smart repair

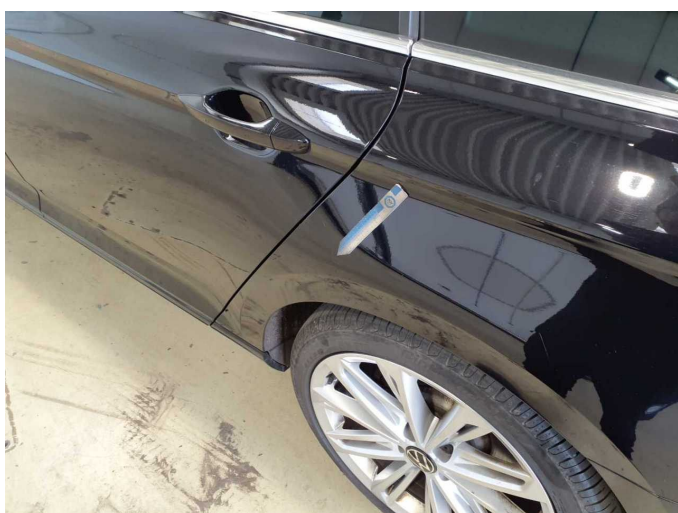
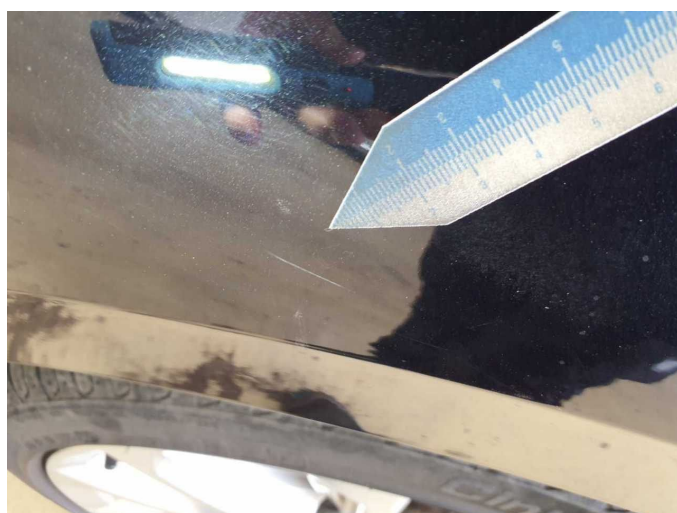
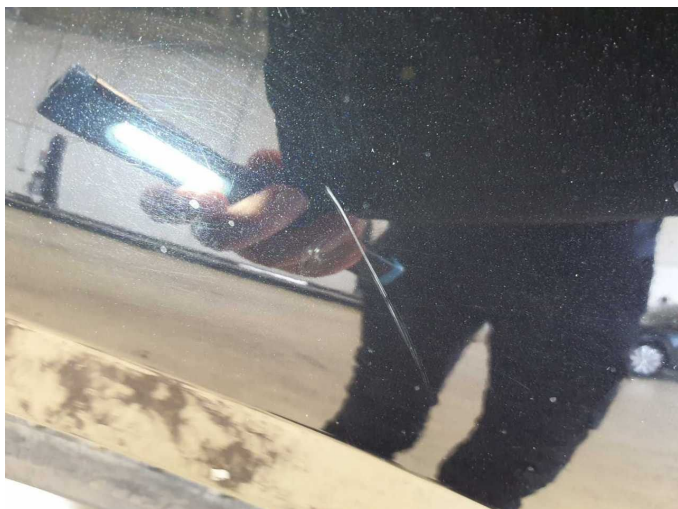
| No. | Component group | Description |
|---|---|---|
| 4 | Side panel - rear left side | Side panel - Scratch(es) - Smart repair |

**Damage 4:** Side panel - rear left side: Side panel - Scratch(es) - Smart repair

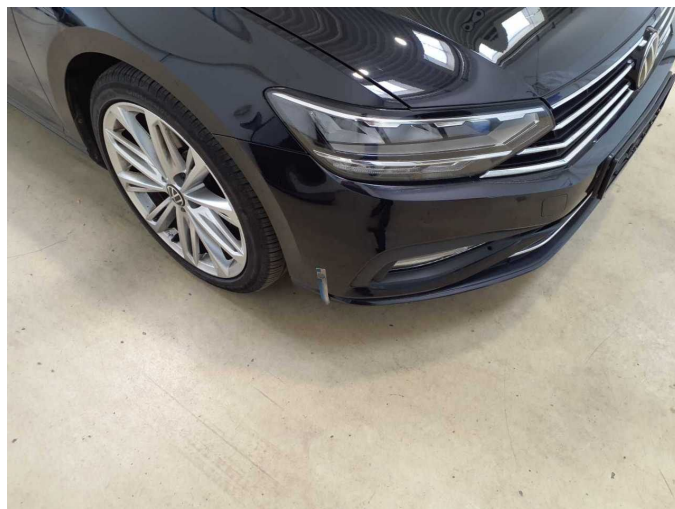
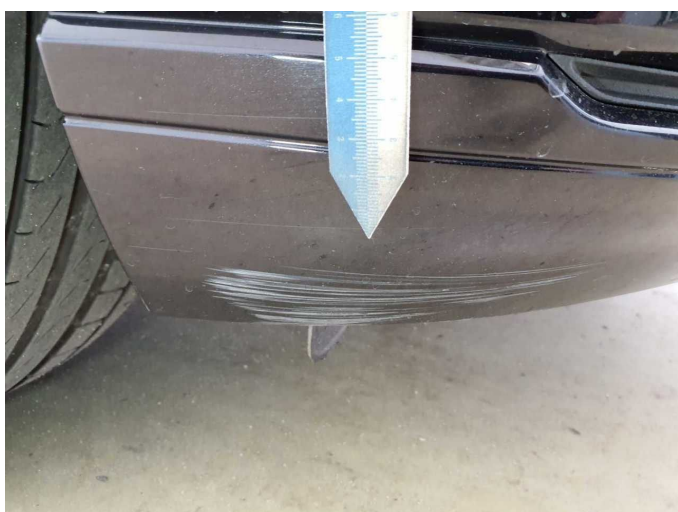
| No. | Component group | Description |
|---|---|---|
| 5 | Front bumper | Front bumper - Scratch(es) - Smart repair |

**Damage 5:** Front bumper: Front bumper - Scratch(es) - Smart repair

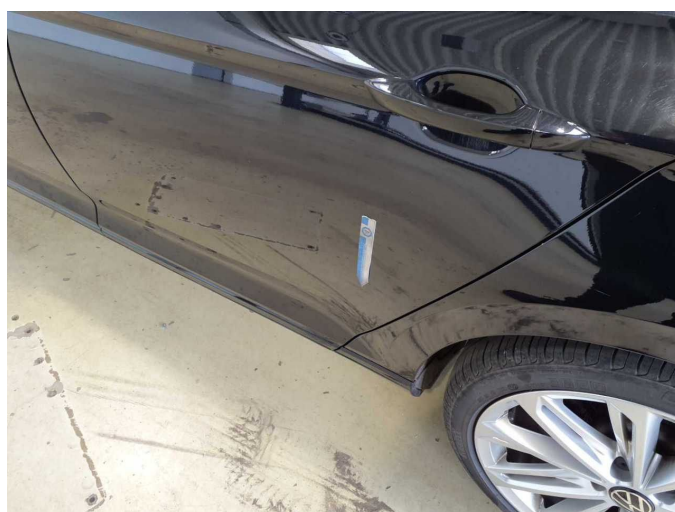
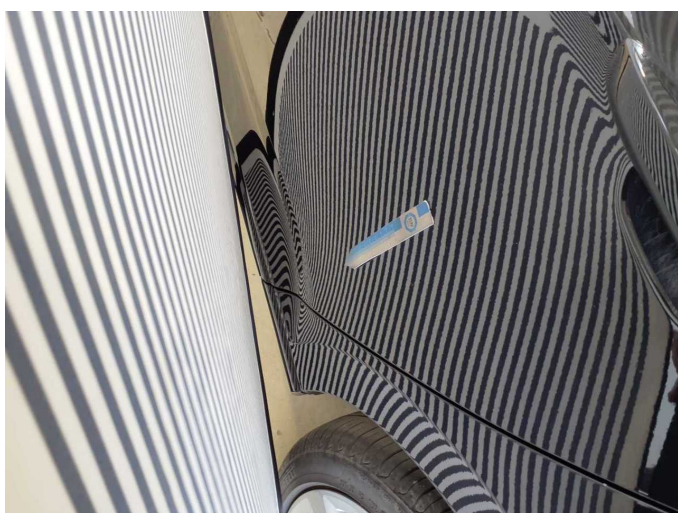
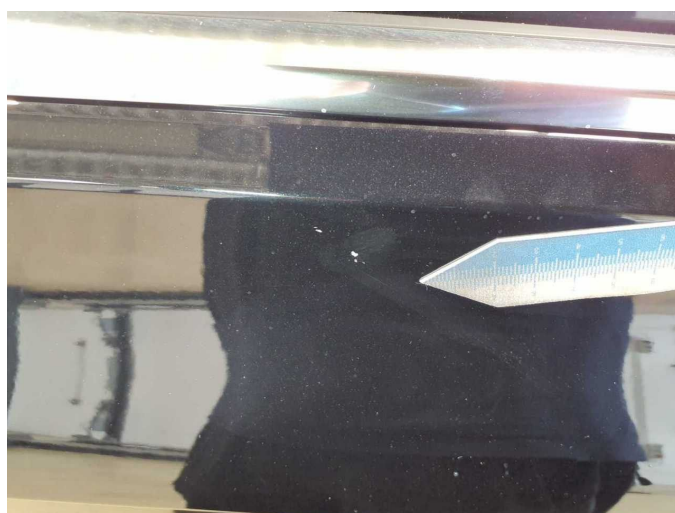
| No. | Component group | Description |
|---|---|---|
| 6 | Door - rear left side | Door - Dent / paintcoat damage - Smart repair |

**Damage 6:** Door - rear left side: Door - Dent / paintcoat damage - Smart repair

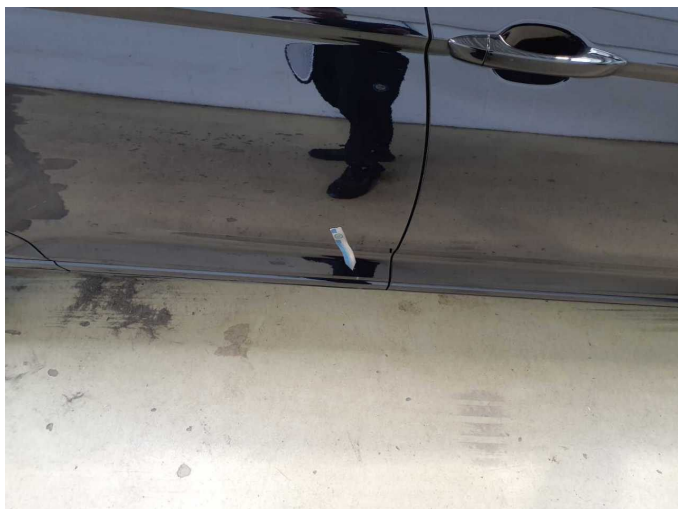
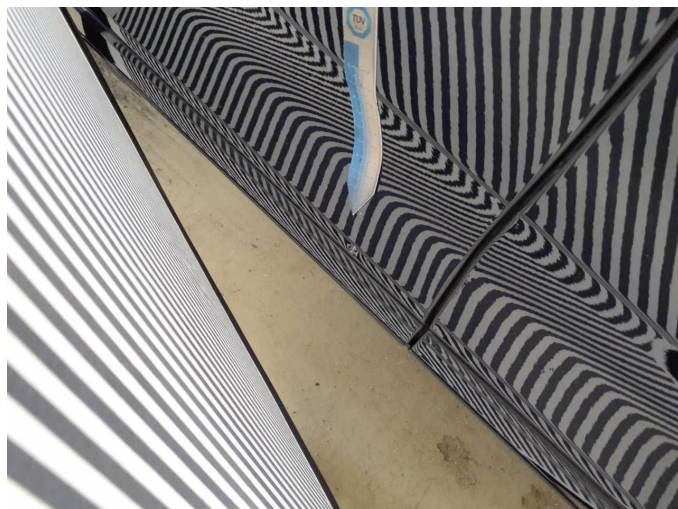
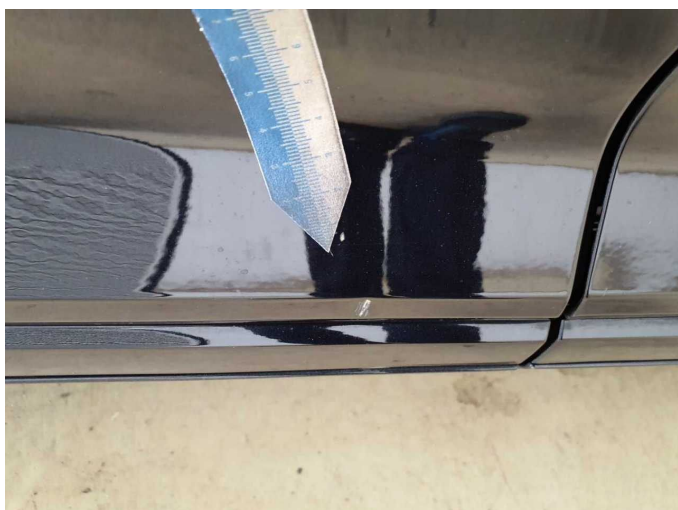
| No. | Component group | Description |
|---|---|---|
| 7 | Door - rear right side | Door - Dent / paintcoat damage - Smart repair |

**Damage 7:** Door - rear right side: Door - Dent / paintcoat damage - Smart repair

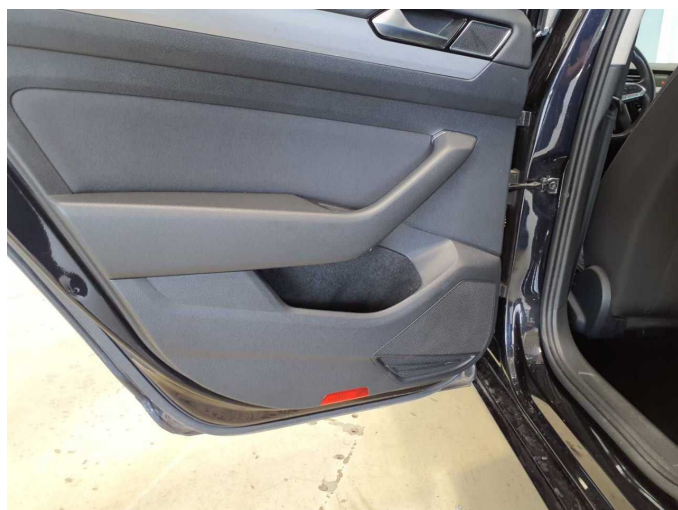
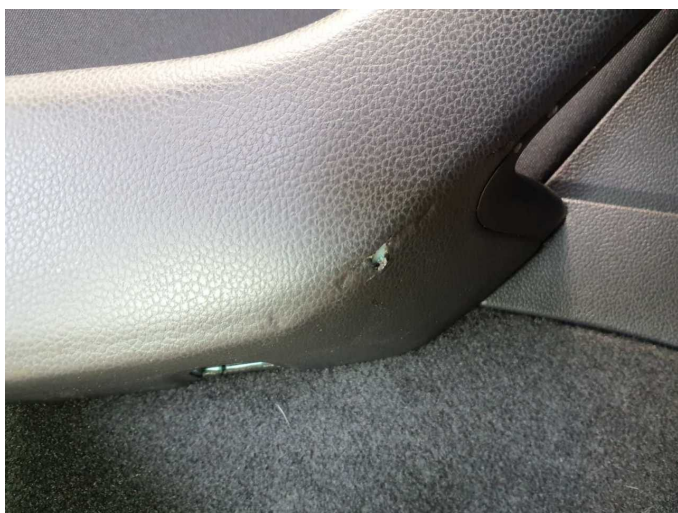
| No. | Component group | Description |
|---|---|---|
| 8 | Trim / covers | Door trim - rear left side - Broken / torn - Smart repair |

**Damage 8:** Trim / covers: Door trim - rear left side - Broken / torn - Smart repair

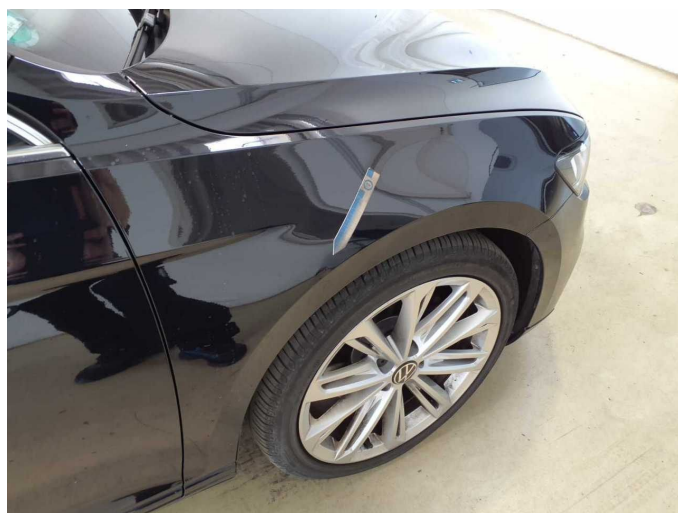
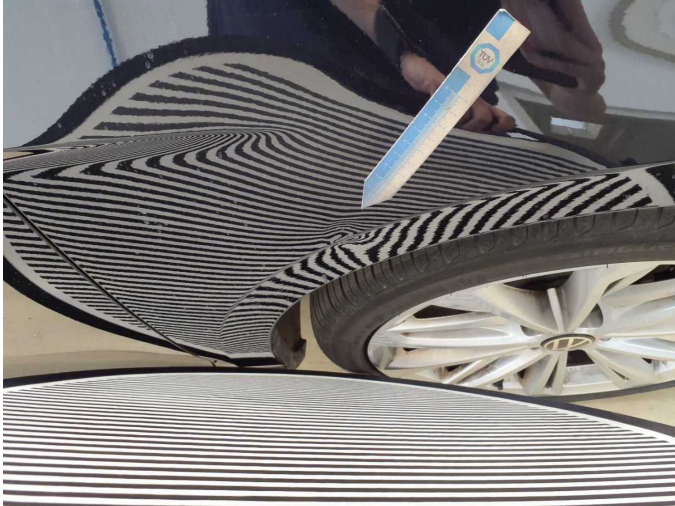
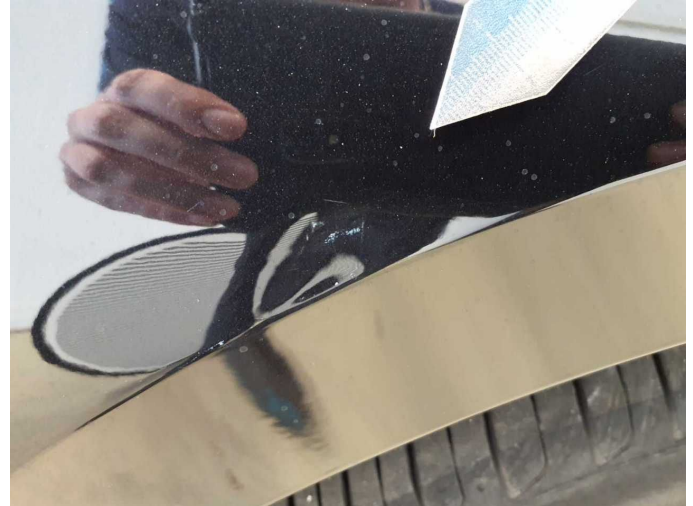
| No. | Component group | Description |
|---|---|---|
| 9 | Mudguard - right side | Mudguard - right side - Dent / paintcoat damage - Smart repair |

**Damage 9:** Mudguard - right side: Mudguard - right side - Dent / paintcoat damage - Smart repair

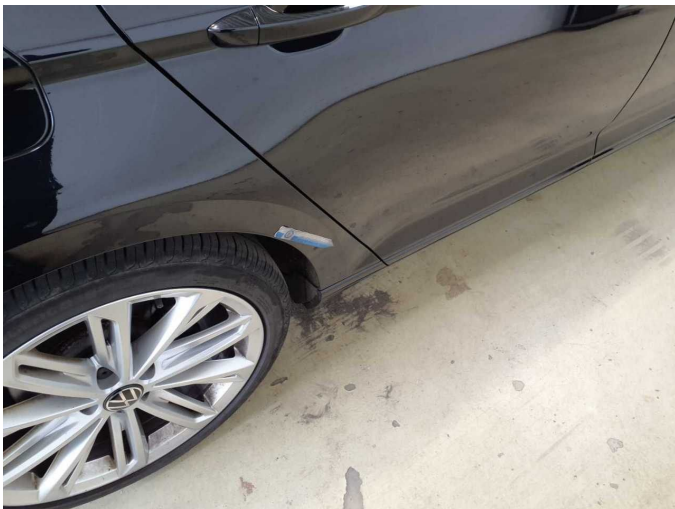
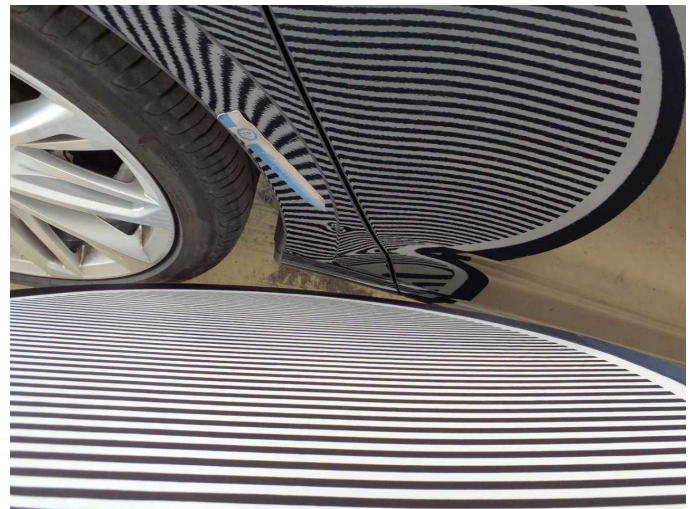
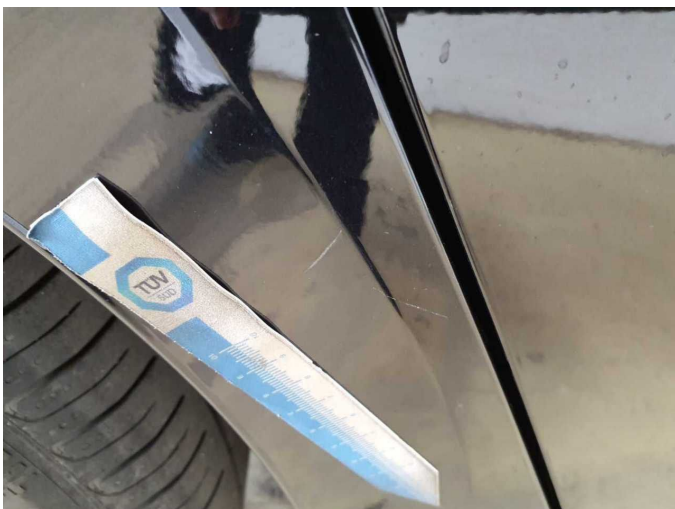
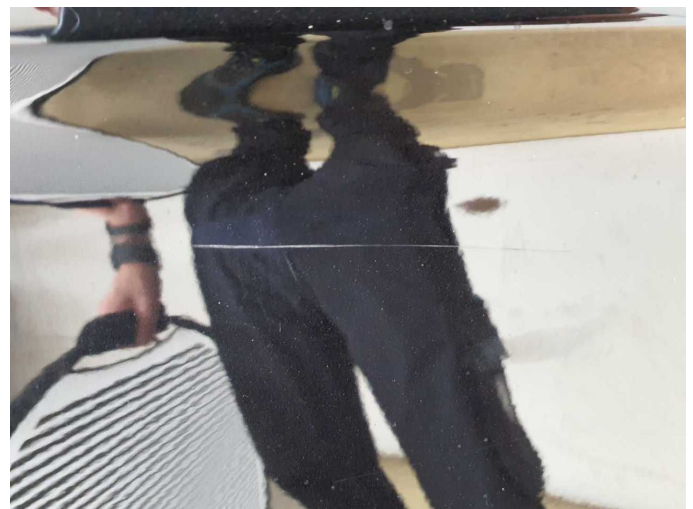
| No. | Component group | Description |
|---|---|---|
| 10 | Side panel - rear right side | Elbow - Dent / paintcoat damage - Smart repair |

**Damage 10:** Side panel - rear right side: Elbow - Dent / paintcoat damage - Smart repair

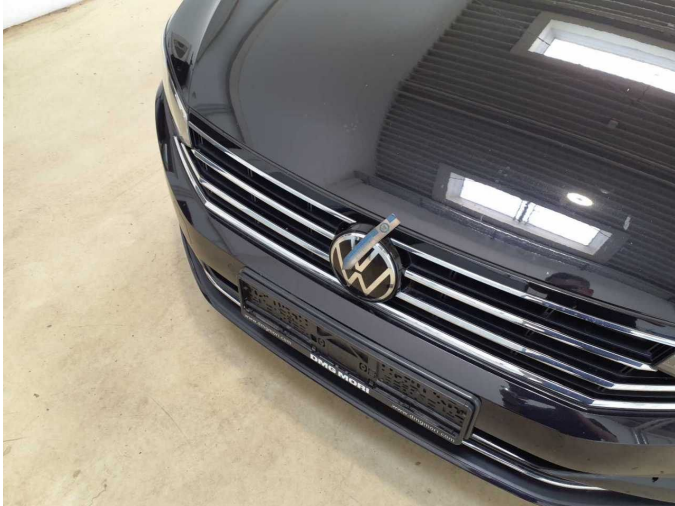
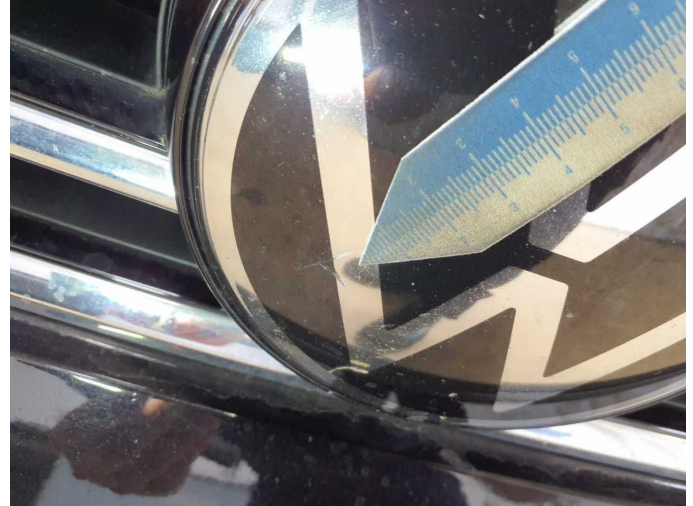
| No. | Component group | Description |
|---|---|---|
| 11 | Front structure | Emblem - Broken / torn - Replace |

**Damage 11:** Front structure: Emblem - Broken / torn - Replace

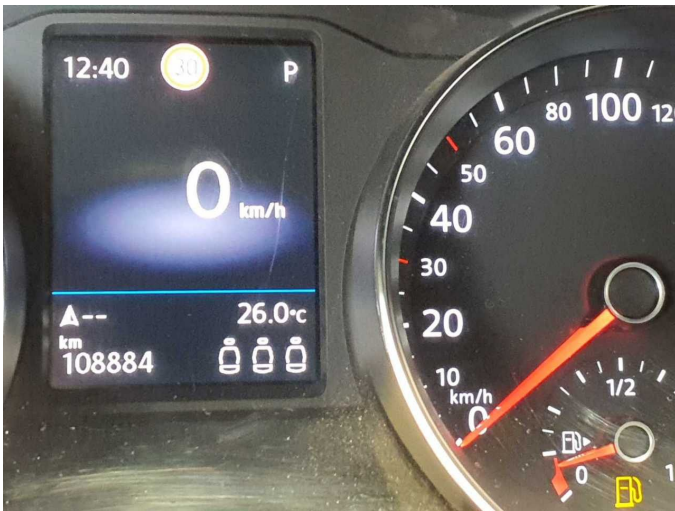
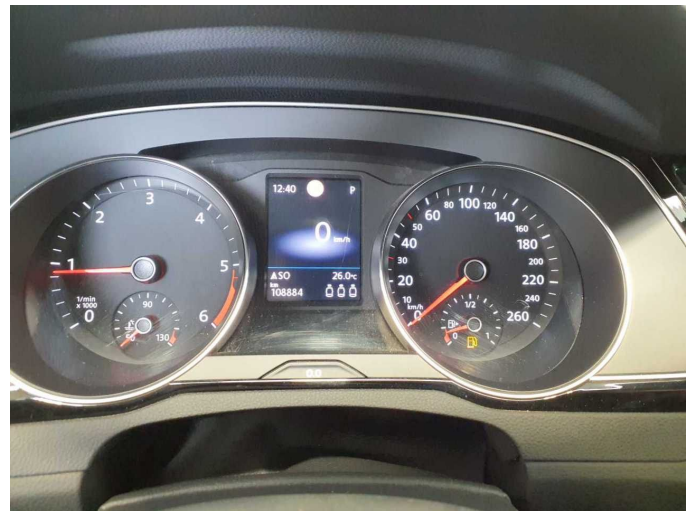
| No. | Component group | Description |
|---|---|---|
| 12 | Instrument panel | Instrument cluster - Scratch(es) - Loss in value |

**Damage 12:** Instrument panel: Instrument cluster - Scratch(es) - Loss in value

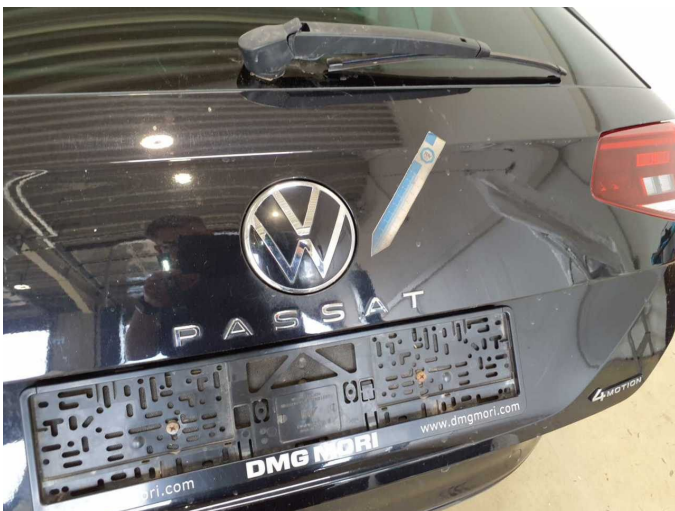
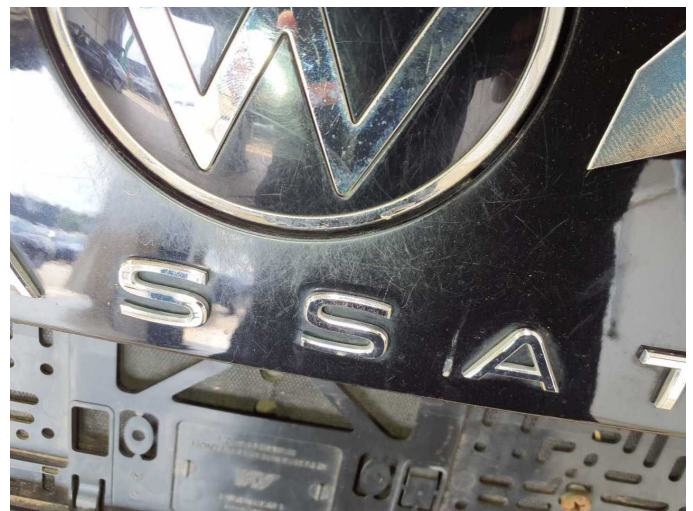
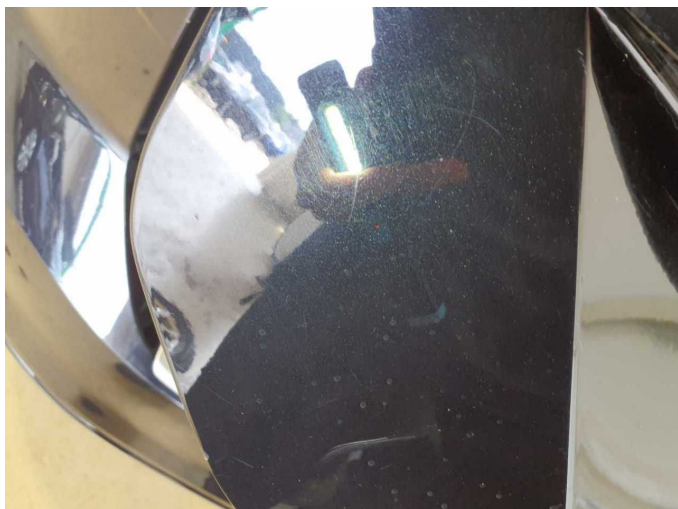
| No. | Component group | Description |
|---|---|---|
| 13 | Boot lid / rear door | Boot lid - Scratch(es) - Paint |

**Damage 13:** Boot lid / rear door: Boot lid - Scratch(es) - Paint

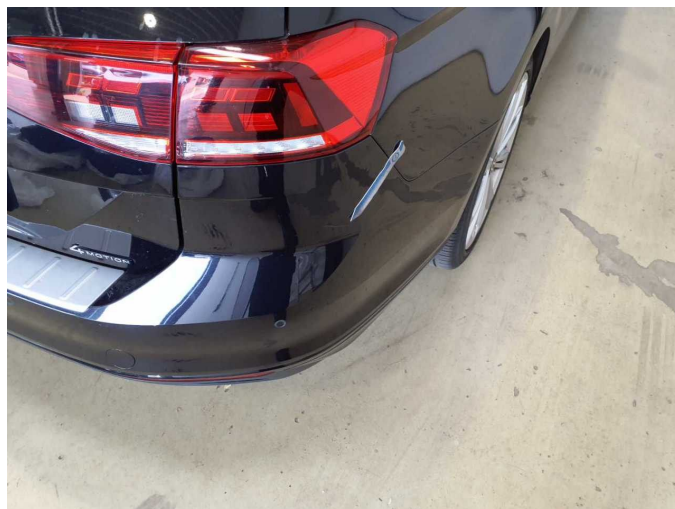
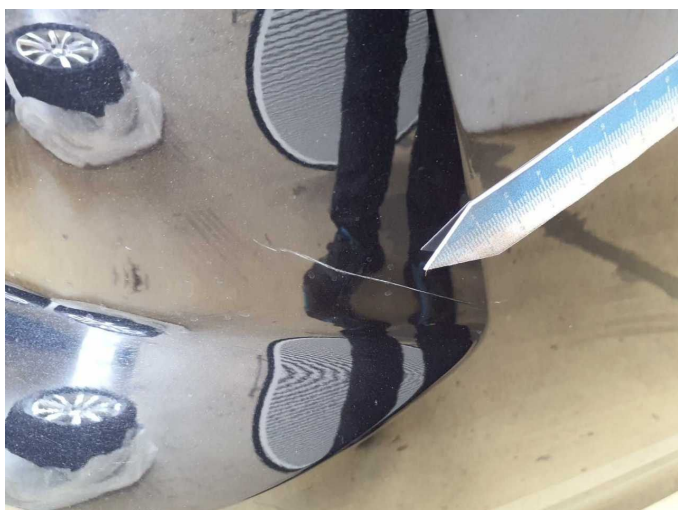
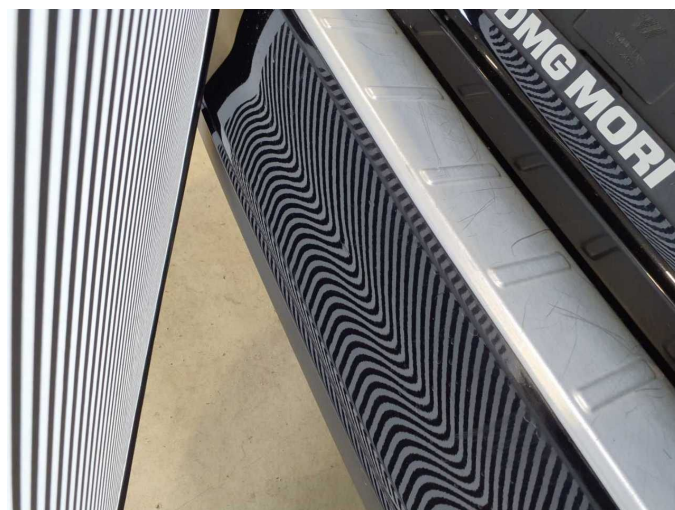
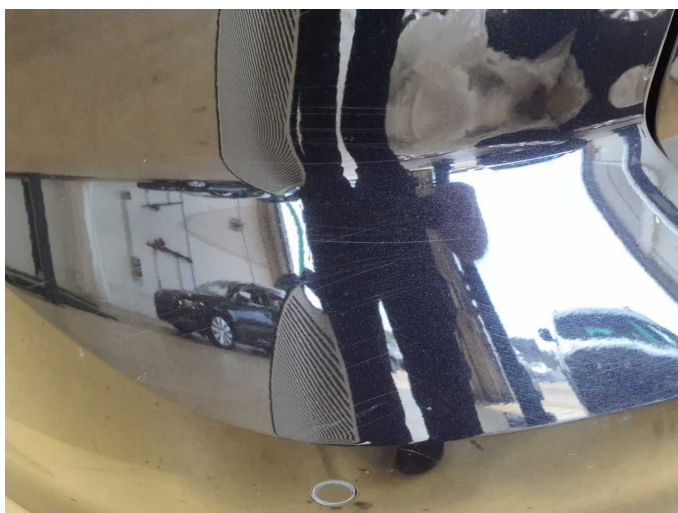
| No. | Component group | Description |
|---|---|---|
| 14 | Rear bumper | Rear bumper - Dent / paintcoat damage - Repair and paint |

**Damage 14:** Rear bumper: Rear bumper - Dent / paintcoat damage - Repair and paint

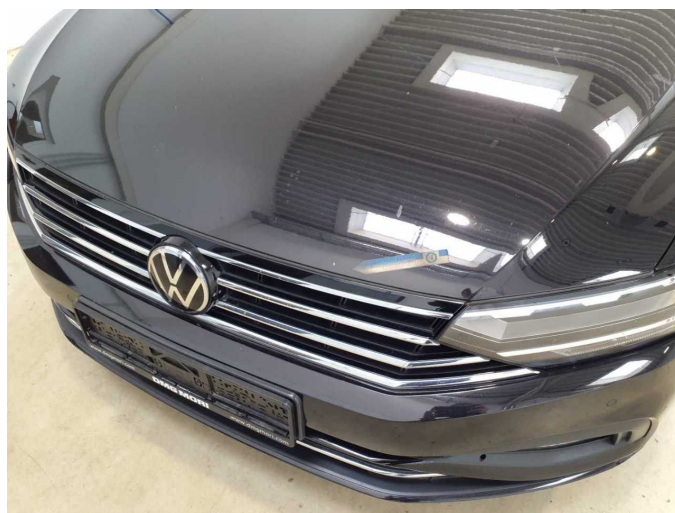
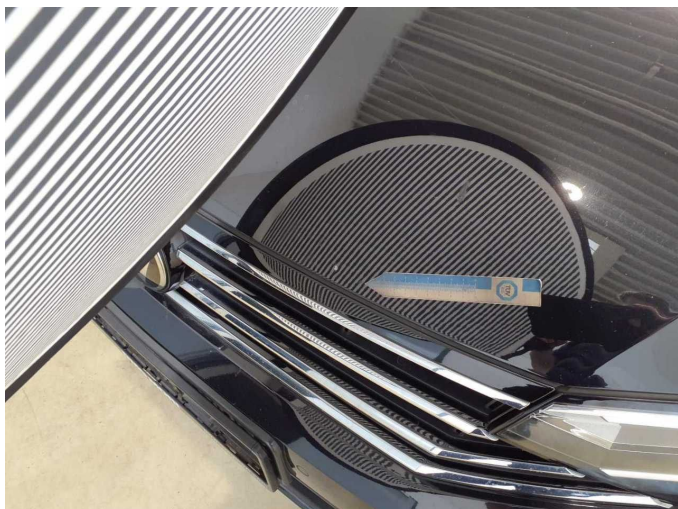
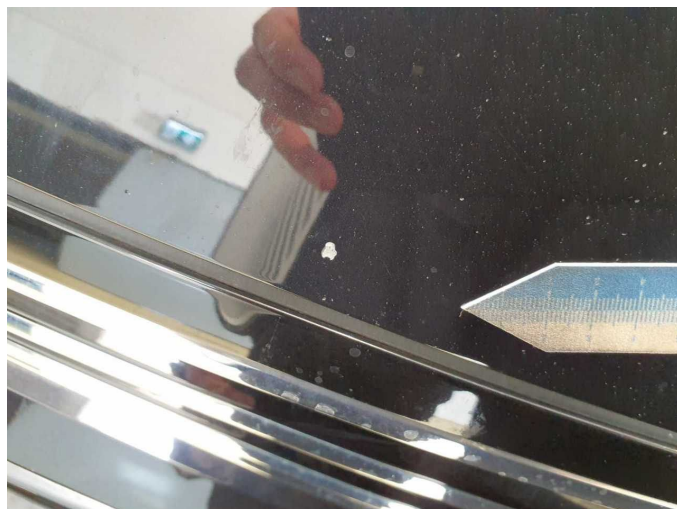
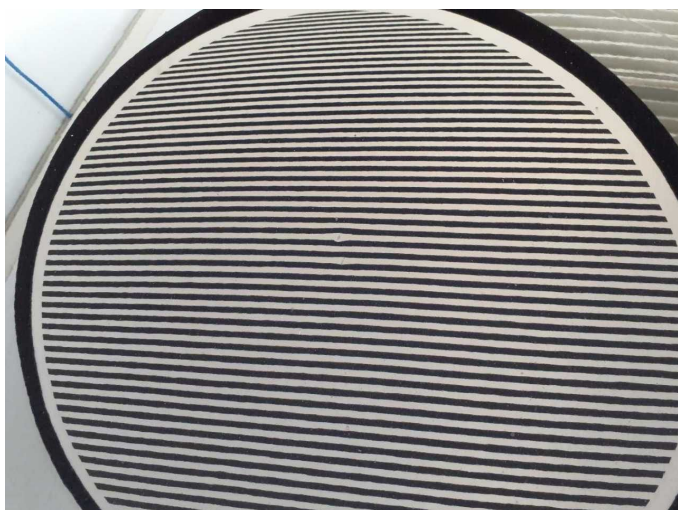
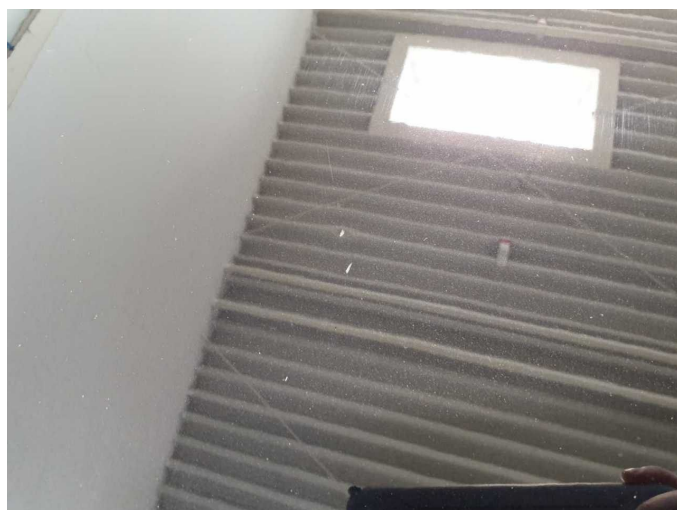
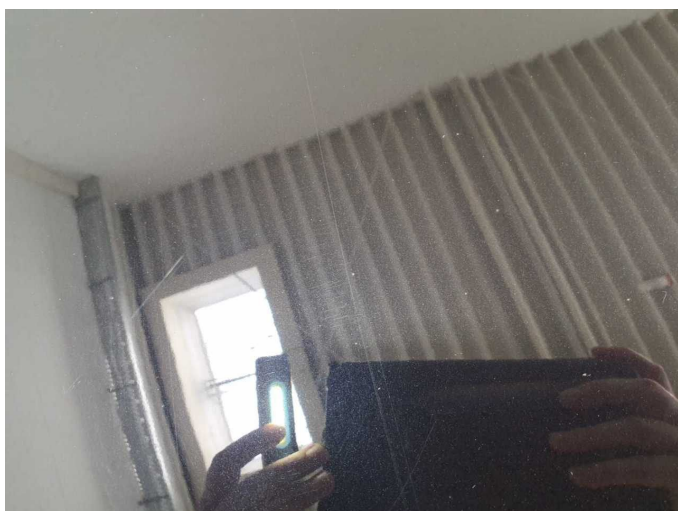
| No. | Component group | Description |
|---|---|---|
| 15 | Bonnet | Bonnet - Dent / paintcoat damage - Repair and paint |

**Damage 15:** Bonnet: Bonnet - Dent / paintcoat damage - Repair and paint

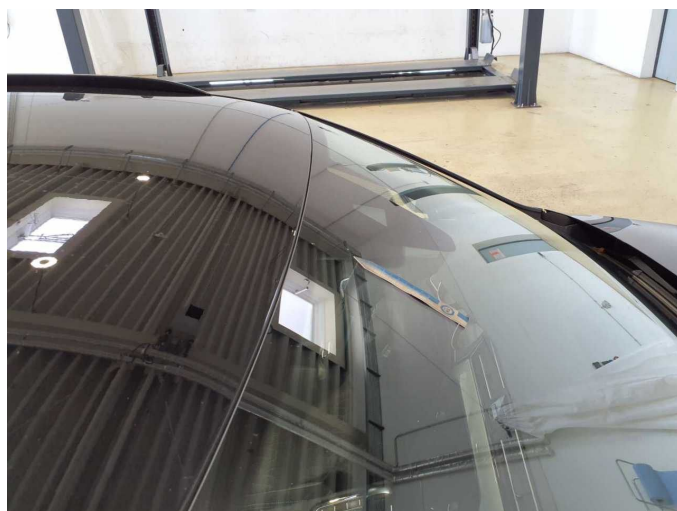
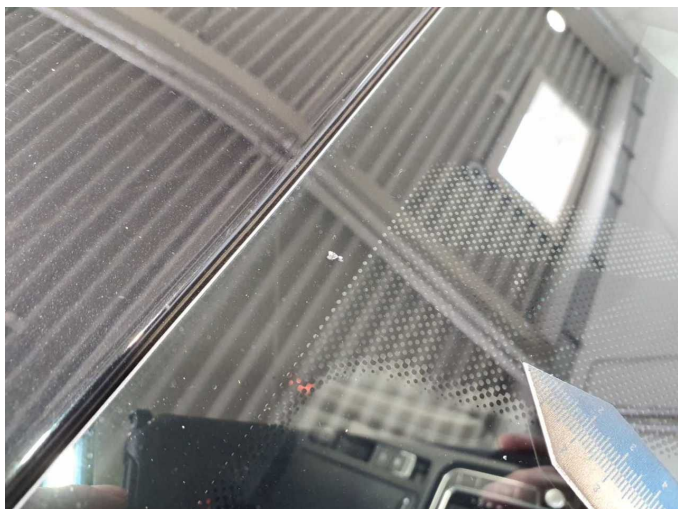
| No. | Component group | Description |
|---|---|---|
| 16 | Vehicle glazing | Windscreen (Randbereich) - Stone chips - repair according to calculation |

**Damage 16:** Vehicle glazing: Windscreen (Randbereich) - Stone chips - repair according to calculation

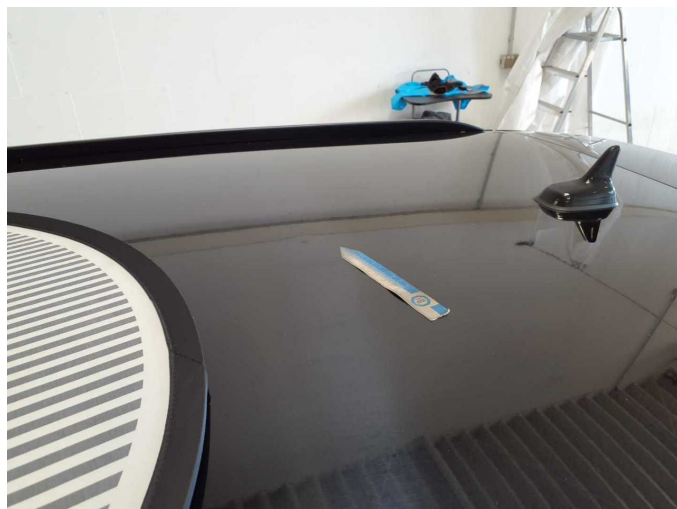
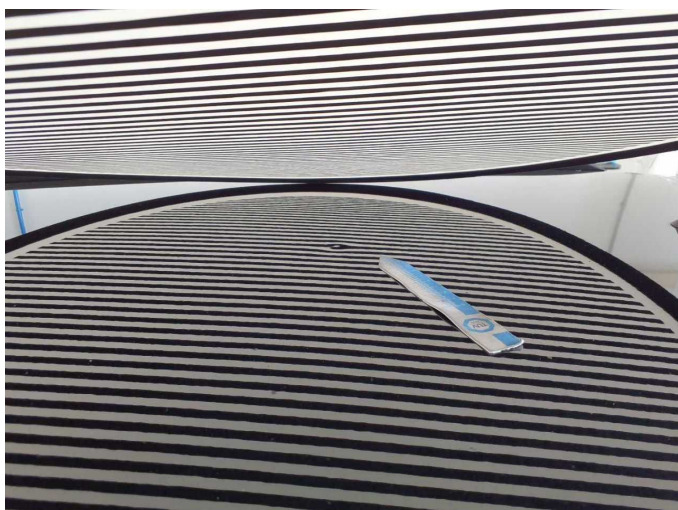
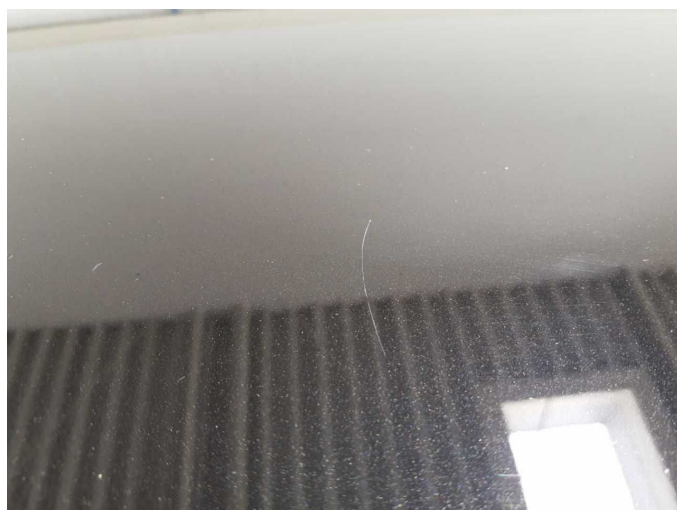
| No. | Component group | Description |
|---|---|---|
| 17 | Roof | Roof - Dent / paintcoat damage - Repair and paint |

**Damage 17:** Roof: Roof - Dent / paintcoat damage - Repair and paint

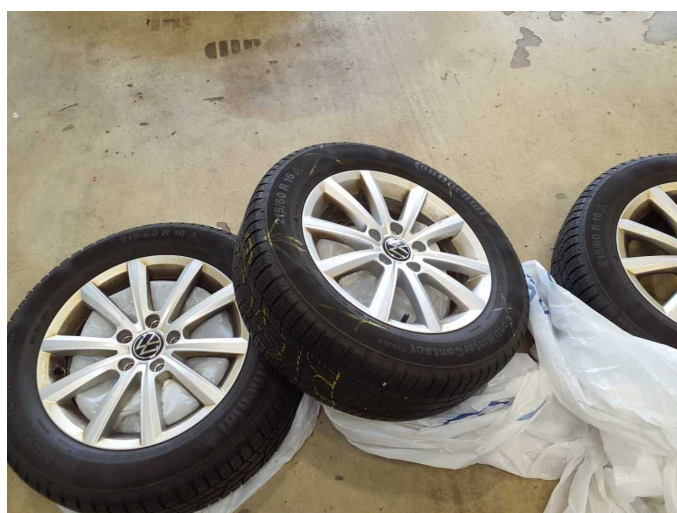
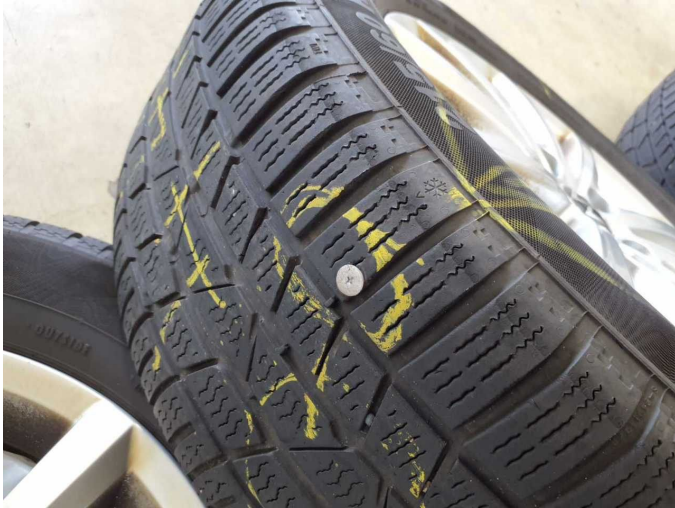
| No. | Component group | Description |
|---|---|---|
| 4 | 2nd wheel set | 1 tyre - Damaged - No deduction |

**Wear and tear 4:** 2nd wheel set: 1 tyre - Damaged - No deduction

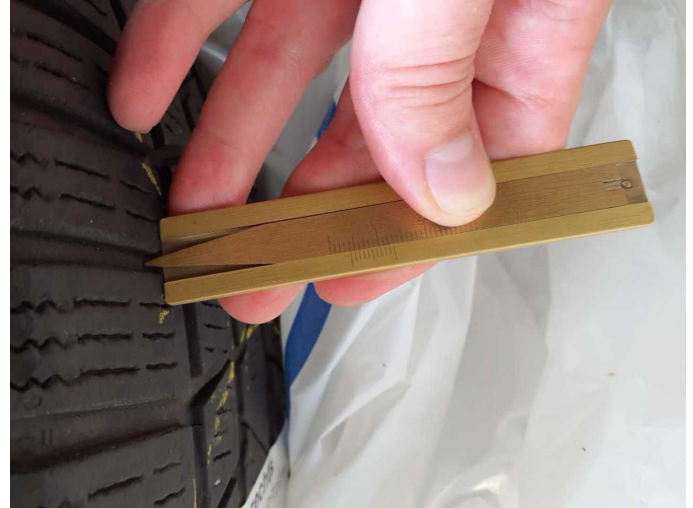
| No. | Component group | Description |
|---|---|---|
| 5 | 2nd wheel set | 1 tyre - does not meet manufacturer specifications - No deduction |

**Wear and tear 5:** 2nd wheel set: 1 tyre - does not meet manufacturer specifications - No deduction
