Expertise

Protocol number: 46132388  
Order No. / Reference: 26430505  
Inspection date: 19 Jun 2026

Manufacturer: Volkswagen

Model: Passat Variant 1.4 TSI Plug-In-Hybrid DSG GTE

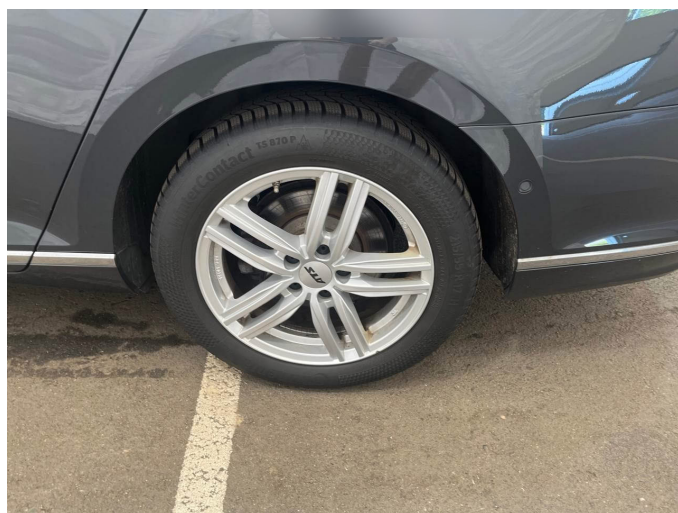
Figure 12: Mounted tyres

| Tyres | | | | |
|---|---|---|---|---|
| 1) | 215/55 R17 94H | Winter tyres on Light alloy | Continental | 6mm / 6mm |
| 2) | 215/55 R17 94H | Winter tyres on Light alloy | Continental | 6mm / 6mm |

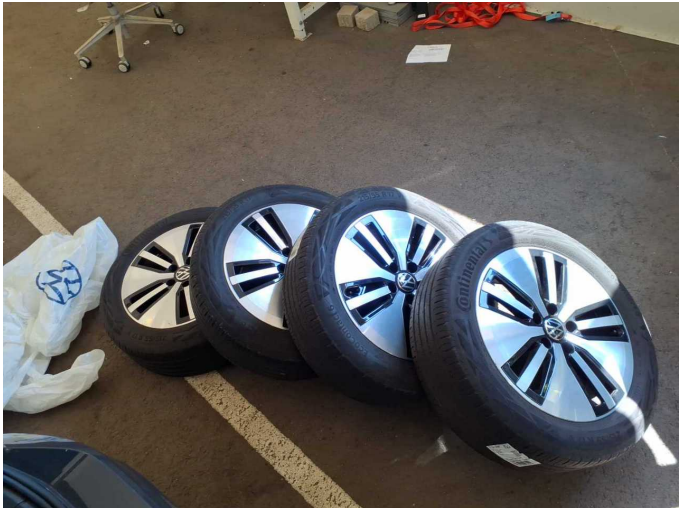
Figure 16: Additional tyres

| Tyres | | | | |
|---|---|---|---|---|
| 1) | 215/55 R17 94V | Summer tires (with run-flat tires) on Light alloy | Continental | 6mm / 6mm |
| 2) | 215/55 R17 94V | Summer tires (with run-flat tires) on Light alloy | Continental | 6mm / 6mm |

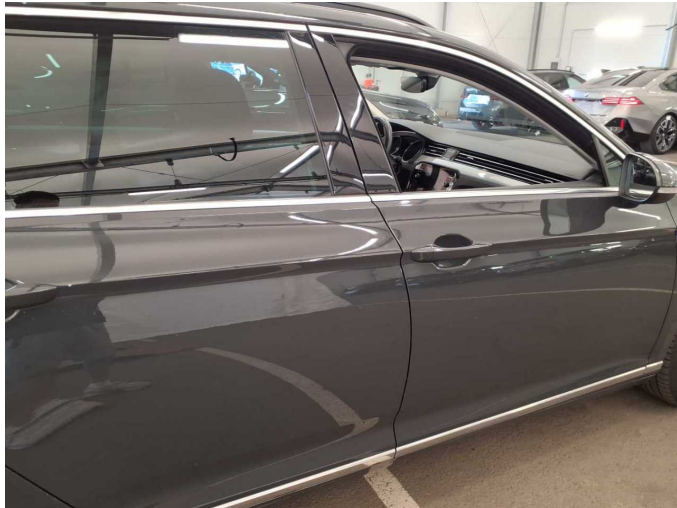
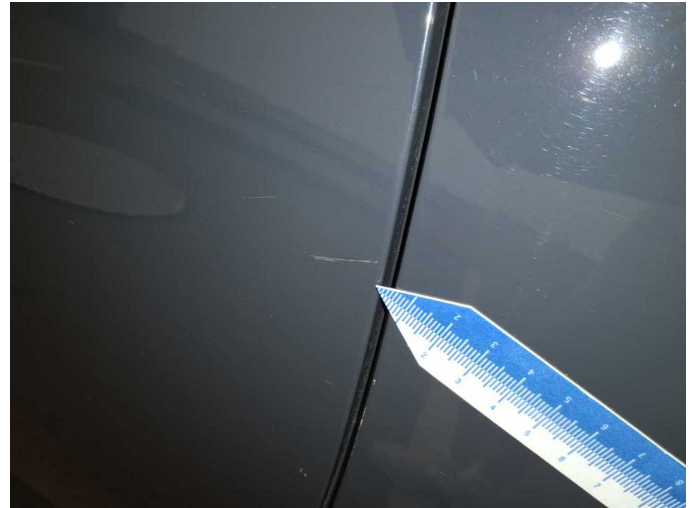
| No. | Component group | Description |
|---|---|---|
| 1 | Door - rear right side | Door - Scratch(es) - Smart repair |

**Damage 1:** Door - rear right side: Door - Scratch(es) - Smart repair

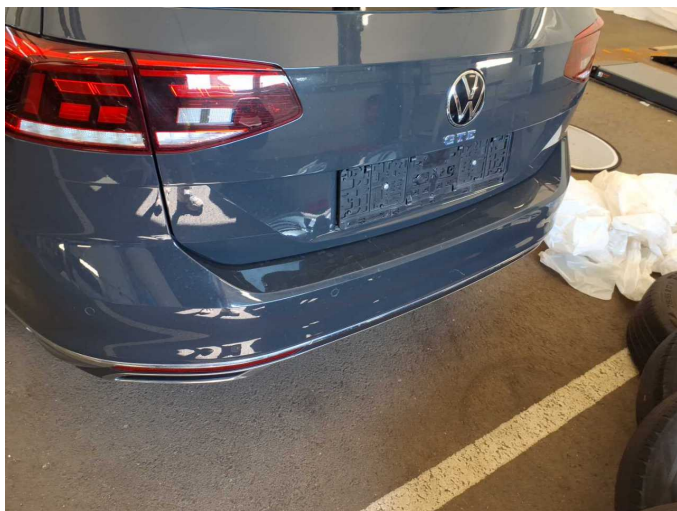
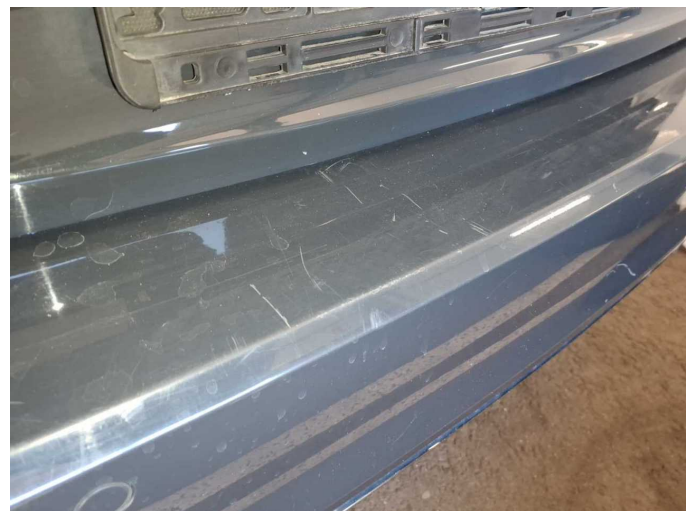
| No. | Component group | Description |
|---|---|---|
| 2 | Rear bumper | Rear bumper - Scratch(es) - Paint |

**Damage 2:** Rear bumper: Rear bumper - Scratch(es) - Paint
