Expertise

Protocol number: 46578495  
Order No. / Reference: 26685384  
Inspection date: 15 Jul 2026

Manufacturer: Volkswagen

Model: Passat Variant 2.0 TDI SCR Business

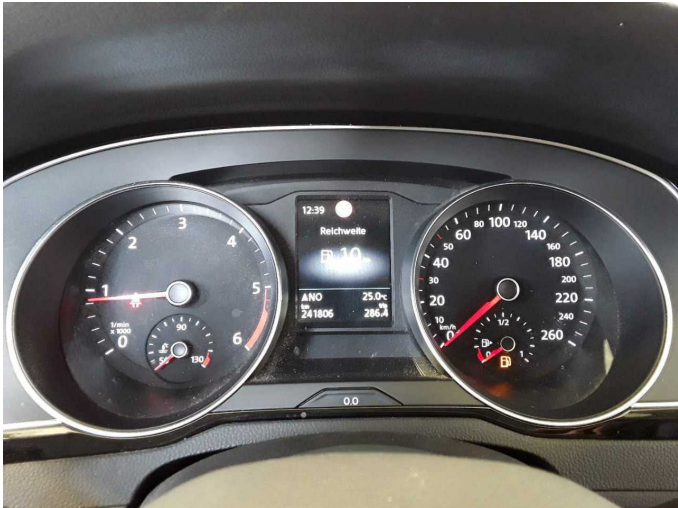
Figure 7: Instrument cluster

| Vehicle details | |
|---|---|
| Mileage (Read) | 241,806 km |

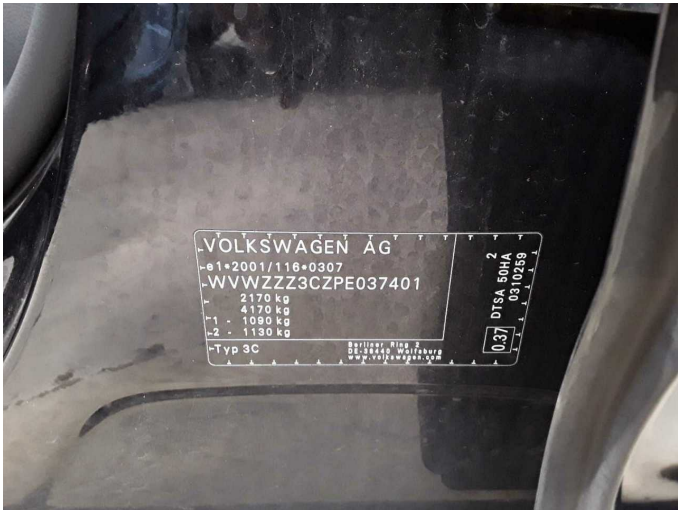
Figure 11: VIN

| VIN comparison | The vehicle identification number (VIN) was read from the vehicle and its conformity with the submitted documents was confirmed by the undersigned during the inspection. |

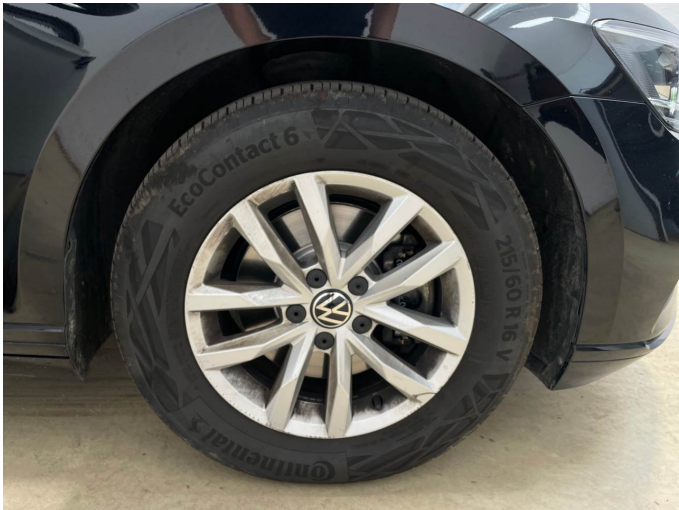
Figure 12: Mounted tyres

| # | Tyre size | Type of tyre | Manufacturer | Tread depth |
|---|---|---|---|---|
| 1) | 215/60 R16 95V | Summer tyres on Light alloy | Continental | 5mm / 5mm |
| 2) | 215/60 R16 95V | Summer tyres on Light alloy | Continental | 5mm / 5mm |

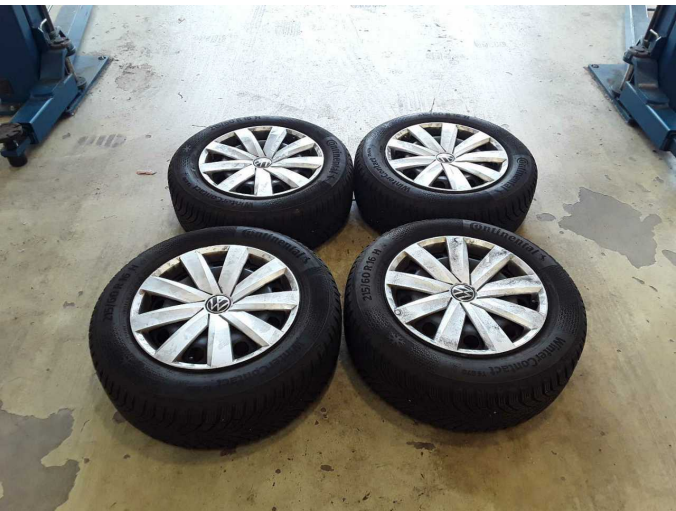
Figure 16: Additional tyres

| # | Tyre size | Type of tyre | Manufacturer | Tread depth |
|---|---|---|---|---|
| 1) | 215/60 R16 95H | Winter tires (with run-flat tires) on Steel rim with wheel cover | Continental | 5mm / 5mm |
| 2) | 215/60 R16 95H | Winter tires (with run-flat tires) on Steel rim with wheel cover | Continental | 7mm / 7mm |

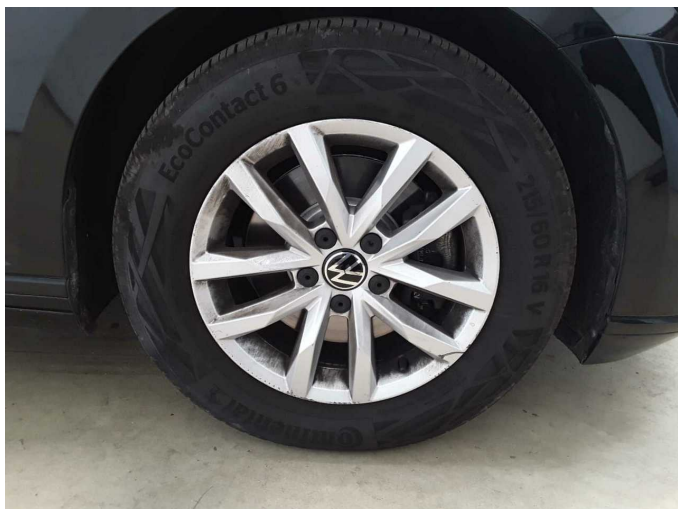
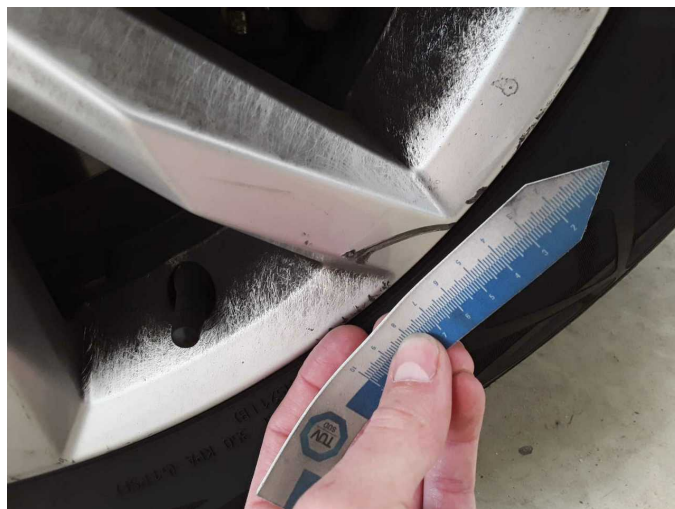
**Damage 1:** Wheel / tyres: Alloy rim - front right side - Scratch(es) - Loss in value

| No. | Component group | Description |
|---|---|---|
| 1 | Wheel / tyres | Alloy rim - front right side - Scratch(es) - Loss in value |

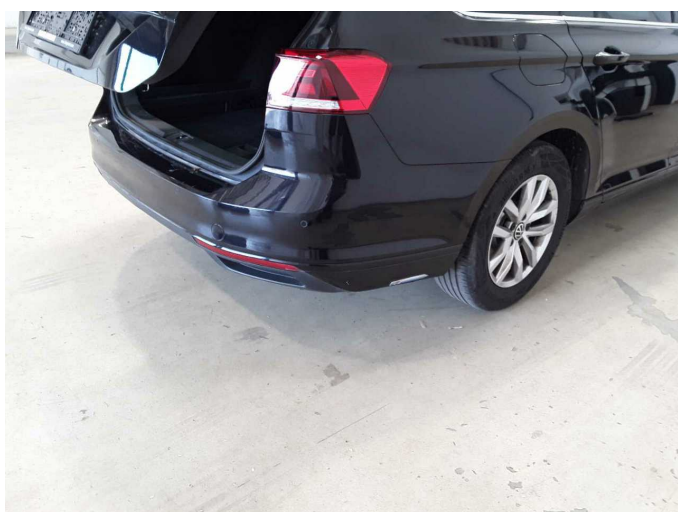
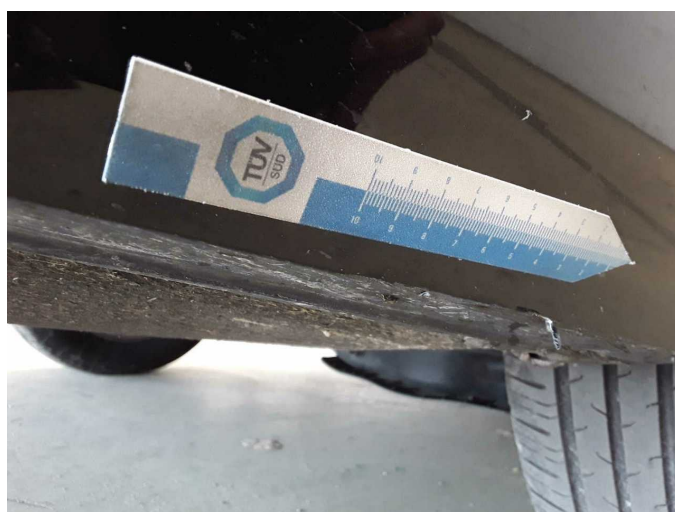
**Damage 2:** Rear bumper: Rear bumper - Scratch(es) - Smart repair

| No. | Component group | Description |
|---|---|---|
| 2 | Rear bumper | Rear bumper - Scratch(es) - Smart repair |

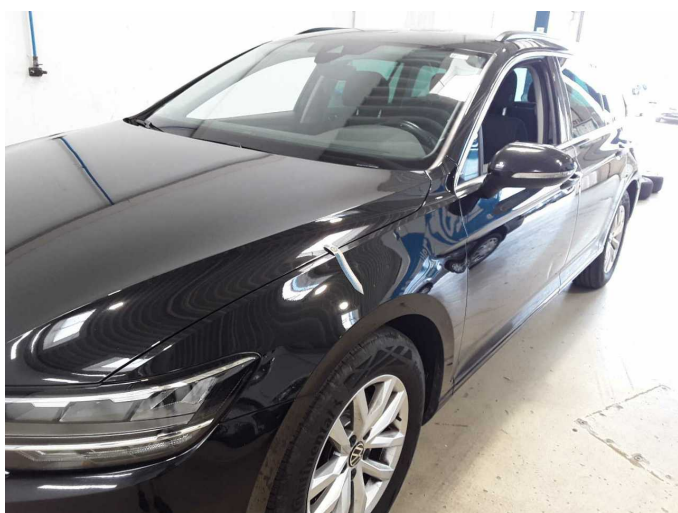
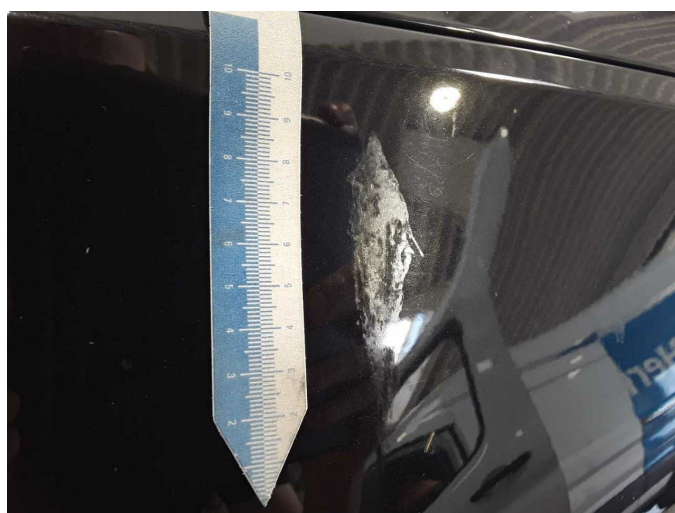
**Damage 3:** Mudguard - left side: Mudguard - left side - Paint defect - Repair and paint

| No. | Component group | Description |
|---|---|---|
| 3 | Mudguard - left side | Mudguard - left side - Paint defect - Repair and paint |

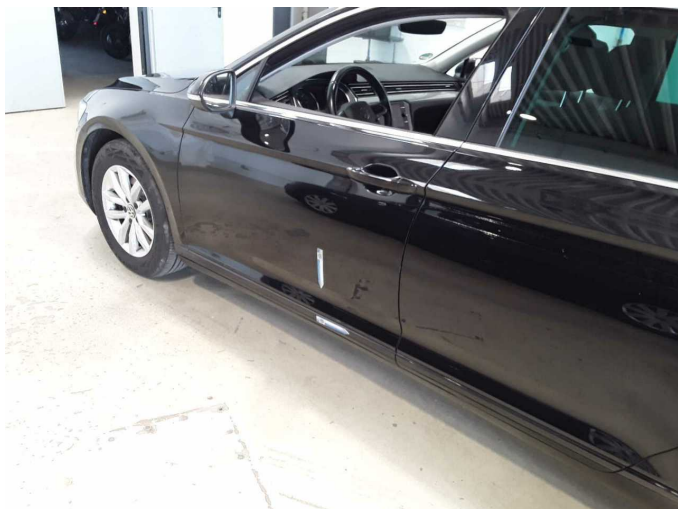
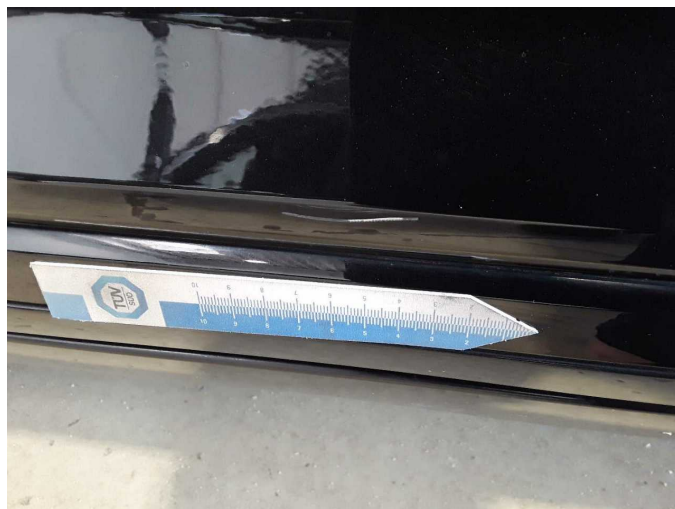
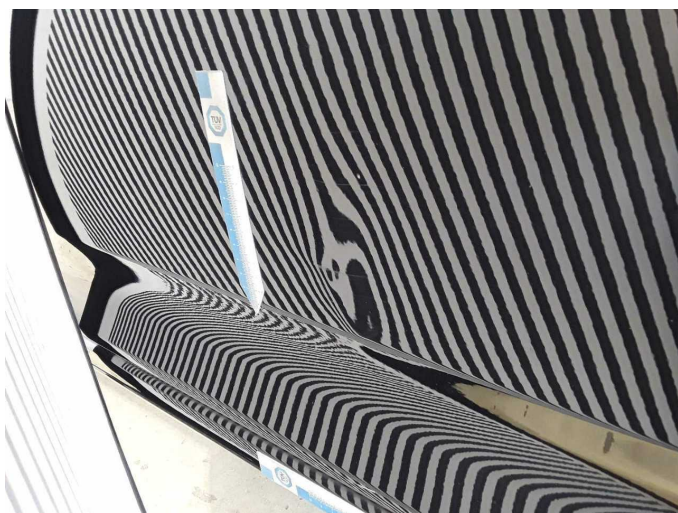
**Damage 4:** Door - front left side: Door - Dent / paintcoat damage - Repair and paint

| No. | Component group | Description |
|---|---|---|
| 4 | Door - front left side | Door - Dent / paintcoat damage - Repair and paint |

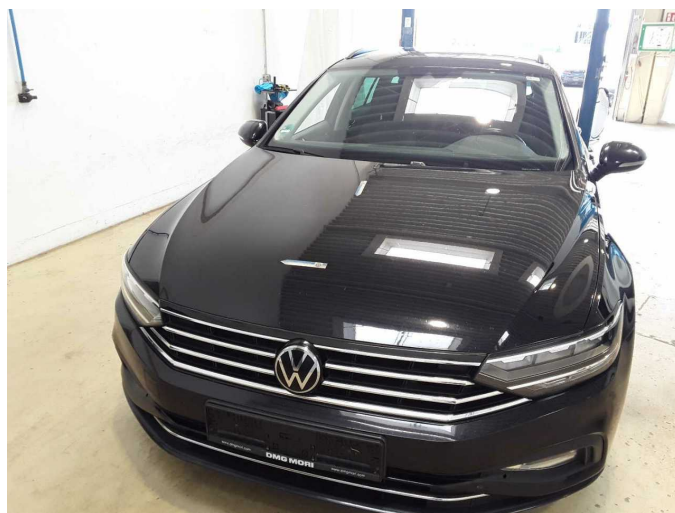
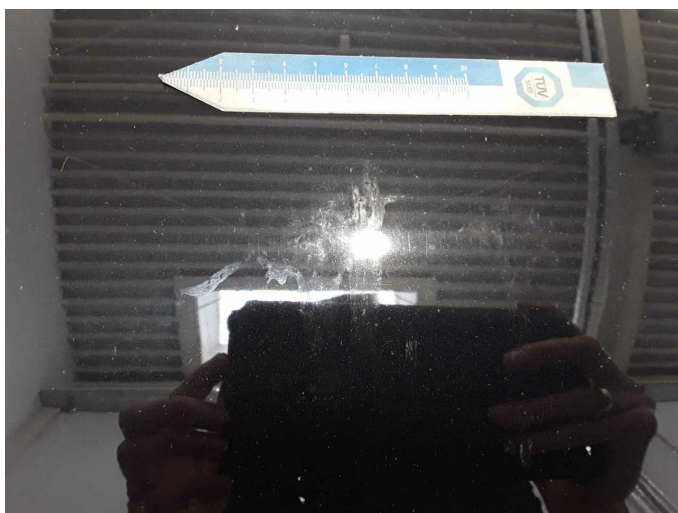
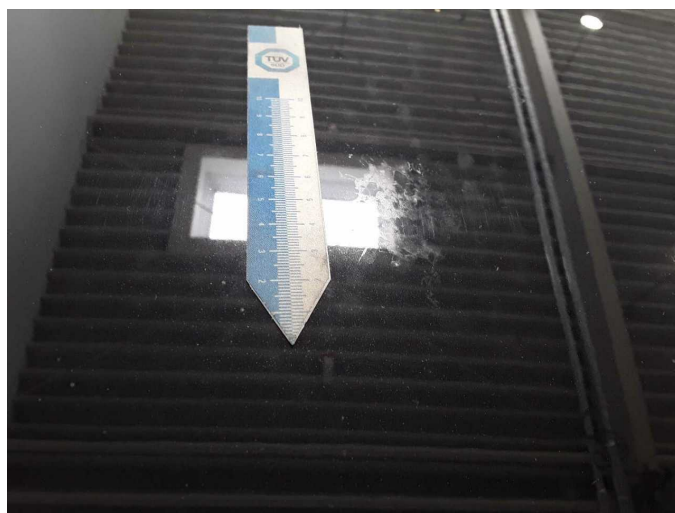
**Damage 5:** Bonnet: Bonnet - Paint defect - Repair and paint

| No. | Component group | Description |
|---|---|---|
| 5 | Bonnet | Bonnet - Paint defect - Repair and paint |
