Expertise

Protocol number: 46355924  
Order No. / Reference: 26610925  
Inspection date: 6 Jul 2026

Manufacturer: Audi  
VIN: WAUZZZGY1PA114247

Model: A3 35 TDI Sportback S tronic

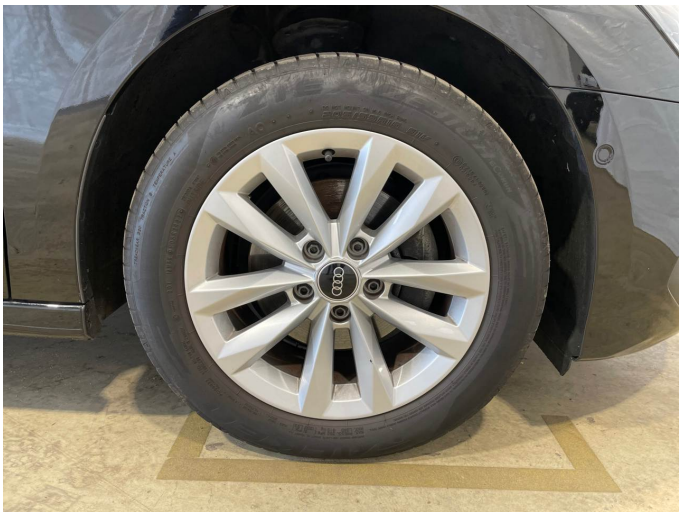
Figure 12: Mounted tyres

| # | Tyre size | Type of tyre | Manufacturer | Tread depth |
|---|---|---|---|---|
| 1) | 205/55 R16 91V | Summer tyres on Light alloy | Falken | 4mm / 4mm |
| 2) | 205/55 R16 91V | Summer tyres on Light alloy | Falken | 5mm / 5mm |

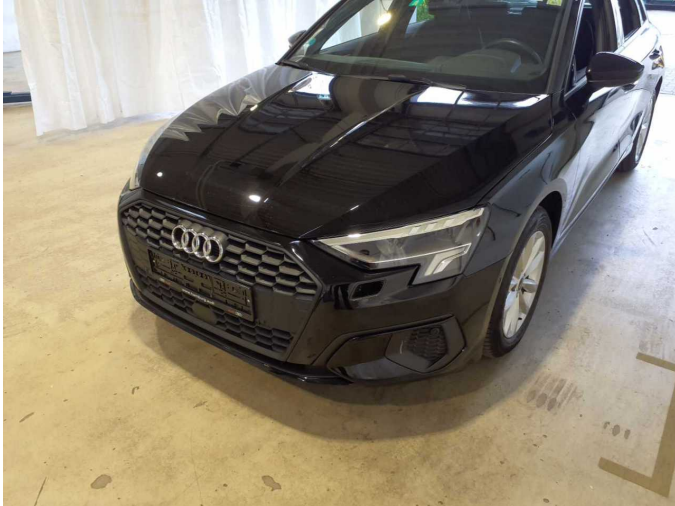
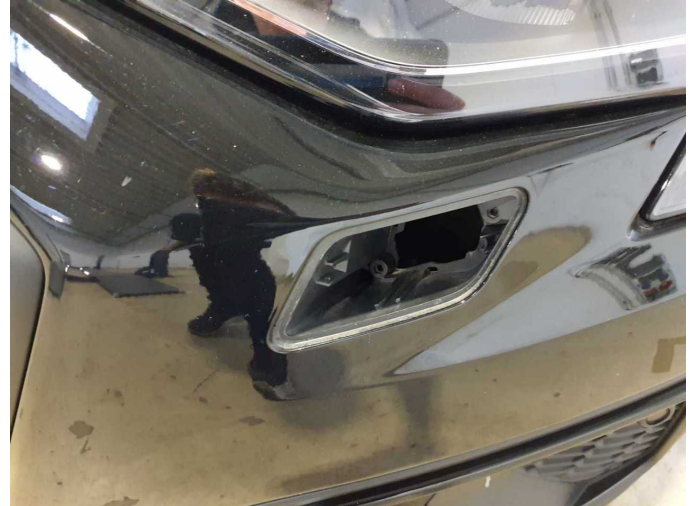
**Damage 1:** Headlight: Headlight cleaning nozzle - left side (Waschwasserdüse) - Missing - Replace

| No. | Component group | Description |
|---|---|---|
| 1 | Headlight | Headlight cleaning nozzle - left side (Waschwasserdüse) - Missing - Replace |

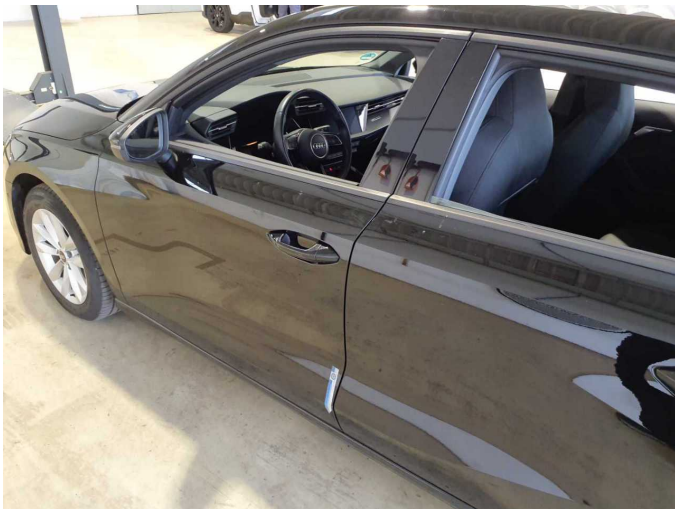
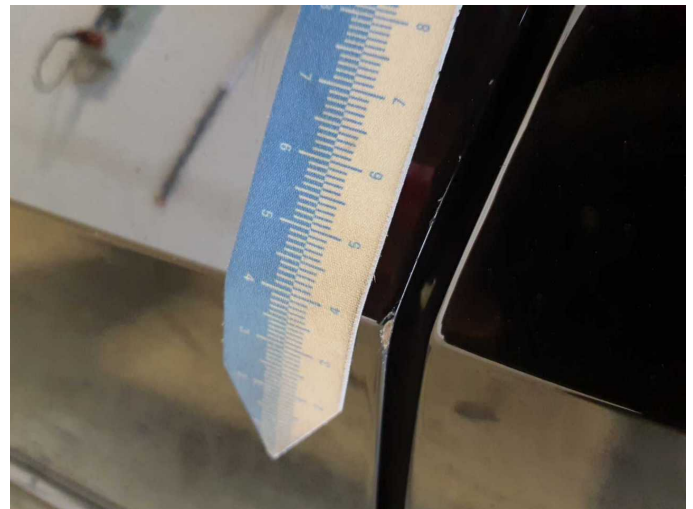
**Damage 2:** Door - front left side: Door edge - Scratch(es) - Smart repair

| No. | Component group | Description |
|---|---|---|
| 2 | Door - front left side | Door edge - Scratch(es) - Smart repair |

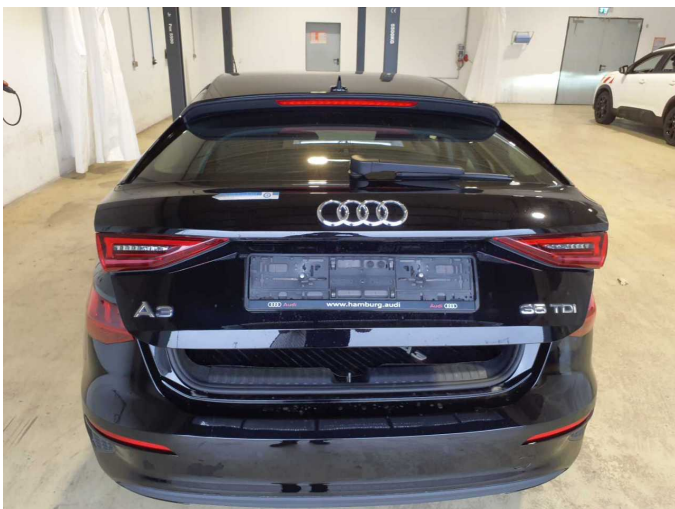
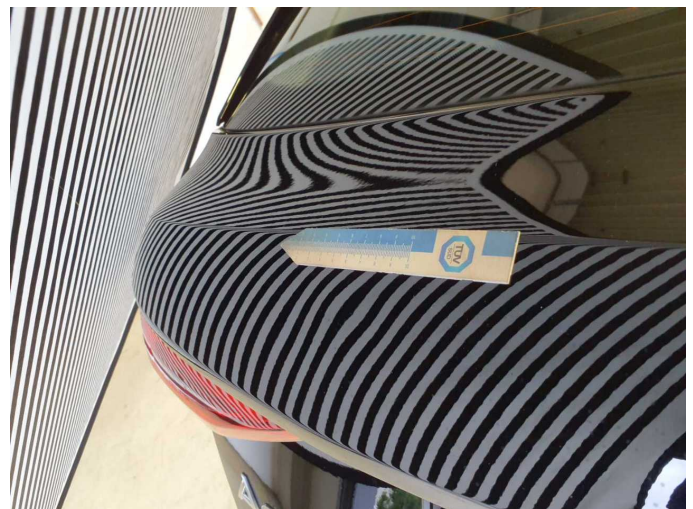
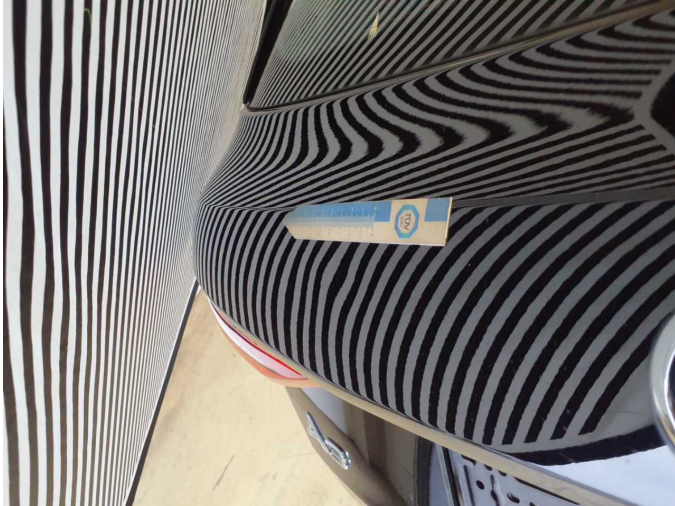
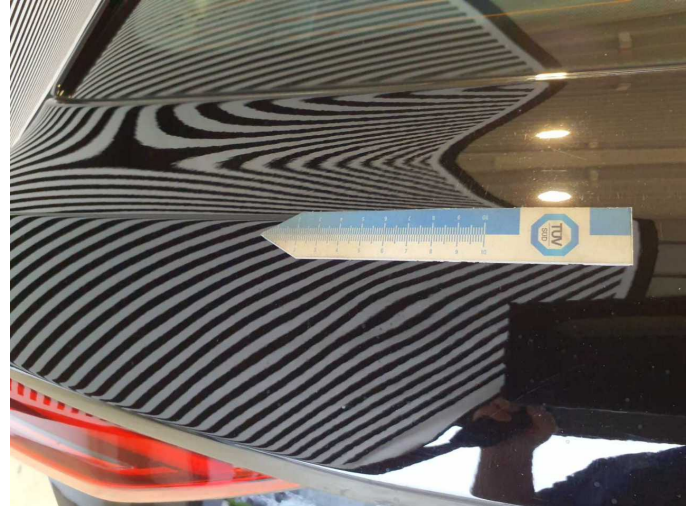
**Damage 3:** Boot lid / rear door: Boot lid - dent(s) - Smooth repair work

| No. | Component group | Description |
|---|---|---|
| 3 | Boot lid / rear door | Boot lid - dent(s) - Smooth repair work |

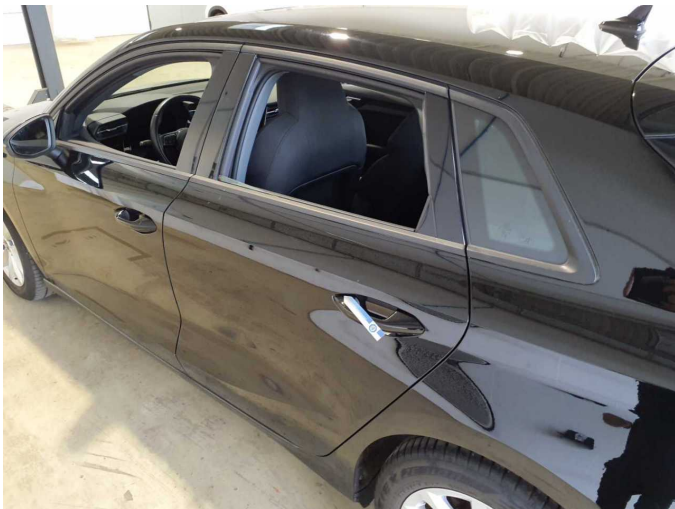
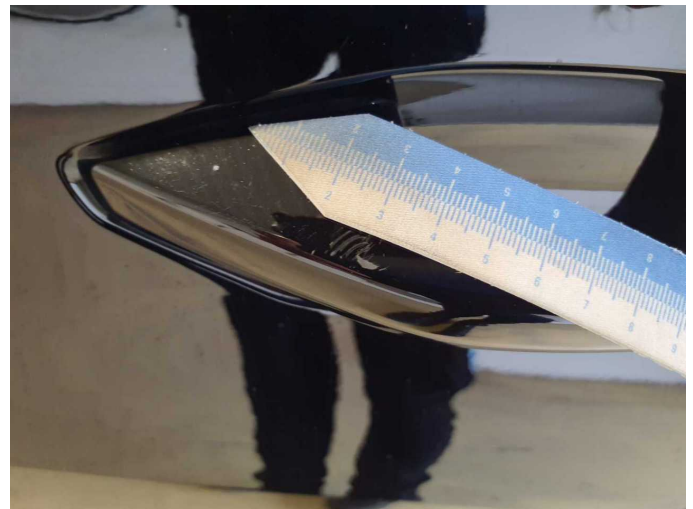
**Damage 4:** Door - rear left side: Door handle - outside - Scratch(es) - Smart repair

| No. | Component group | Description |
|---|---|---|
| 4 | Door - rear left side | Door handle - outside - Scratch(es) - Smart repair |

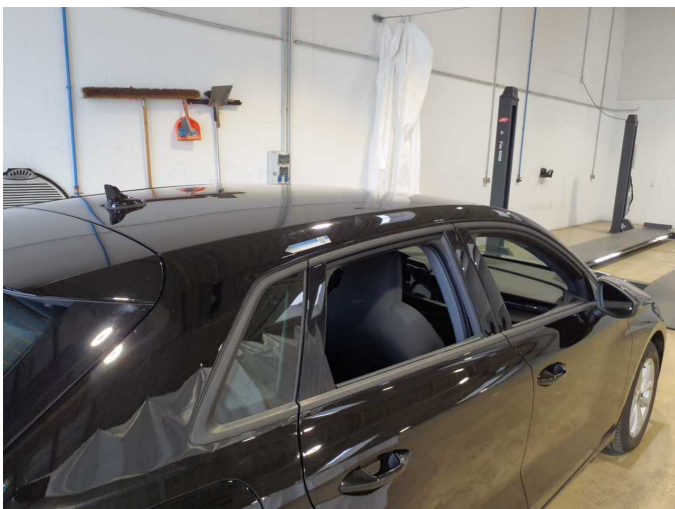
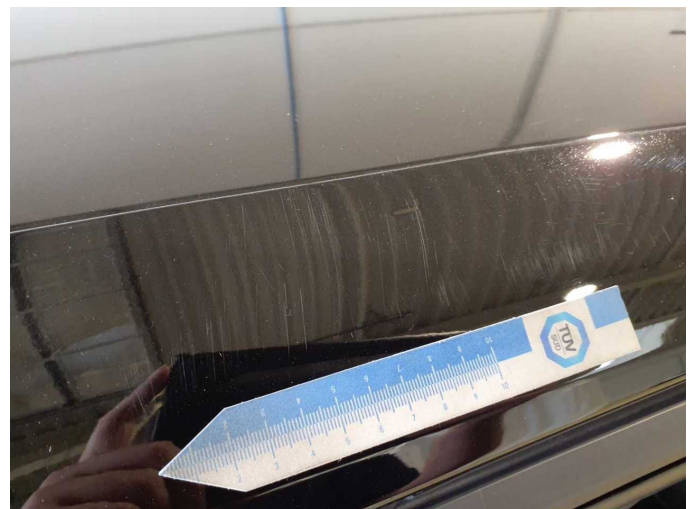
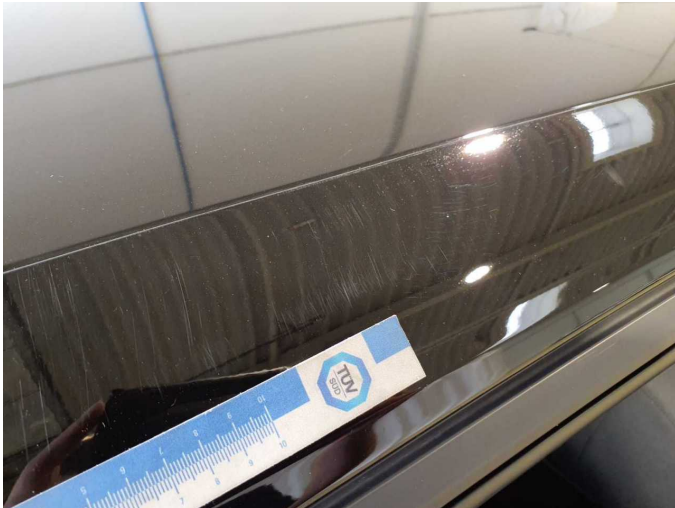
**Damage 5:** Roof: Roof rail - right side - Scratch(es) - Paint

| No. | Component group | Description |
|---|---|---|
| 5 | Roof | Roof rail - right side - Scratch(es) - Paint |

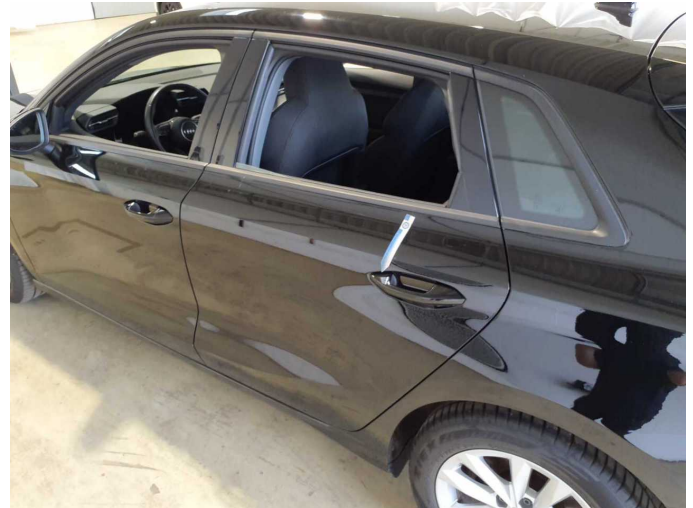
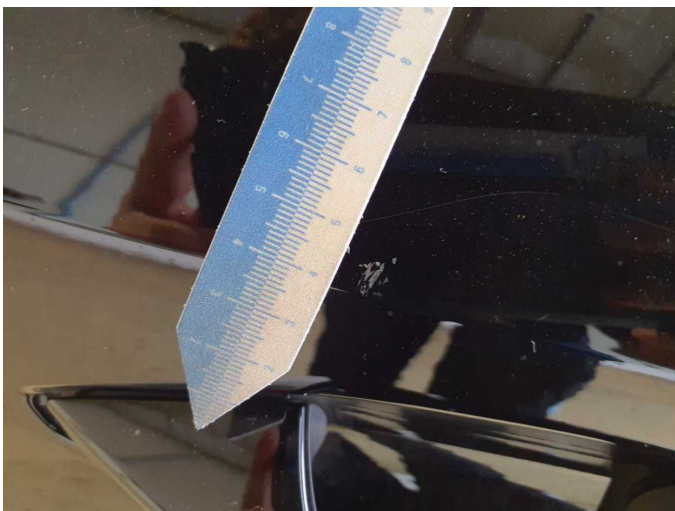
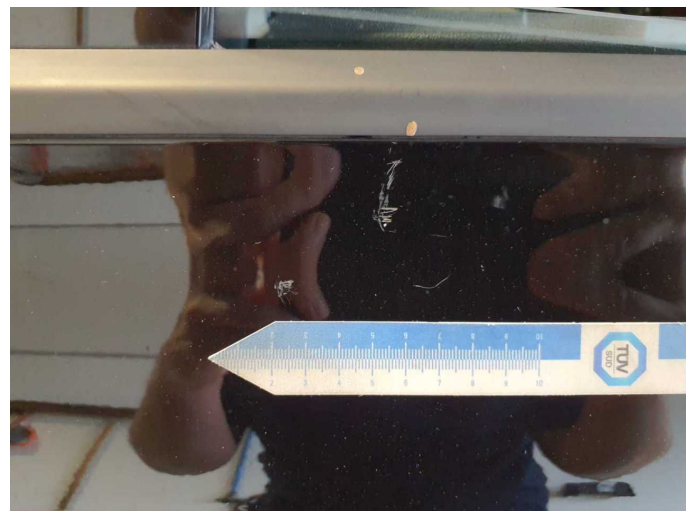
**Damage 6:** Door - rear left side: Door - Scratch(es) - Paint

| No. | Component group | Description |
|---|---|---|
| 6 | Door - rear left side | Door - Scratch(es) - Paint |

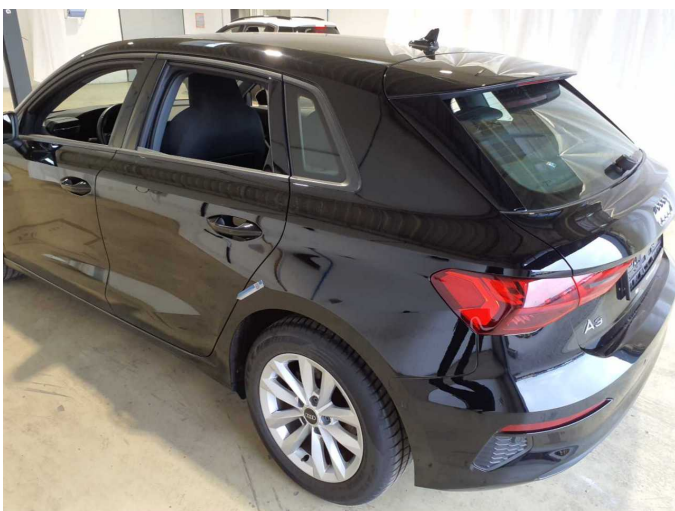
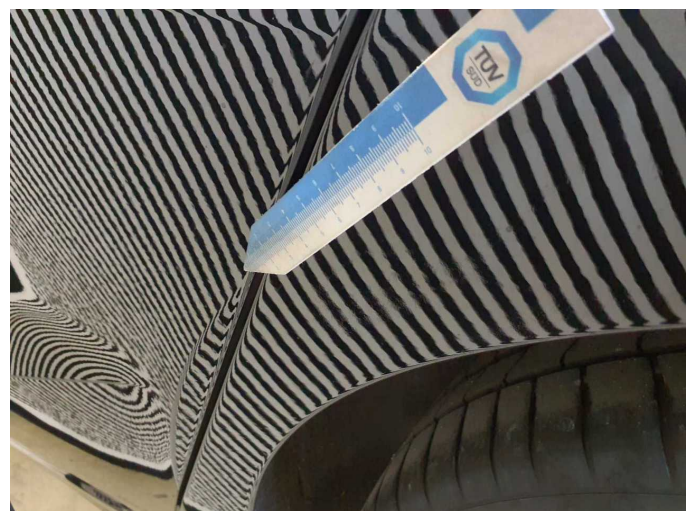
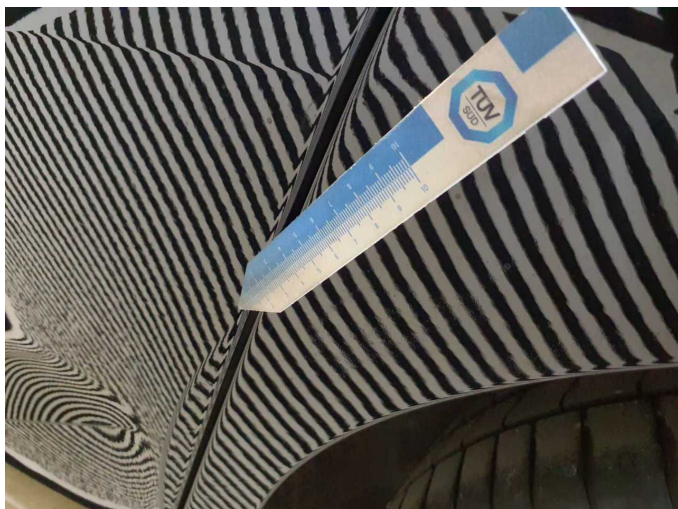
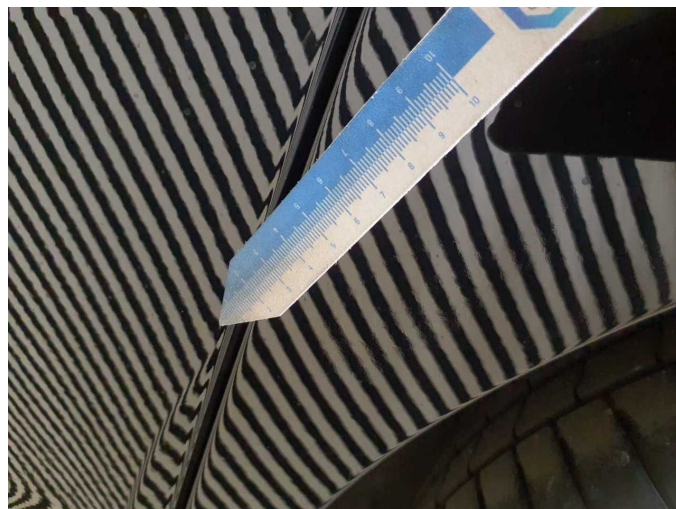
| No. | Previous damage | Extent of damage (Net) |
|---|---|---|
| 4 | Side - left, not professionally repaired | |

| Side panel - rear left side | 290 µm | Side panel - rear right side | 461 µm |

**Damage 7:** Side panel - rear left side: Side panel (Spachtelmasse eingefallen) - Unprofessionally repaired - Repair and paint

| No. | Component group | Description |
|---|---|---|
| 7 | Side panel - rear left side | Side panel (Spachtelmasse eingefallen) - Unprofessionally repaired - Repair and paint |

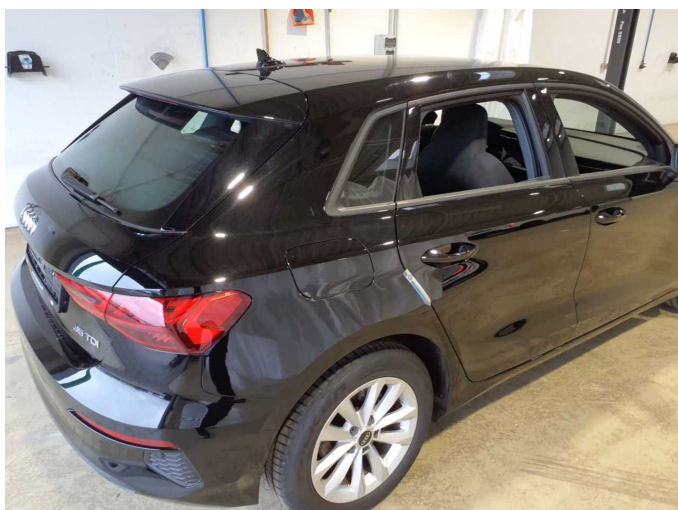
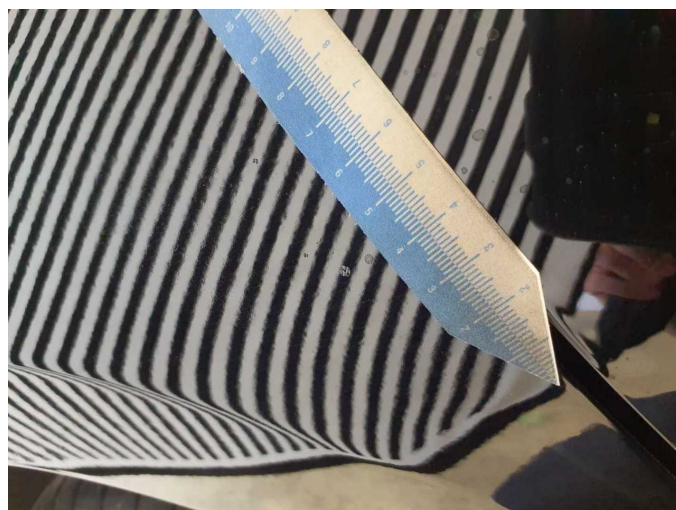
| No. | Previous damage | Extent of damage (Net) |
|---|---|---|
| 5 | Side right, not professionally repaired | |

**Damage 8:** Side panel - rear right side: Side panel (Blasen im Lack) - Unprofessionally repaired - Repair and paint

| No. | Component group | Description |
|---|---|---|
| 8 | Side panel - rear right side | Side panel (Blasen im Lack) - Unprofessionally repaired - Repair and paint |

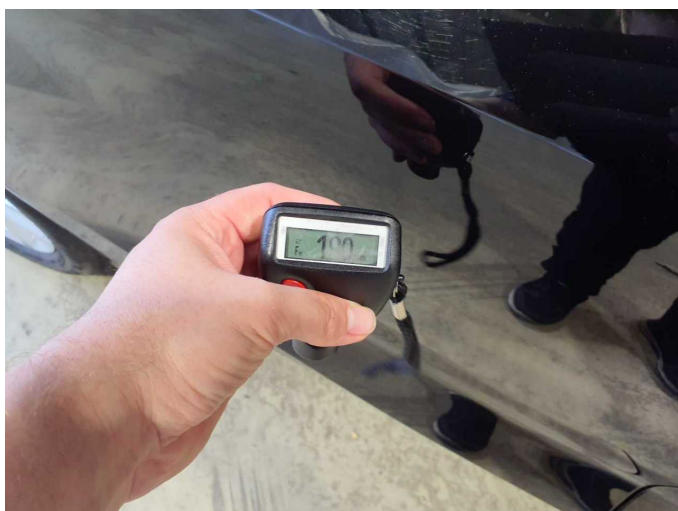
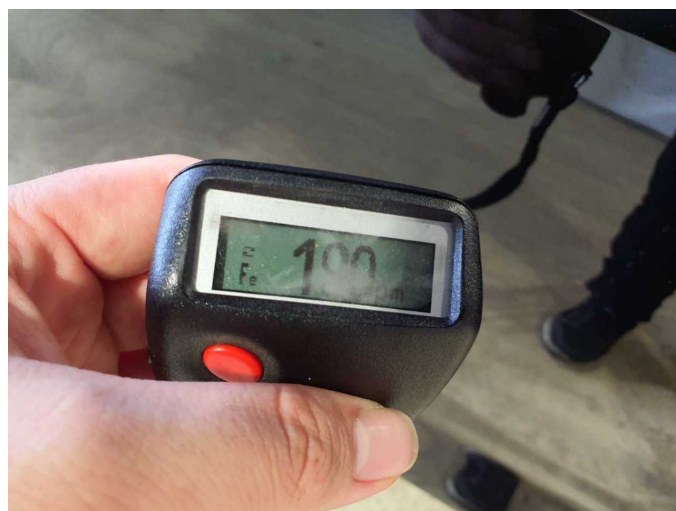
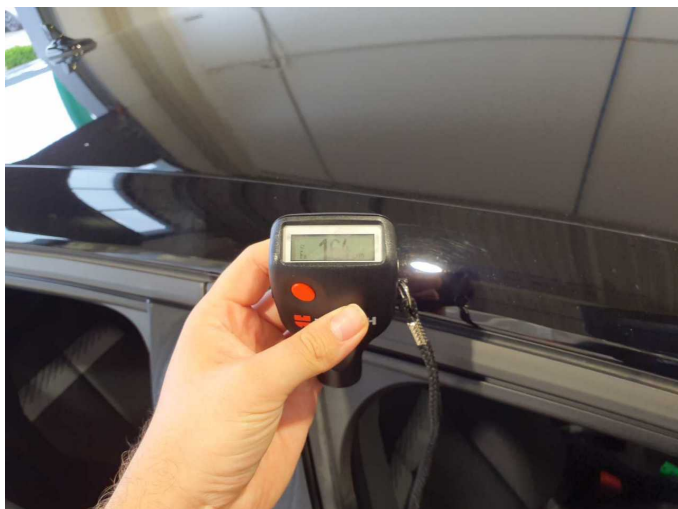
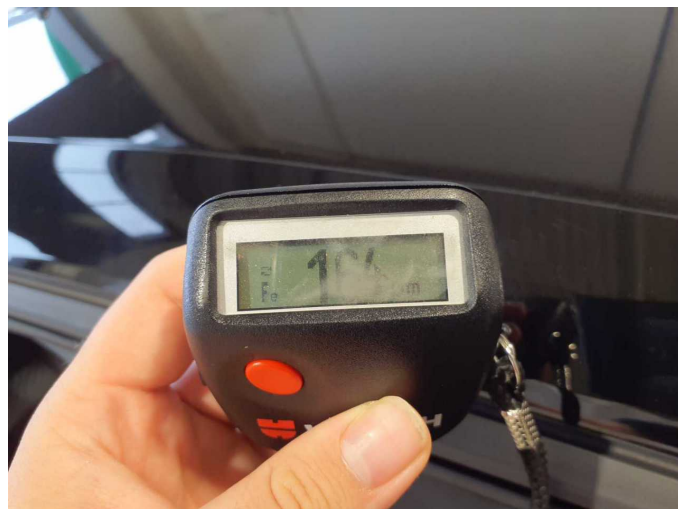
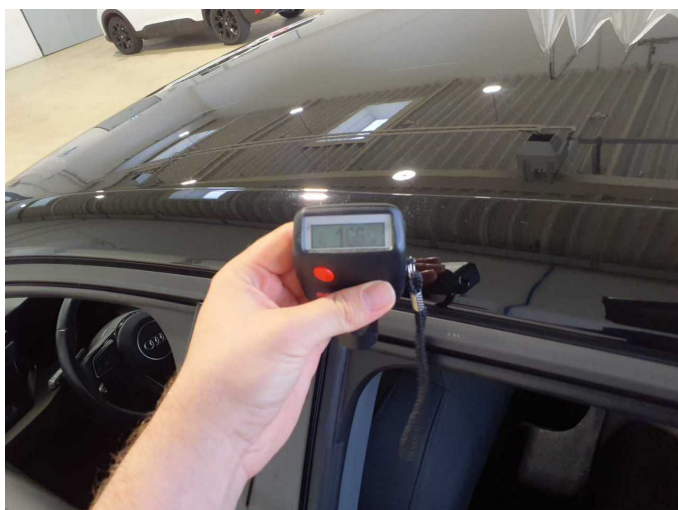
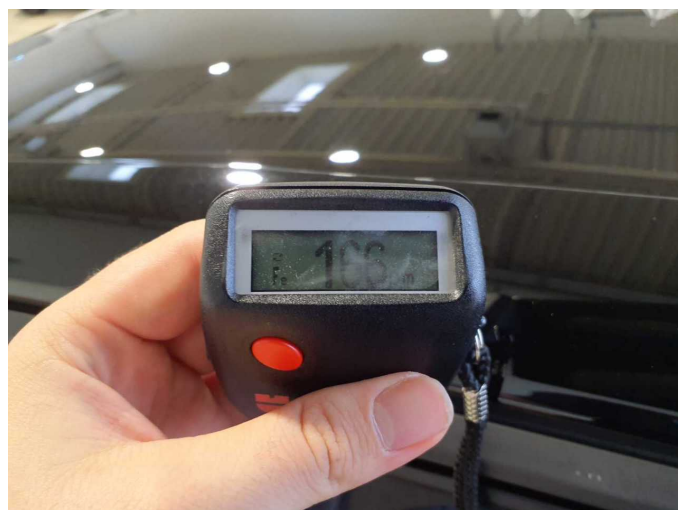
| No. | Repainting |
|---|---|
| 1 | Roof rail - left side, Roof rail - right side, Door - rear right side, Professionally carried out |

| Roof rail - left side | 166 µm | Roof rail - right side | 164 µm |
| Door - rear right side | 190 µm | | |

**Repainting 1:** Roof rail - left side, Roof rail - right side, Door - rear right side

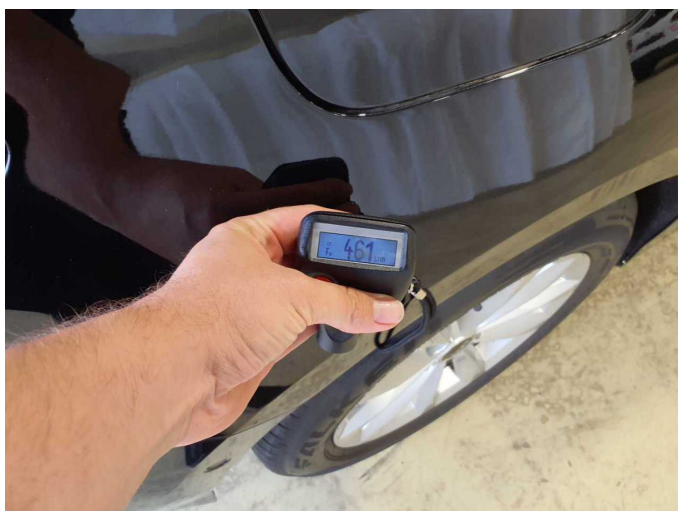
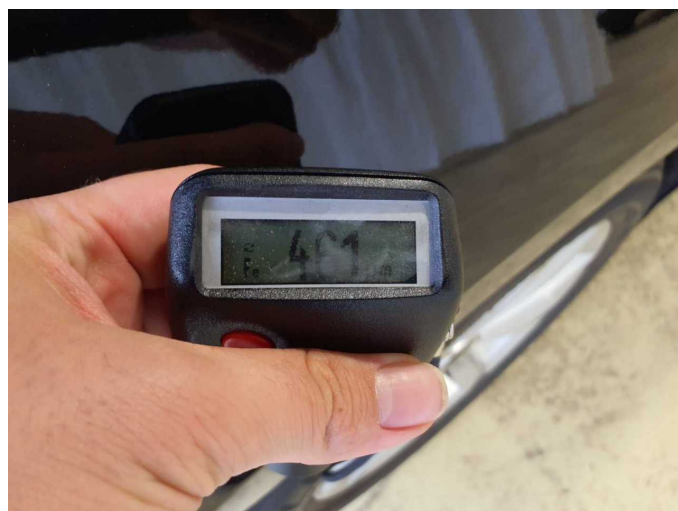
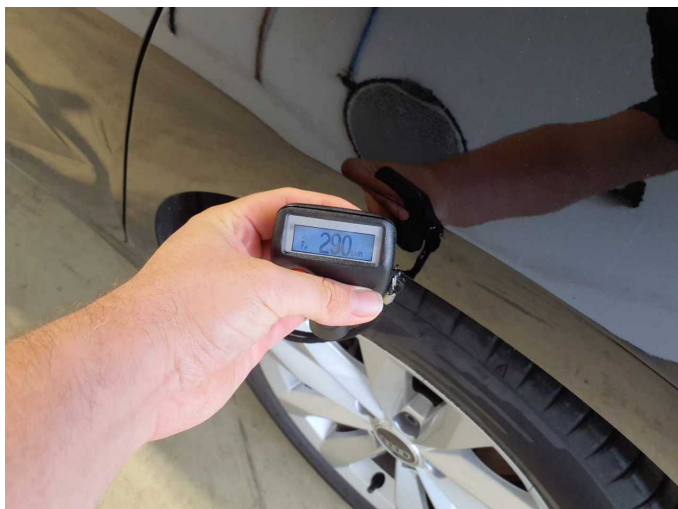
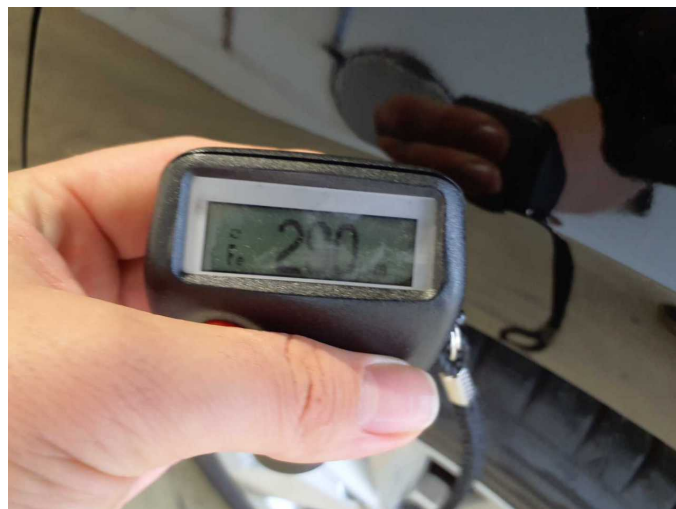
| No. | Repainting |
|---|---|
| 2 | Side panel - rear left side, Side panel - rear right side, Unprofessionally carried out |

An unprofessionally repaired previous damage was found at the vehicle.

**Repainting 2:** Side panel - rear left side, Side panel - rear right side
