Expertise

Protocol number: 46539964  
Order No. / Reference: 26566913  
Inspection date: 10 Jul 2026

Manufacturer: Mercedes-Benz  
VIN: W1NKM5GB7PF038939

Model: GLC 300 e 4Matic 9G-TRONIC Avantgarde Advanced

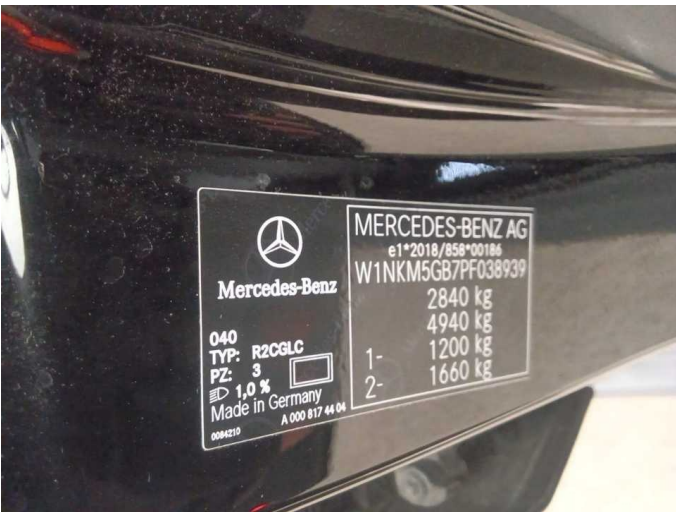
Figure 11: VIN

| VIN comparison | The vehicle identification number (VIN) was read from the vehicle and its conformity with the submitted documents was confirmed by the undersigned during the inspection. |

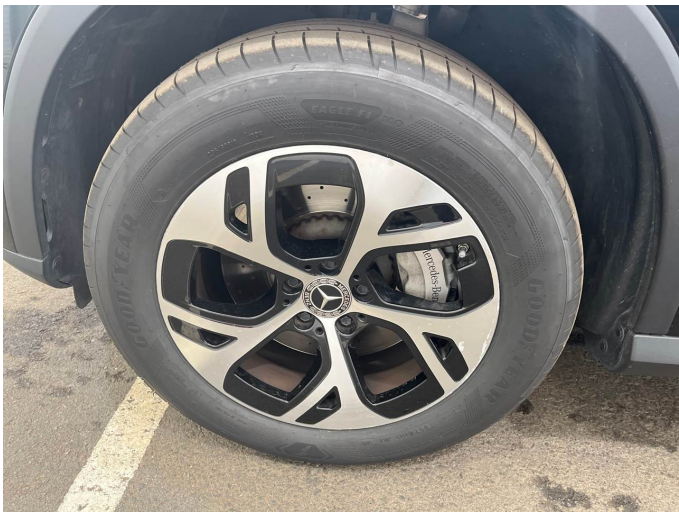
Figure 12: Mounted tyres

| # | Tyre size | Type of tyre | Manufacturer | Tread depth |
|---|---|---|---|---|
| 1) | 235/60 R18 103W | Summer tyres on Light alloy | Goodyear | 6mm / 6mm |
| 2) | 255/55 R18 109W | Summer tyres on Light alloy | Goodyear | 4mm / 4mm |

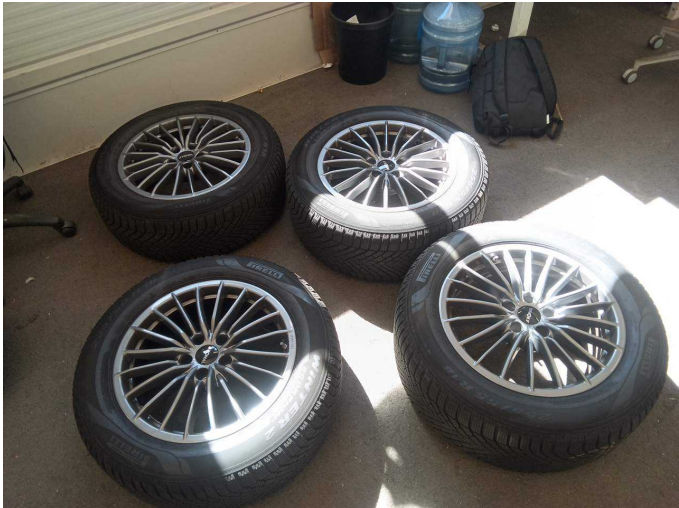
Figure 16: Additional tyres

| # | Tyre size | Type of tyre | Manufacturer | Tread depth |
|---|---|---|---|---|
| 1) | 235/60 R18 107V | Winter tyres on Light alloy | Pirelli | 6mm / 6mm |
| 2) | 255/55 R18 109V | Winter tyres on Light alloy | Pirelli | 6mm / 6mm |

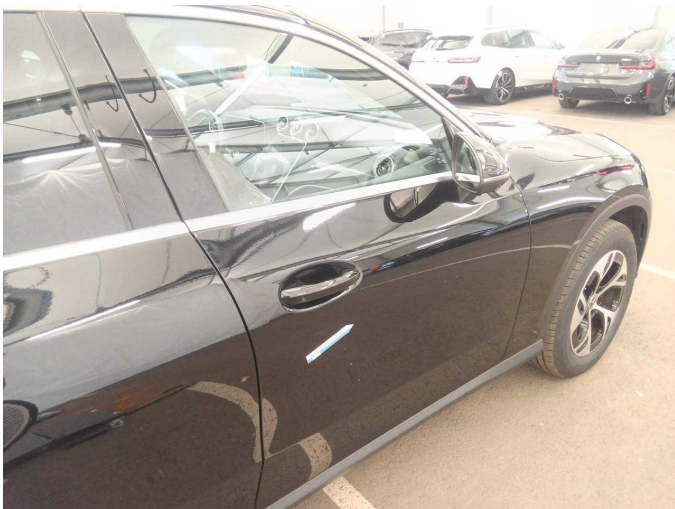
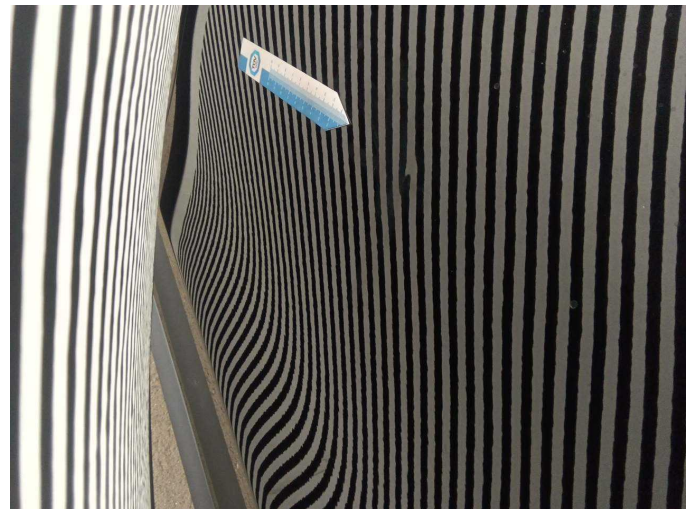
| No. | Component group | Description |
|---|---|---|
| 1 | Door - front right side | Door - dent(s) - Smooth repair work |

**Damage 1:** Door - front right side: Door - dent(s) - Smooth repair work

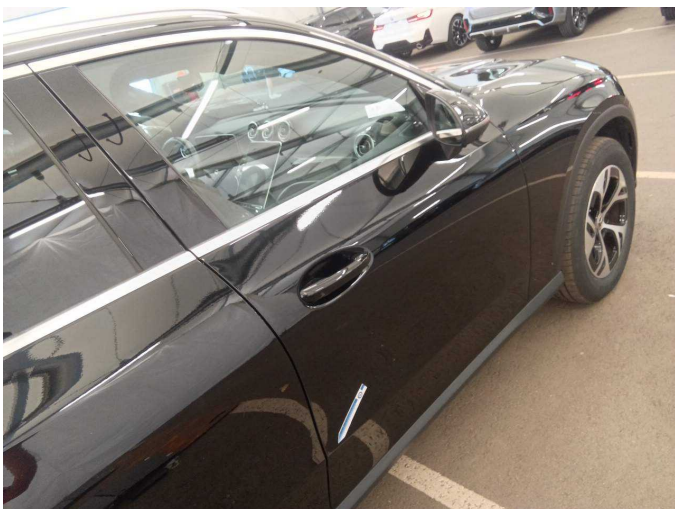
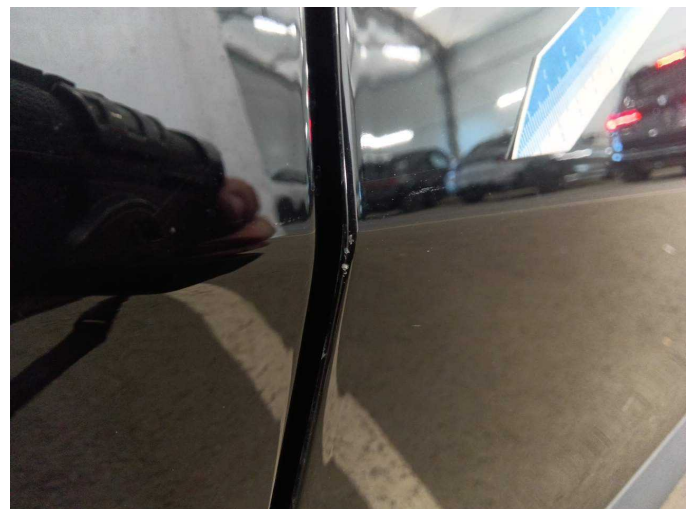
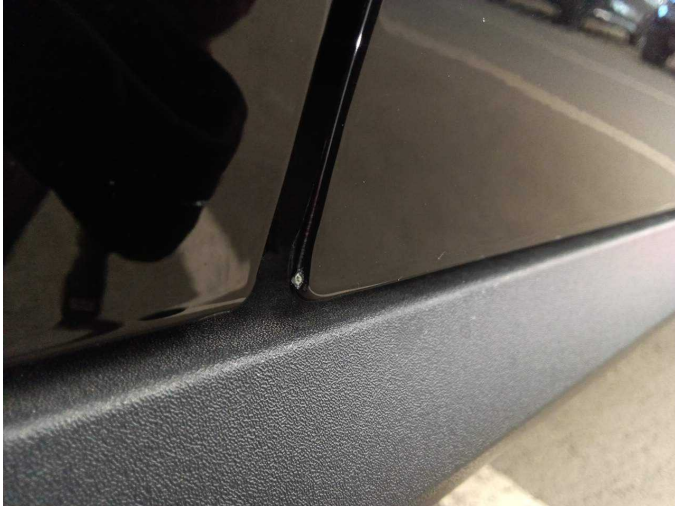
| No. | Component group | Description |
|---|---|---|
| 2 | Door - front right side | Door edge - Scratch(es) - Smart repair |

**Damage 2:** Door - front right side: Door edge - Scratch(es) - Smart repair

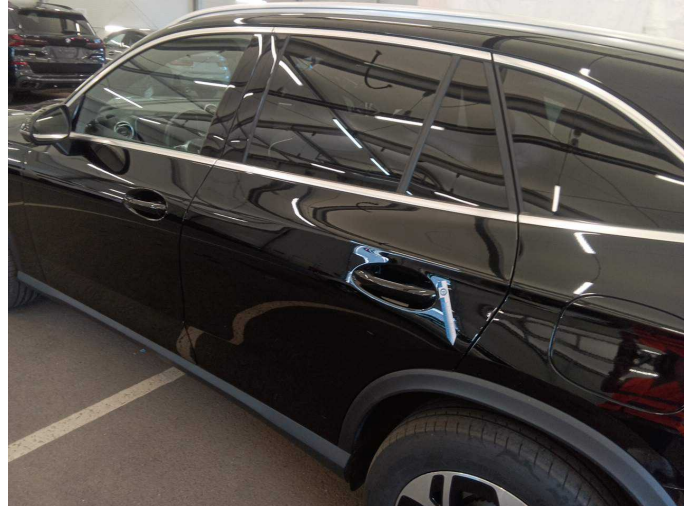
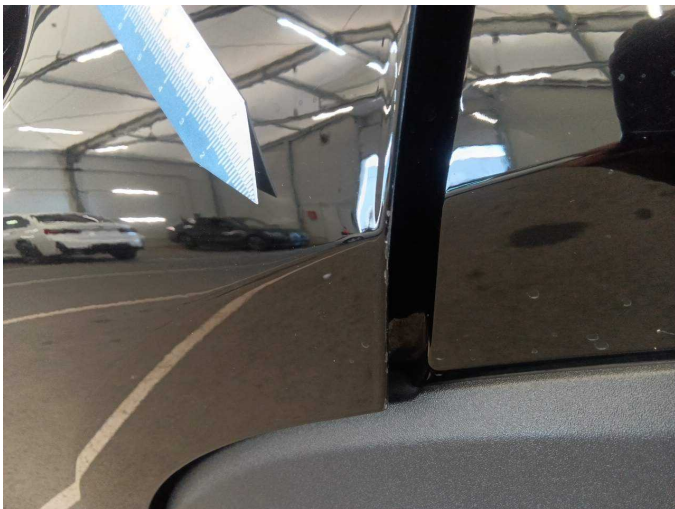
| No. | Component group | Description |
|---|---|---|
| 3 | Door - rear left side | Door edge - Scratch(es) - Smart repair |

**Damage 3:** Door - rear left side: Door edge - Scratch(es) - Smart repair

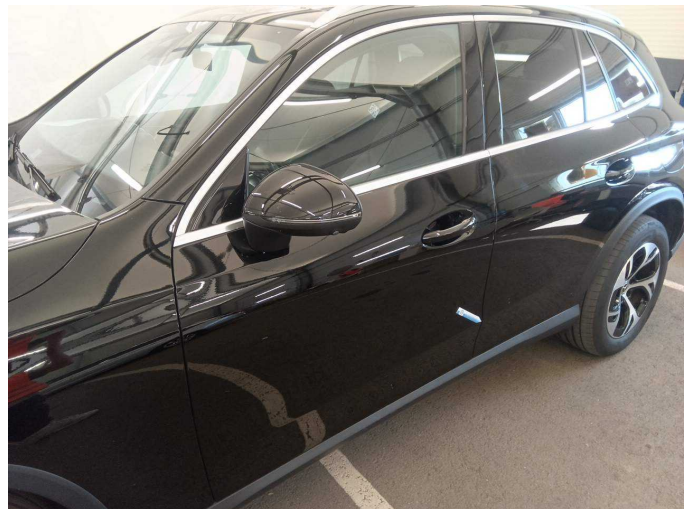
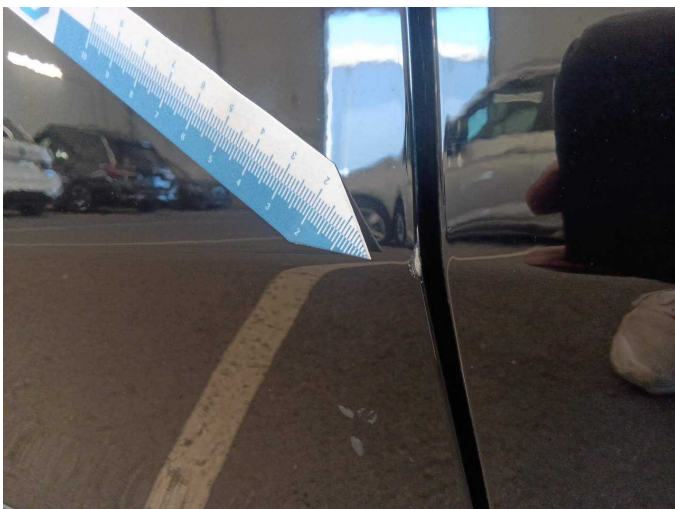
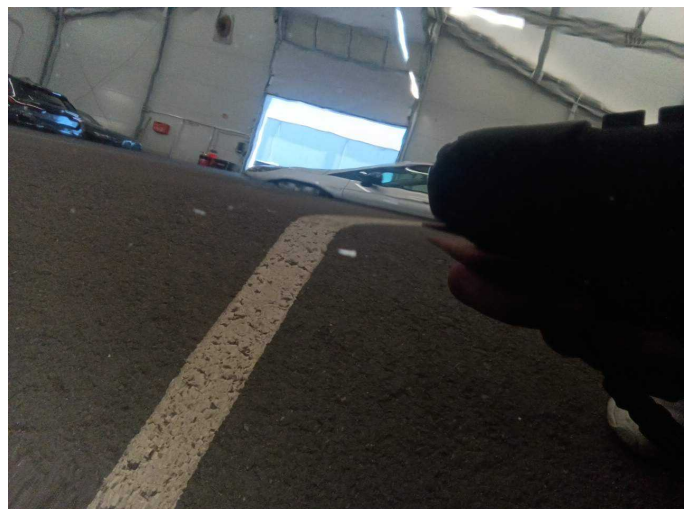
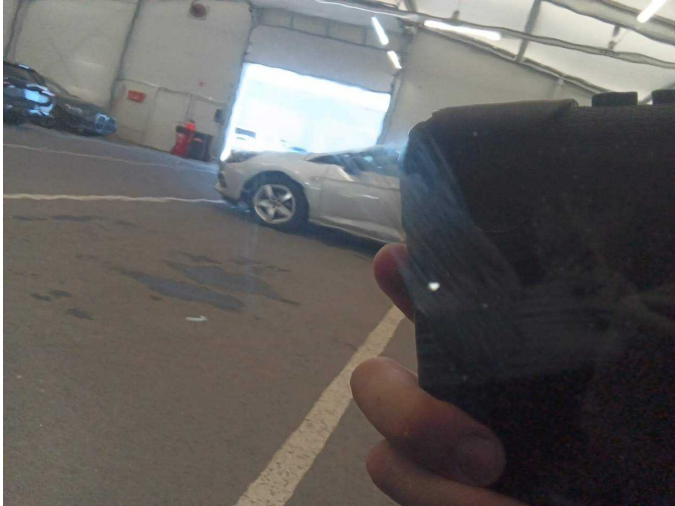
| No. | Component group | Description |
|---|---|---|
| 4 | Door - front left side | Door - Scratch(es) - Smart repair |

**Damage 4:** Door - front left side: Door - Scratch(es) - Smart repair

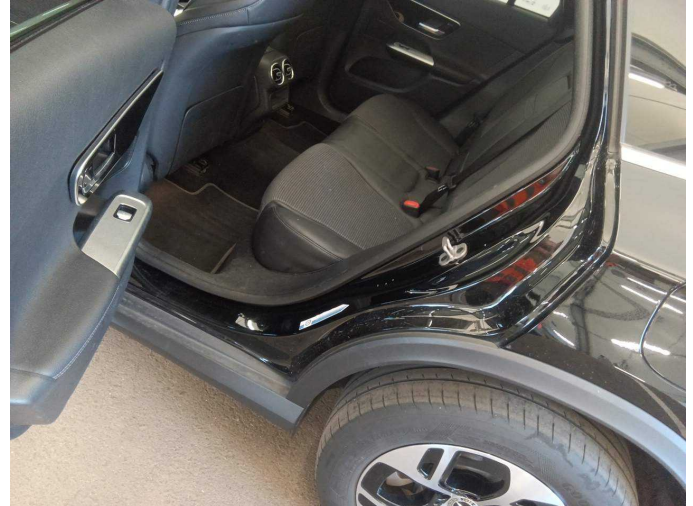
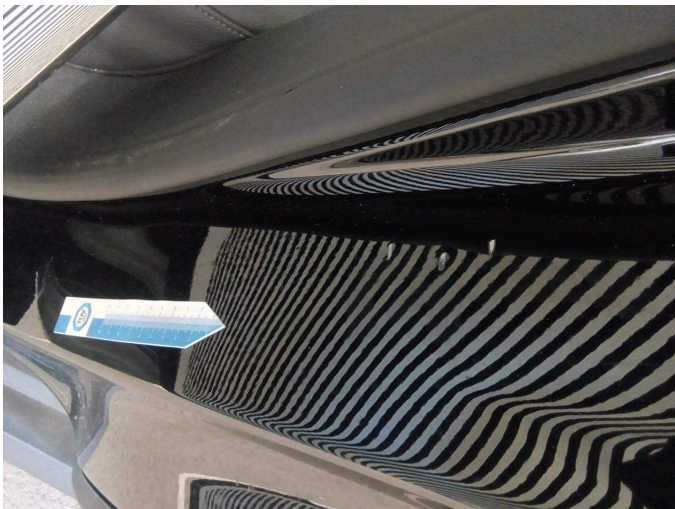
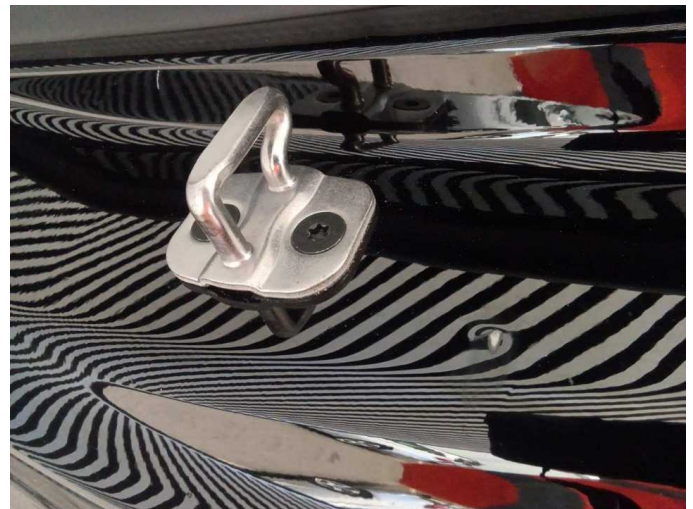
| No. | Component group | Description |
|---|---|---|
| 5 | Side panel - rear left side | Sill - Dent / paintcoat damage - Smart repair |

**Damage 5:** Side panel - rear left side: Sill - Dent / paintcoat damage - Smart repair

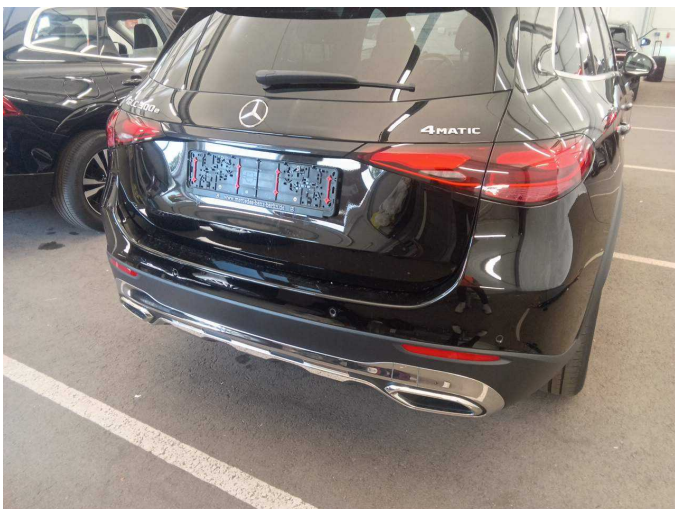
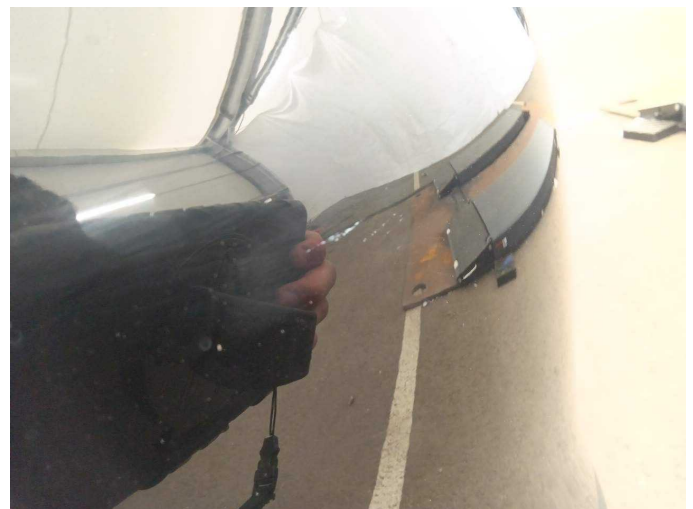
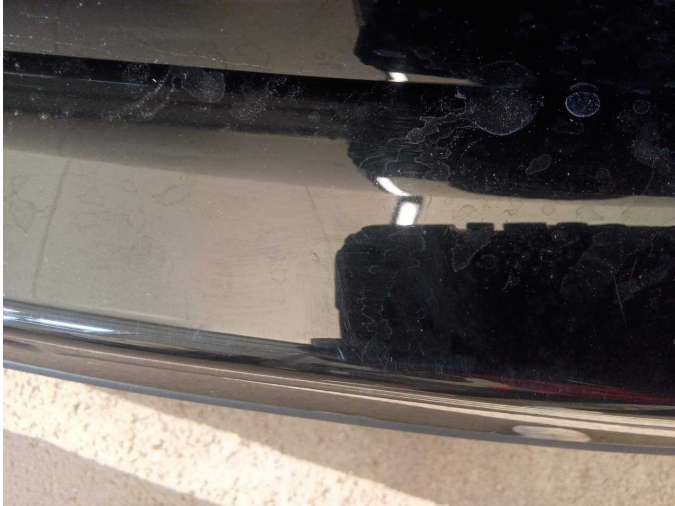
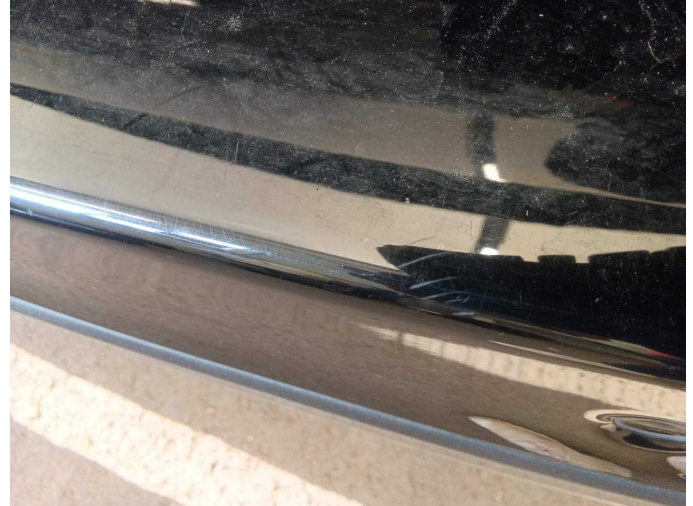
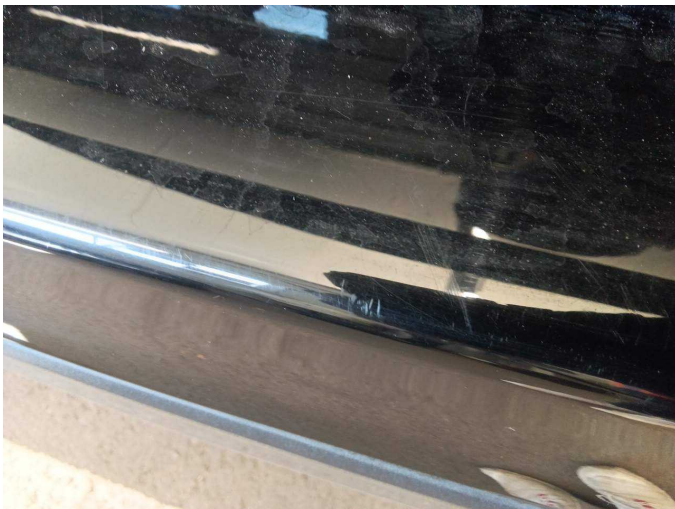
| No. | Component group | Description |
|---|---|---|
| 6 | Rear bumper | Rear bumper - Scratch(es) - Paint |

**Damage 6:** Rear bumper: Rear bumper - Scratch(es) - Paint

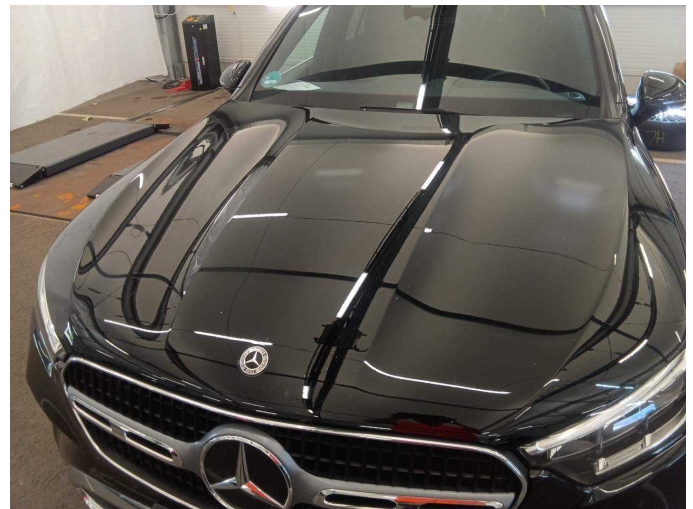
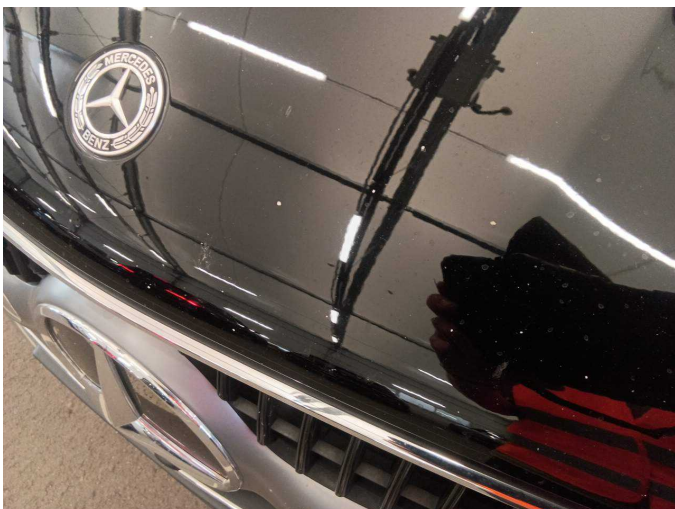
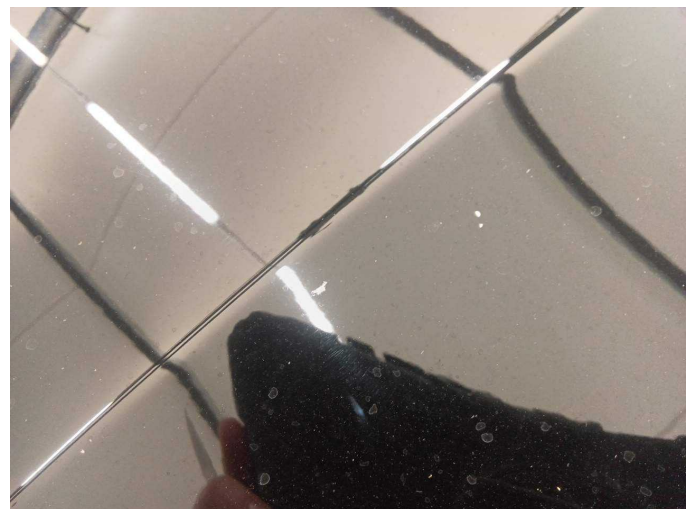
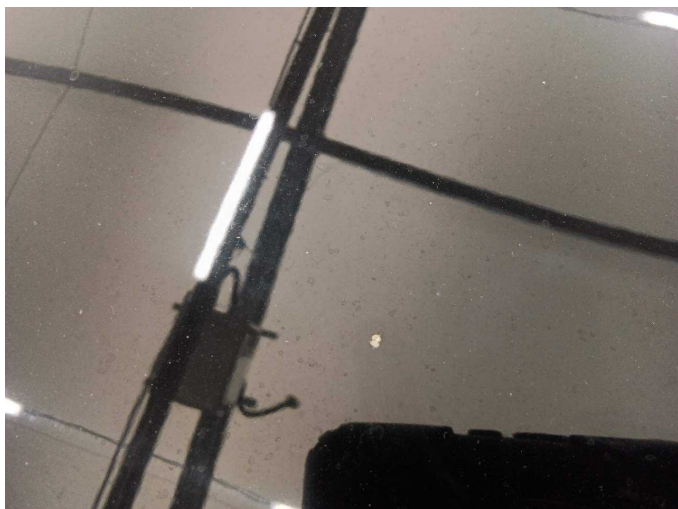
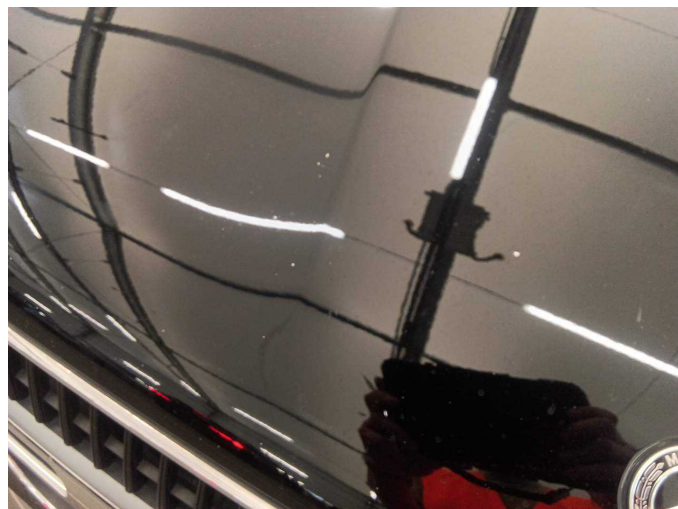
| No. | Component group | Description |
|---|---|---|
| 7 | Bonnet | Bonnet - Stone chips - Paint |

**Damage 7:** Bonnet: Bonnet - Stone chips - Paint

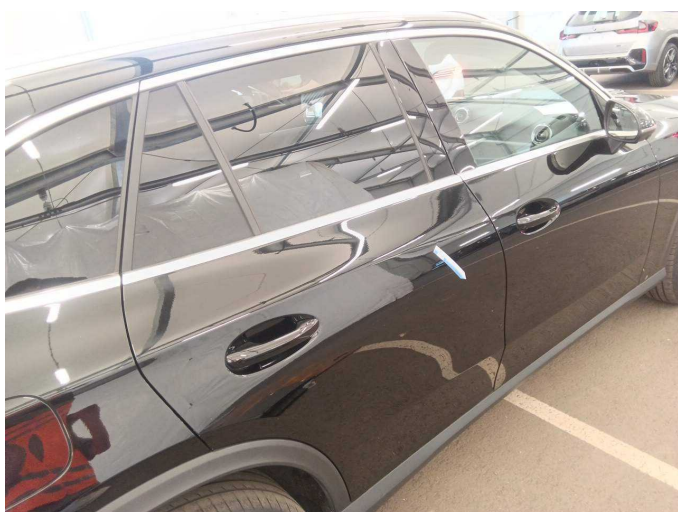
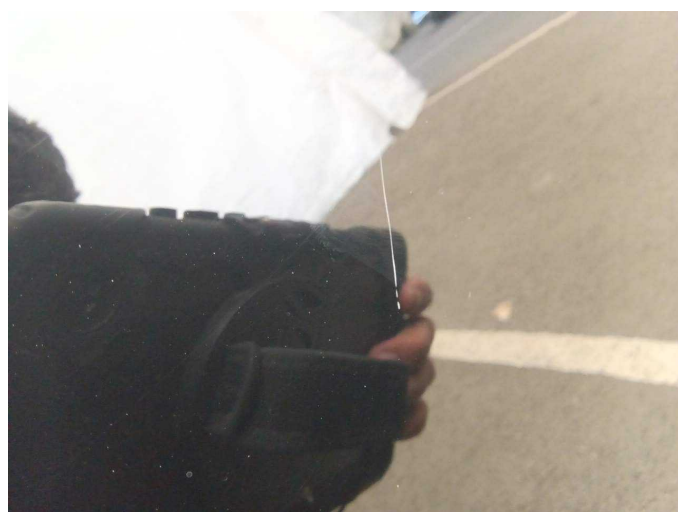
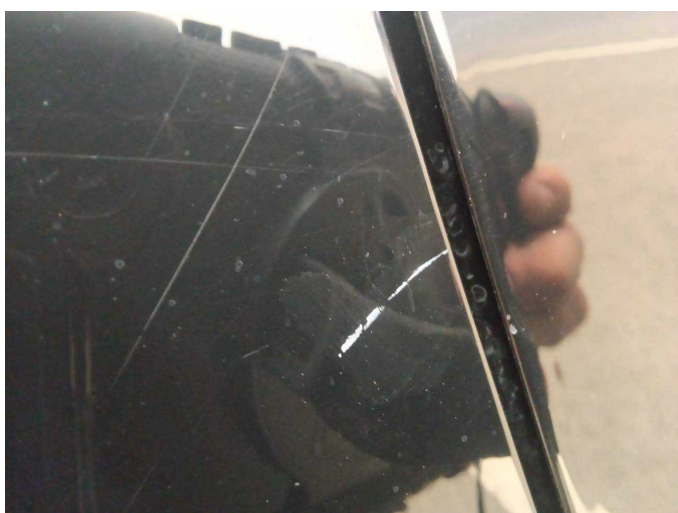
| No. | Component group | Description |
|---|---|---|
| 8 | Door - rear right side | Door - Scratch(es) - Paint |

**Damage 8:** Door - rear right side: Door - Scratch(es) - Paint

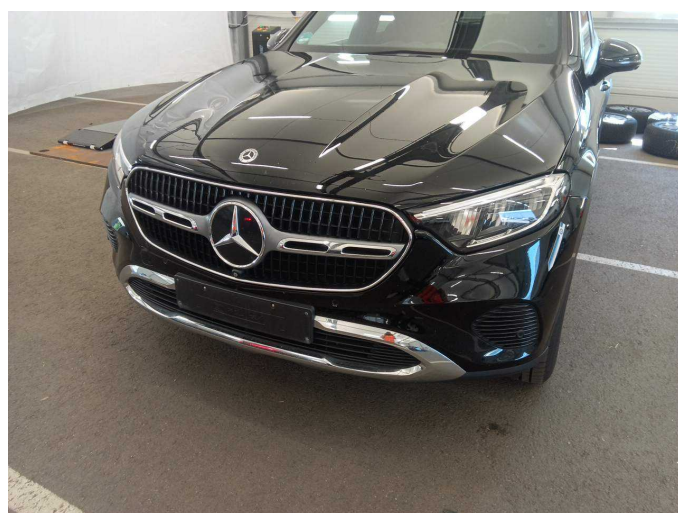
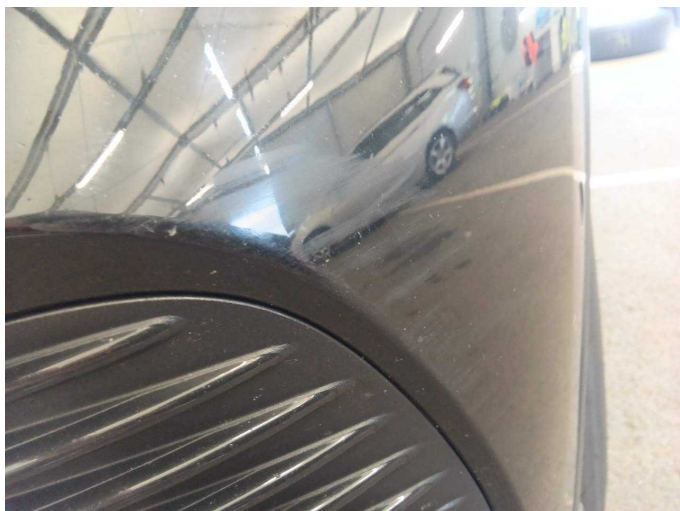
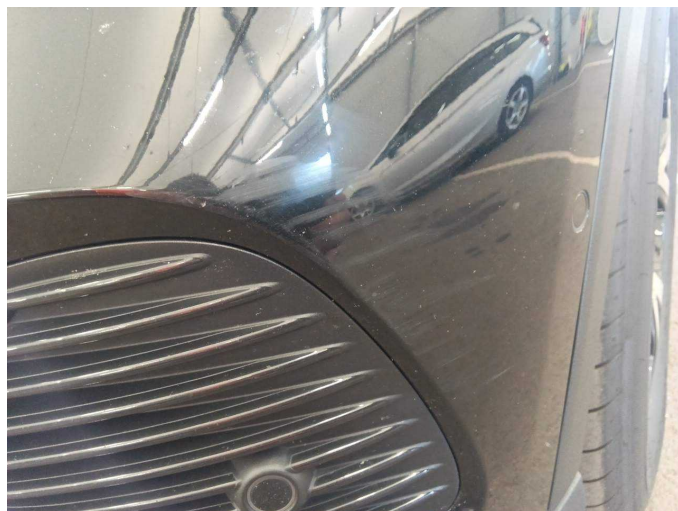
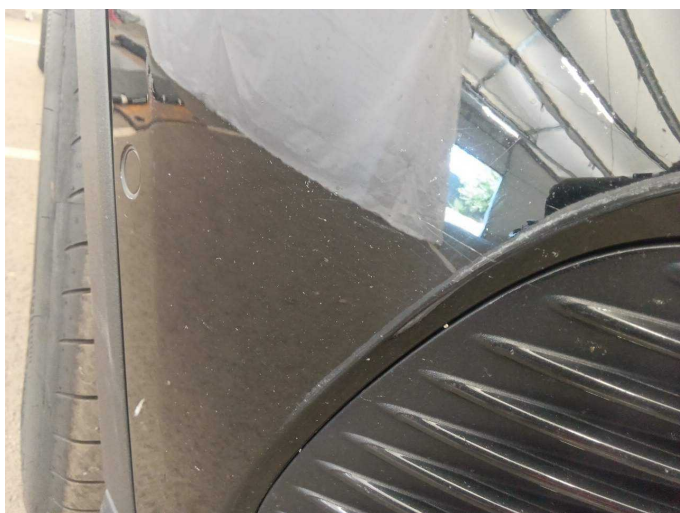
| No. | Component group | Description |
|---|---|---|
| 9 | Front bumper | Front bumper - Scratch(es) - Paint |

**Damage 9:** Front bumper: Front bumper - Scratch(es) - Paint
