Expertise

Protocol number: 46540184  
Order No. / Reference: 26584024  
Inspection date: 9 Jul 2026

Model: GLC-Coupe 300 de 4Matic 9G-TRONIC AMG Line

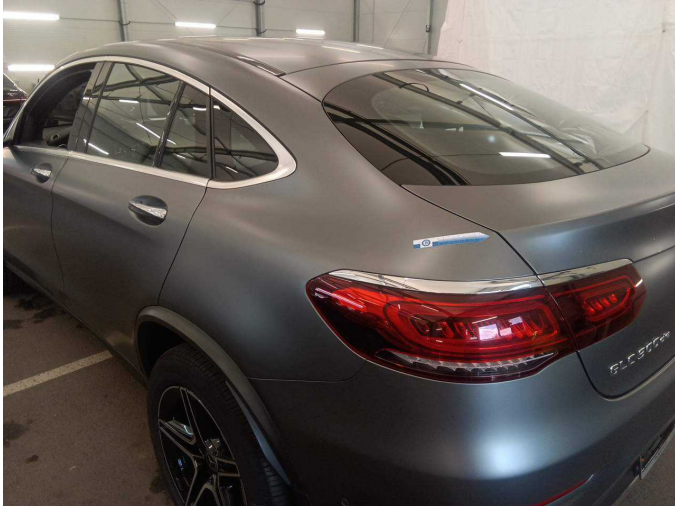
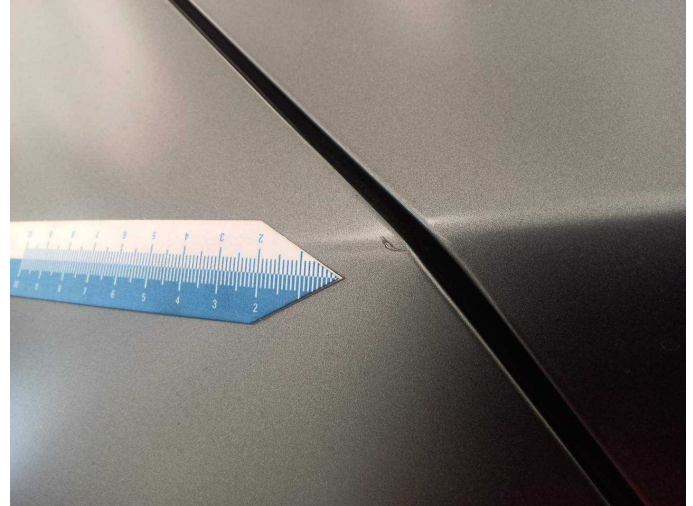
| No. | Component group | Description |
|---|---|---|
| 1 | Side panel - rear left side | Mudguard - rear left side - Scratch(es) - Smart repair |

**Damage 1:** Side panel - rear left side: Mudguard - rear left side - Scratch(es) - Smart repair

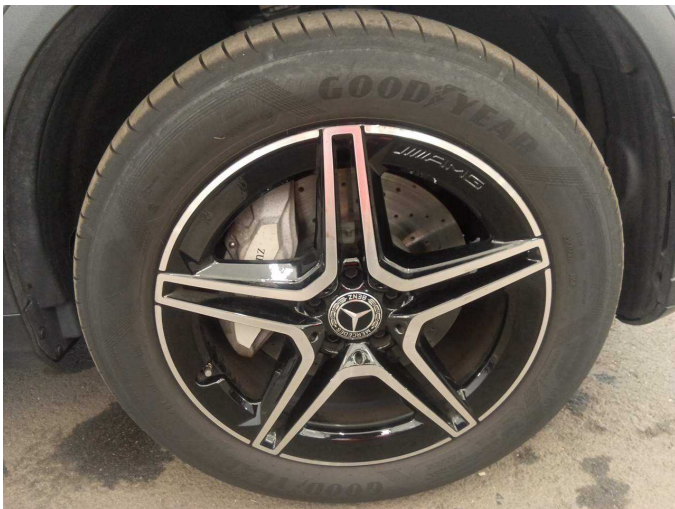
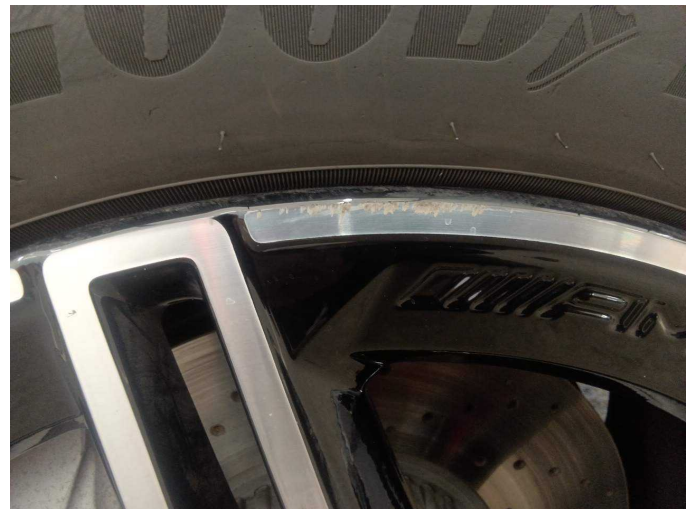
| No. | Component group | Description |
|---|---|---|
| 2 | Wheel / tyres | Alloy rim - front right side - Scratch(es) - Loss in value |

**Damage 2:** Wheel / tyres: Alloy rim - front right side - Scratch(es) - Loss in value

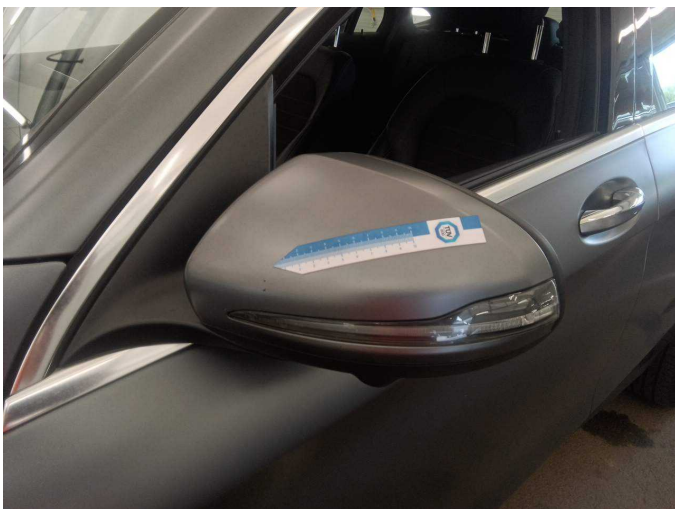
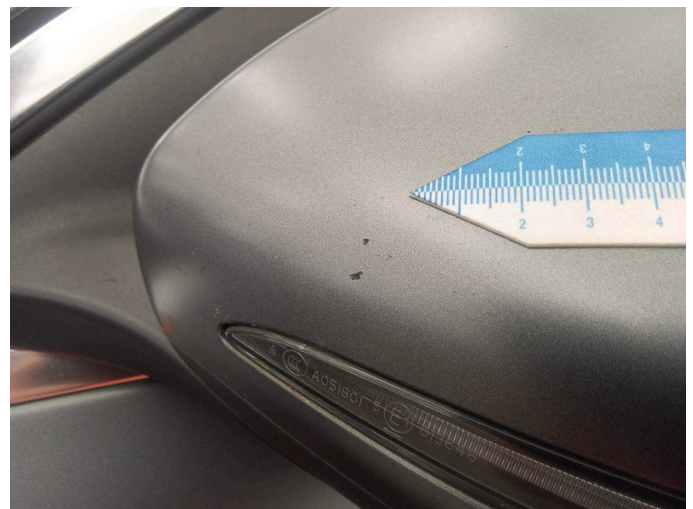
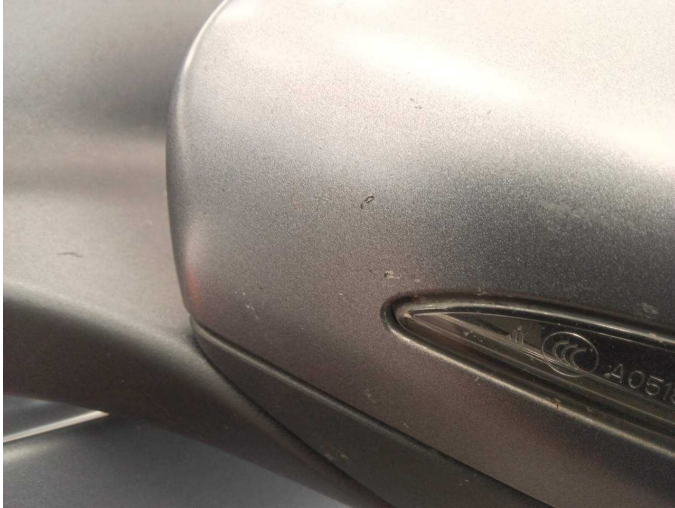
| No. | Component group | Description |
|---|---|---|
| 3 | Wing mirror - left side | Cap - Scratch(es) - Replace |

**Damage 3:** Wing mirror - left side: Cap - Scratch(es) - Replace

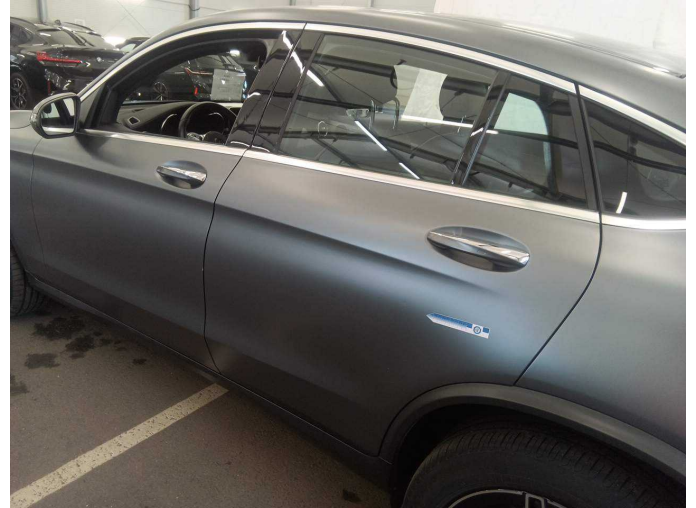
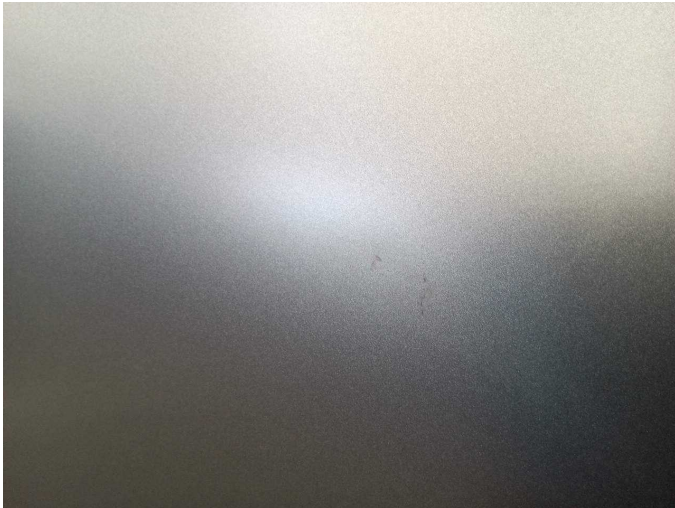
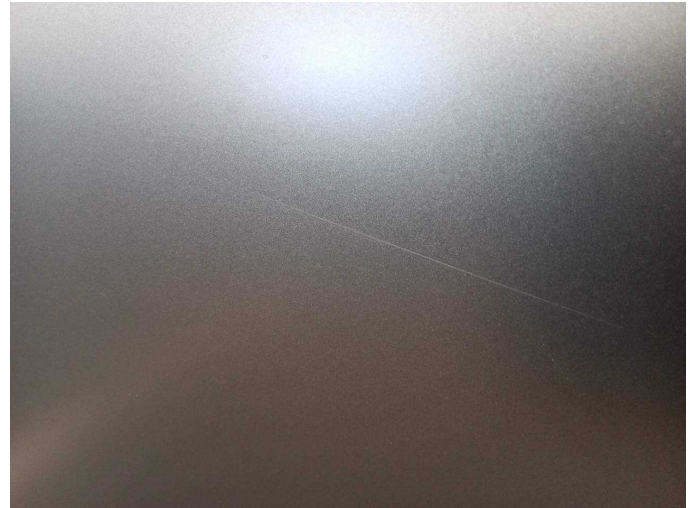
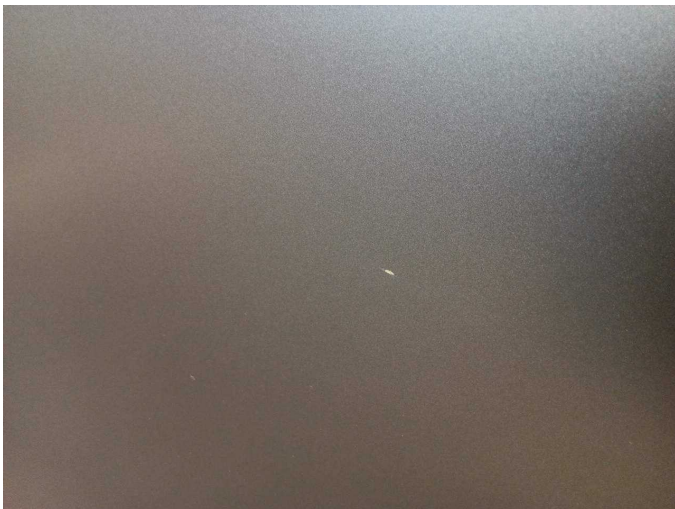
| No. | Component group | Description |
|---|---|---|
| 4 | Door - rear left side | Door - Dent / paintcoat damage - Paint |

**Damage 4:** Door - rear left side: Door - Dent / paintcoat damage - Paint

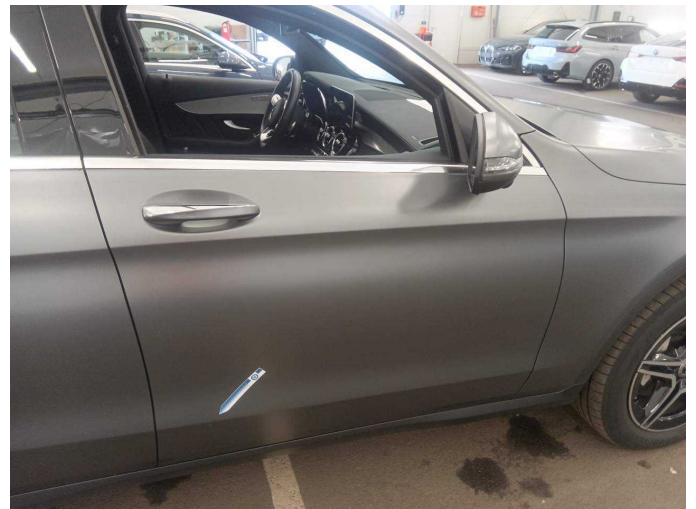
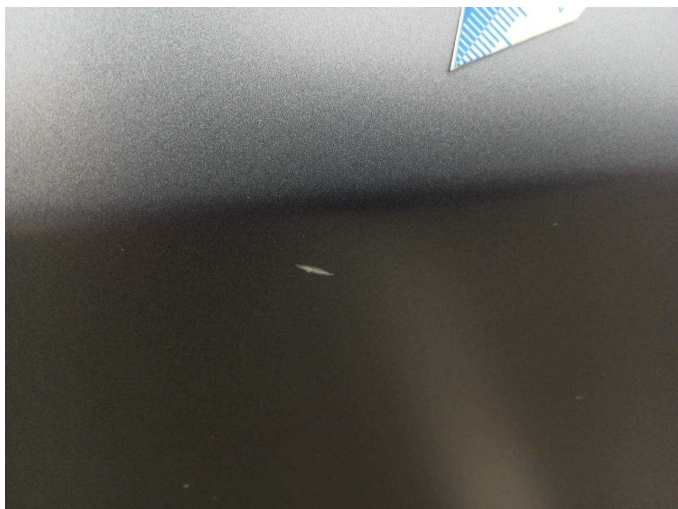
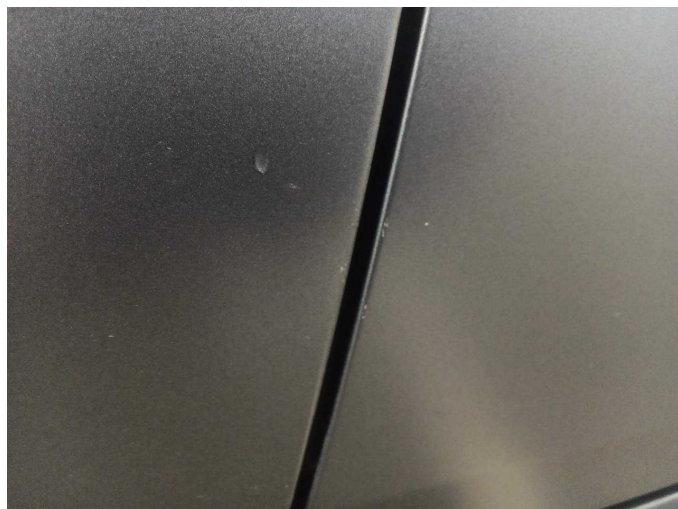
| No. | Component group | Description |
|---|---|---|
| 5 | Door - front right side | Door - Scratch(es) - Paint |

**Damage 5:** Door - front right side: Door - Scratch(es) - Paint

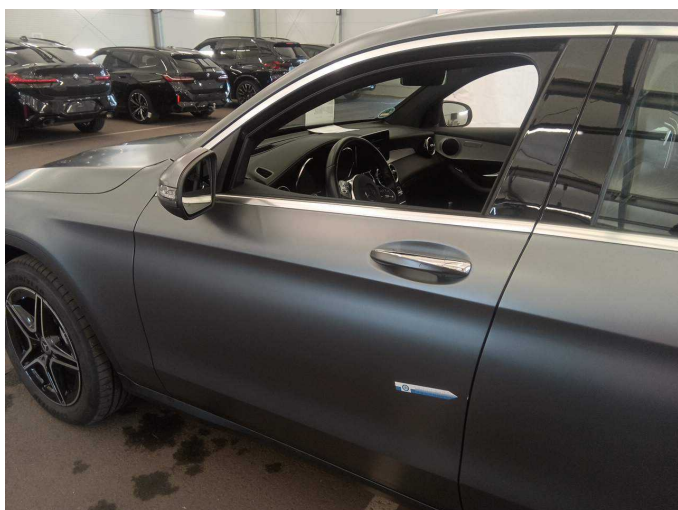
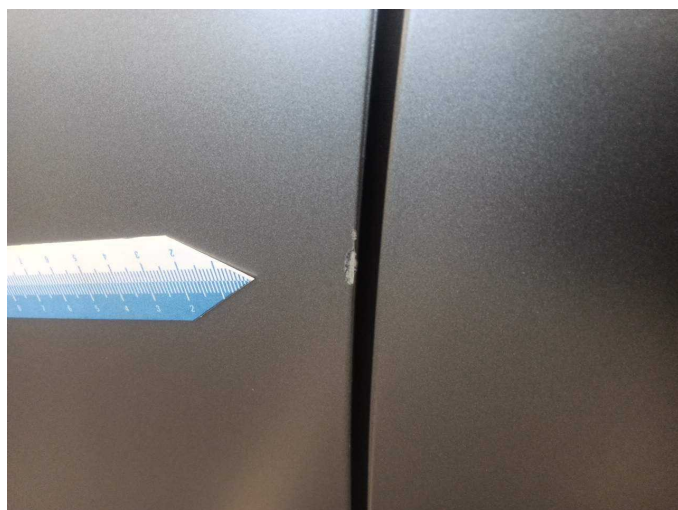
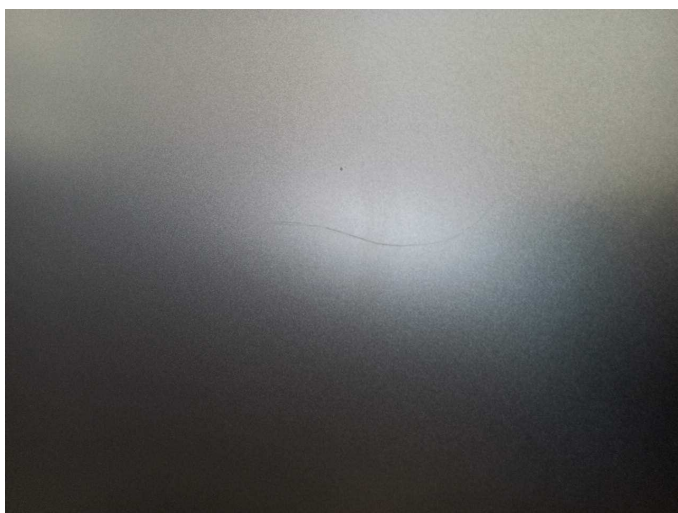
| No. | Component group | Description |
|---|---|---|
| 6 | Door - front left side | Door - Scratch(es) - Paint |

**Damage 6:** Door - front left side: Door - Scratch(es) - Paint

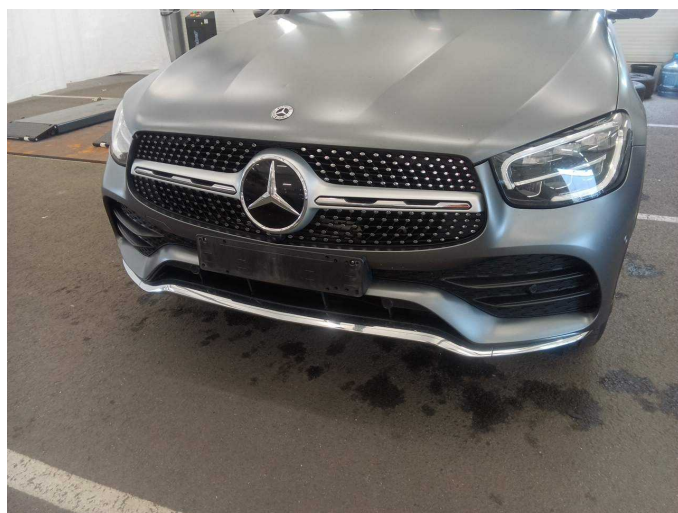
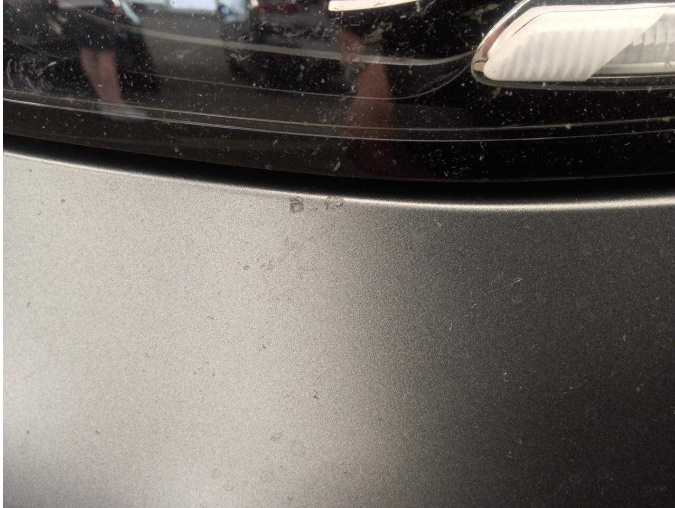
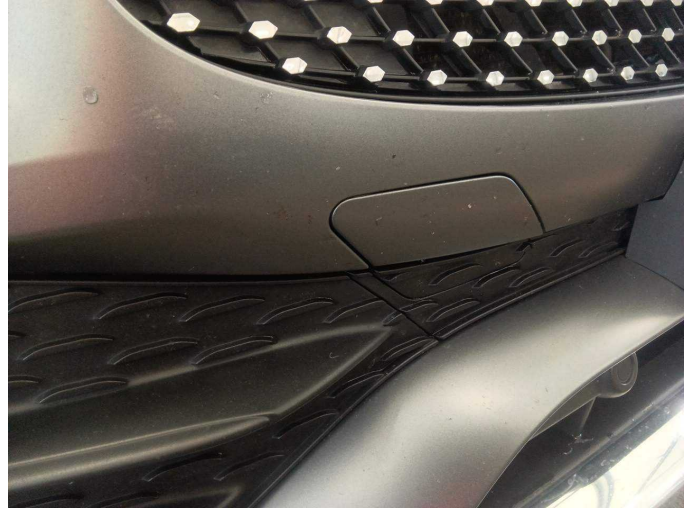
| No. | Component group | Description |
|---|---|---|
| 7 | Front bumper | Front bumper (Sandstrahleffekt) - Stone chips - Paint |

**Damage 7:** Front bumper: Front bumper (Sandstrahleffekt) - Stone chips - Paint

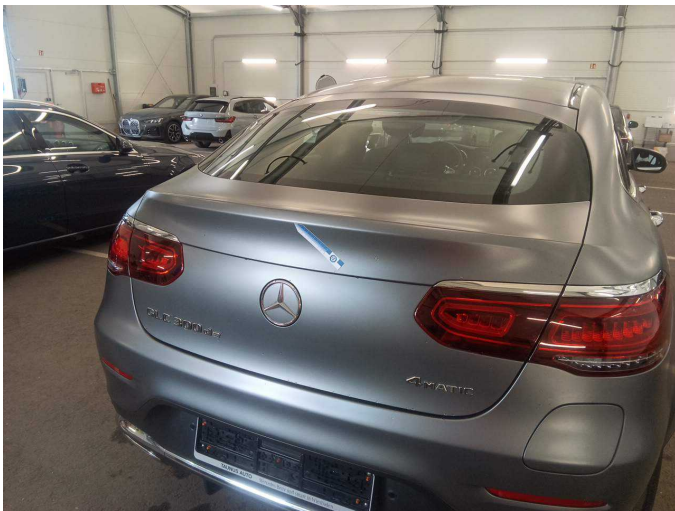
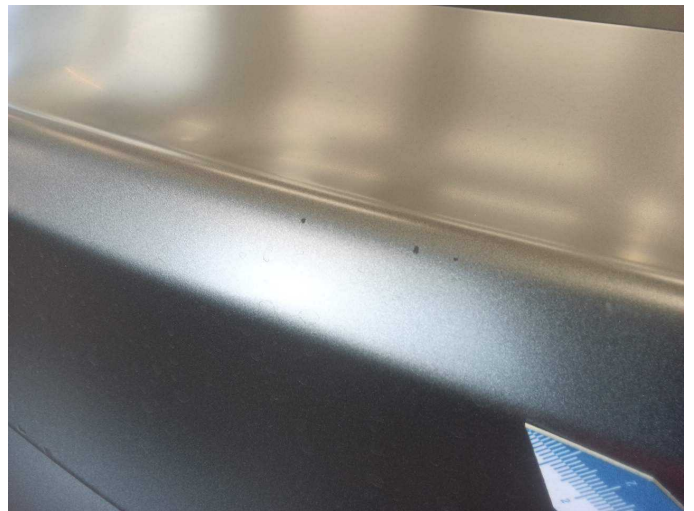
| No. | Component group | Description |
|---|---|---|
| 8 | Boot lid / rear door | Boot lid - Scratch(es) - Paint |

**Damage 8:** Boot lid / rear door: Boot lid - Scratch(es) - Paint

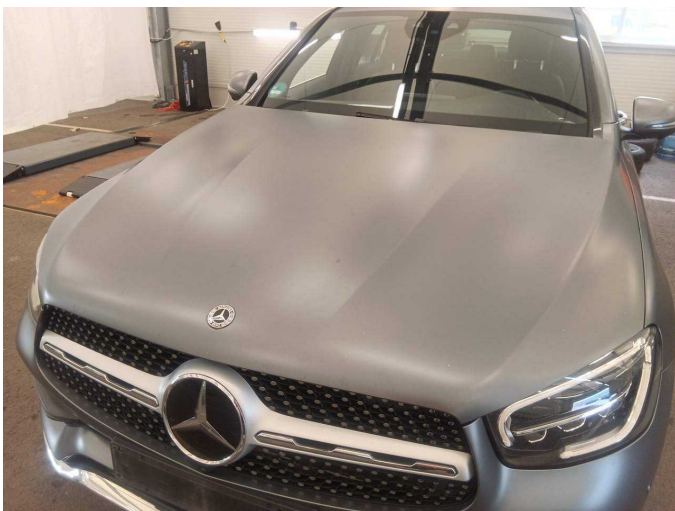
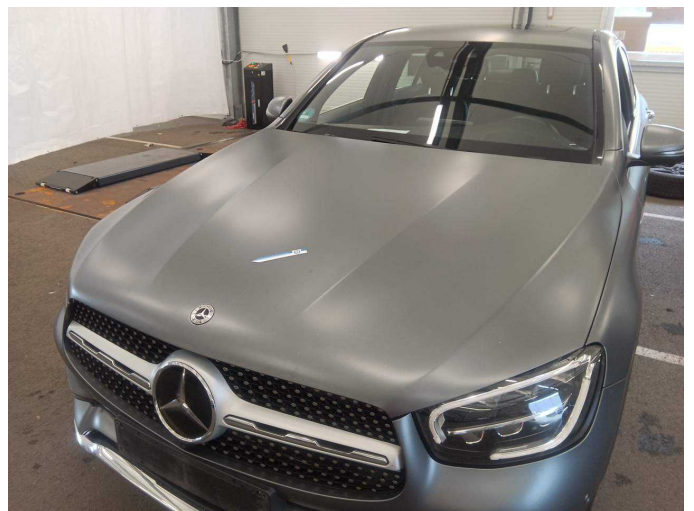
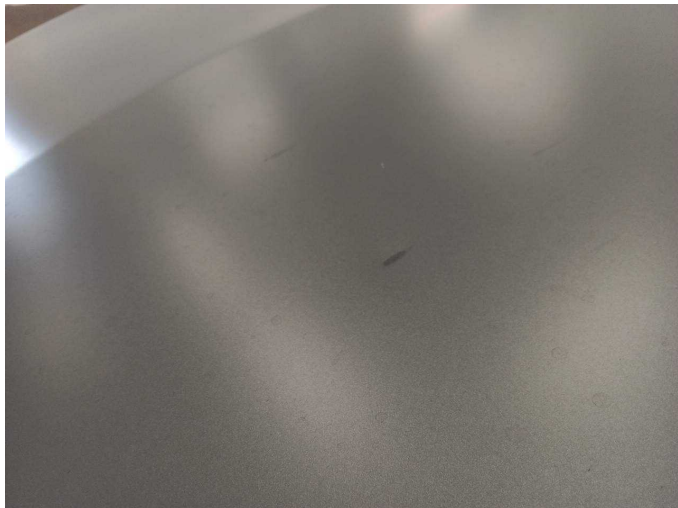
| No. | Component group | Description |
|---|---|---|
| 9 | Bonnet | Bonnet - Dent / paintcoat damage - Repair and paint |

**Damage 9:** Bonnet: Bonnet - Dent / paintcoat damage - Repair and paint

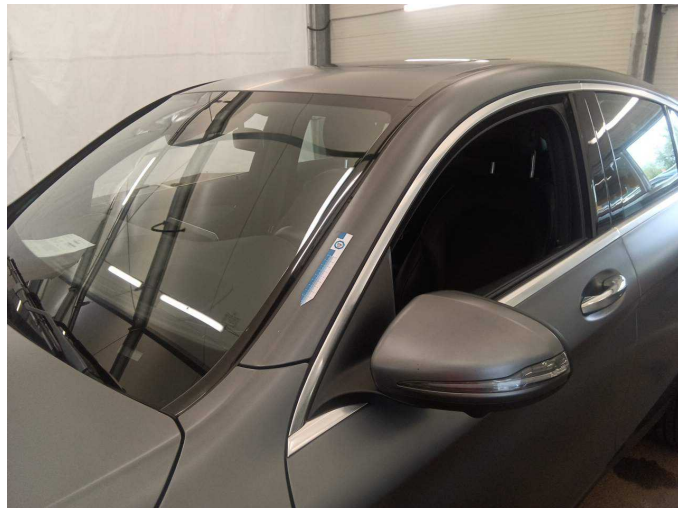
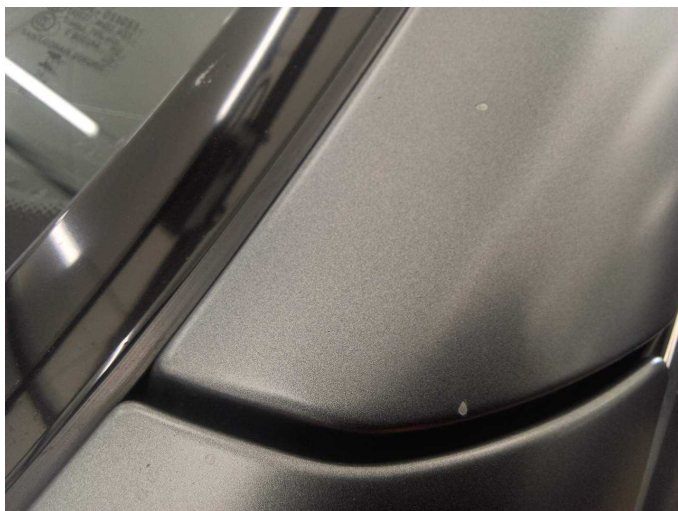
| No. | Component group | Description |
|---|---|---|
| 1 | Body | A-pillar - left side - Stone chips - No deduction |

**Wear and tear 1:** Body: A-pillar - left side - Stone chips - No deduction

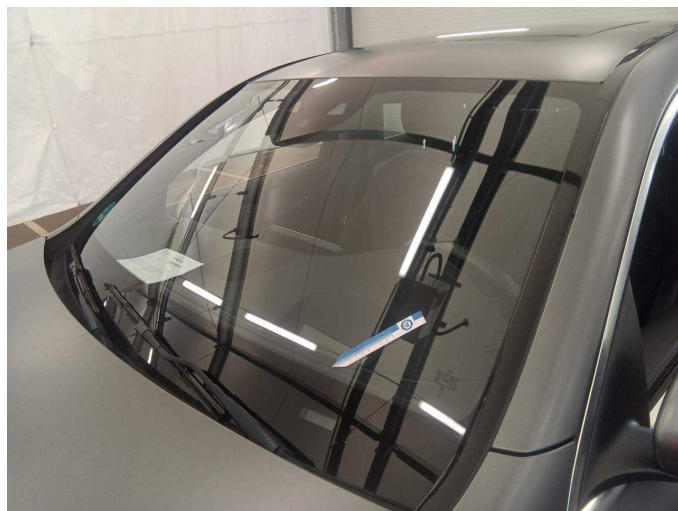
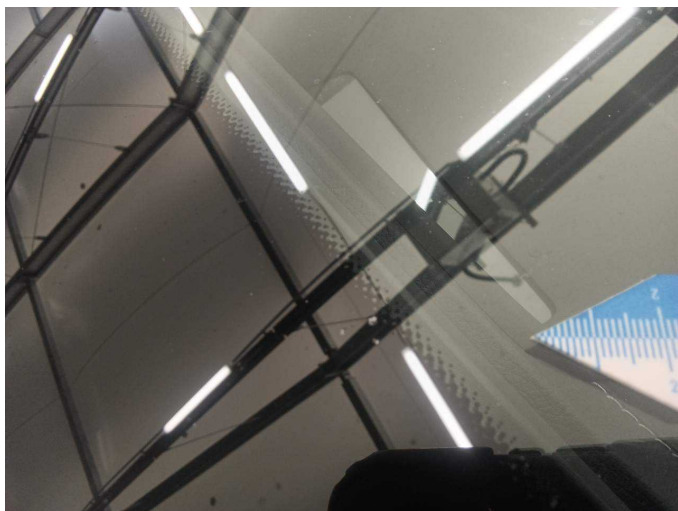
| No. | Component group | Description |
|---|---|---|
| 2 | Vehicle glazing | Windscreen - Stone chips - No deduction |

**Wear and tear 2:** Vehicle glazing: Windscreen - Stone chips - No deduction
