Expertise

Protocol number: 46334615  
Order No. / Reference: 26417707  
Inspection date: 6 Jul 2026

Manufacturer: Opel

Model: Grandland 1.5 D Automatik Elegance

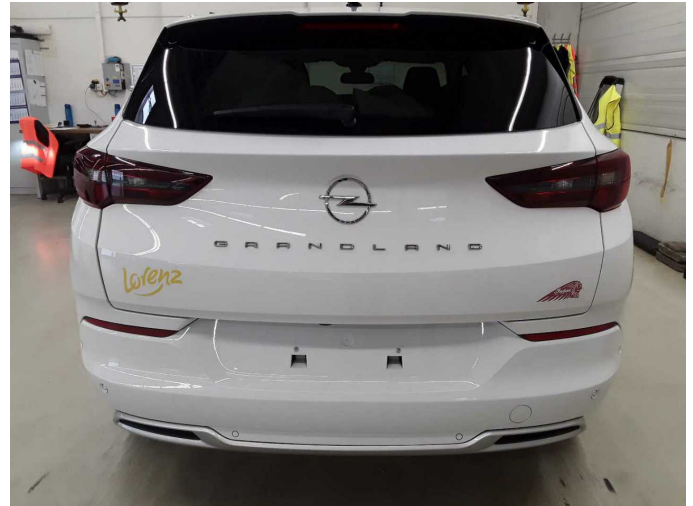
**Damage 1:** Boot lid / rear door: Boot lid (Mehrkosten nach Demontage möglich) - Glued / labelled - De-glue / neutralise

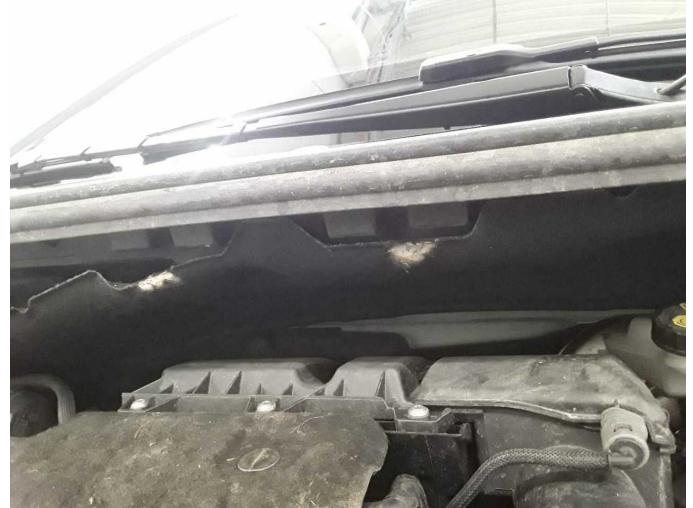
| No. | Component group | Description |
|---|---|---|
| 2 | Body | Firewall trim (Mehrkosten möglich) - Damage caused by marten / rodent - Replace |

**Damage 2:** Body: Firewall trim (Mehrkosten möglich) - Damage caused by marten / rodent - Replace

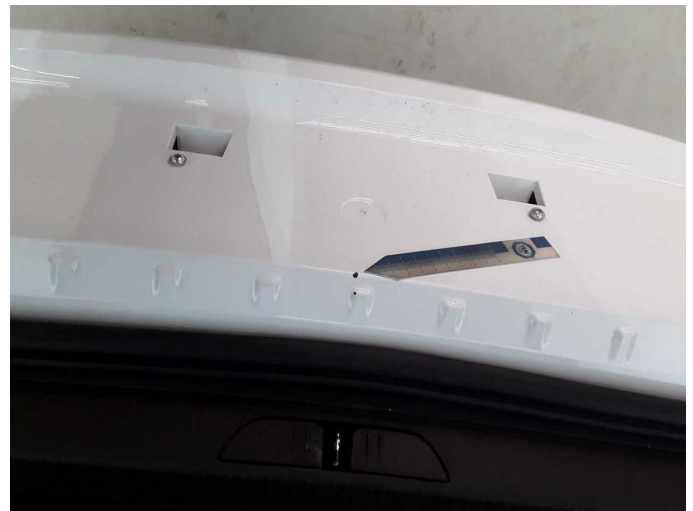
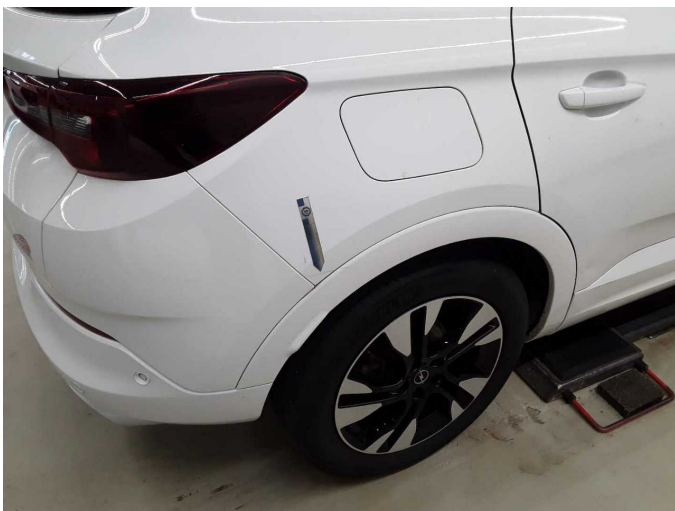
| No. | Component group | Description |
|---|---|---|
| 3 | Rear bumper | Rear bumper - Scratch(es) - Smart repair |

**Damage 3:** Rear bumper: Rear bumper - Scratch(es) - Smart repair

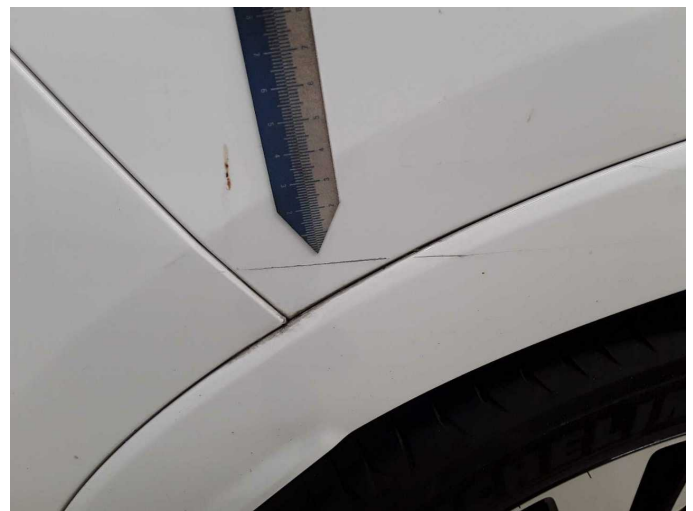
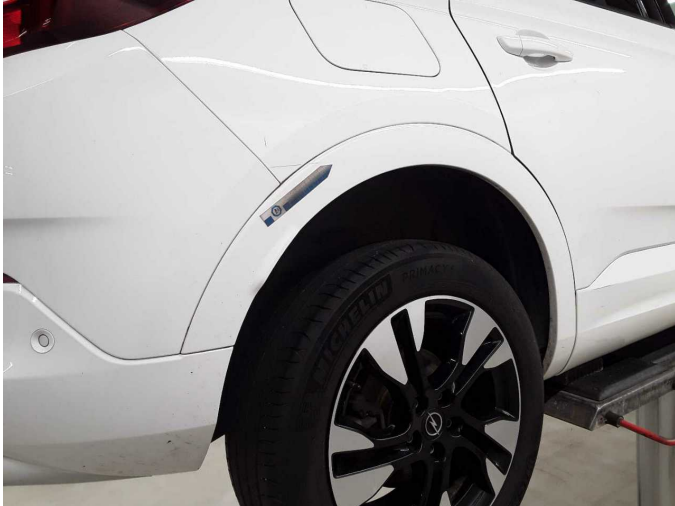
| No. | Component group | Description |
|---|---|---|
| 4 | Side panel - rear right side | Side panel - Scratch(es) - Smart repair |

**Damage 4:** Side panel - rear right side: Side panel - Scratch(es) - Smart repair

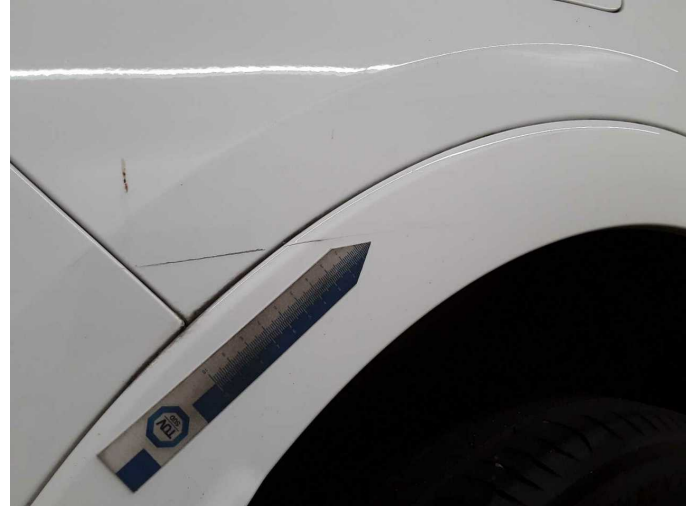
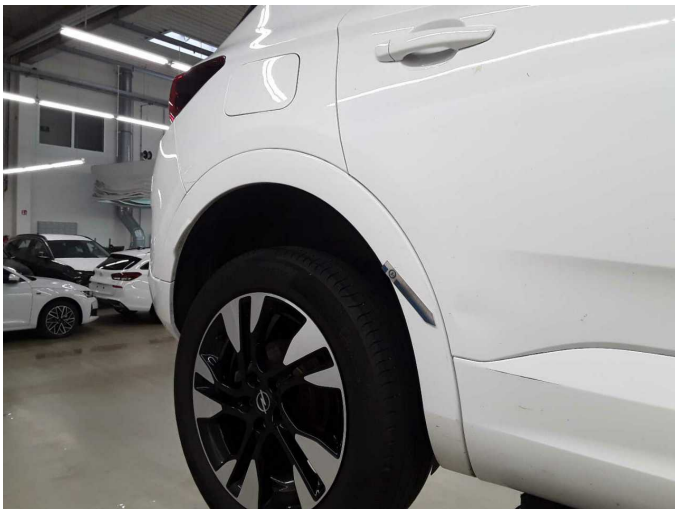
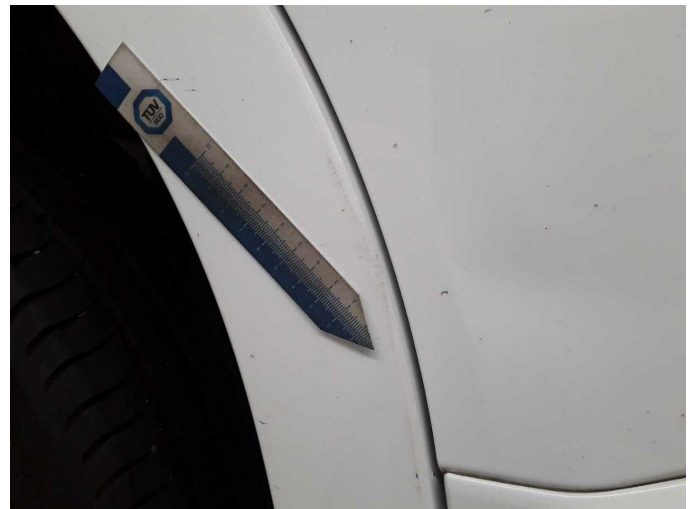
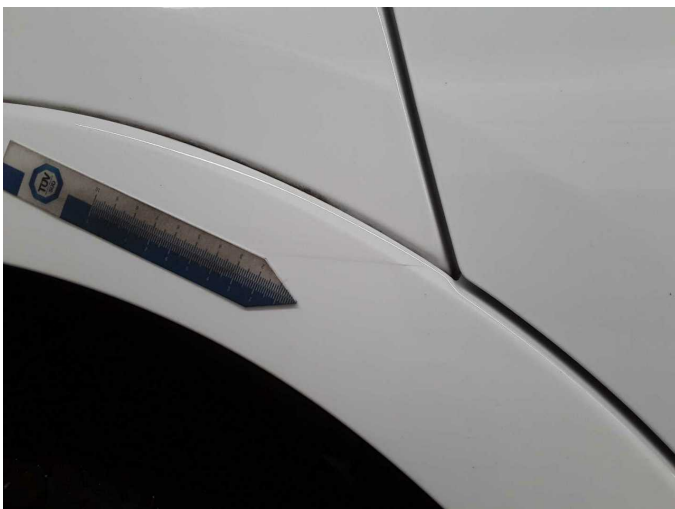
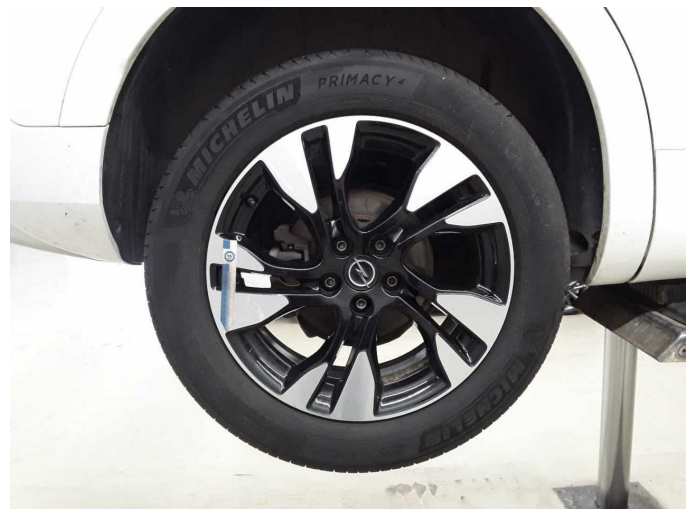
| No. | Component group | Description |
|---|---|---|
| 5 | Side panel - rear right side | Wheel well extension - Scratched - Paint |

**Damage 5:** Side panel - rear right side: Wheel well extension - Scratched - Paint

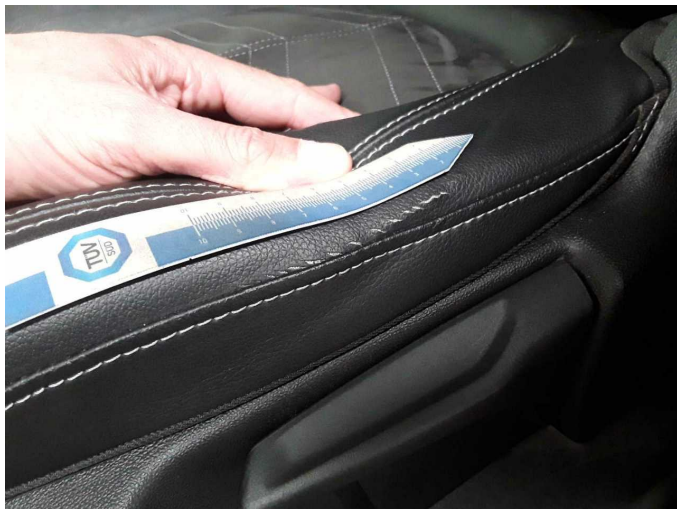
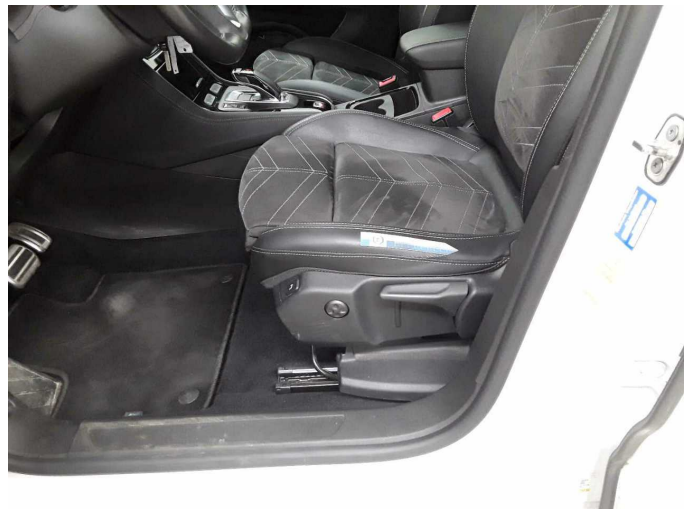
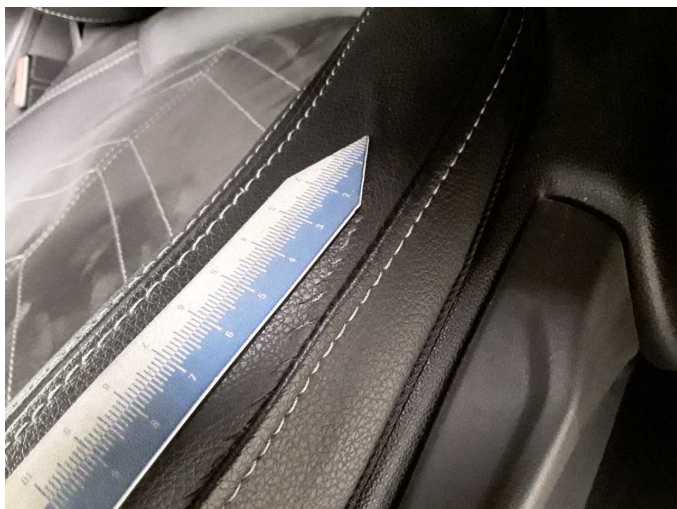
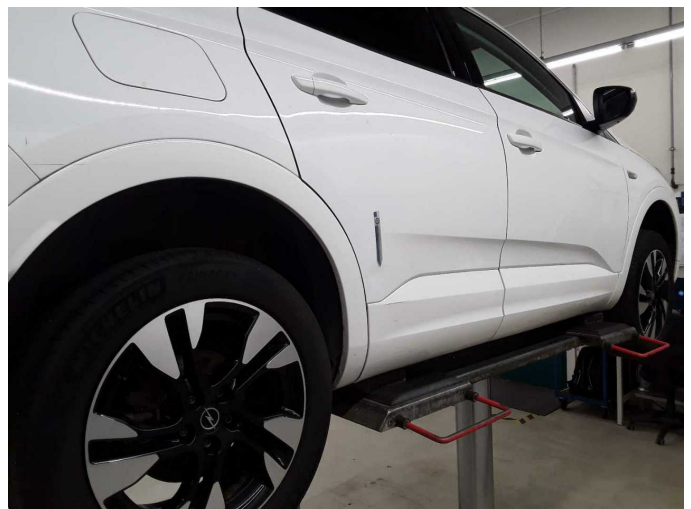
| No. | Component group | Description |
|---|---|---|
| 7 | Seat - front | Seat cover - left side - Broken / torn - Replace |

**Damage 7:** Seat - front: Seat cover - left side - Broken / torn - Replace

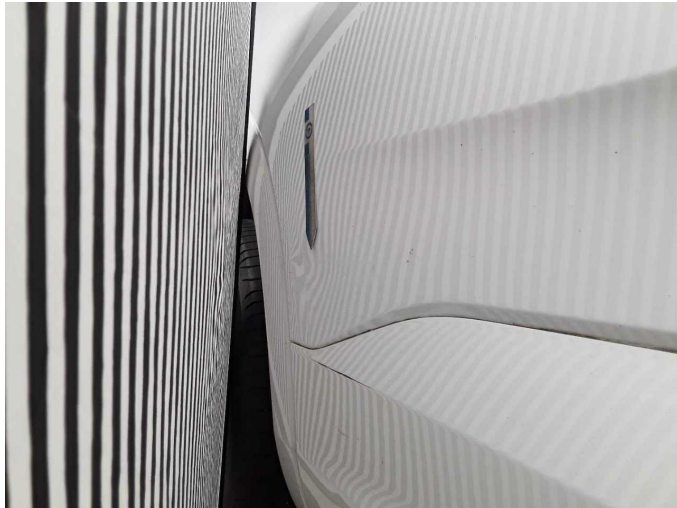
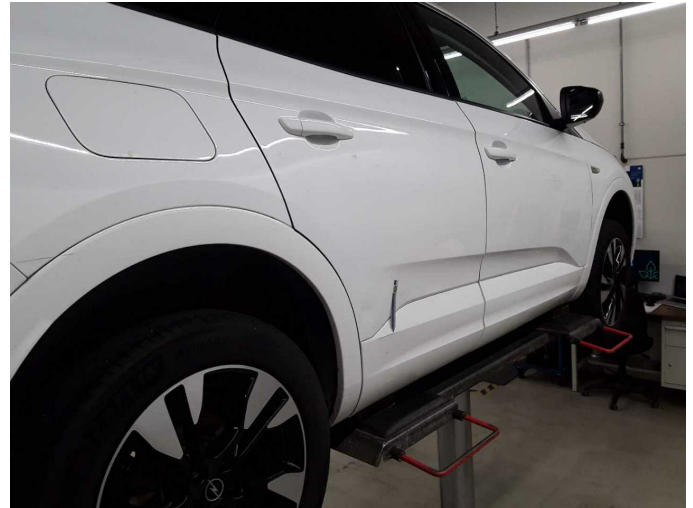
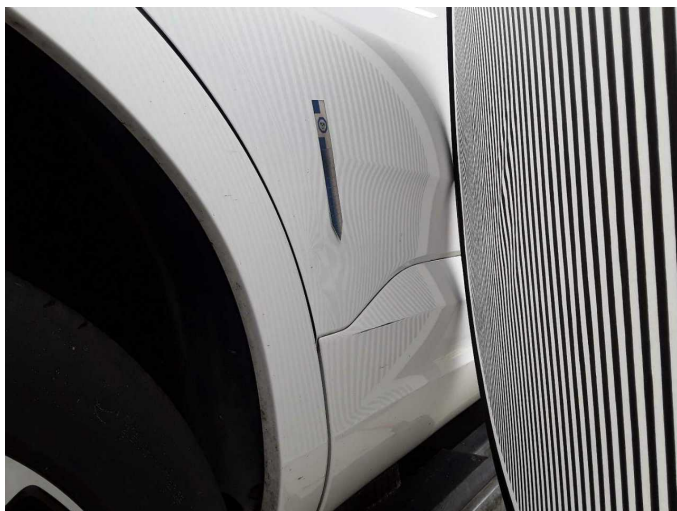
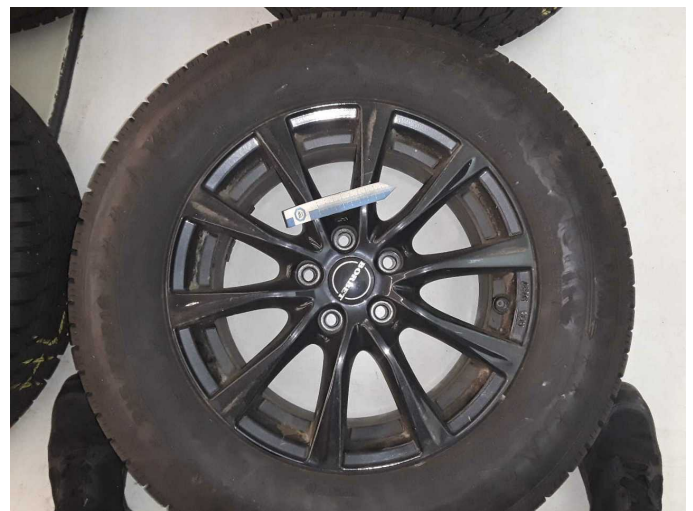
| No. | Component group | Description |
|---|---|---|
| 8 | Door - rear right side | Door (inkl. Zierleiste Tür unten erneuern) - Dent / paintcoat damage - Repair and paint |

**Damage 8:** Door - rear right side: Door (inkl. Zierleiste Tür unten erneuern) - Dent / paintcoat damage - Repair and paint

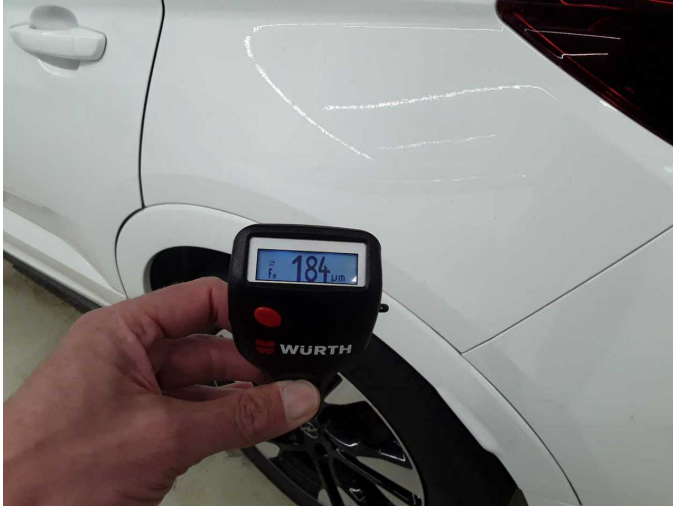
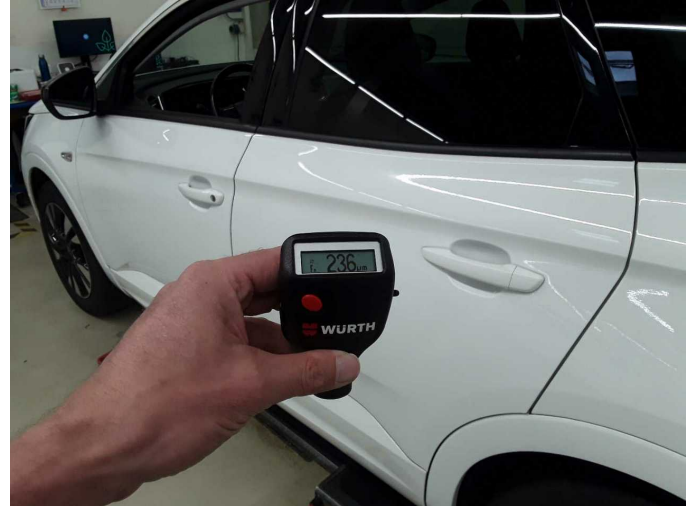
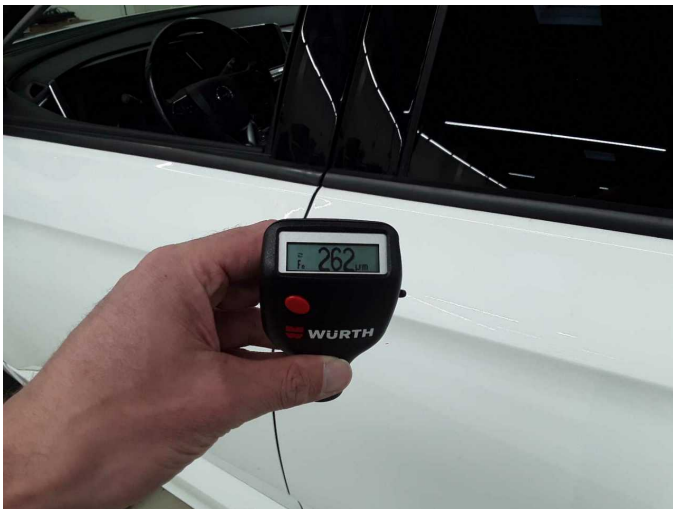
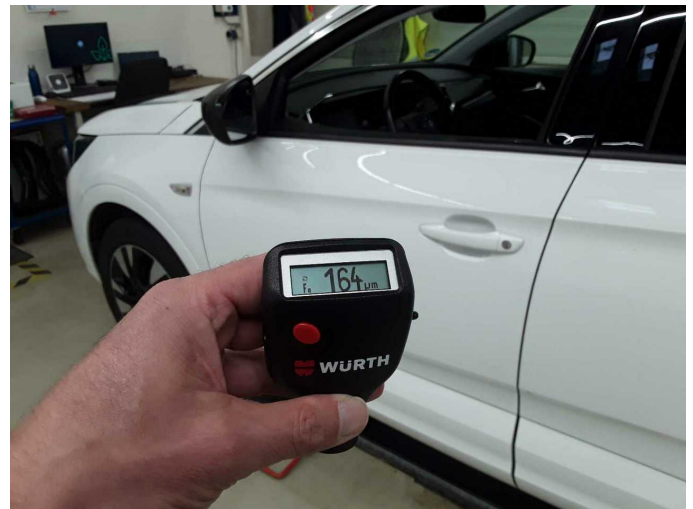
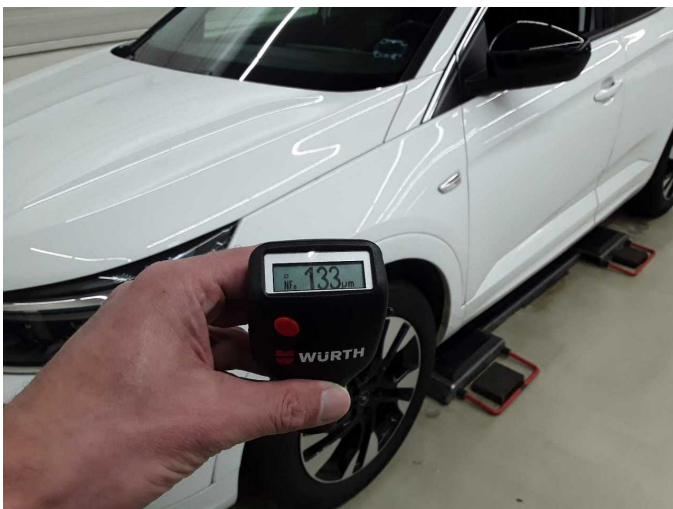
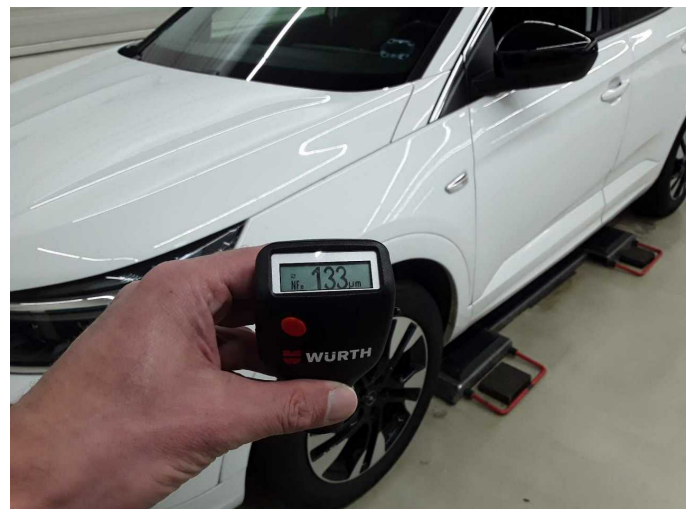
| No. | Repainting |
|---|---|
| 1 | Mudguard - left side, Side panel - rear left side, Door - rear left side, Door - front left side, Professionally carried out, Invoice of repair done Non-existent |

**Repainting 1:** Mudguard - left side, Side panel - rear left side, Door - rear left side, Door - front left side

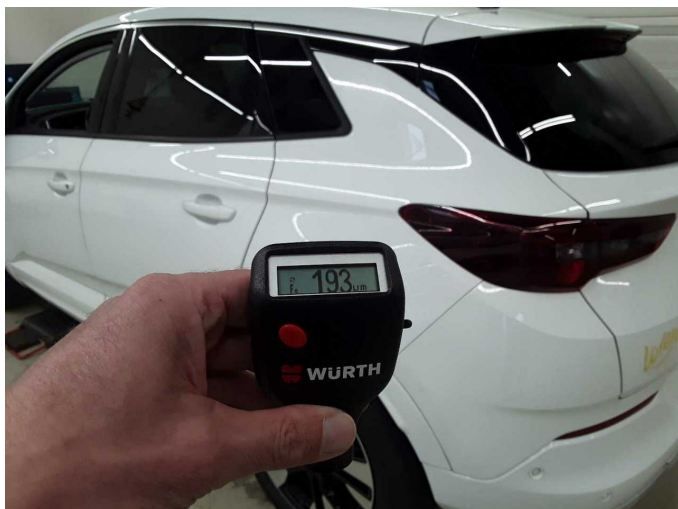
**Mudguard - left side:** 133 µm

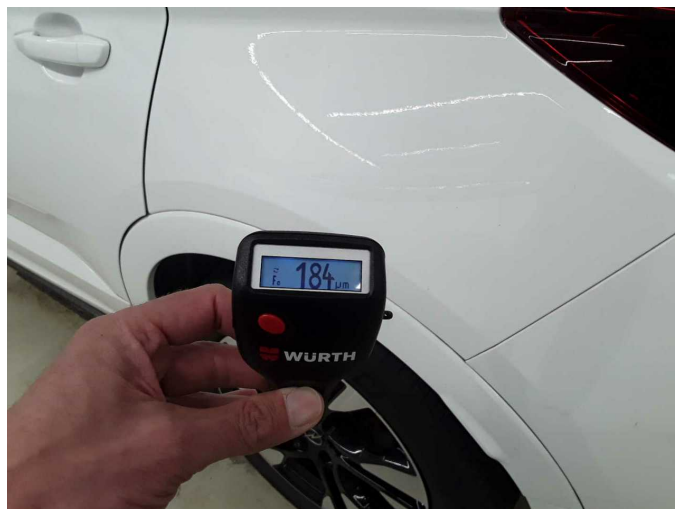
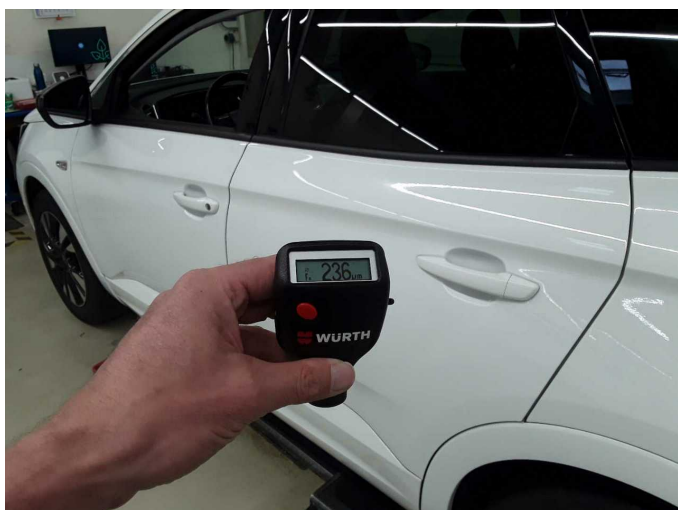
Side panel - rear left side: 193 µm

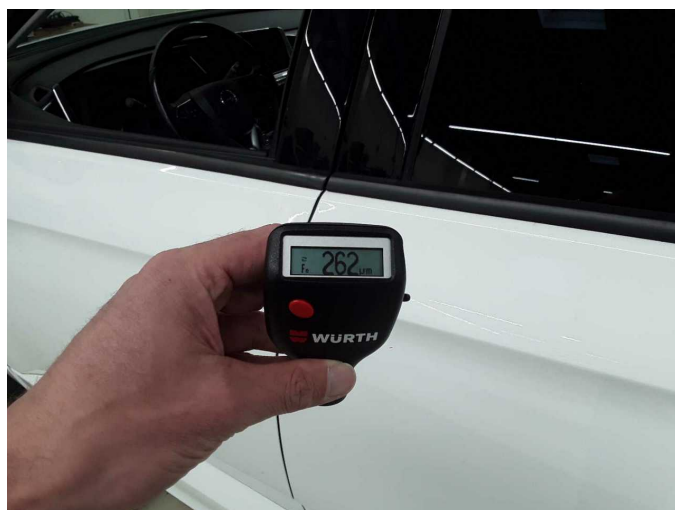
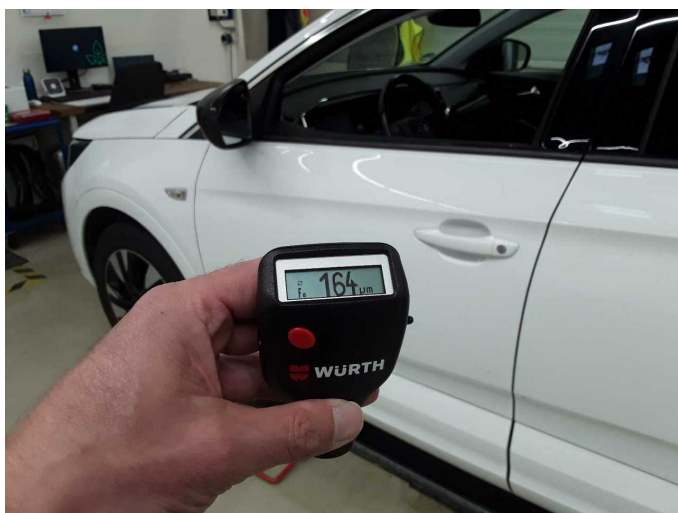
Door - rear left side: 262 µm
