Expertise

Protocol number: 46519513  
Order No. / Reference: 26511197  
Inspection date: 7 Jul 2026

Manufacturer: Skoda  
VIN: TMBLN9PS7ST104643

Model: Kodiaq 2.0 TDI 4x4 DSG Sportline

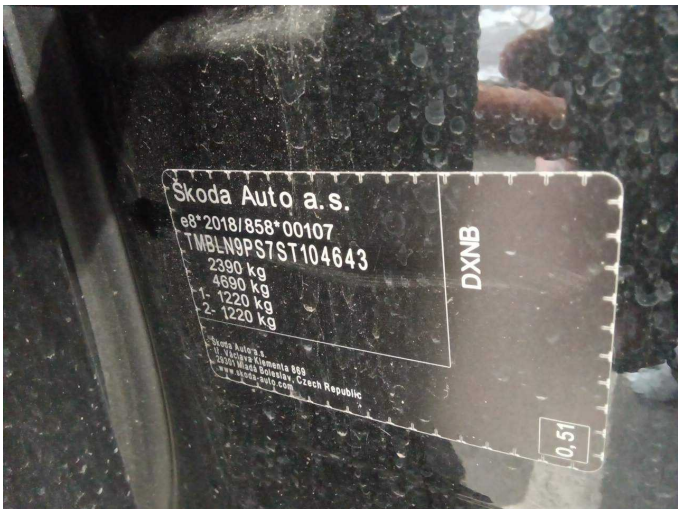
Figure 11: VIN

| VIN comparison | The vehicle identification number (VIN) was read from the vehicle and its conformity with the submitted documents was confirmed by the undersigned during the inspection. |

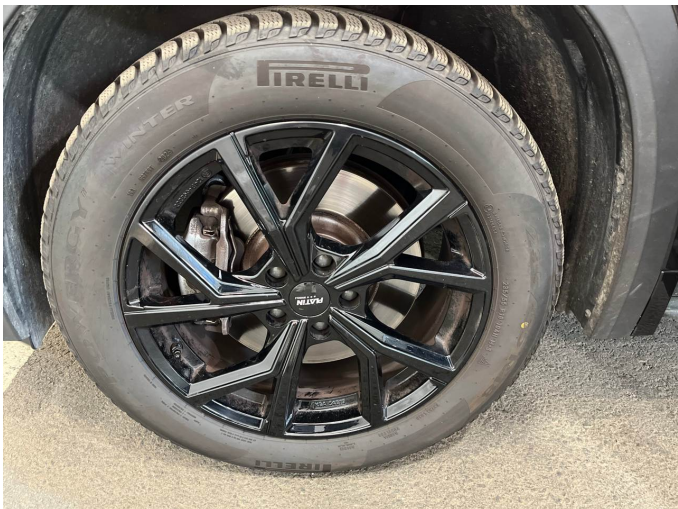
Figure 12: Mounted tyres

| # | Tyre size | Type of tyre | Manufacturer | Tread depth |
|---|---|---|---|---|
| 1) | 235/50 R19 99V | Summer tyres on Light alloy | Hankook | 6mm / 6mm |
| 2) | 235/50 R19 99V | Summer tyres on Light alloy | Hankook | 6mm / 6mm |

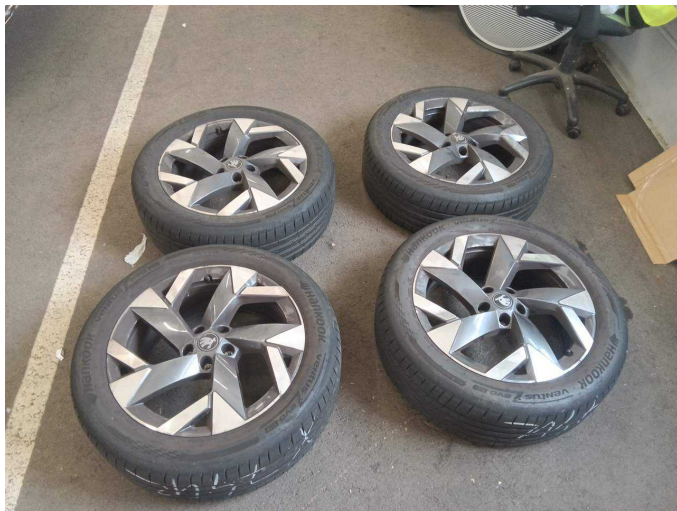
Figure 15: Additional tyres

| # | Tyre size | Type of tyre | Manufacturer | Tread depth |
|---|---|---|---|---|
| 1) | 235/55 R18 104H | Winter tyres on Light alloy | Pirelli | 7mm / 7mm |
| 2) | 235/55 R18 104H | Winter tyres on Light alloy | Pirelli | 7mm / 7mm |

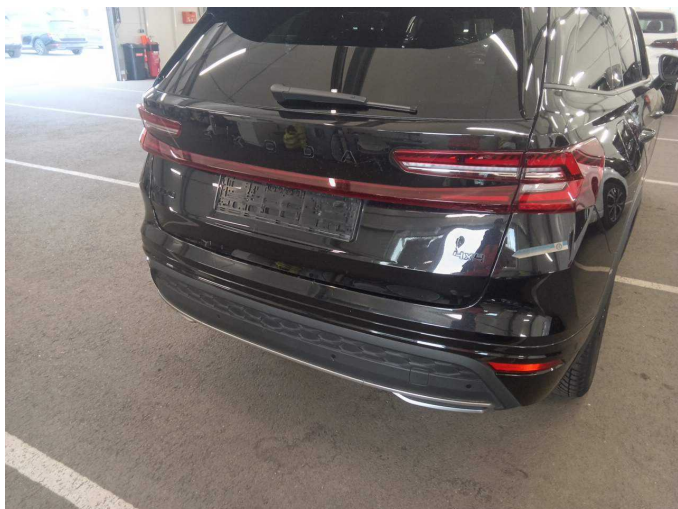
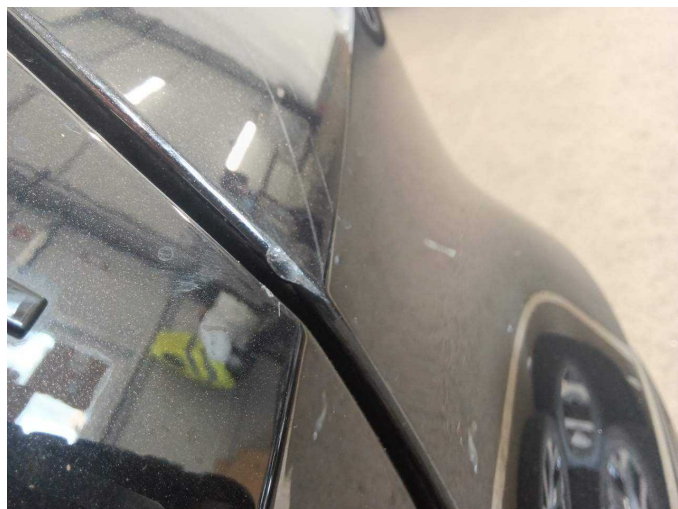
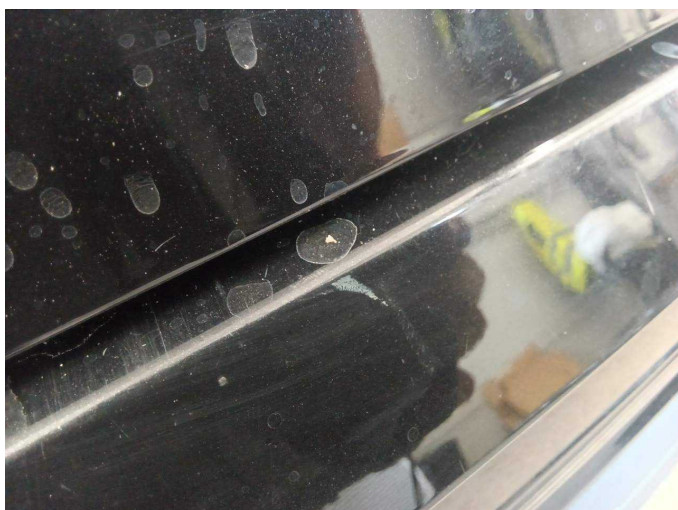
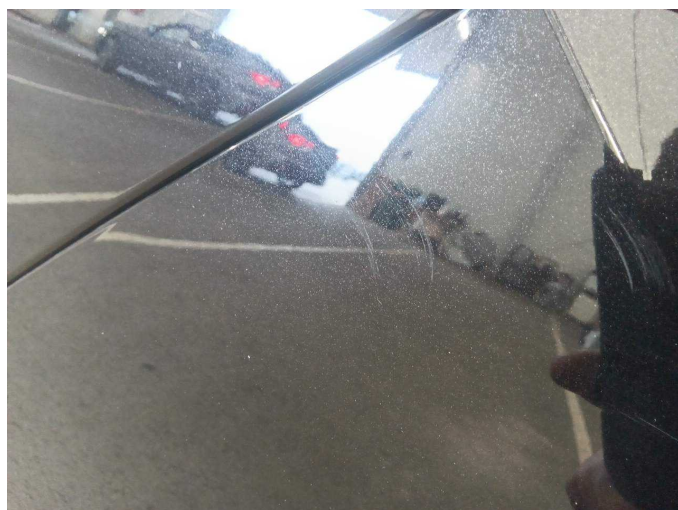
| No. | Component group | Description |
|---|---|---|
| 1 | Rear bumper | Rear bumper - Scratch(es) - Paint |

**Damage 1:** Rear bumper: Rear bumper - Scratch(es) - Paint

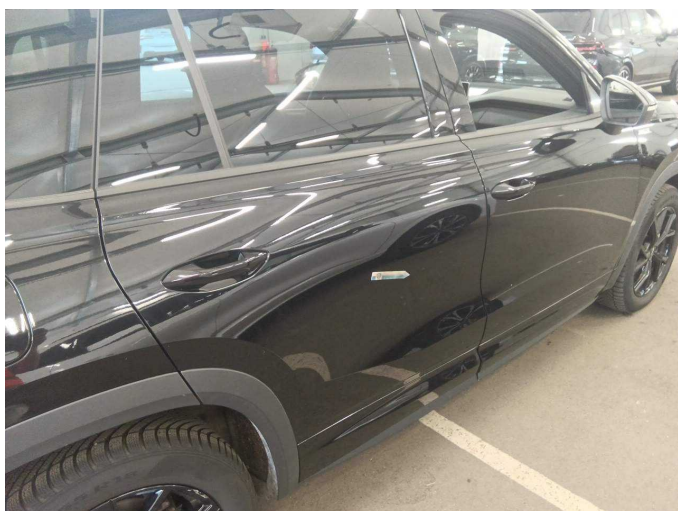
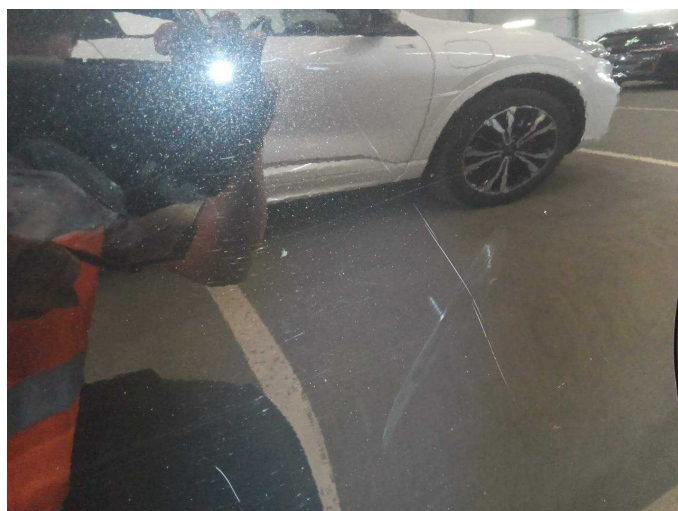
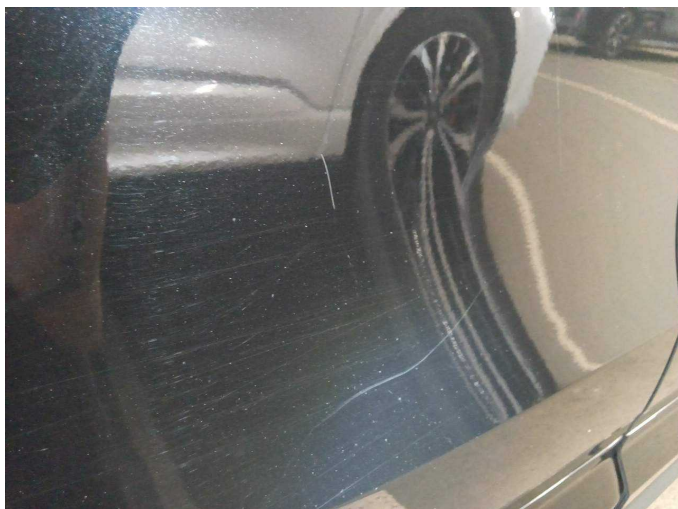
| No. | Component group | Description |
|---|---|---|
| 2 | Door - rear right side | Door - Scratch(es) - Paint |

**Damage 2:** Door - rear right side: Door - Scratch(es) - Paint

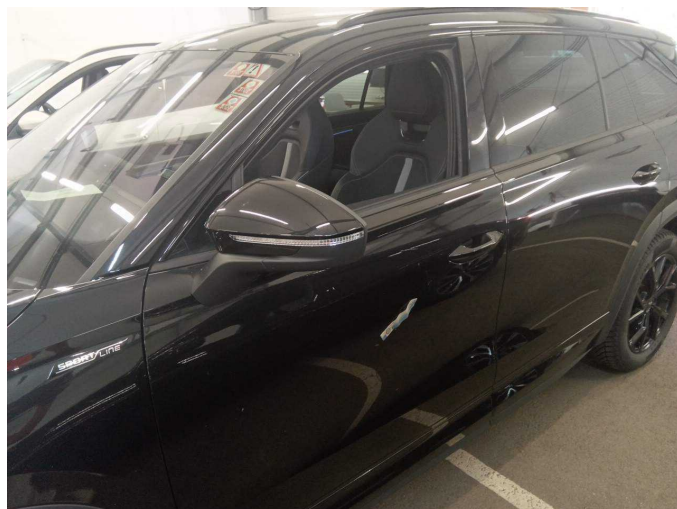
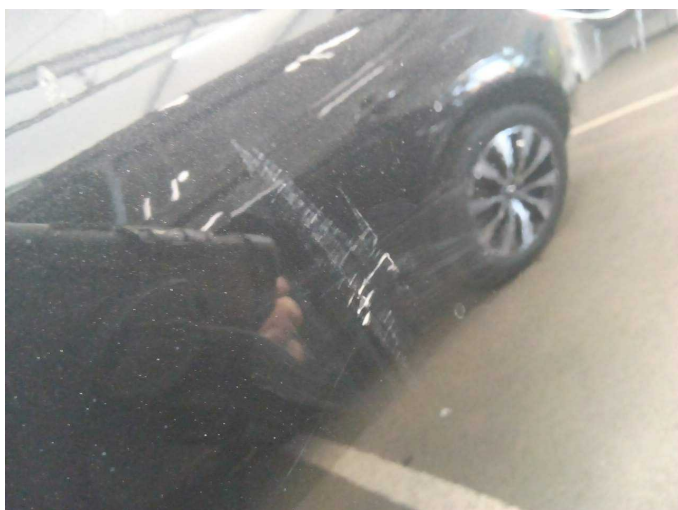
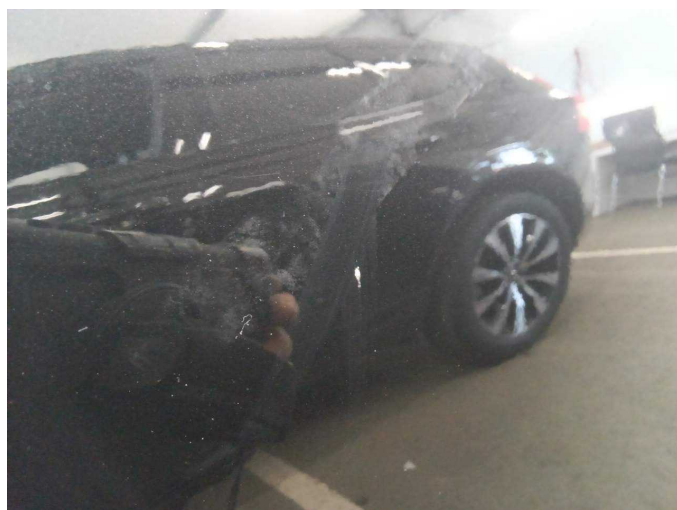
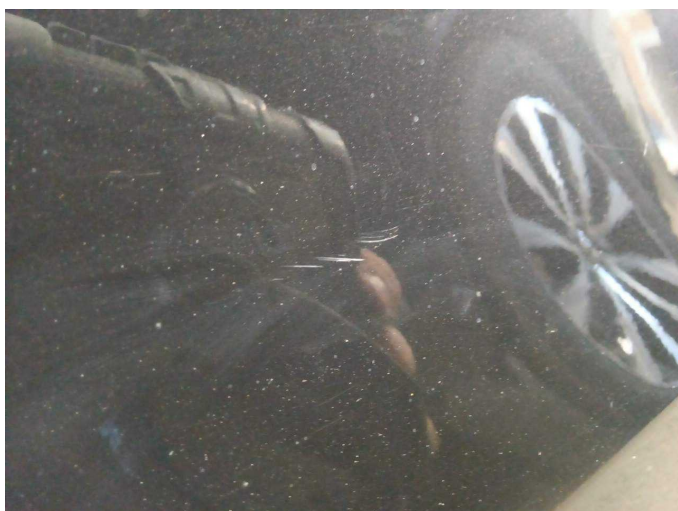
| No. | Component group | Description |
|---|---|---|
| 3 | Door - front left side | Door - Scratch(es) - Paint |

**Damage 3:** Door - front left side: Door - Scratch(es) - Paint

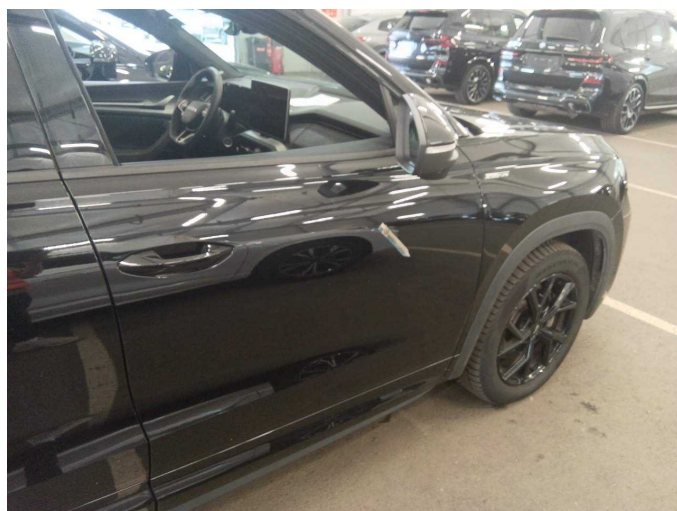
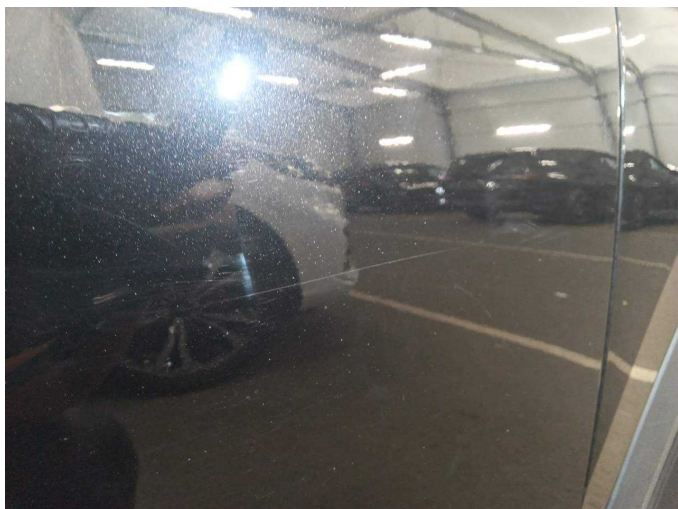
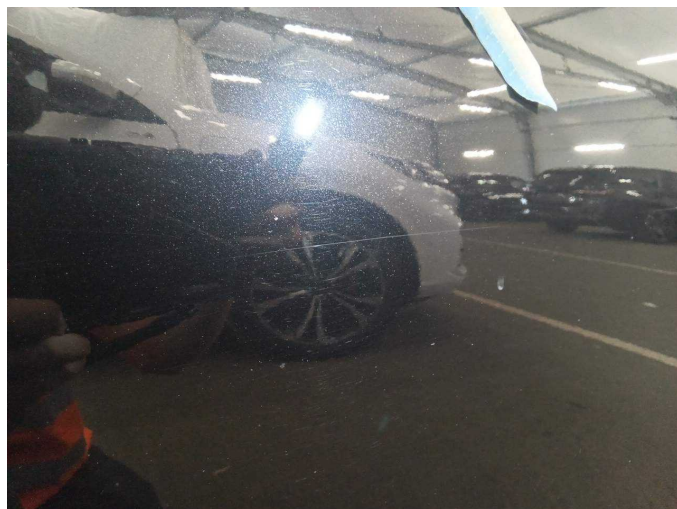
| No. | Component group | Description |
|---|---|---|
| 4 | Door - front right side | Door - Scratch(es) - Paint |

**Damage 4:** Door - front right side: Door - Scratch(es) - Paint

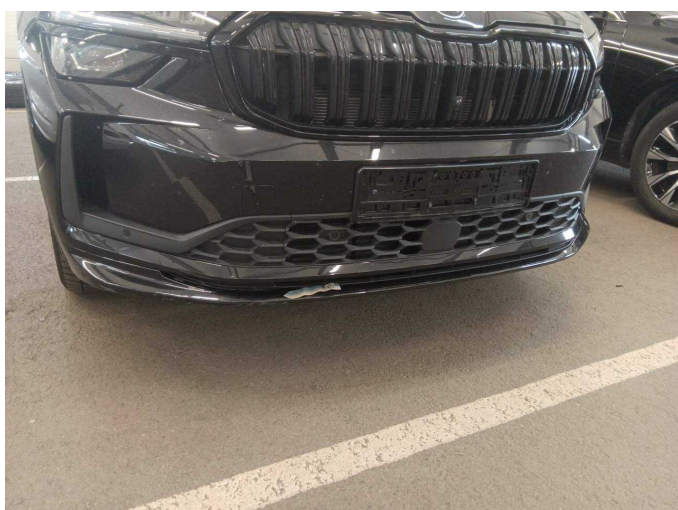
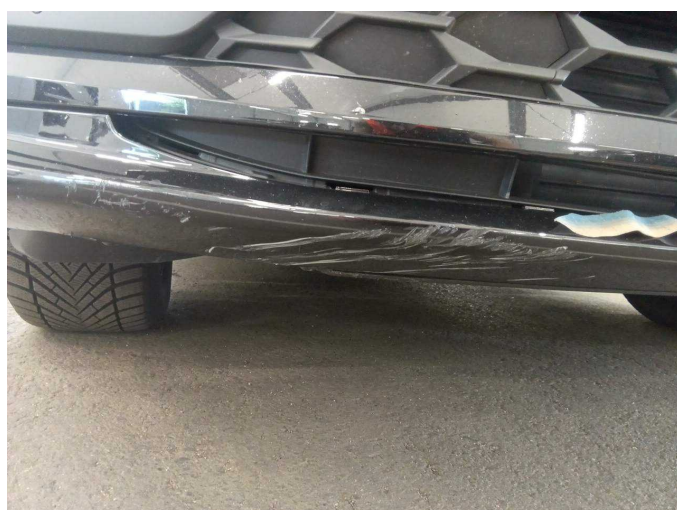
| No. | Component group | Description |
|---|---|---|
| 5 | Front bumper | Front bumper - Scratched - Repair and paint |

**Damage 5:** Front bumper: Front bumper - Scratched - Repair and paint

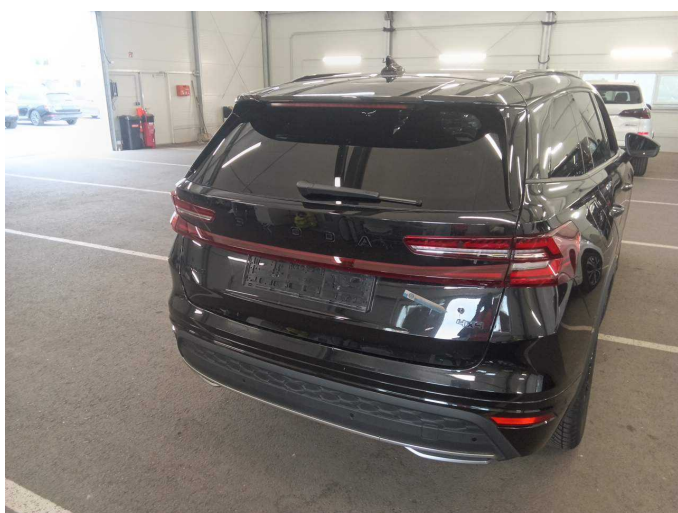
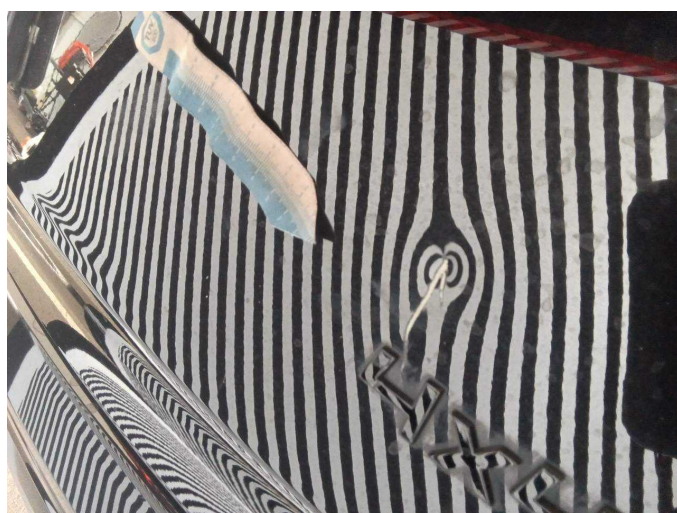
| No. | Component group | Description |
|---|---|---|
| 6 | Boot lid / rear door | Boot lid - Dent / paintcoat damage - Repair and paint |

**Damage 6:** Boot lid / rear door: Boot lid - Dent / paintcoat damage - Repair and paint

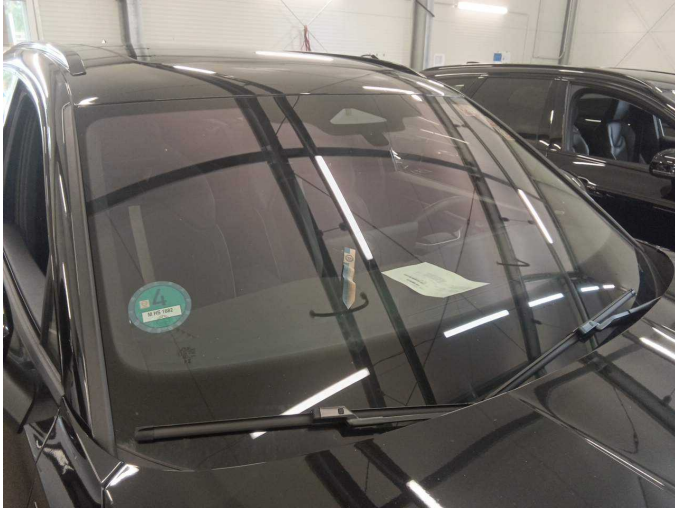
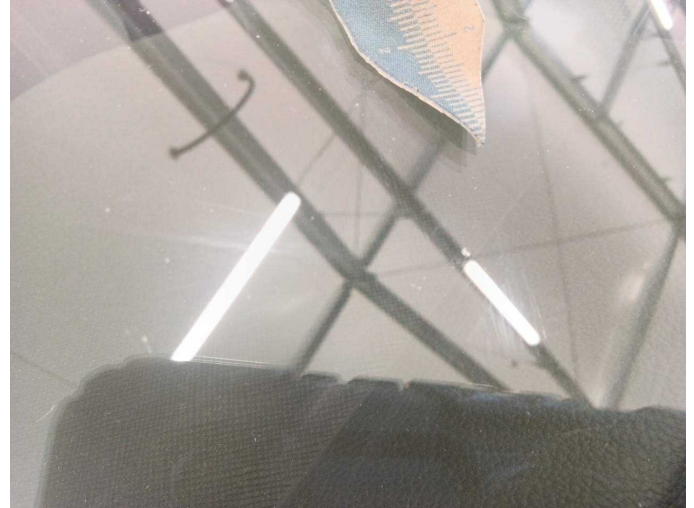
| No. | Component group | Description |
|---|---|---|
| 1 | Vehicle glazing | Windscreen - Stone chips - No deduction |

**Wear and tear 1:** Vehicle glazing: Windscreen - Stone chips - No deduction
