Expertise

Protocol number: 46100664
Order No. / Reference: 26470150
Inspection date: 23 Jun 2026

Model: Kodiaq 2.0 TDI DSG Style

VIN: TMBJJ9NS2P8045467

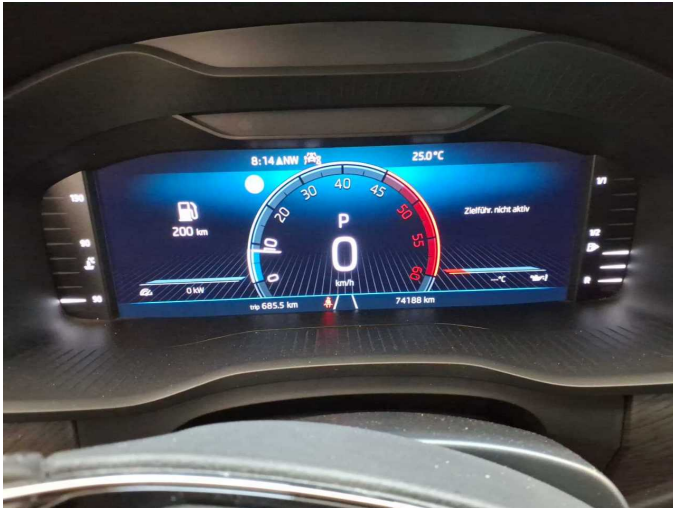
Figure 7: Instrument cluster

Mileage (Read) 74,188 km

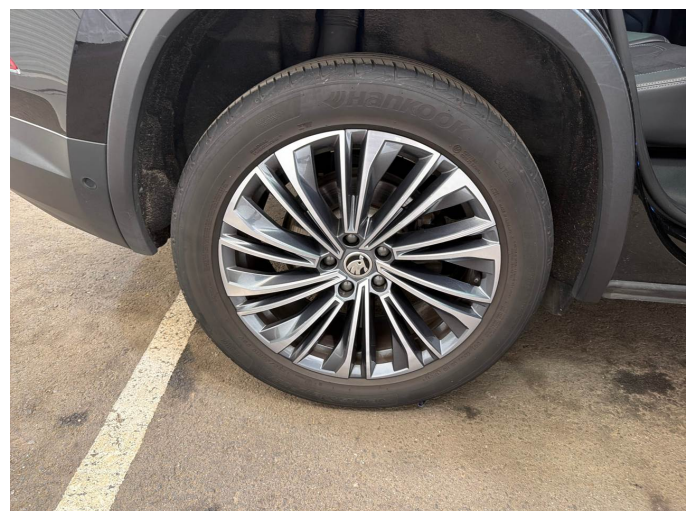
Figure 12: Mounted tyres

#	Tyre size	Type of tyre	Manufacturer	Tread depth
1)	235/50 R19 99V	Summer tyres on Light alloy	Hankook	5mm / 5mm
2)	235/50 R19 99V	Summer tyres on Light alloy	Hankook	5mm / 5mm

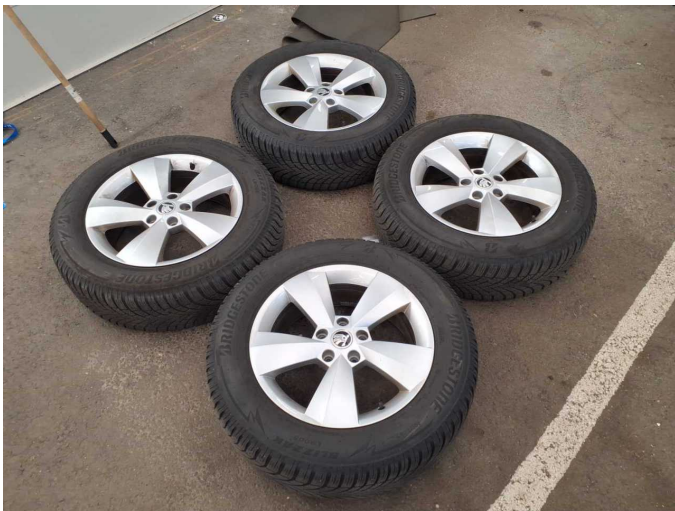
Figure 15: Additional tyres

#	Tyre size	Type of tyre	Manufacturer	Tread depth
1)	215/65 R17 103H	Winter tyres on Light alloy	Bridgestone	6mm / 6mm
2)	215/65 R17 103H	Winter tyres on Light alloy	Bridgestone	6mm / 6mm

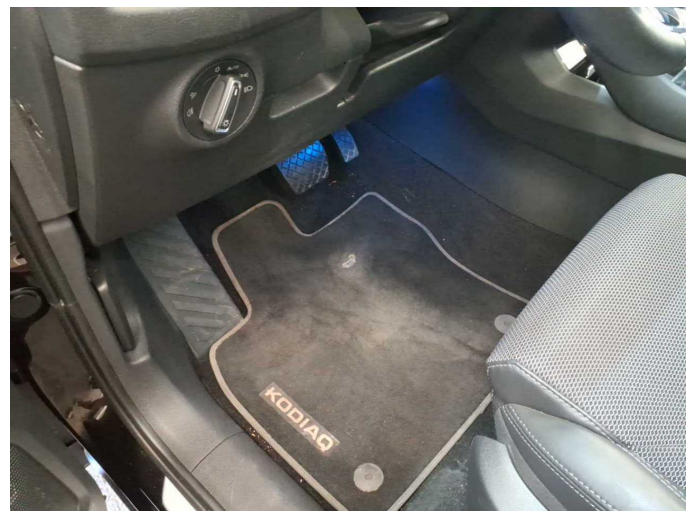
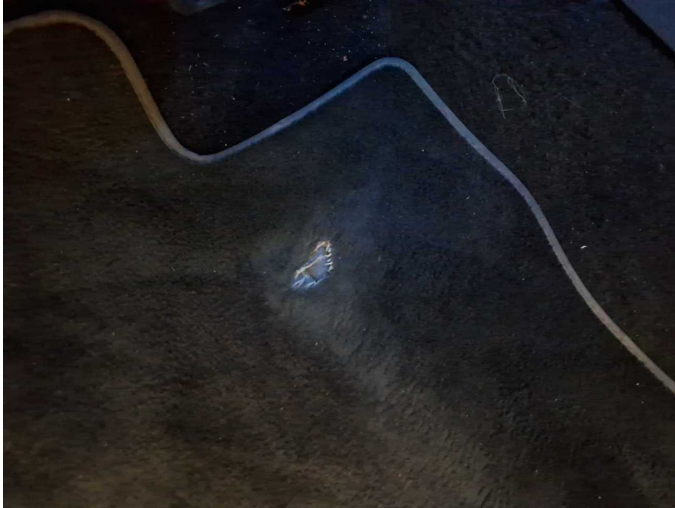
Damage 1: Trim / covers: Floor mats (vorne links) - Damaged - Replace

No.	Component group	Description
1	Trim / covers	Floor mats (vorne links) - Damaged - Replace
2	Side panel - rear right side	Side panel - Scratched - Smart repair
3	Vehicle glazing	Windscreen (Mit Rissbildung im Randbereich) - Stone chips - Replace

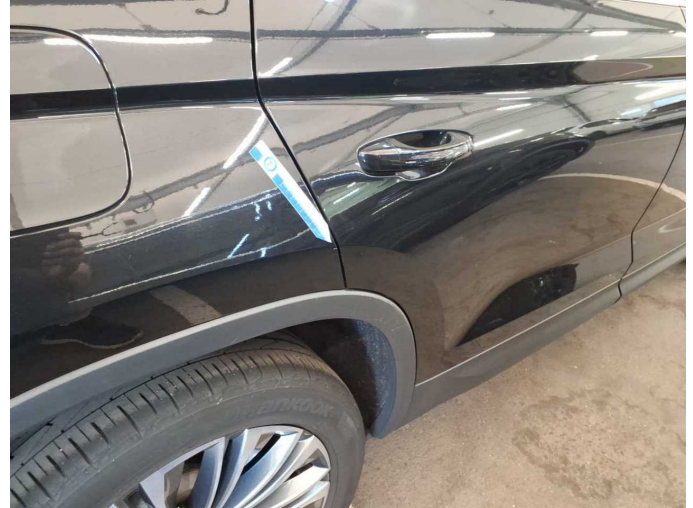
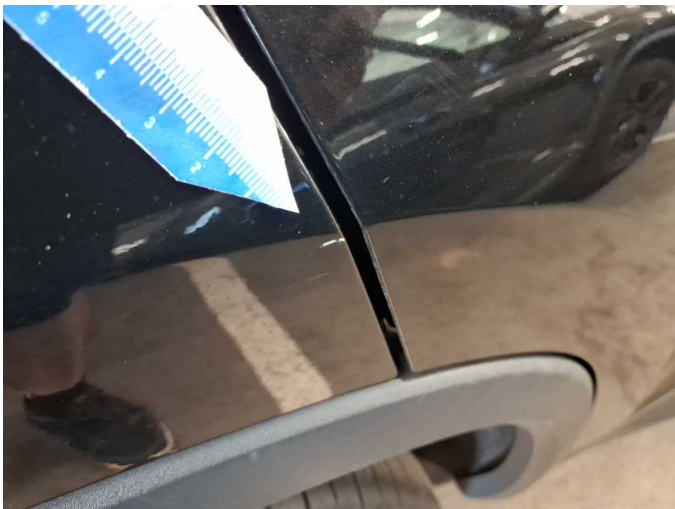
Damage 2: Side panel - rear right side: Side panel - Scratched - Smart repair

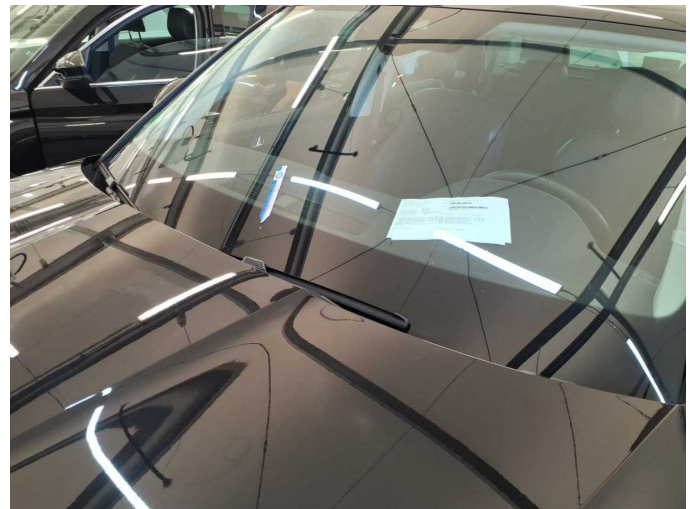
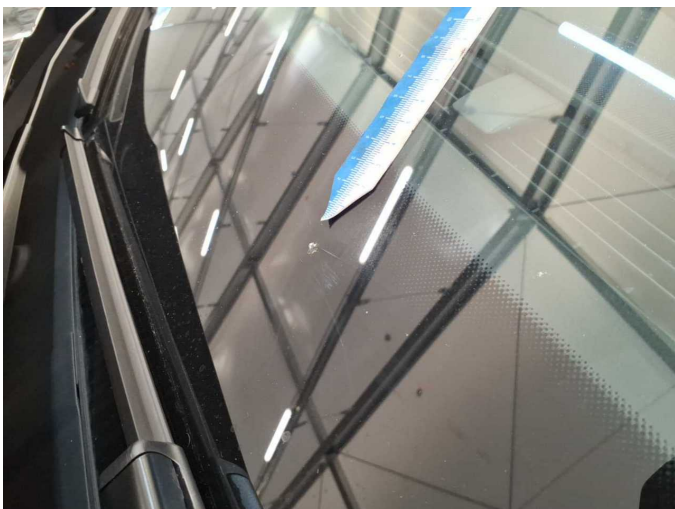
Damage 3: Vehicle glazing: Windscreen (Mit Rissbildung im Randbereich) - Stone chips - Replace
