Expertise

Protocol number: 46471221  
Order No. / Reference: 26611787  
Inspection date: 13 Jul 2026

Model: Grandland Plug-in-Hybrid 1.6 DI Automatik Elegance

VIN: W0VZ4DGZ5P6005182

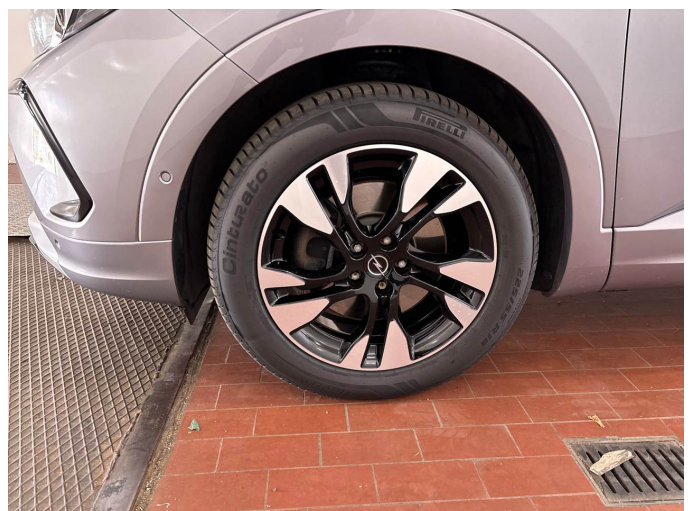
Figure 12: Mounted tyres

| # | Tyre size | Type of tyre | Manufacturer | Tread depth |
|---|---|---|---|---|
| 1) | 225/55 R18 102Y | Summer tyres on Light alloy | Pirelli | 7mm / 7mm |
| 2) | 225/55 R18 102Y | Summer tyres on Light alloy | Pirelli | 7mm / 7mm |

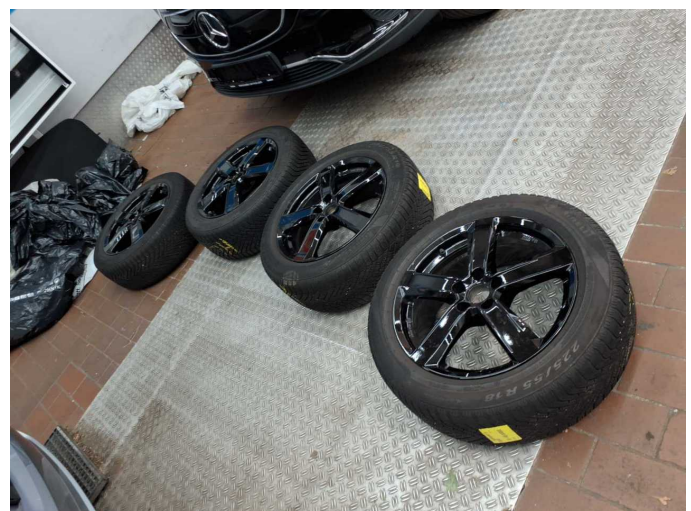
Figure 18: Additional tyres

| # | Tyre size | Type of tyre | Manufacturer | Tread depth |
|---|---|---|---|---|
| 1) | 225/55 R18 102V | Winter tyres on Light alloy | Pirelli | 5mm / 5mm |
| 2) | 225/55 R18 102V | Winter tyres on Light alloy | Pirelli | 3mm / 3mm |

| No. | Component group | Description |
|---|---|---|
| 1 | 2nd wheel set | 2 tyres - Does not meet the leasing specifications - No deduction |

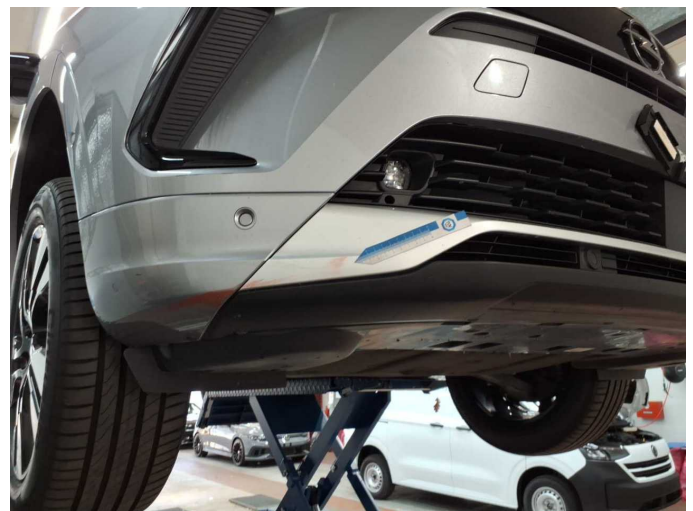
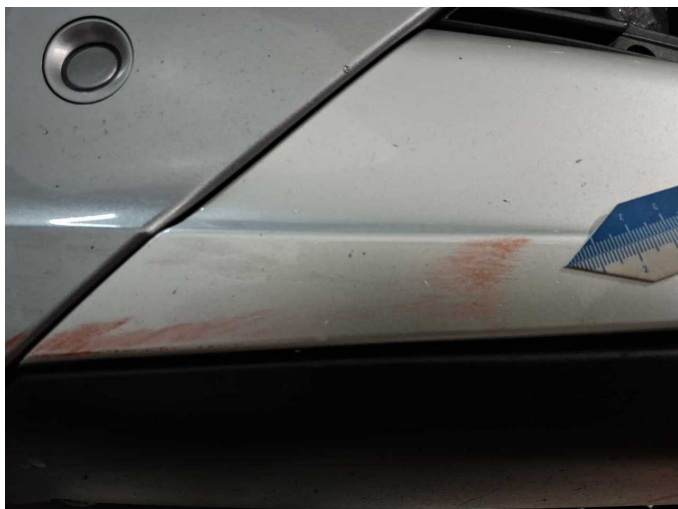
| No. | Component group | Description |
|---|---|---|
| 1 | Front bumper | Spoiler - Scratched - Cover / polish |

Damage 1: Front bumper: Spoiler - Scratched - Cover / polish

**Damage 1:** Front bumper: Spoiler - Scratched - Cover / polish

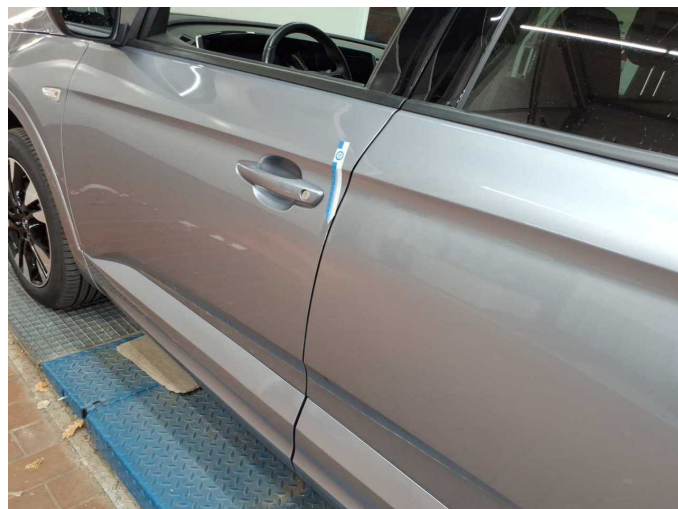
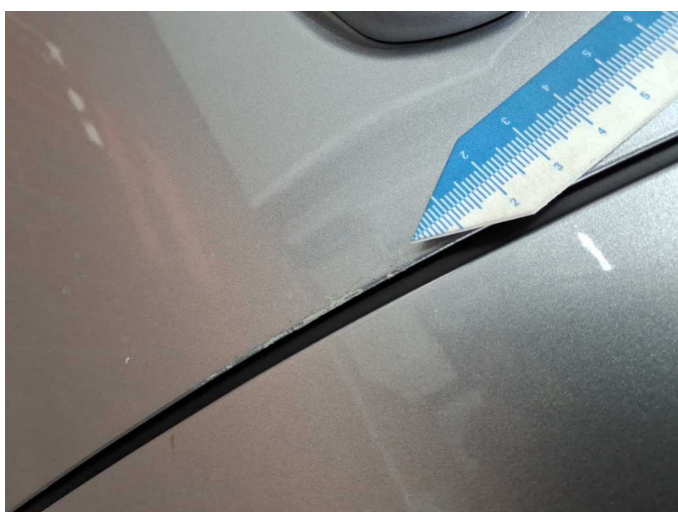
| No. | Component group | Description |
|---|---|---|
| 2 | Door - front left side | Door - Scratch(es) - Smart repair |

**Damage 2:** Door - front left side: Door - Scratch(es) - Smart repair

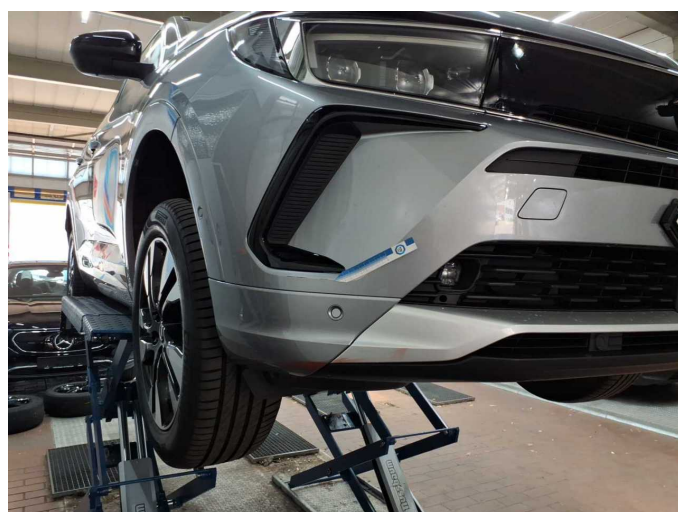
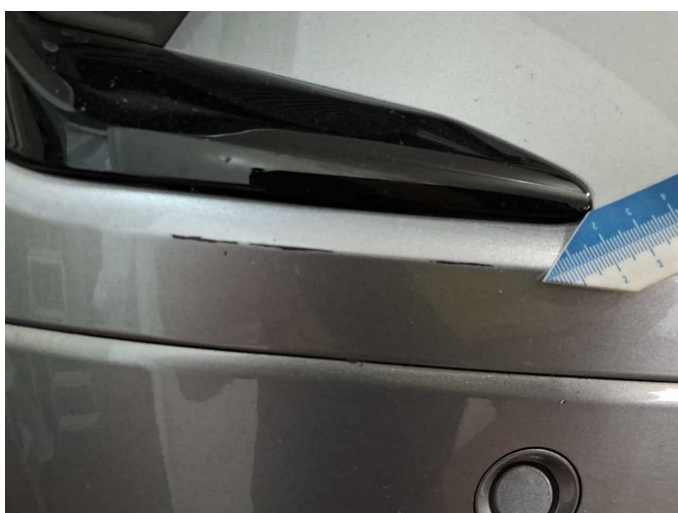
| No. | Component group | Description |
|---|---|---|
| 3 | Front bumper | Front bumper - Scratched - Smart repair |

**Damage 3:** Front bumper: Front bumper - Scratched - Smart repair

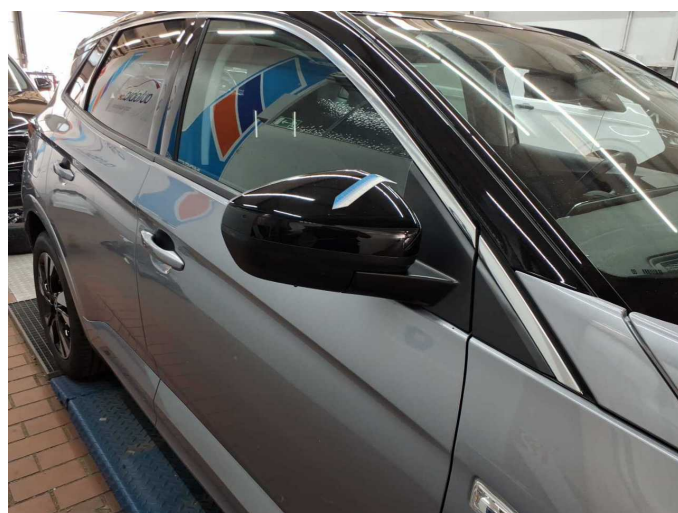
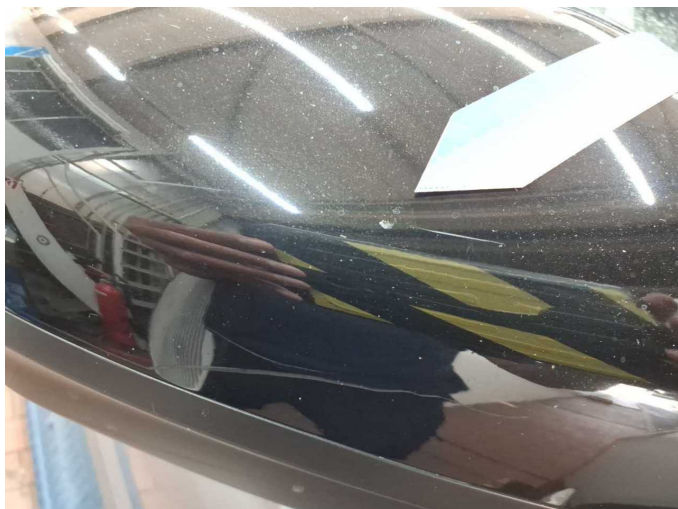
| No. | Component group | Description |
|---|---|---|
| 4 | Wing mirror - right side | Cap - Scratch(es) - Paint |

**Damage 4:** Wing mirror - right side: Cap - Scratch(es) - Paint

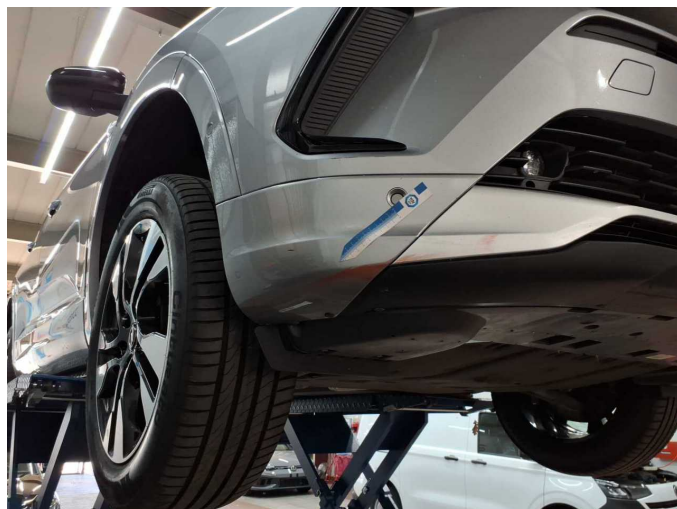
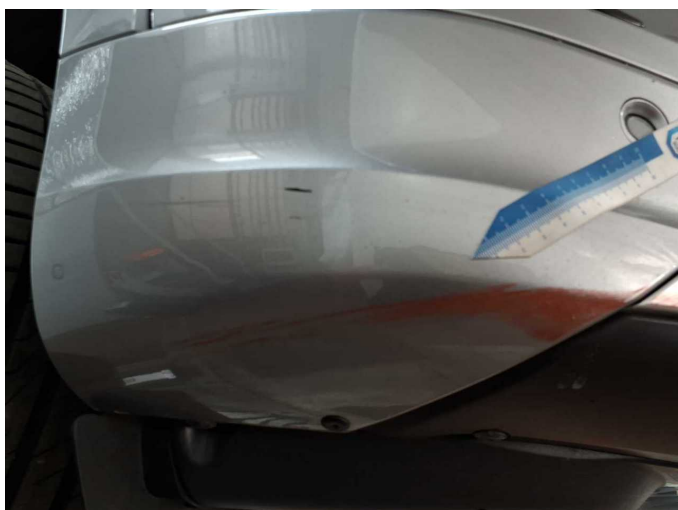
| No. | Component group | Description |
|---|---|---|
| 5 | Front bumper | Spoiler (Zierleiste re) - Scratched - Paint |

**Damage 5:** Front bumper: Spoiler (Zierleiste re) - Scratched - Paint

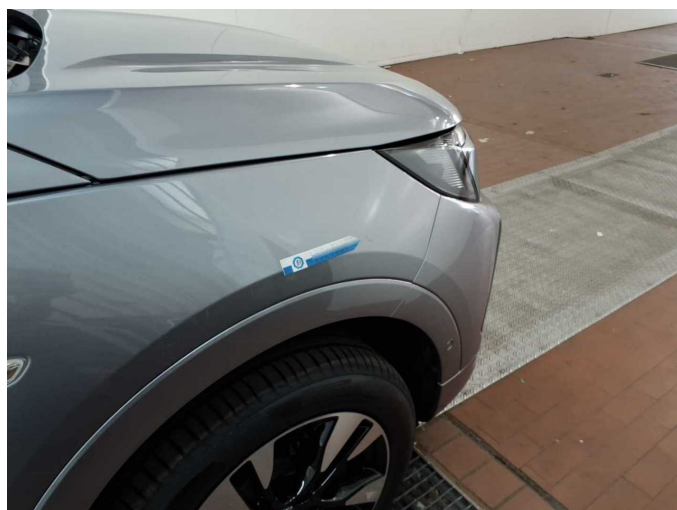
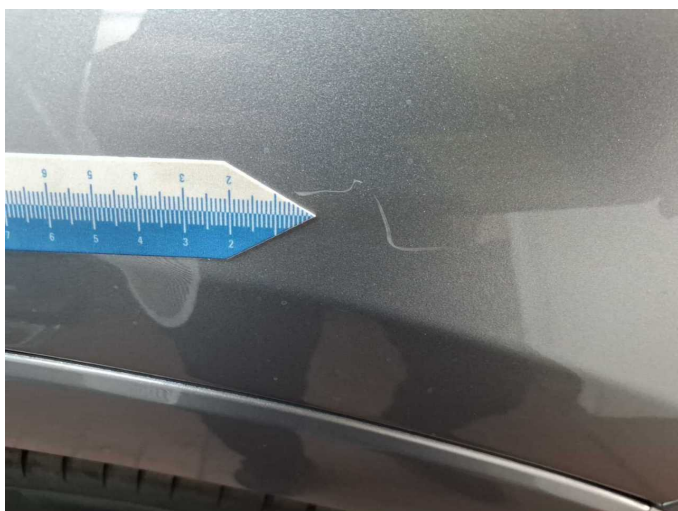
| No. | Component group | Description |
|---|---|---|
| 6 | Mudguard - right side | Mudguard - right side - Scratch(es) - Paint |

**Damage 6:** Mudguard - right side: Mudguard - right side - Scratch(es) - Paint

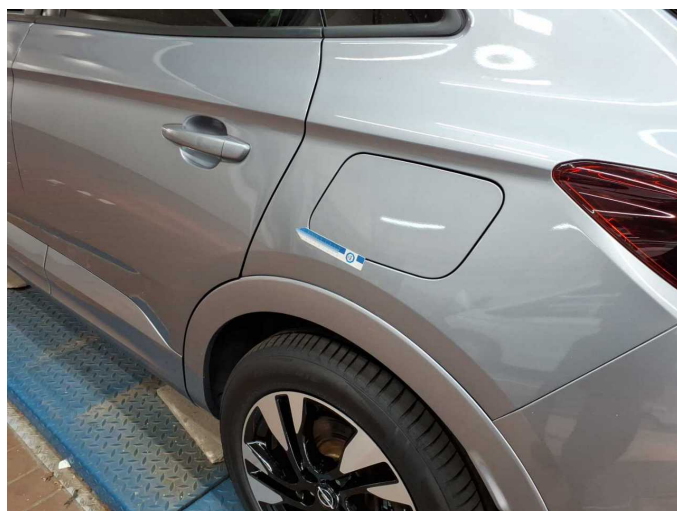
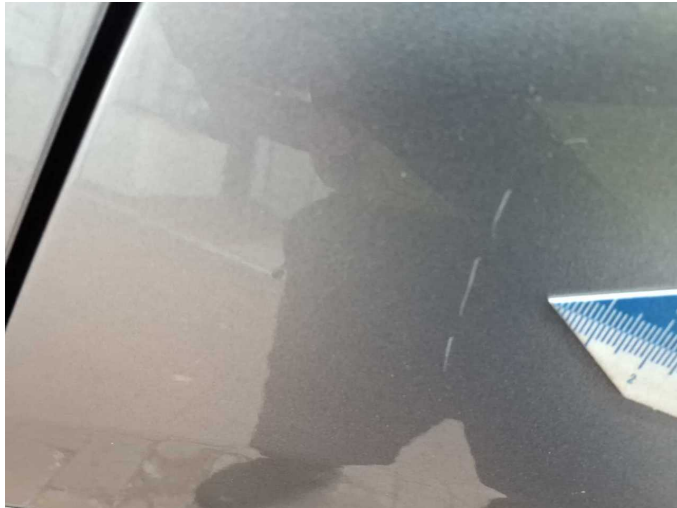
| No. | Component group | Description |
|---|---|---|
| 7 | Side panel - rear left side | Side panel - Scratch(es) - Paint |

**Damage 7:** Side panel - rear left side: Side panel - Scratch(es) - Paint

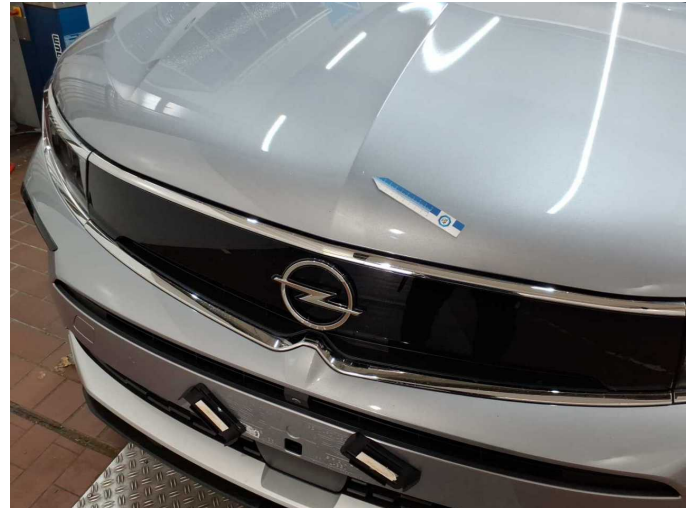
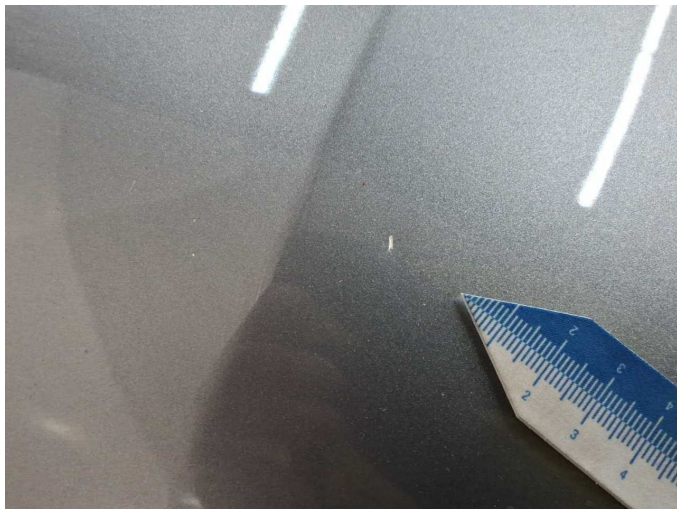
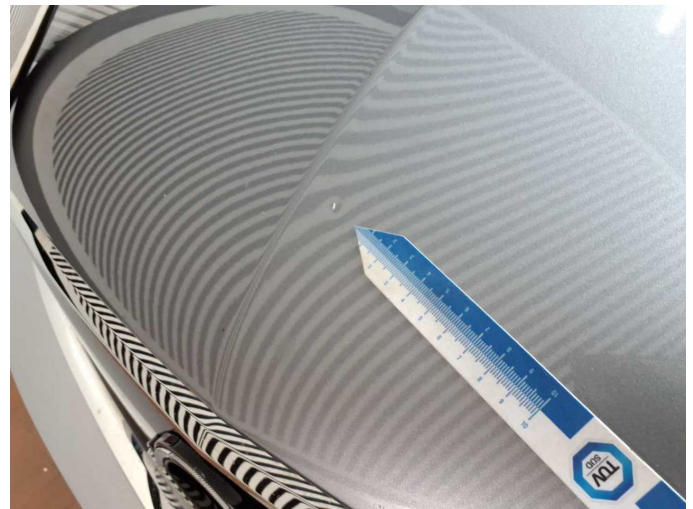
| No. | Component group | Description |
|---|---|---|
| 8 | Bonnet | Bonnet - Dent / paintcoat damage - Paint |

**Damage 8:** Bonnet: Bonnet - Dent / paintcoat damage - Paint
