Expertise

Protocol number: 45797499
Order No. / Reference: 26342924
Inspection date: 22 May 2026

Model: A 180 d 8G-DCT Lim. AMG Line Advanced Plus

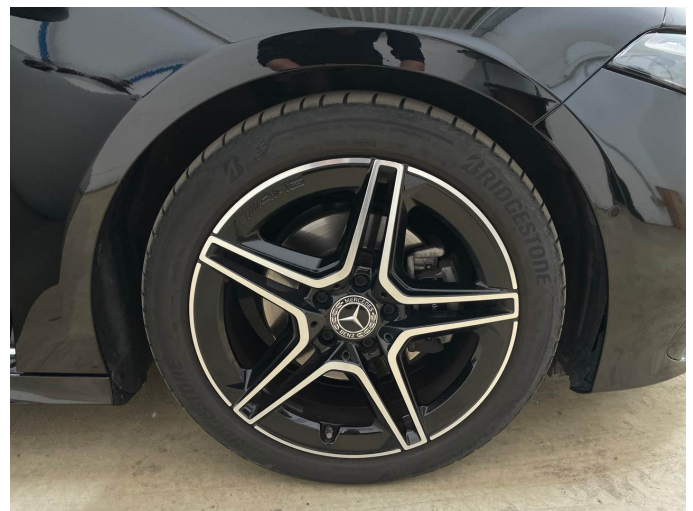
#	Tyre size	Type of tyre	Manufacturer	Tread depth
1)	225/45 R18 91W	Summer tyres on Light alloy	Bridgestone	3mm / 3mm
2)	225/45 R18 91W	Summer tyres on Light alloy	Bridgestone	4mm / 4mm

Figure 12: Mounted tyres

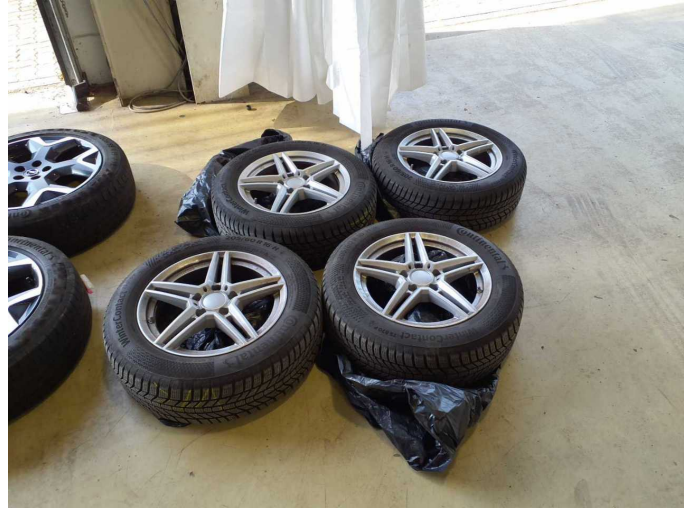
#	Tyre size	Type of tyre	Manufacturer	Tread depth
1)	205/60 R16 92H	Winter tyres on Light alloy	Continental	5mm / 5mm
2)	205/60 R16 92H	Winter tyres on Light alloy	Continental	7mm / 7mm

Figure 14: Additional tyres

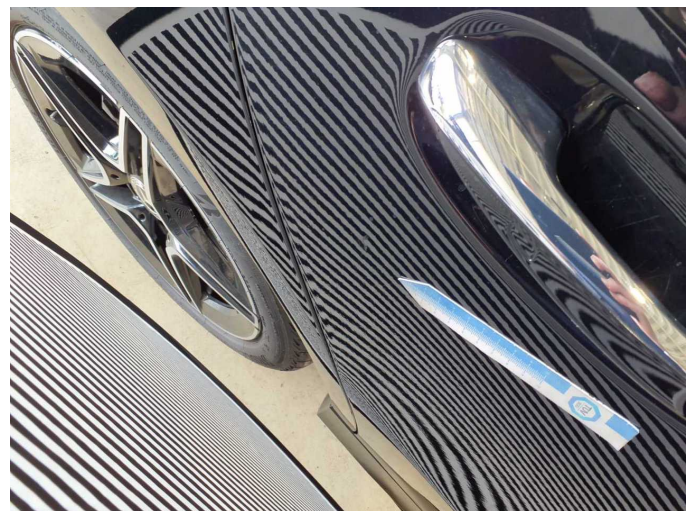
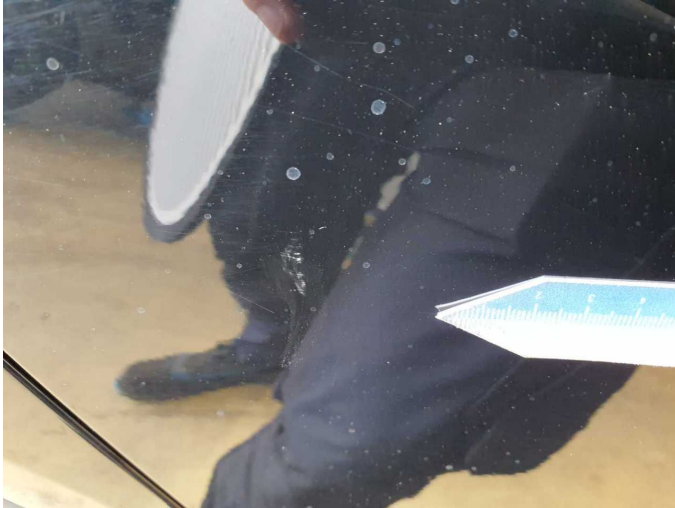
Damage 1: Door - rear right side: Door - Dent / paintcoat damage - Smart repair

No.	Component group	Description
1	Door - rear right side	Door - Dent / paintcoat damage - Smart repair
2	Bonnet	Bonnet - Scratch(es) - Smart repair
3	Misc.	Inspection / maintenance - Due - Perform

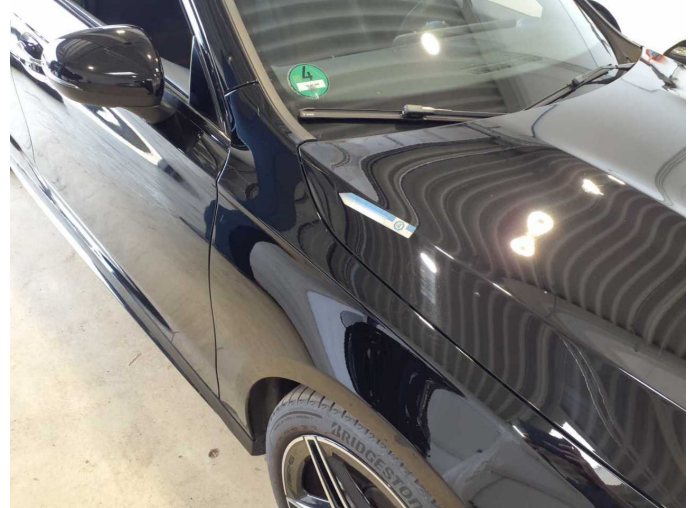
Damage 2: Bonnet: Bonnet - Scratch(es) - Smart repair

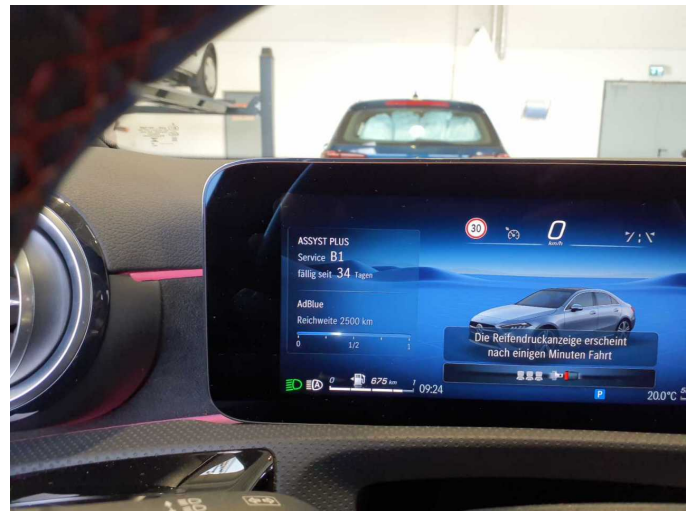
Damage 3: Misc.: Inspection / maintenance - Due - Perform

Maintenance booklet / proof	digital evidence / incomplete	Next maintenance in	-34 Tag(e)
Last service on / at	04/2025 at 20,892 km		
Key is / should be	2 / 2	FZG documents	ZB#2 (B) was available (copy), ZB#1 (S) was not available.
		Letter No.	HB198768
Previous damage / Accident	Detectable	Repainting	Detectable
Inspection conditions	sufficient	Lifting equipment / pit	No
Test drive	Not performed	Engine function test	Performed
Manufacturer key number/ type code number	2222 / AWW 00052		
Emission standard	EURO6;WLTP;EA;PI/CI;M, N1, N2	fine dust sticker	
Permitted total weight	2,030 kg	Empty weight

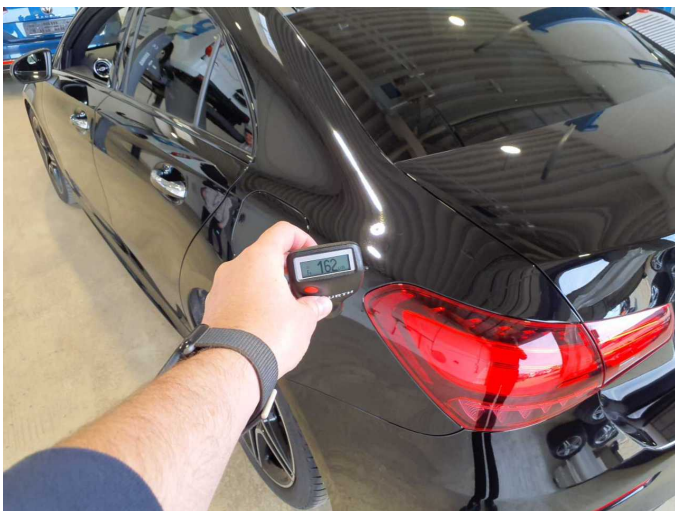
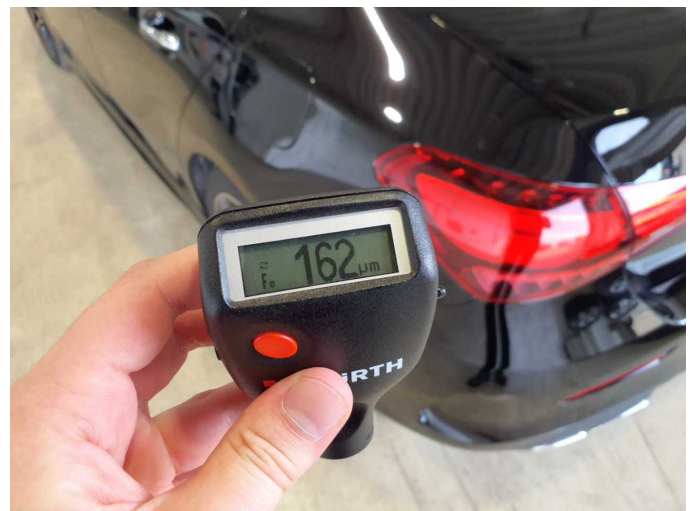
- 1 Side panel - rear left side, Professionally carried out, Invoice of repair done Non-existent

Side panel - rear left side 162 µm

Repainting 1: Side panel - rear left side
