Expertise

Protocol number: 46880776  
Order No. / Reference: 26702420  
Inspection date: 5 Aug 2026

Manufacturer: Skoda  
VIN: TMBJJ7NS2N8035474

Model: Kodiaq 2.0 TDI DSG Sportline

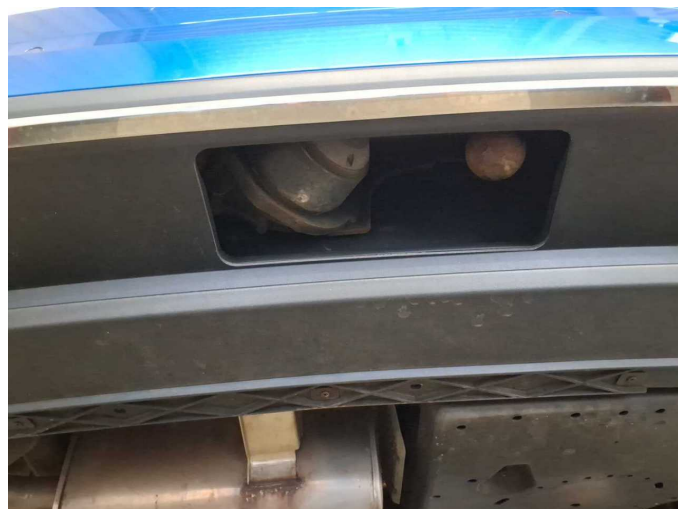
| No. | Component group | Description |
|---|---|---|
| 1 | Trailer hitch | Trailer hitch (lässt sich nicht ausklappen) - Functional / admissibility - Perform diagnosis |

**Damage 1:** Trailer hitch: Trailer hitch (lässt sich nicht ausklappen) - Functional / admissibility - Perform diagnosis

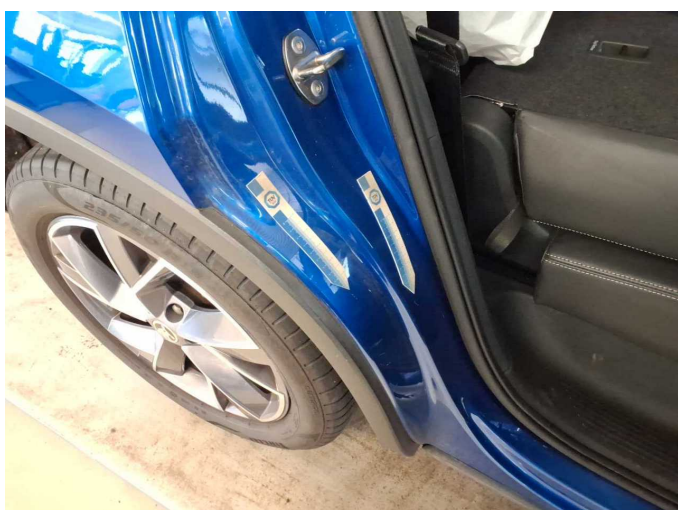
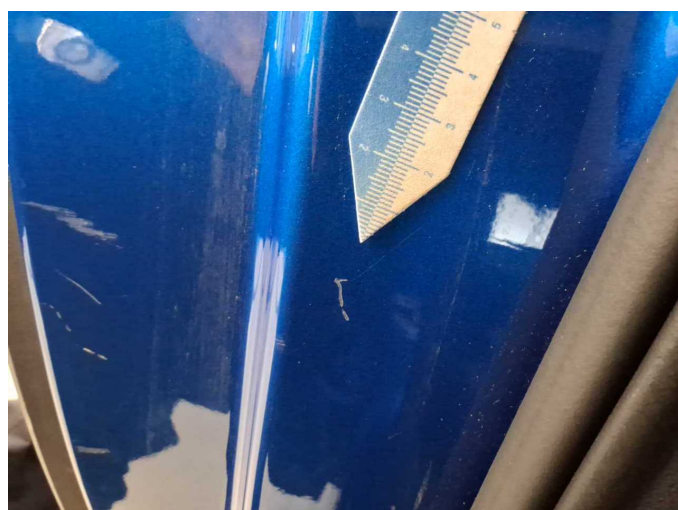
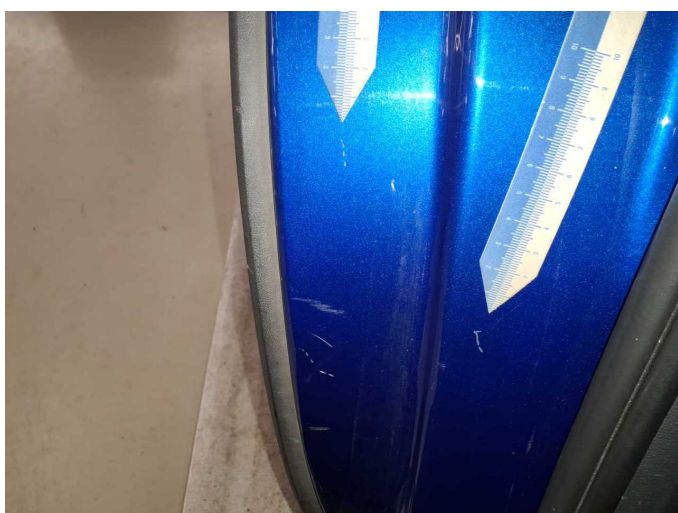
| No. | Component group | Description |
|---|---|---|
| 2 | Side panel - rear right side | Sill - Scratch(es) - Smart repair |

**Damage 2:** Side panel - rear right side: Sill - Scratch(es) - Smart repair

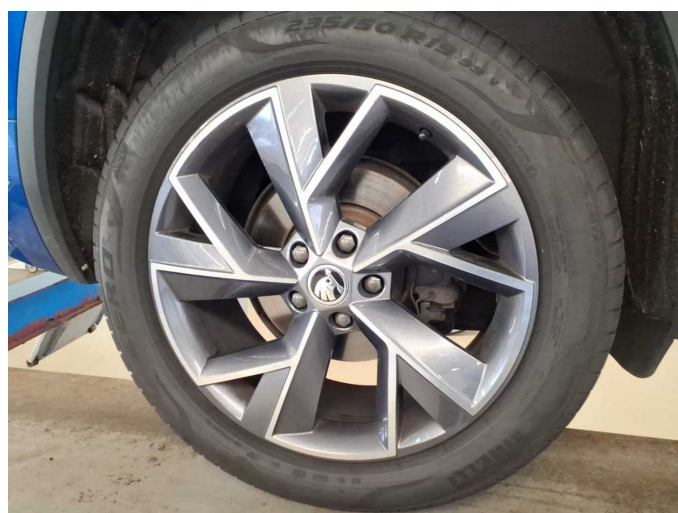
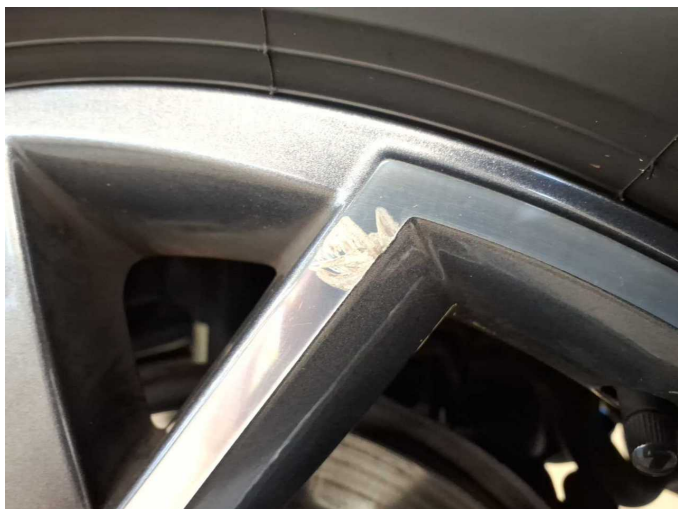
| No. | Component group | Description |
|---|---|---|
| 3 | Wheel / tyres | Alloy rim - rear right side - Scratch(es) - Loss in value |

**Damage 3:** Wheel / tyres: Alloy rim - rear right side - Scratch(es) - Loss in value

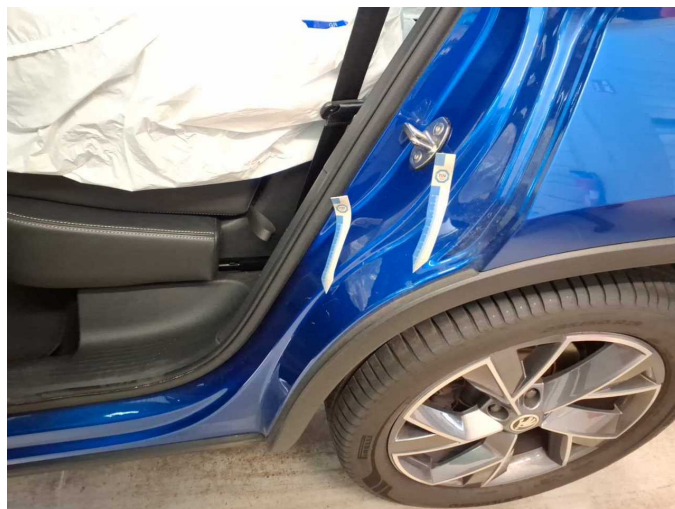
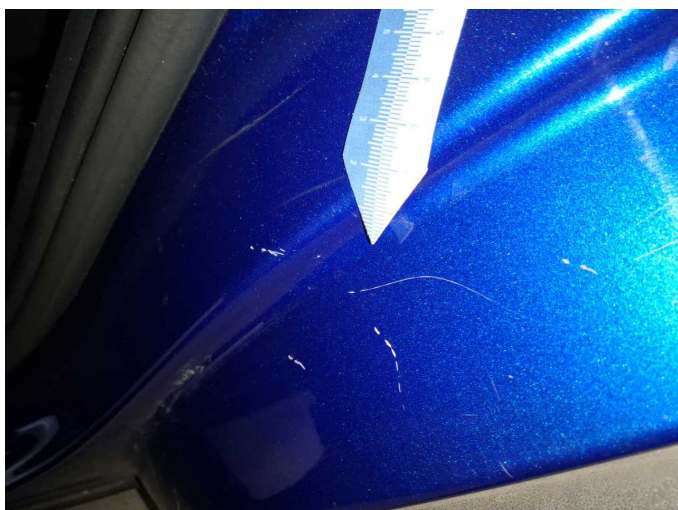
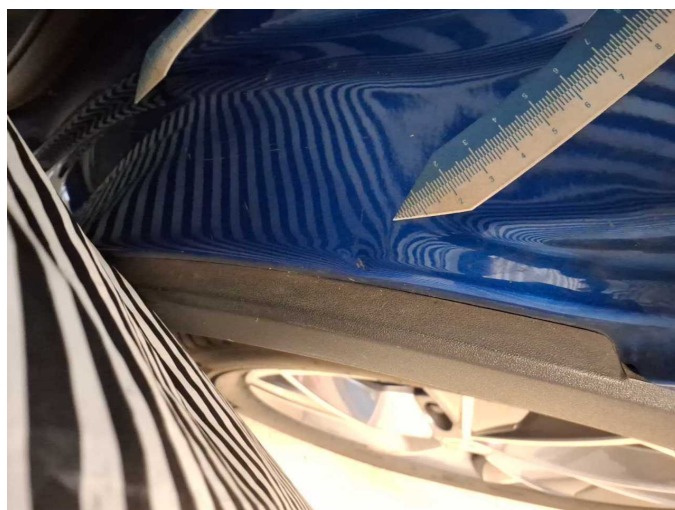
| No. | Component group | Description |
|---|---|---|
| 4 | Side panel - rear left side | Sill - Dent / paintcoat damage - Repair and paint |

**Damage 4:** Side panel - rear left side: Sill - Dent / paintcoat damage - Repair and paint

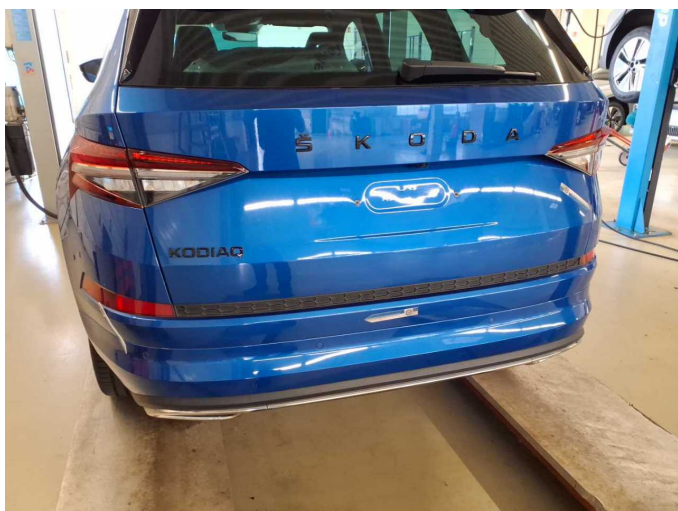
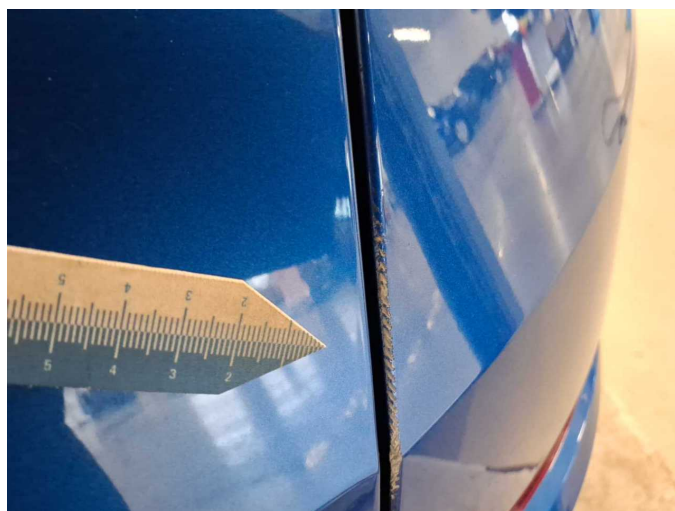
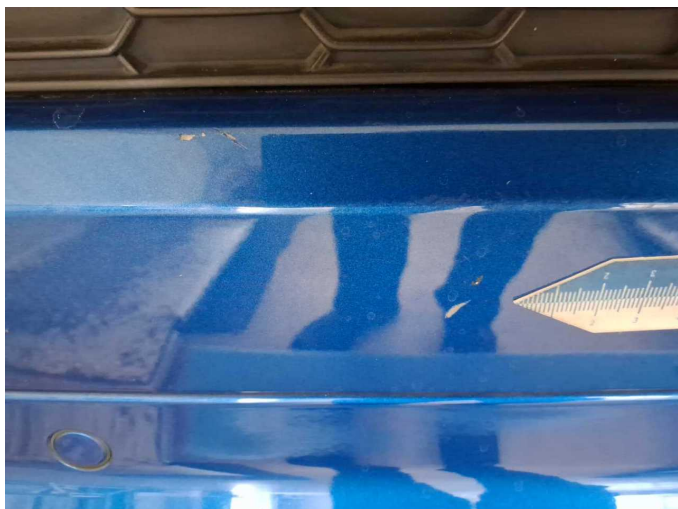
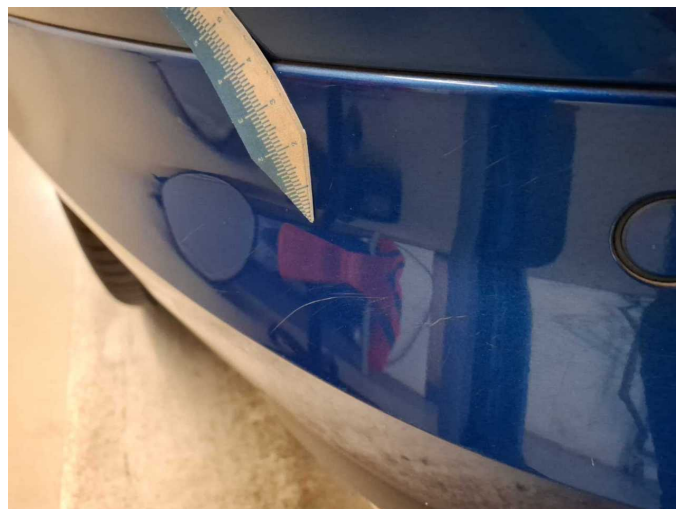
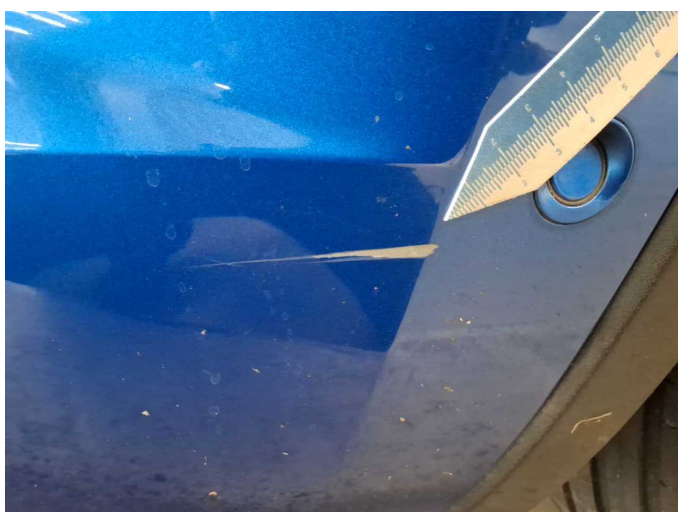
| No. | Component group | Description |
|---|---|---|
| 5 | Rear bumper | Bumper with Parktronic - Scratched - Paint |

**Damage 5:** Rear bumper: Bumper with Parktronic - Scratched - Paint

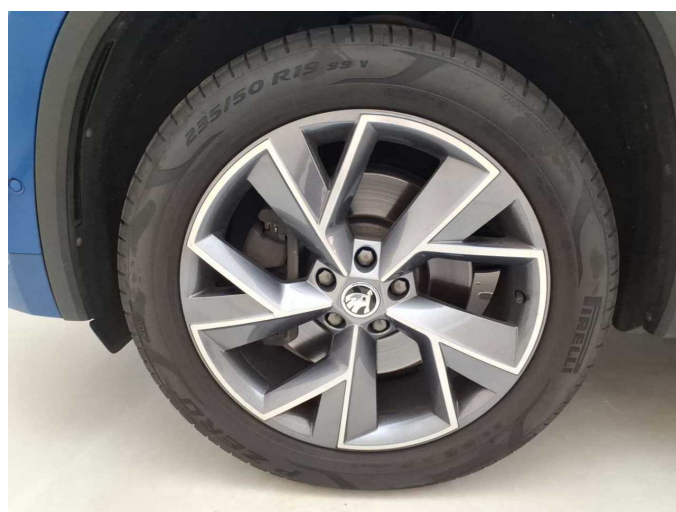
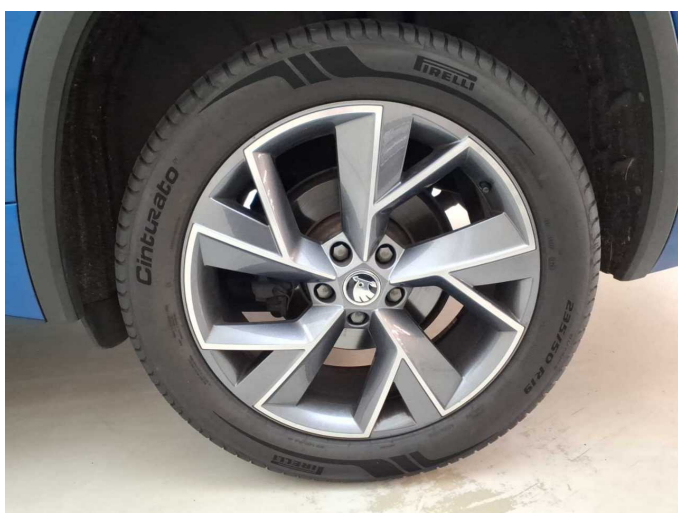
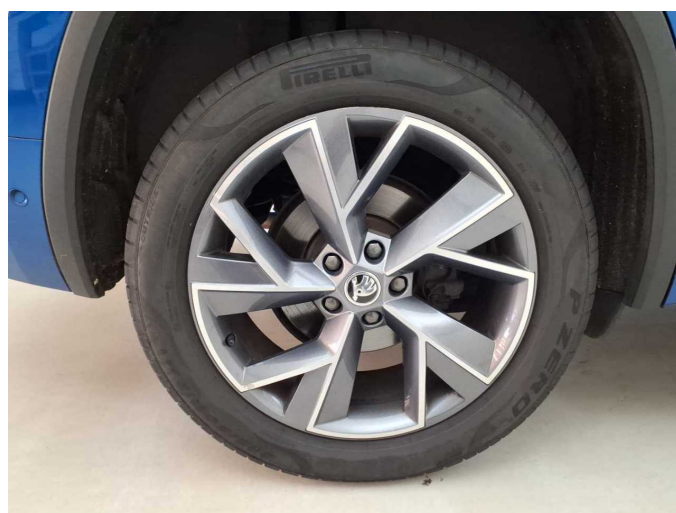
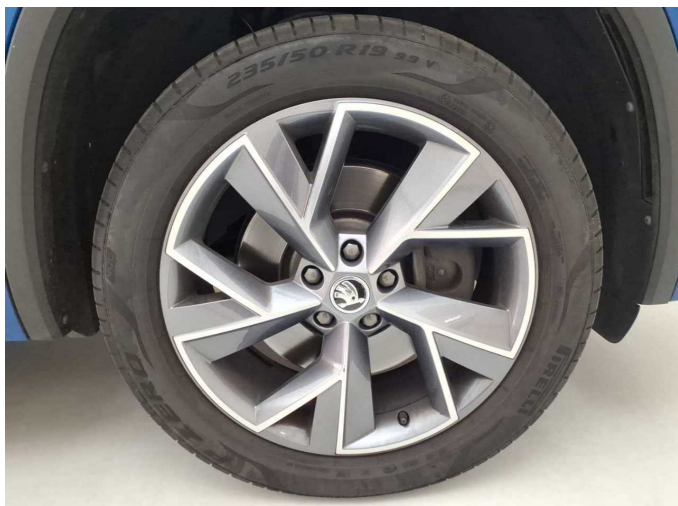
| No. | Component group | Description |
|---|---|---|
| 6 | Wheel / tyres | Tyres - complete set (keine Run-Flat verbaut) - Differs from the original configuration - Replace |

**Damage 6:** Wheel / tyres: Tyres - complete set (keine Run-Flat verbaut) - Differs from the original configuration - Replace

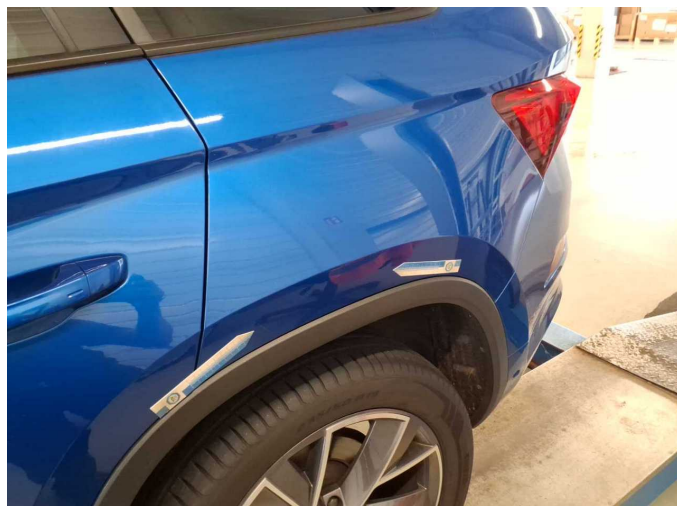
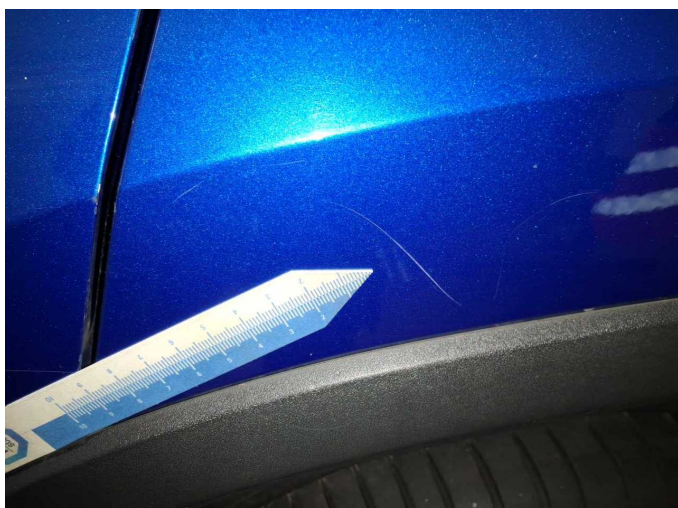
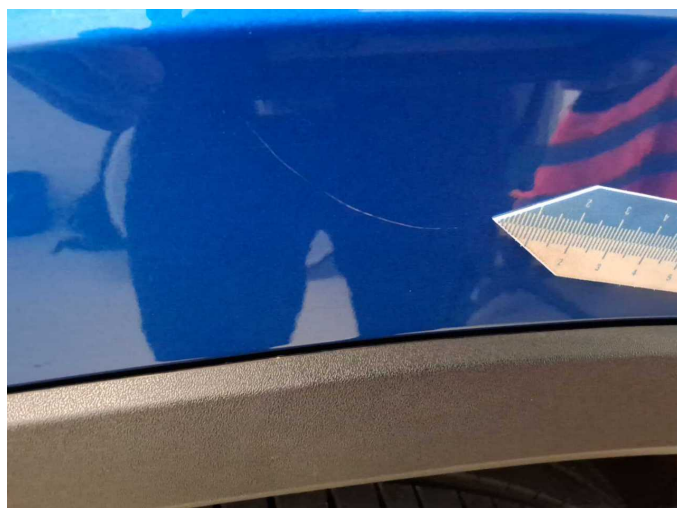
| No. | Component group | Description |
|---|---|---|
| 7 | Side panel - rear left side | Side panel - Scratch(es) - Paint |

**Damage 7:** Side panel - rear left side: Side panel - Scratch(es) - Paint

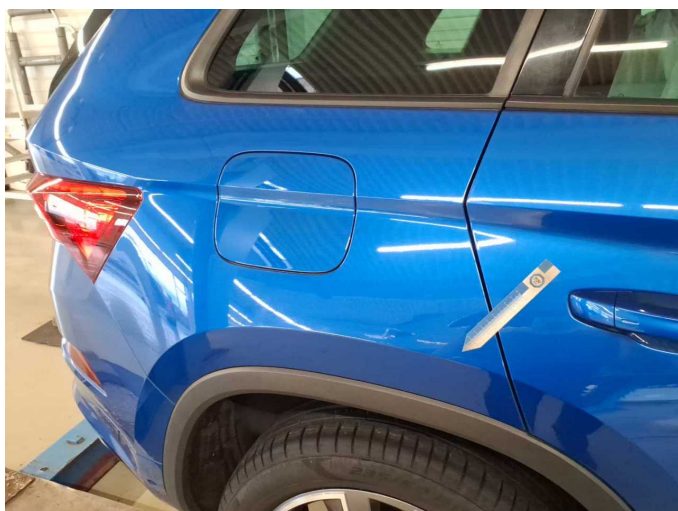
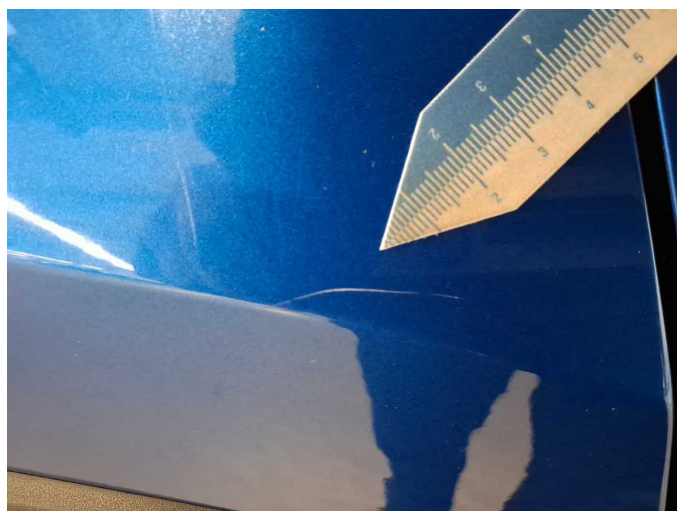
| No. | Component group | Description |
|---|---|---|
| 8 | Side panel - rear right side | Side panel - Scratch(es) - Paint |

**Damage 8:** Side panel - rear right side: Side panel - Scratch(es) - Paint

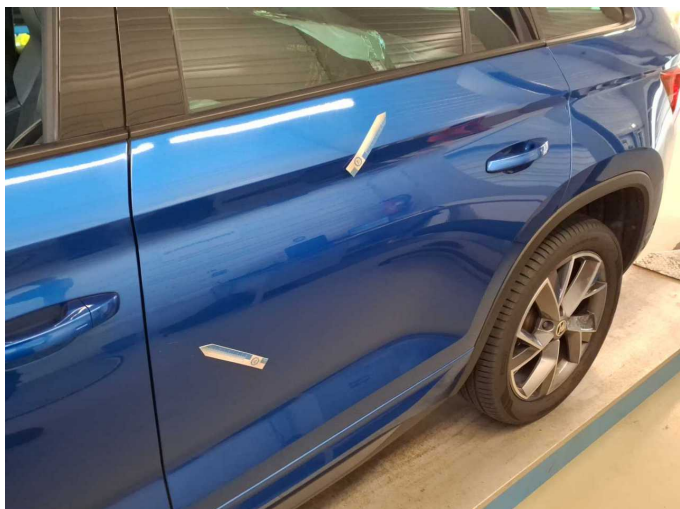
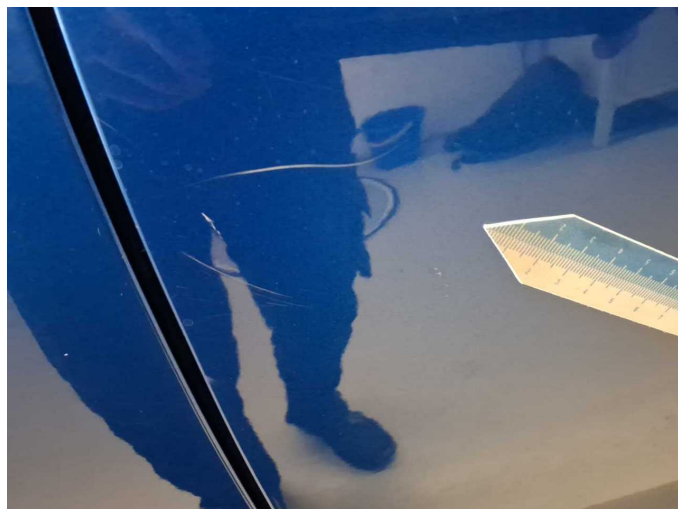
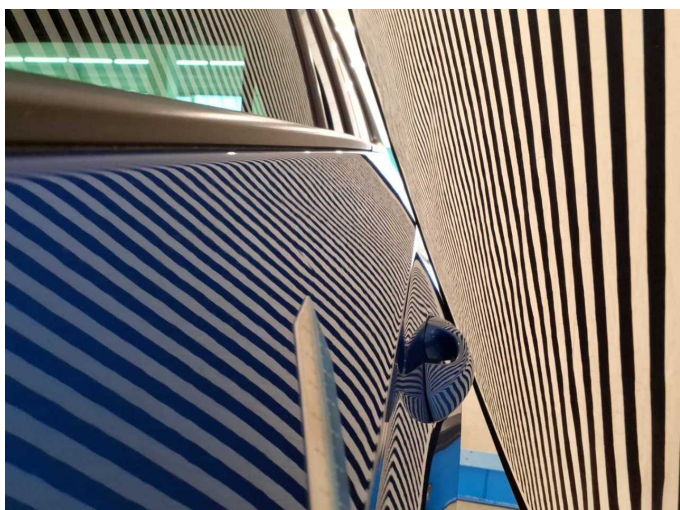
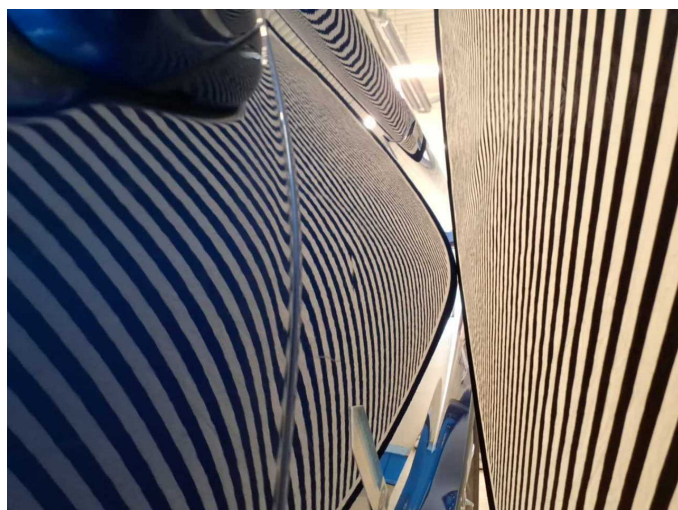
| No. | Component group | Description |
|---|---|---|
| 9 | Door - rear left side | Door - Dent / paintcoat damage - Repair and paint |

**Damage 9:** Door - rear left side: Door - Dent / paintcoat damage - Repair and paint

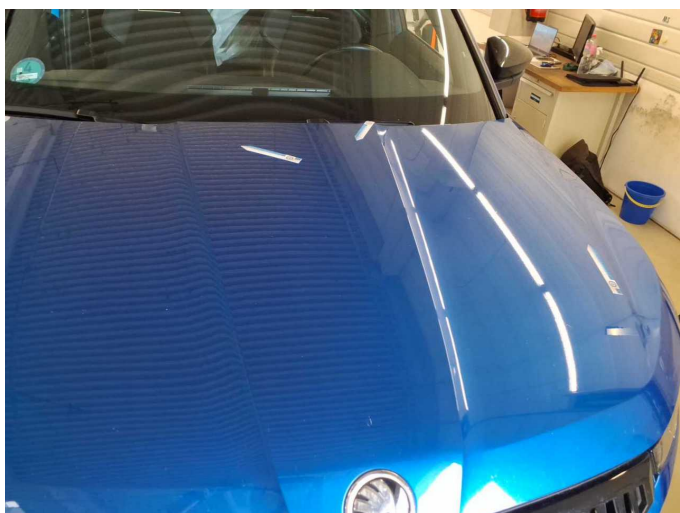
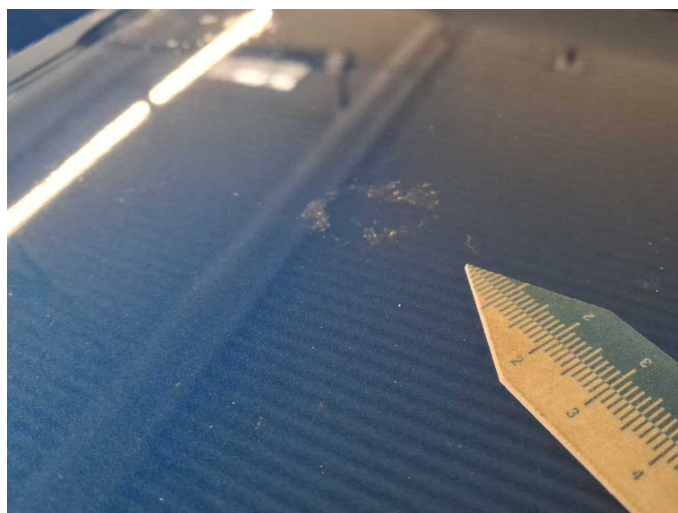
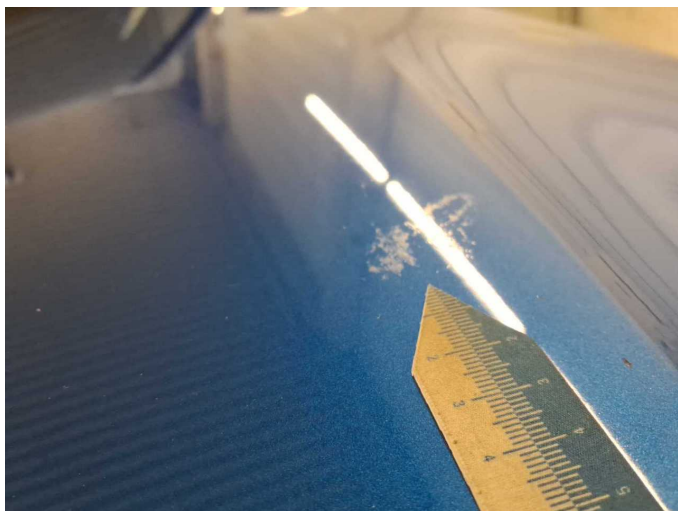
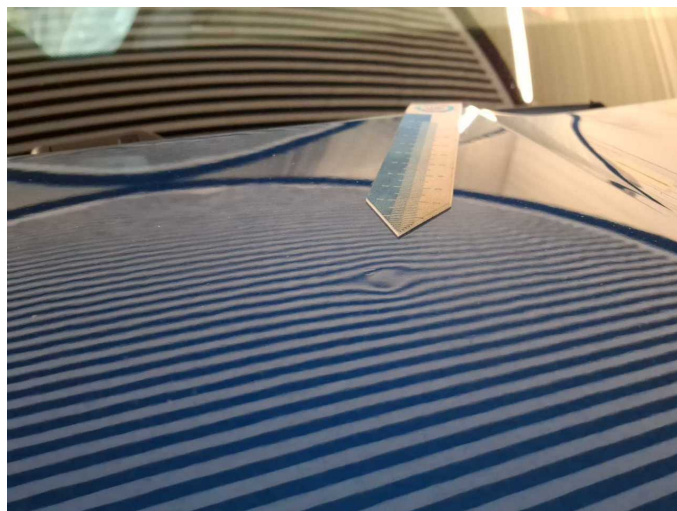
| No. | Component group | Description |
|---|---|---|
| 10 | Bonnet | Bonnet (Einätzungen + Dellen) - Paint defect - Repair and paint |

**Damage 10:** Bonnet: Bonnet (Einätzungen + Dellen) - Paint defect - Repair and paint

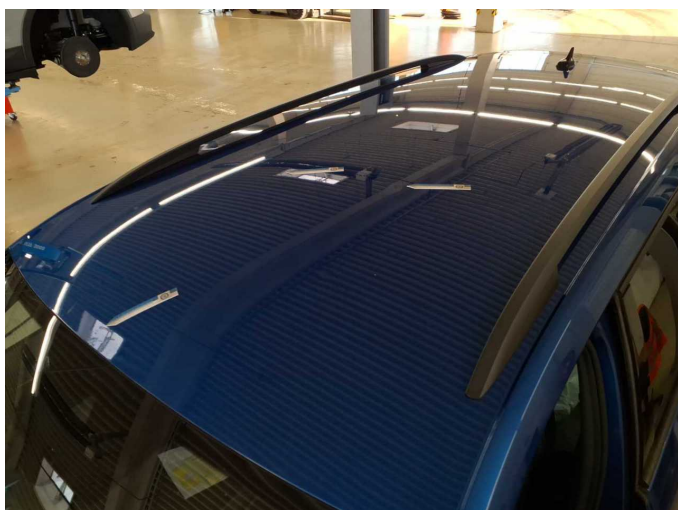
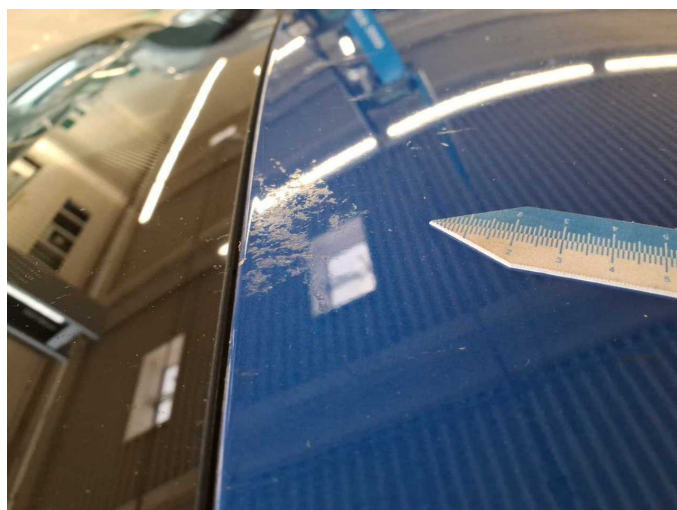
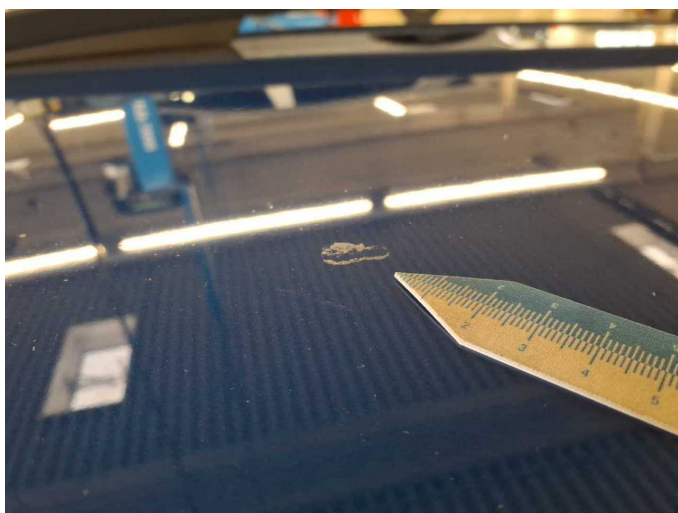
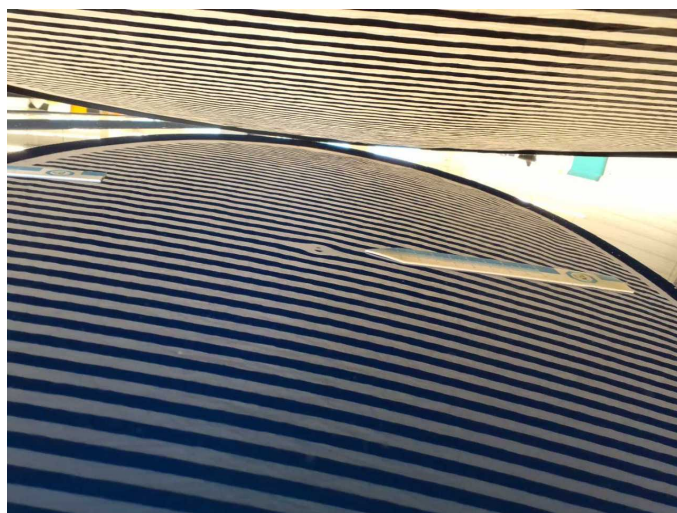
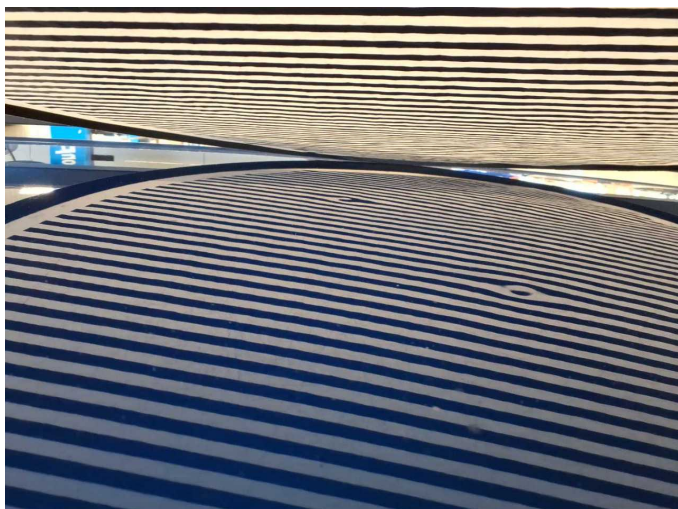
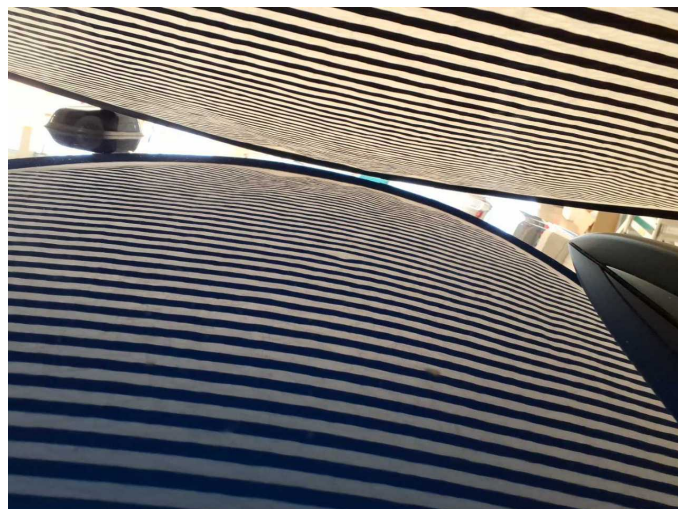
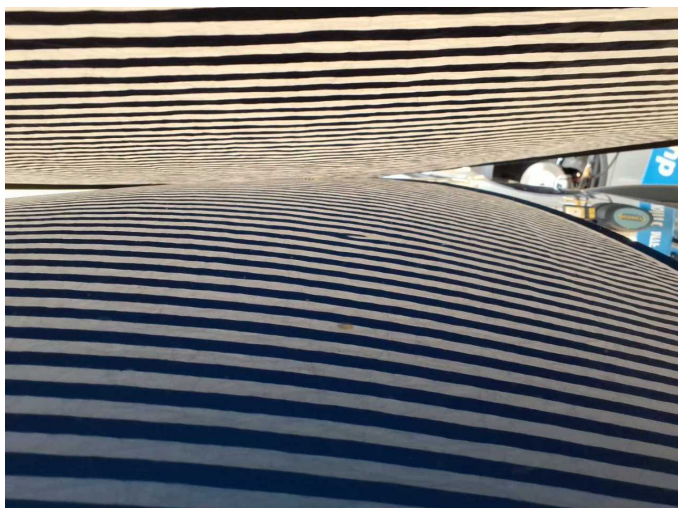
| No. | Component group | Description |
|---|---|---|
| 11 | Roof | Roof (Einätzungen + Dellen) - Paint defect - Repair and paint |

**Damage 11:** Roof: Roof (Einätzungen + Dellen) - Paint defect - Repair and paint

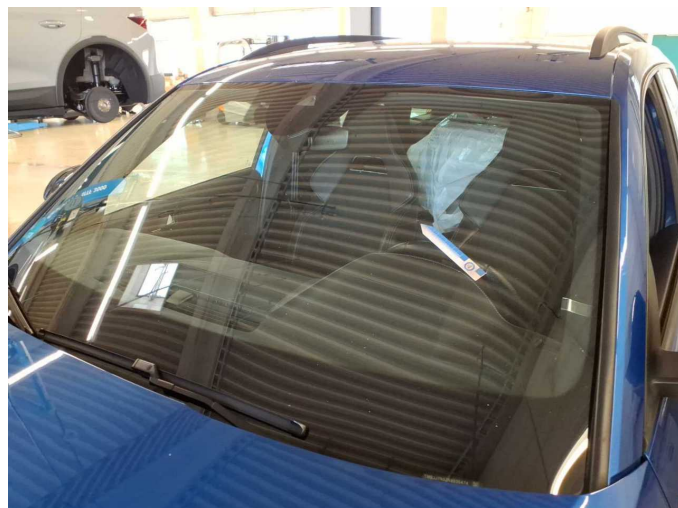
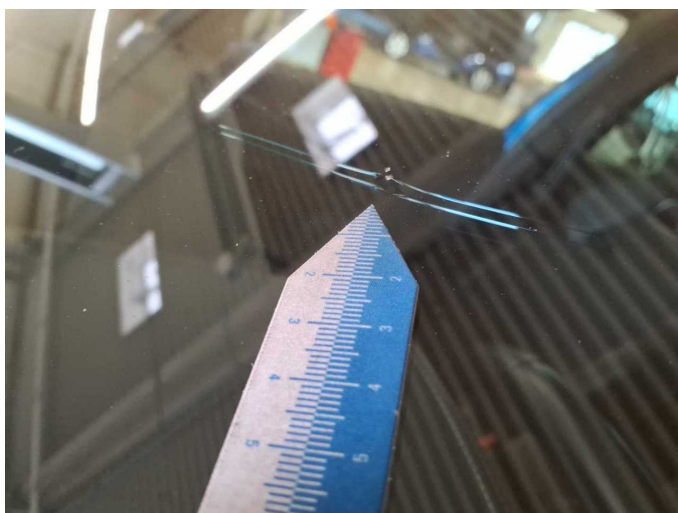
| No. | Component group | Description |
|---|---|---|
| 12 | Vehicle glazing | Windscreen with lane departure assistant - Broken / torn - Replace |

**Damage 12:** Vehicle glazing: Windscreen with lane departure assistant - Broken / torn - Replace

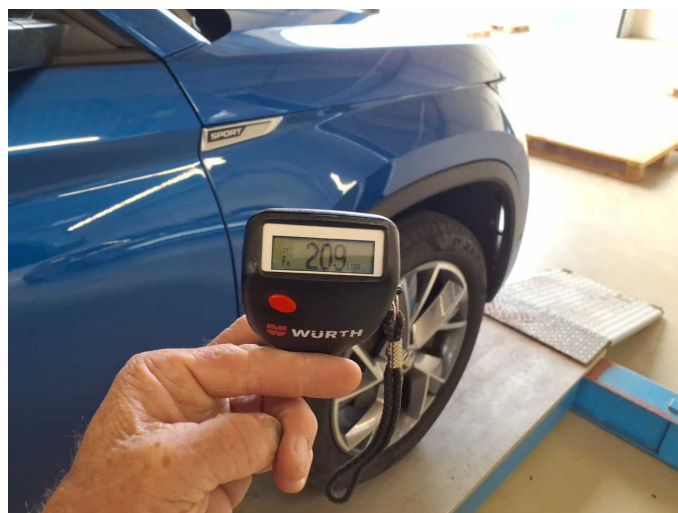
| No. | Repainting |
|---|---|
| 1 | Mudguard - right side, Professionally carried out |

| Mudguard - right side | 209 µm |

**Mudguard - right side:** 209 µm
