Expertise

Protocol number: 46653668  
Order No. / Reference: 26725934  
Inspection date: 21 Jul 2026

Manufacturer: Ford

Model: Focus Turnier 1.5 EcoBlue Start-Stopp-System Aut. TITANIUM  
STYLE

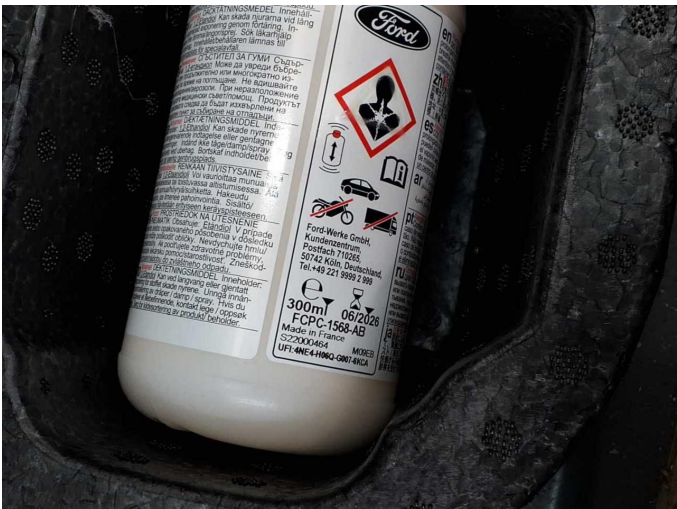
| No. | Component group | Description |
|---|---|---|
| 1 | Equipment | Tirefit filler - Expired - Replace |

Damage 1: Equipment: Tirefit filler - Expired - Replace

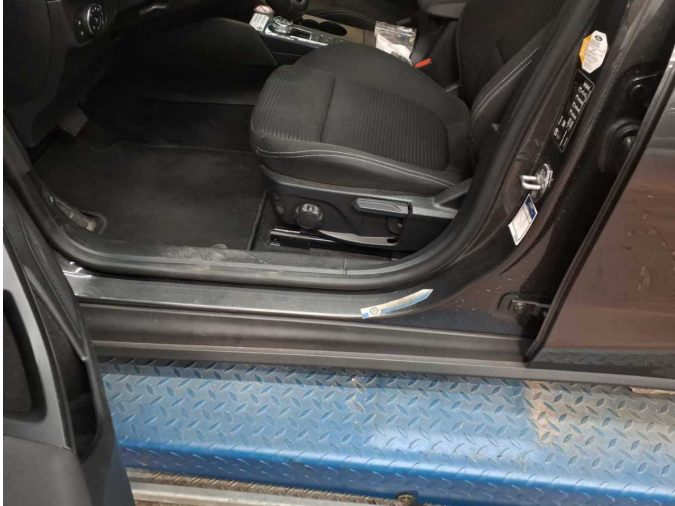
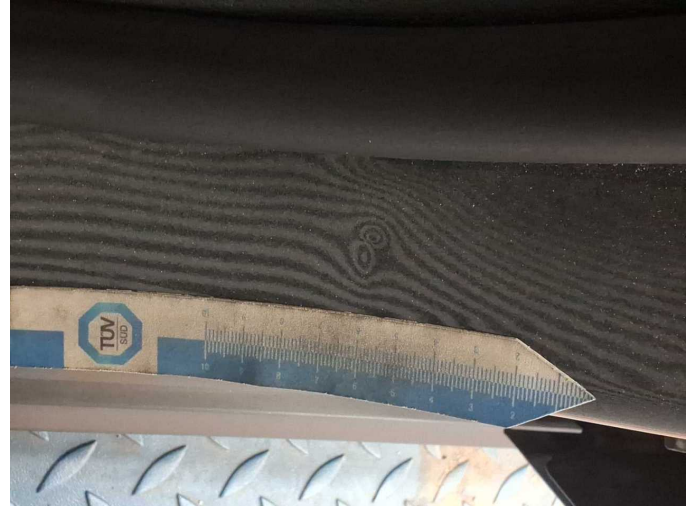
| No. | Component group | Description |
|---|---|---|
| 2 | Sill - left side | Sill - dent(s) - Smart repair |

**Damage 2:** Sill - left side: Sill - dent(s) - Smart repair

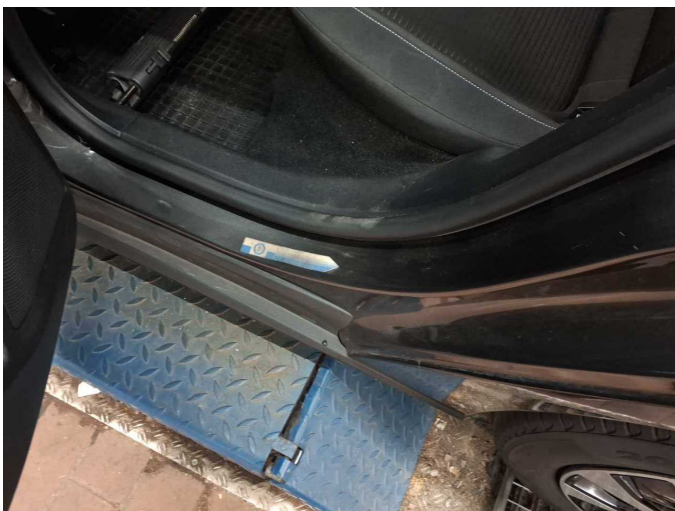
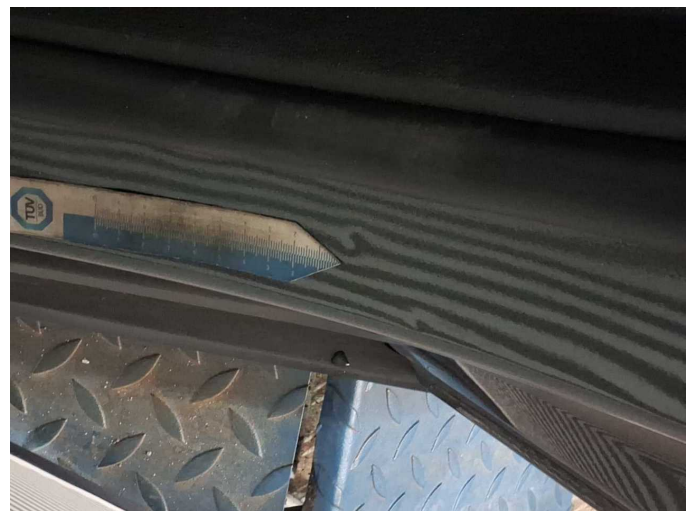
| No. | Component group | Description |
|---|---|---|
| 3 | Side panel - rear left side | Sill (+ Dellen) - Scratch(es) - Smart repair |

**Damage 3:** Side panel - rear left side: Sill (+ Dellen) - Scratch(es) - Smart repair

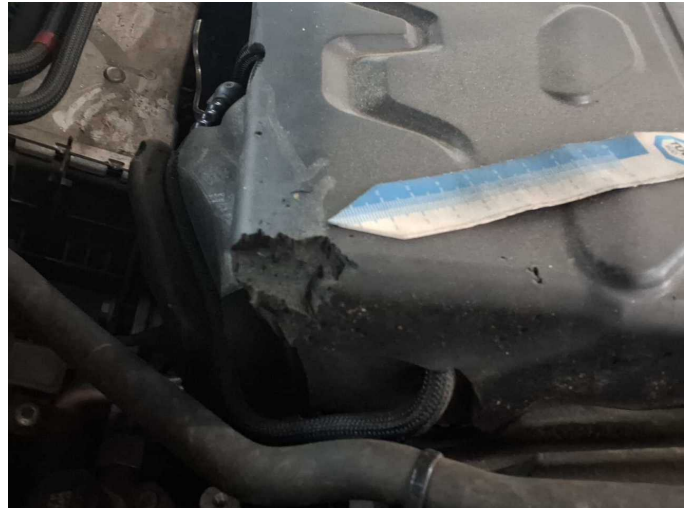
| No. | Component group | Description |
|---|---|---|
| 4 | Engine | Engine cover - Damage caused by marten / rodent - Replace |

**Damage 4:** Engine: Engine cover - Damage caused by marten / rodent - Replace

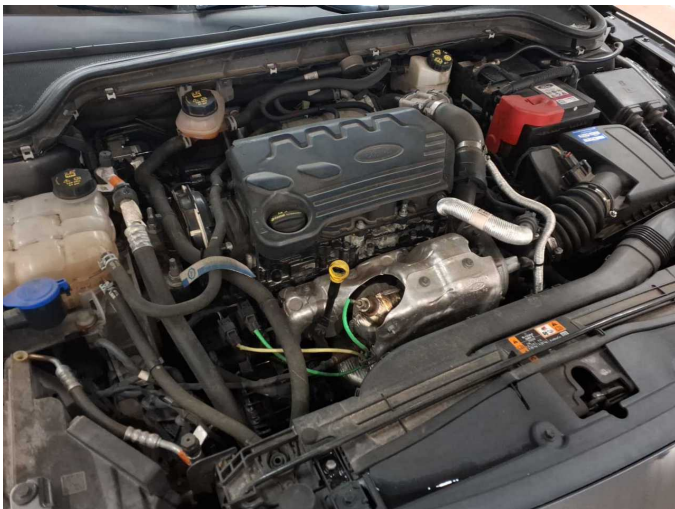
| No. | Component group | Description |
|---|---|---|
| 5 | Engine | Engine (Ölverlust) - Leaking - Diagnosed and repair if necessary |

**Damage 5:** Engine: Engine (Ölverlust) - Leaking - Diagnosed and repair if necessary

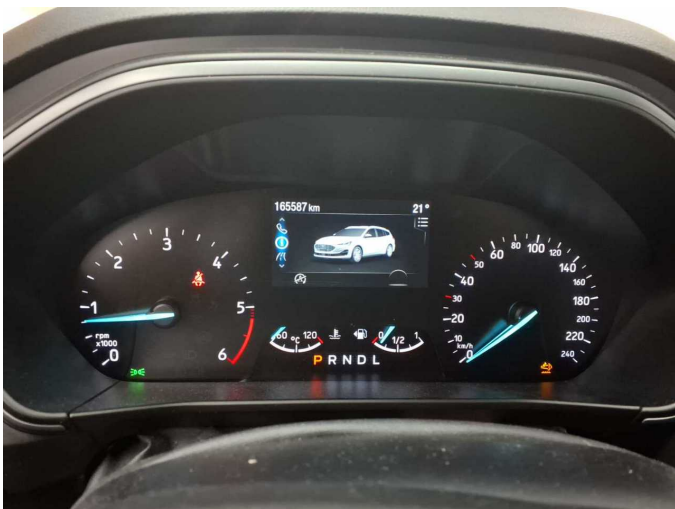
| No. | Component group | Description |
|---|---|---|
| 4 | Instrument panel | Indicator light (Ad Blue Stand ist niedrig) - on - No deduction |

**Wear and tear 4:** Instrument panel: Indicator light (Ad Blue Stand ist niedrig) - on - No deduction

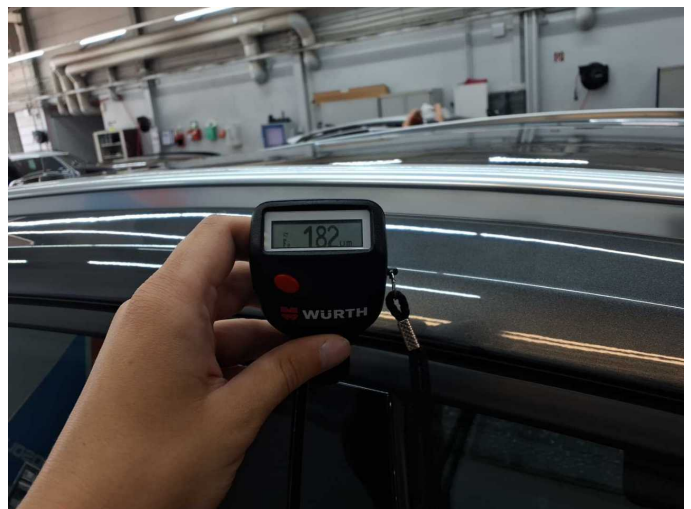
- 1 Roof rail - right side, Professionally carried out, Invoice of repair done Non-existent
- 2 Side panel - rear right side, Professionally carried out, Invoice of repair done Non-existent
- 3 Door - front right side, Professionally carried out, Invoice of repair done Non-existent

| Roof rail - right side | 182 µm | Side panel - rear right side | 255 µm |

**Repainting 1:** Roof rail - right side

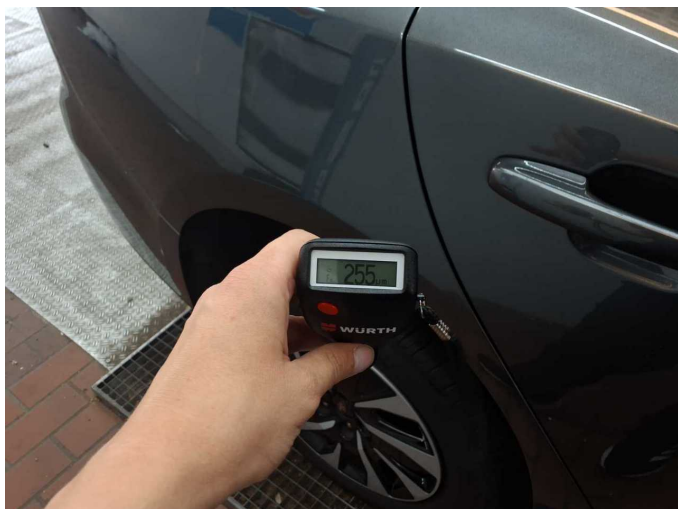
**Repainting 2:** Side panel - rear right side

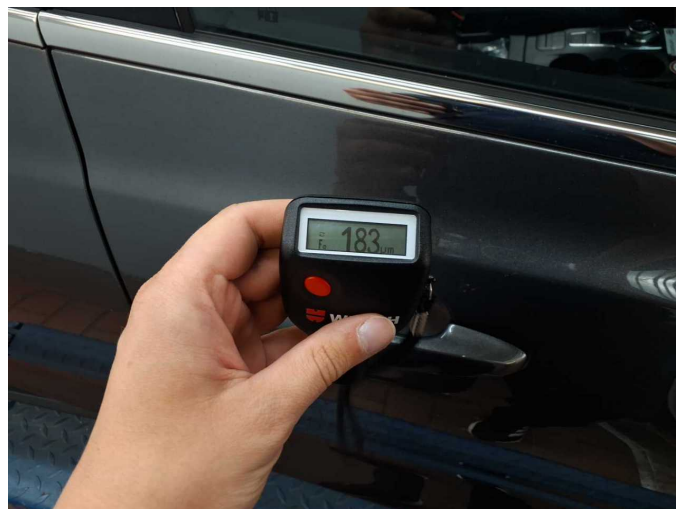
| Door - front right side | 183 µm | | |

**Repainting 3:** Door - front right side
