Expertise

Protocol number: 46838813  
Order No. / Reference: 26621763  
Inspection date: 30 Jul 2026

Manufacturer: Volkswagen

Model: Tiguan Allspace 2.0 TDI SCR DSG Life

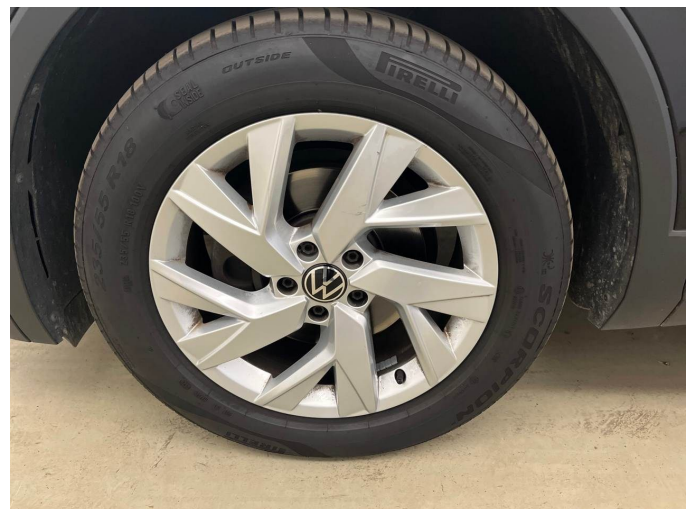
Figure 12: Mounted tyres

| # | Tyre size | Type of tyre | Manufacturer | Tread depth |
|---|---|---|---|---|
| 1) | 235/55 R18 100V | Summer tyres on Light alloy | Pirelli | 6mm / 6mm |
| 2) | 235/55 R18 100V | Summer tyres on Light alloy | Pirelli | 7mm / 7mm |

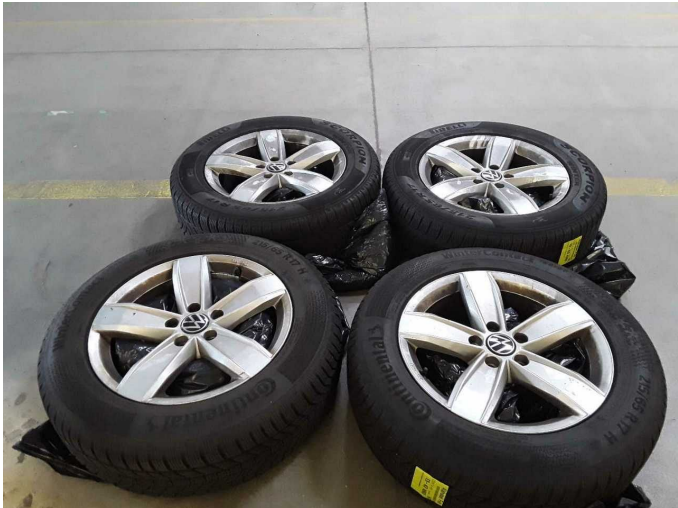
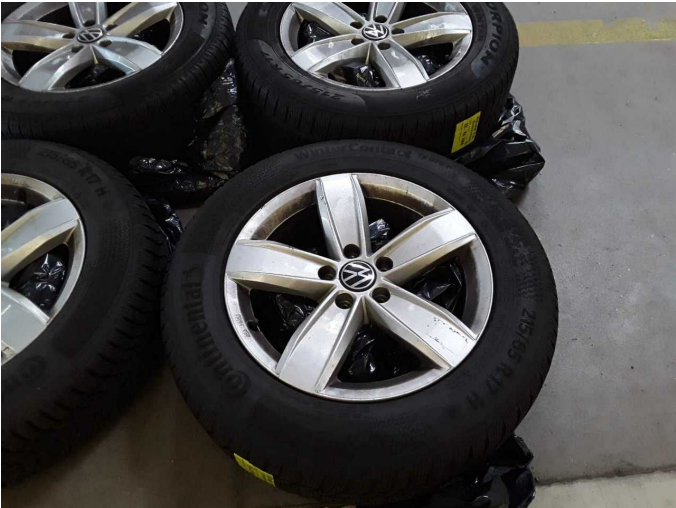
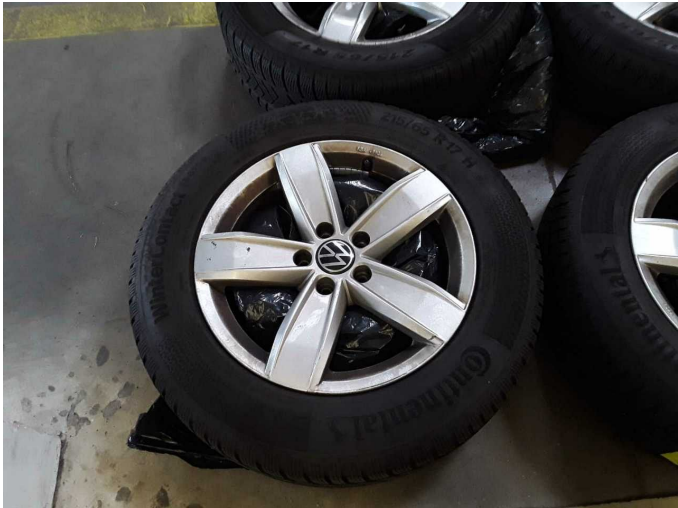
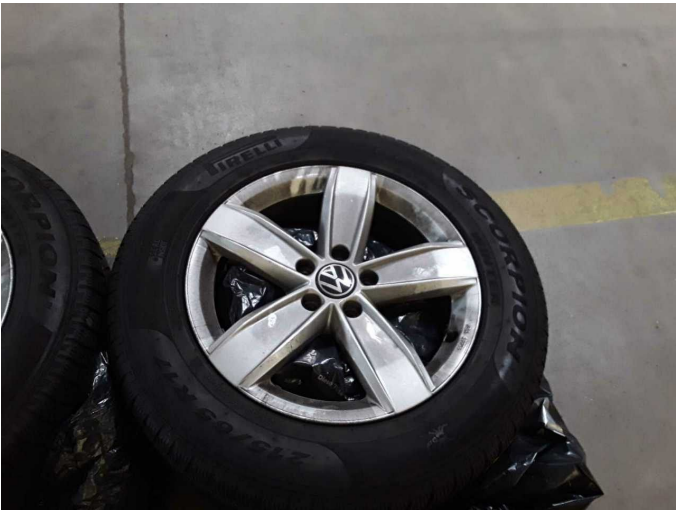
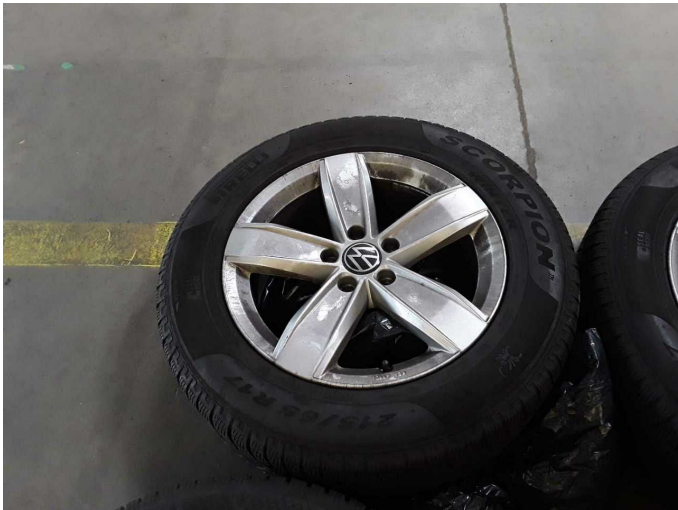
Der beiliegende Winterradsatz ist kein Bestandteil der Ausstattung.

Figure 14: Additional tyres

Figure 15: Additional tyres

Figure 16: Additional tyres

Figure 17: Additional tyres

Figure 18: Additional tyres

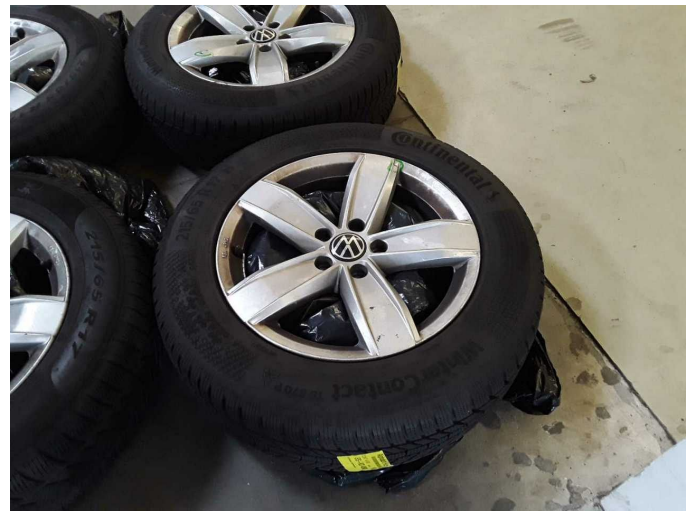
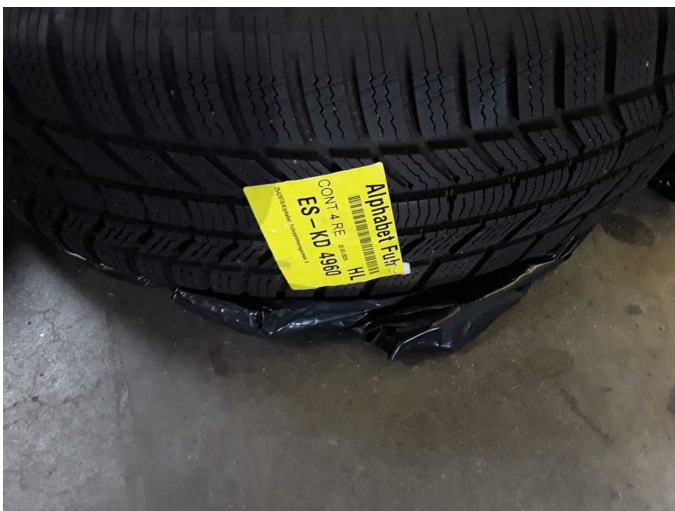
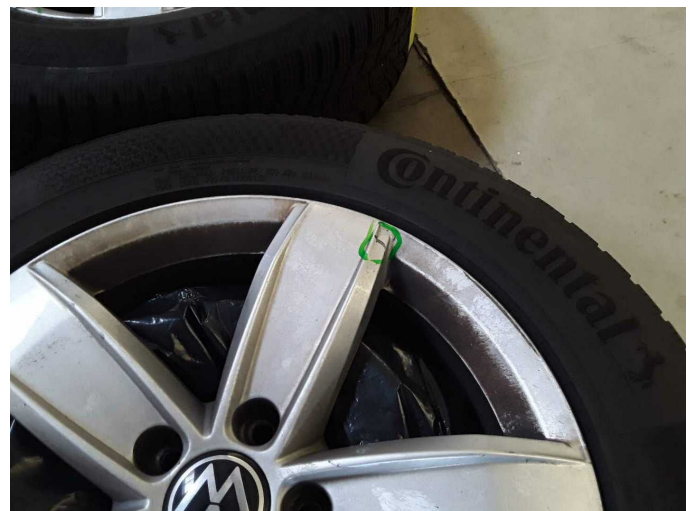
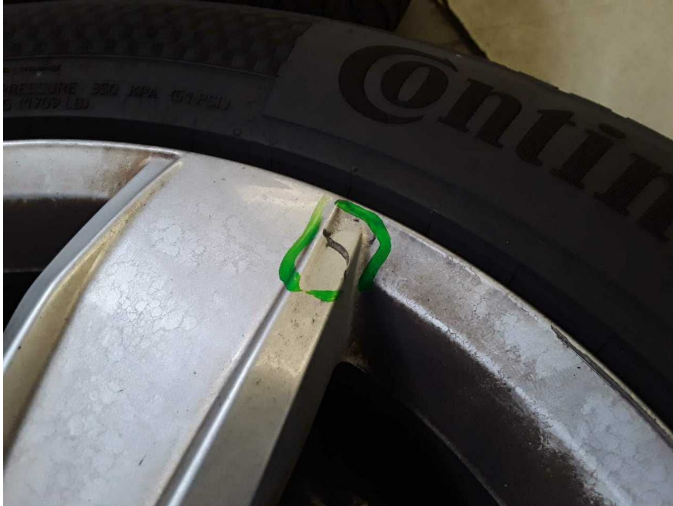
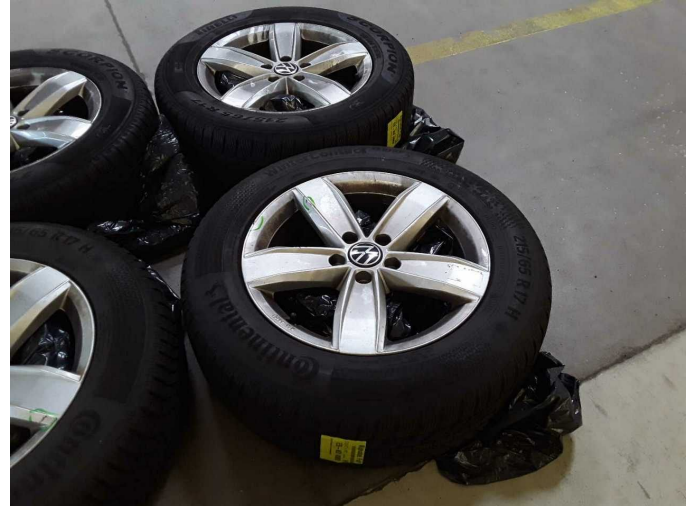
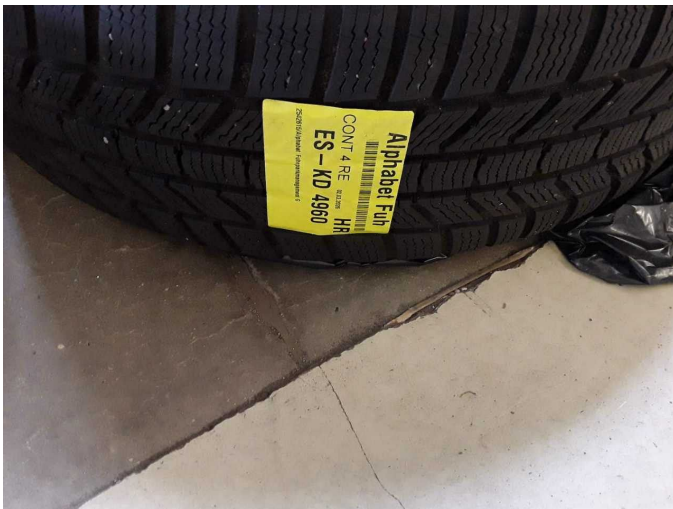
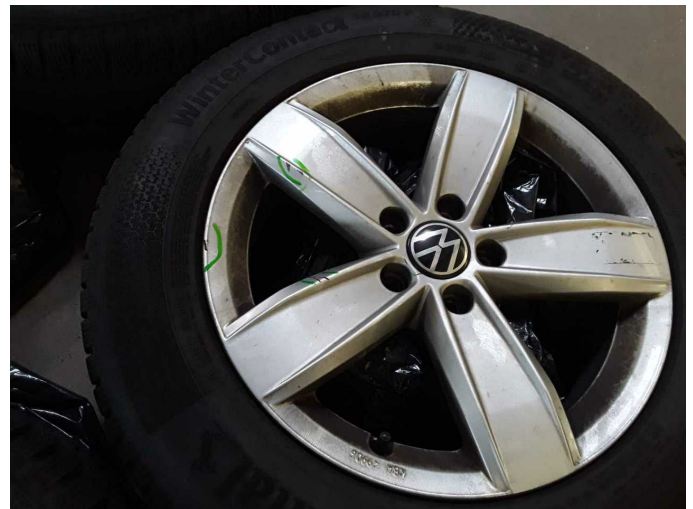
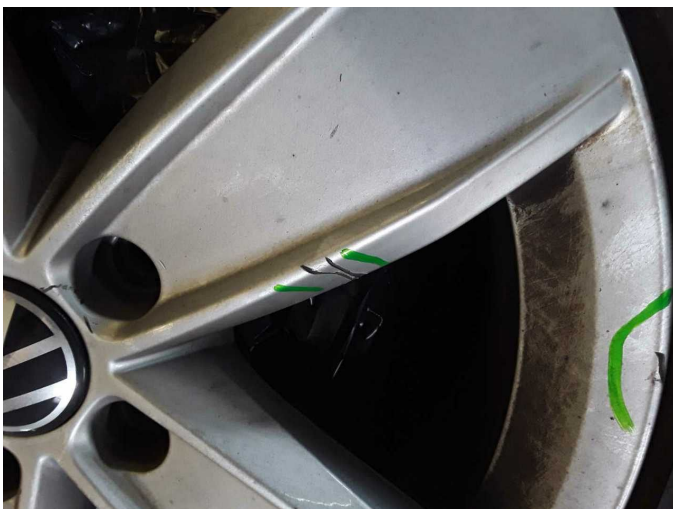
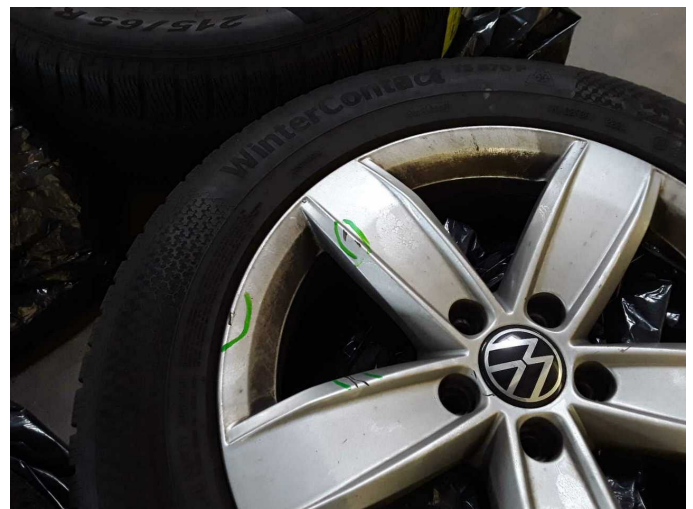
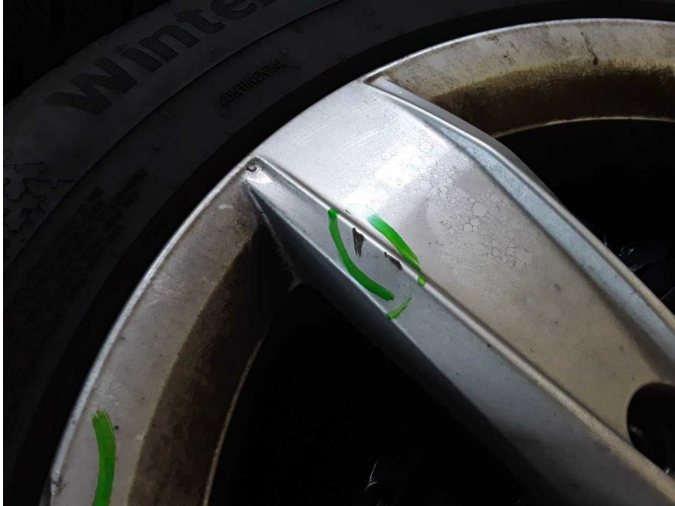
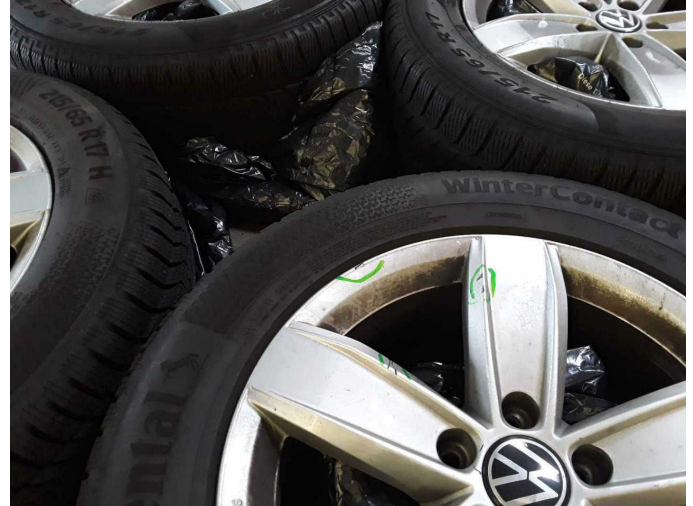
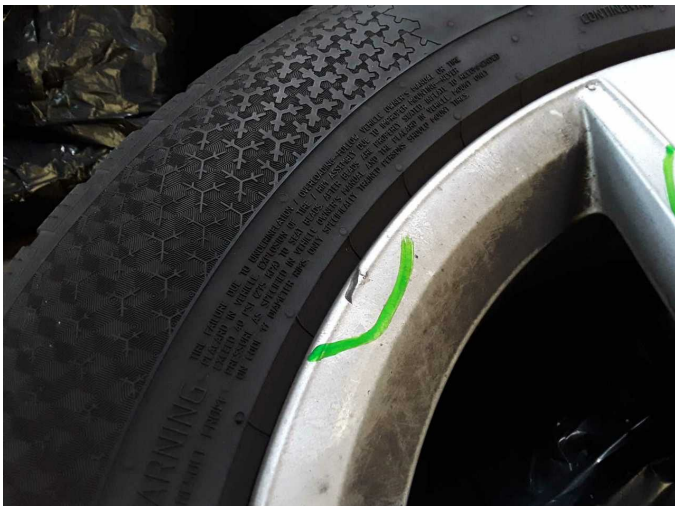
| No. | Component group | Description |
|---|---|---|
| 1 | 2nd wheel set | 2 alloy rims (gehören nicht zur Ausstattung) - Scratched - No deduction |

**Damage 1:** 2nd wheel set: 2 alloy rims (gehören nicht zur Ausstattung) - Scratched - No deduction

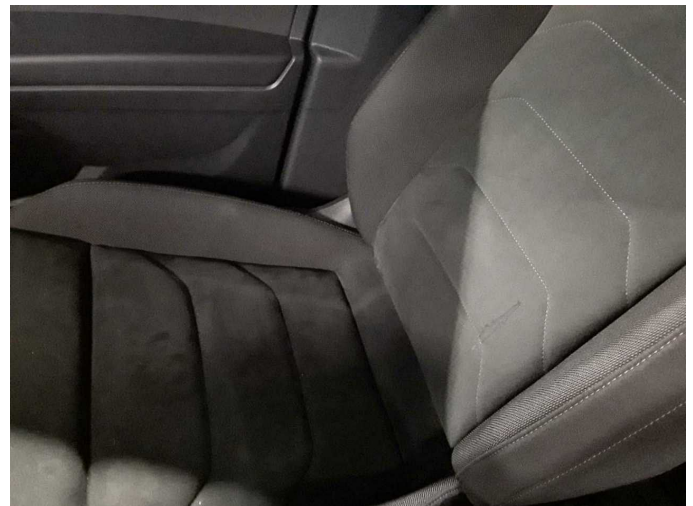
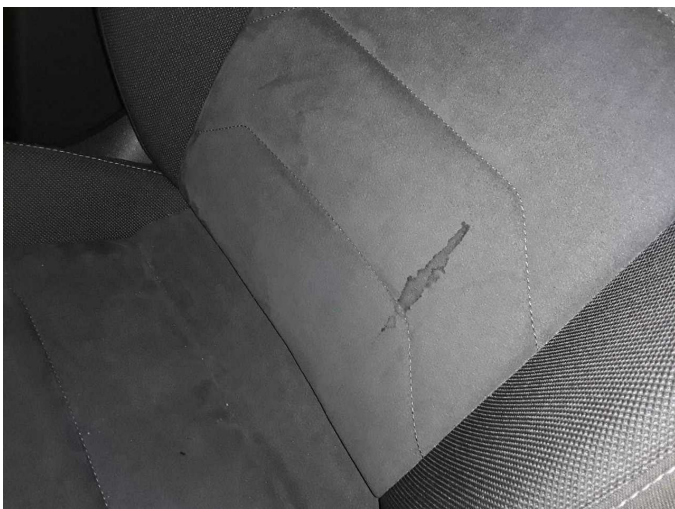
| No. | Component group | Description |
|---|---|---|
| 2 | Seat - front | Seat cover - right side - Soiled - Clean |

**Damage 2:** Seat - front: Seat cover - right side - Soiled - Clean

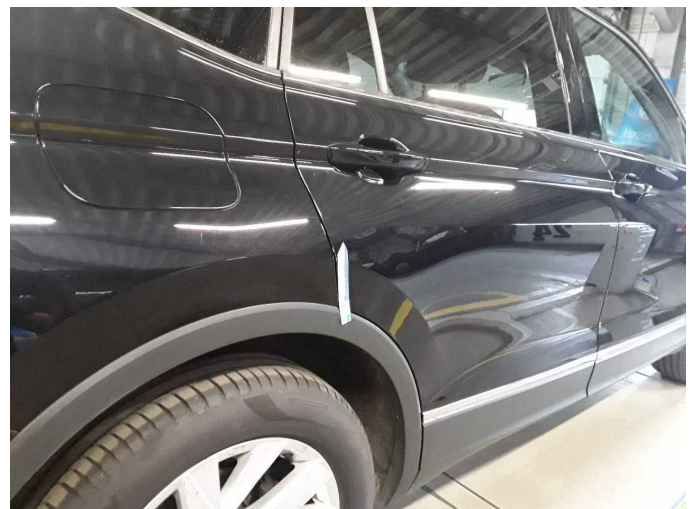
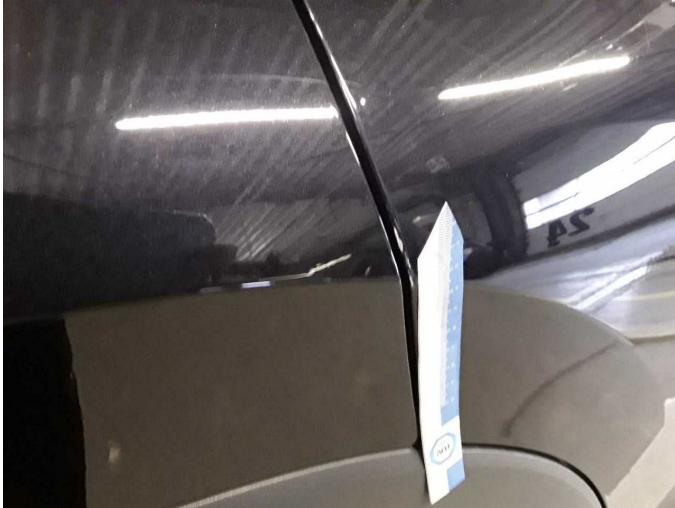
| No. | Component group | Description |
|---|---|---|
| 3 | Door - rear right side | Door - Scratch(es) - Smart repair |

**Damage 3:** Door - rear right side: Door - Scratch(es) - Smart repair

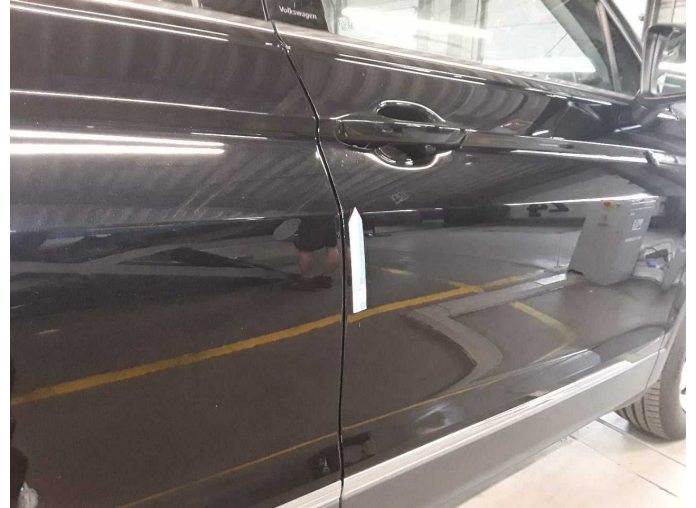
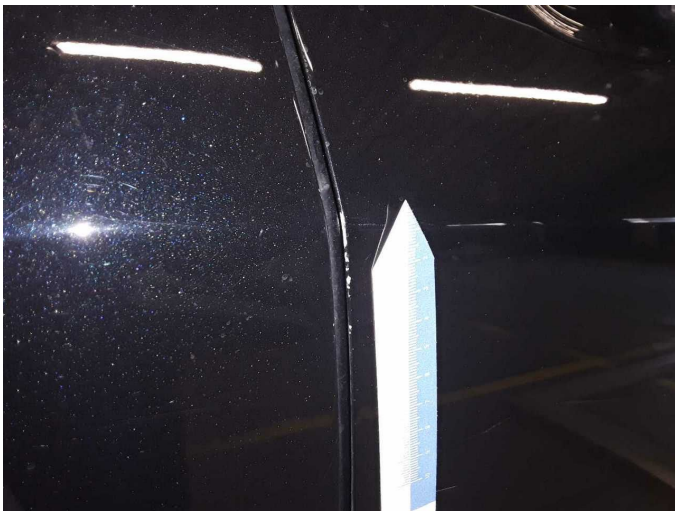
| No. | Component group | Description |
|---|---|---|
| 4 | Door - front right side | Door edge - Scratch(es) - Smart repair |

**Damage 4:** Door - front right side: Door edge - Scratch(es) - Smart repair

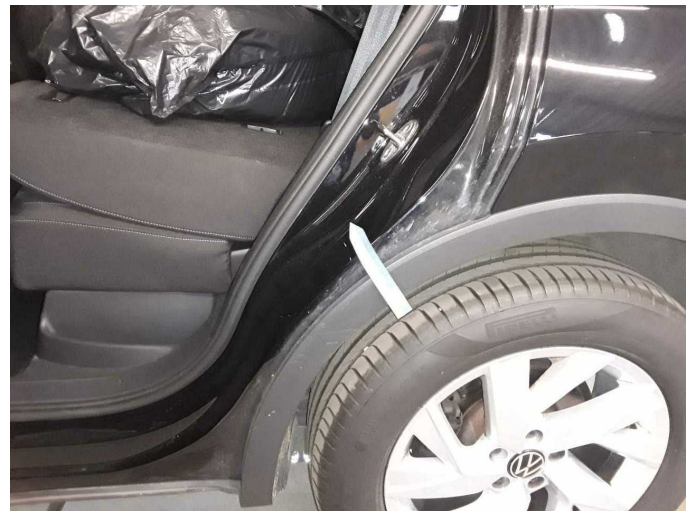
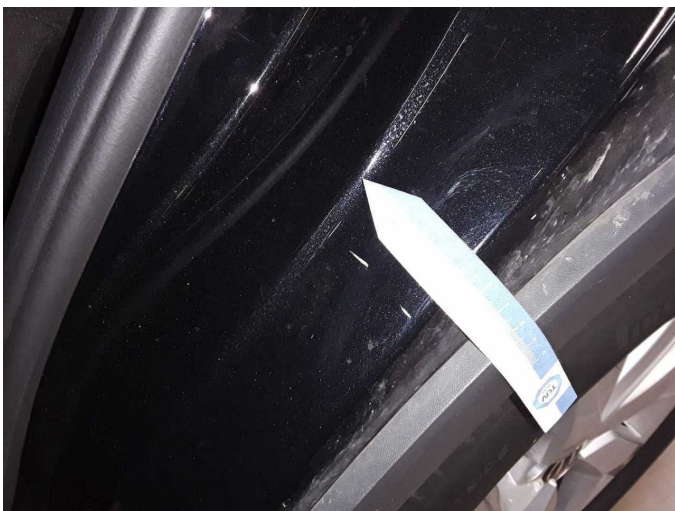
| No. | Component group | Description |
|---|---|---|
| 5 | Body | C-pillar - left side - Dent / paintcoat damage - Smart repair |

**Damage 5:** Body: C-pillar - left side - Dent / paintcoat damage - Smart repair

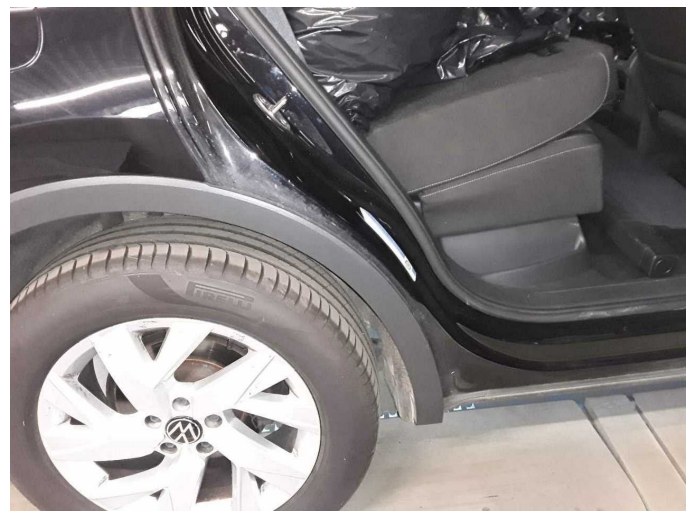
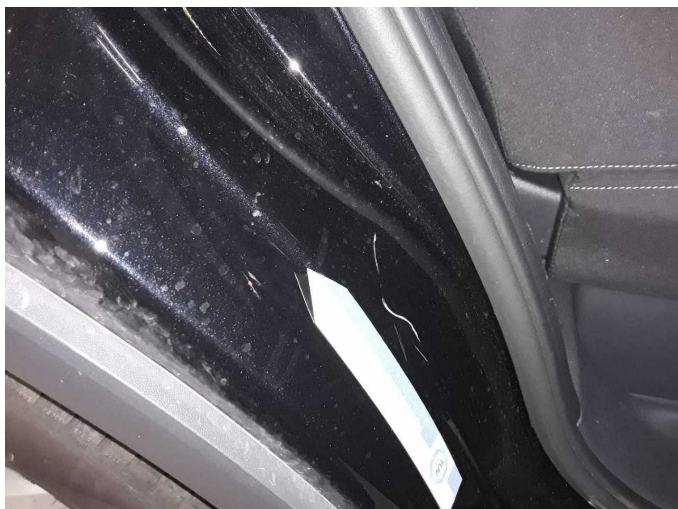
| No. | Component group | Description |
|---|---|---|
| 6 | Body | C-pillar - right side - Dent / paintcoat damage - Smart repair |

**Damage 6:** Body: C-pillar - right side - Dent / paintcoat damage - Smart repair

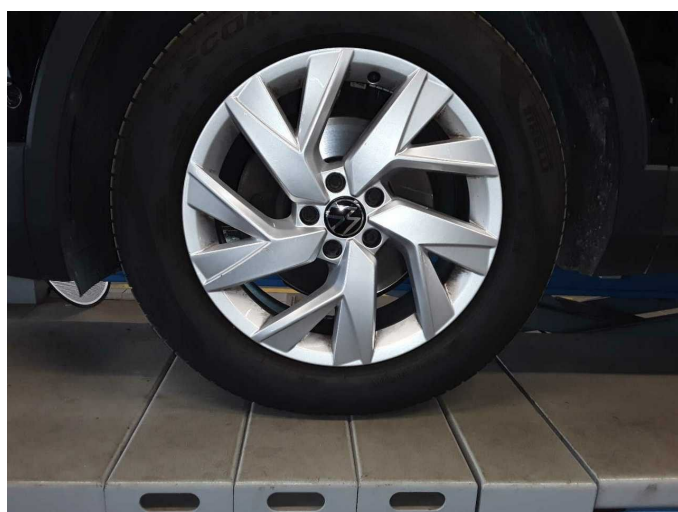
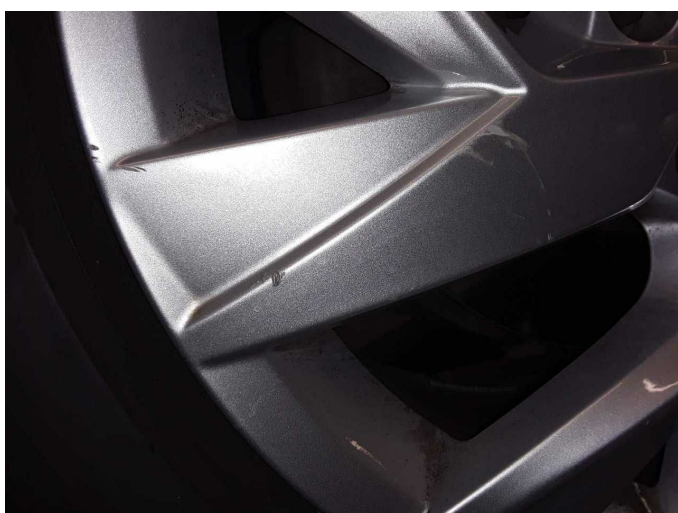
| No. | Component group | Description |
|---|---|---|
| 8 | Wheel / tyres | Alloy rim - front left side - Scratch(es) - Loss in value |

**Damage 8:** Wheel / tyres: Alloy rim - front left side - Scratch(es) - Loss in value

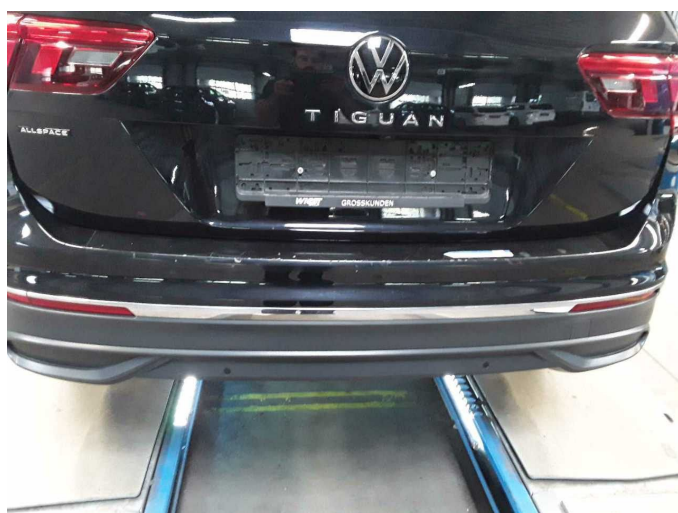
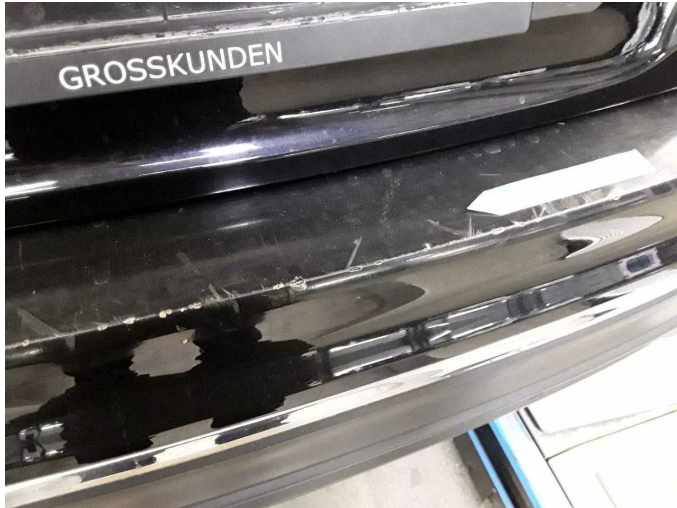
| No. | Component group | Description |
|---|---|---|
| 9 | Rear bumper | Rear bumper - Scratch(es) - Paint |

**Damage 9:** Rear bumper: Rear bumper - Scratch(es) - Paint

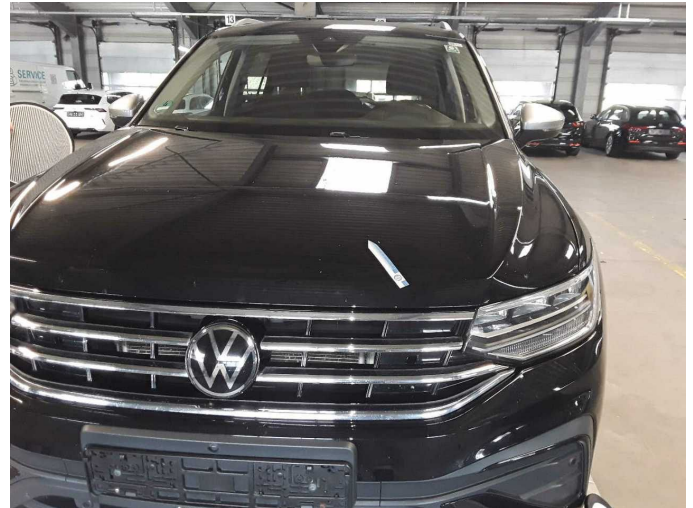
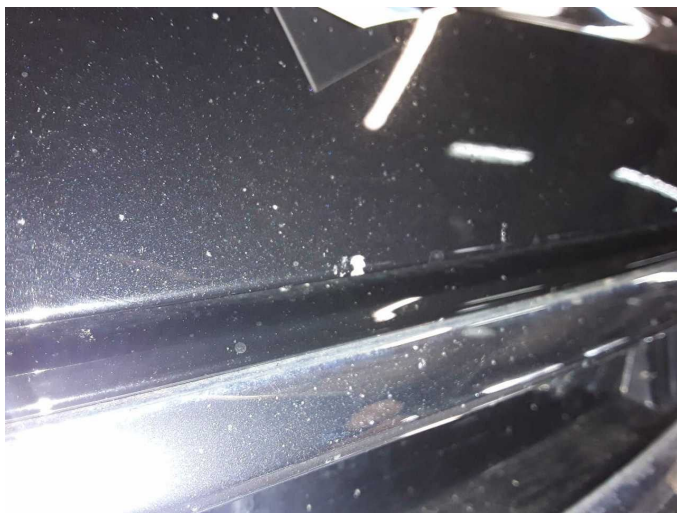
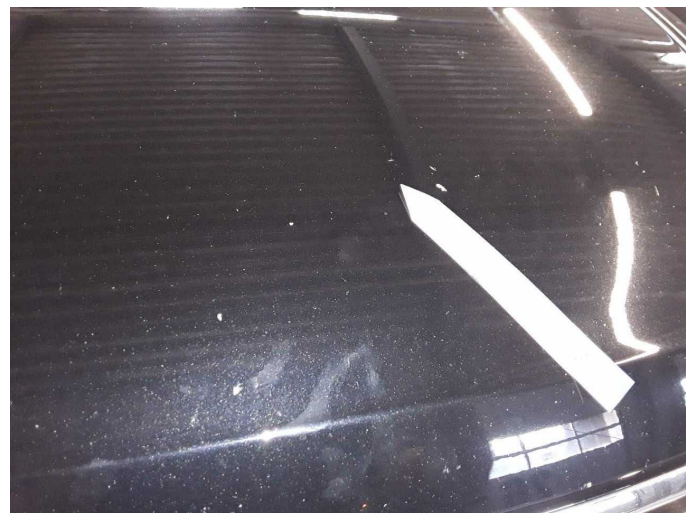
| No. | Component group | Description |
|---|---|---|
| 10 | Bonnet | Bonnet - Stone chips - Paint |

**Damage 10:** Bonnet: Bonnet - Stone chips - Paint

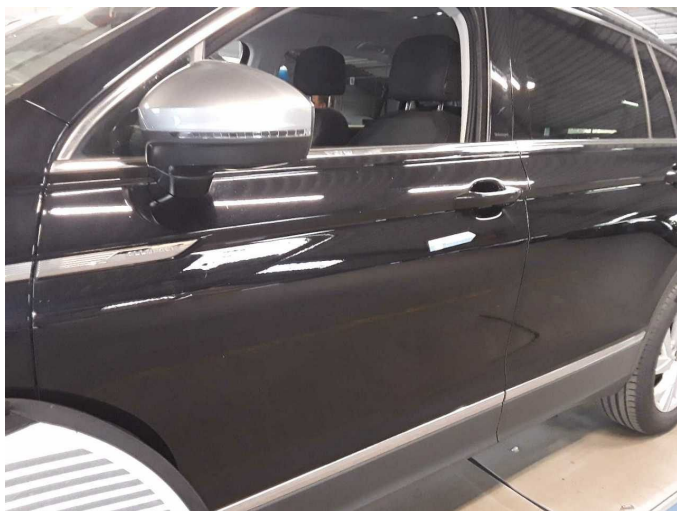
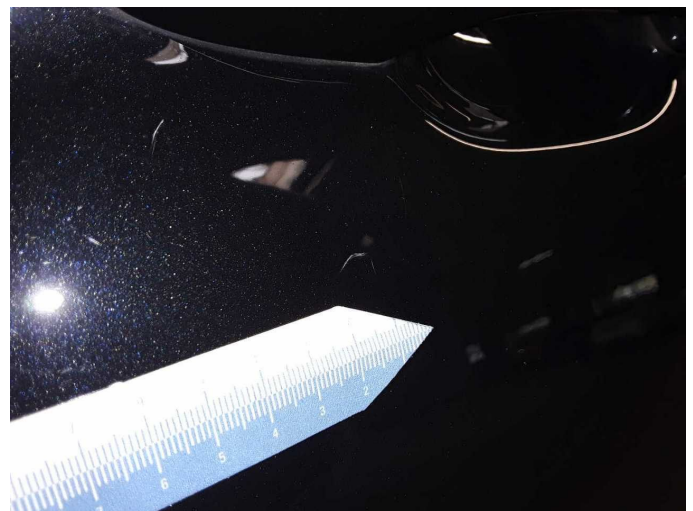
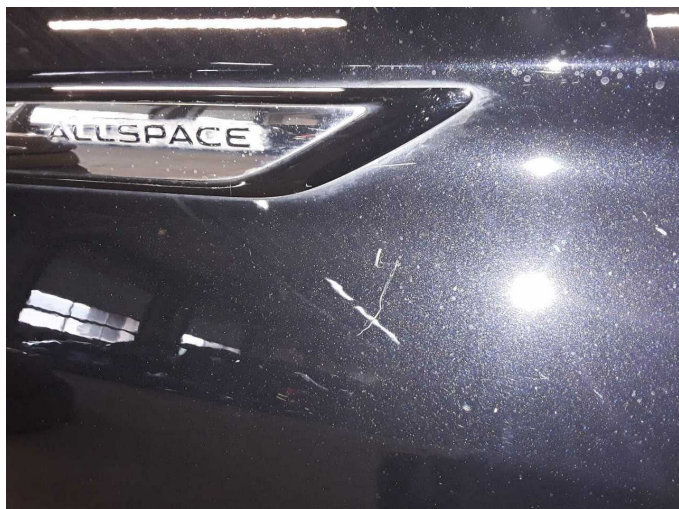
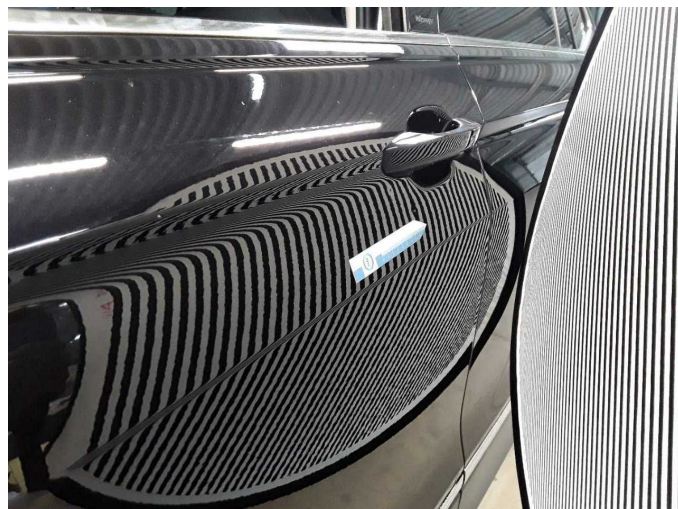
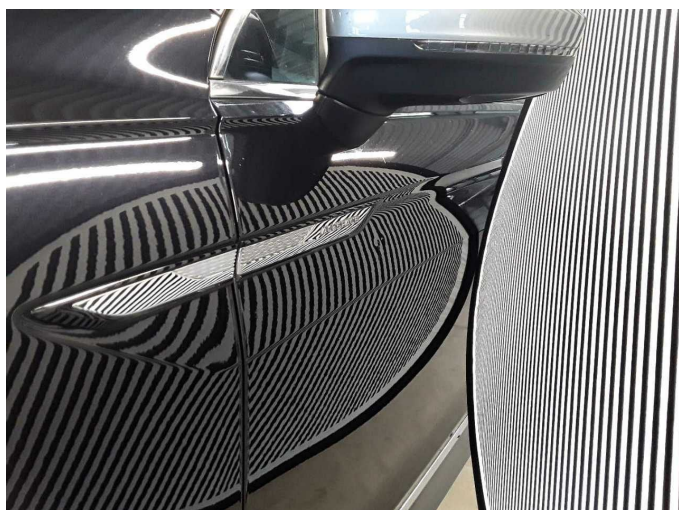
| No. | Component group | Description |
|---|---|---|
| 11 | Door - front left side | Door - Dent / paintcoat damage - Repair and paint |

**Damage 11:** Door - front left side: Door - Dent / paintcoat damage - Repair and paint

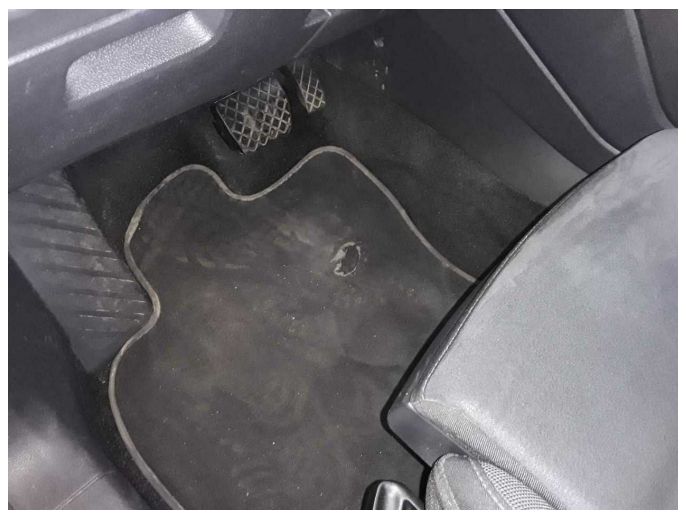
| No. | Component group | Description |
|---|---|---|
| 5 | Trim / covers | Carpet - front left side - Broken / torn - No deduction |

**Wear and tear 5:** Trim / covers: Carpet - front left side - Broken / torn - No deduction
