Expertise

Protocol number: 46435829  
Order No. / Reference: 26707134  
Inspection date: 10 Jul 2026

Manufacturer: Ford

Model: Mondeo Turnier 2.0 EcoBlue Aut. Titanium

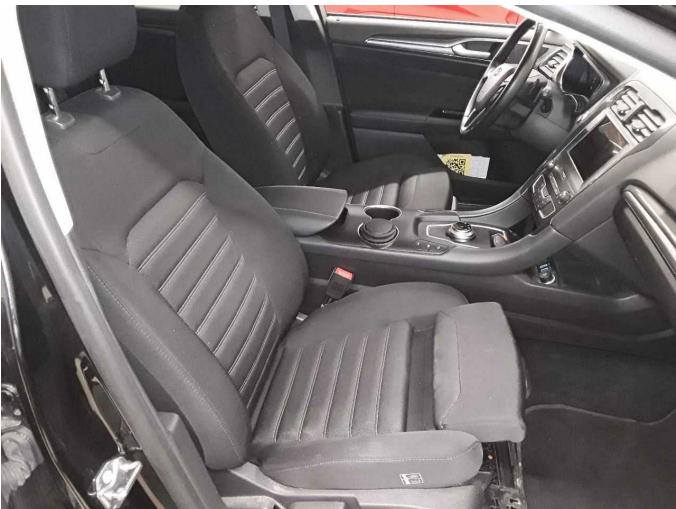
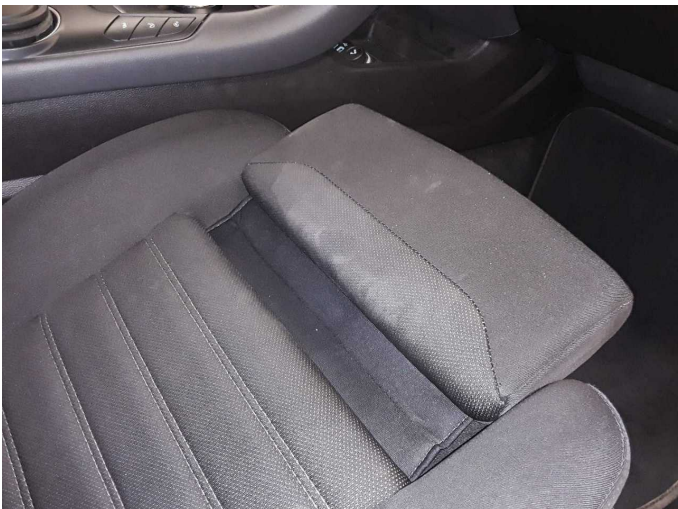
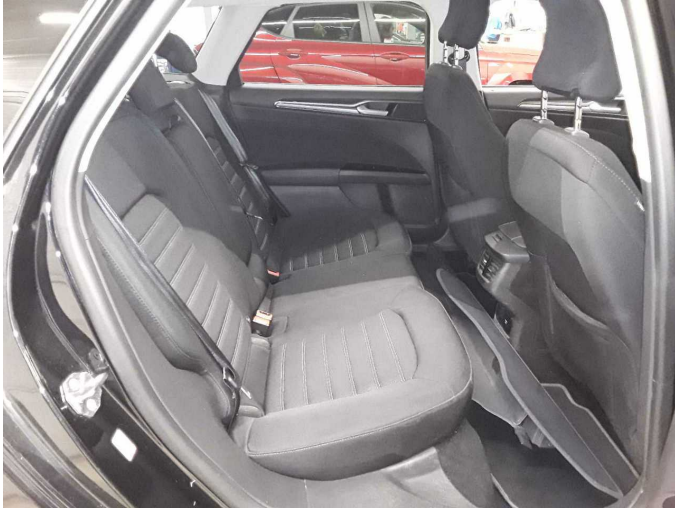
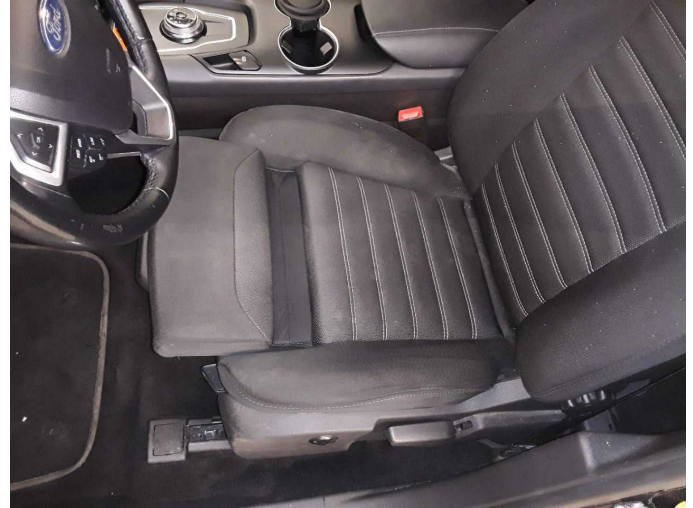
| No. | Component group | Description |
|---|---|---|
| 1 | Seat - front | Seat cover - right side (Sitze) - Soiled - Clean |

Damage 1: Seat - front: Seat cover - right side (Sitze) - Soiled - Clean

**Damage 1:** Seat - front: Seat cover - right side (Sitze) - Soiled - Clean

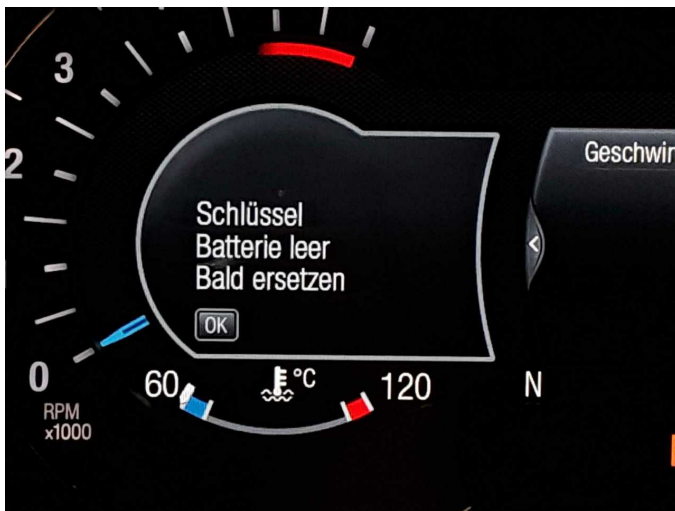
| No. | Component group | Description |
|---|---|---|
| 2 | Equipment | Vehicle key - Empty - Replace |

**Damage 2:** Equipment: Vehicle key - Empty - Replace

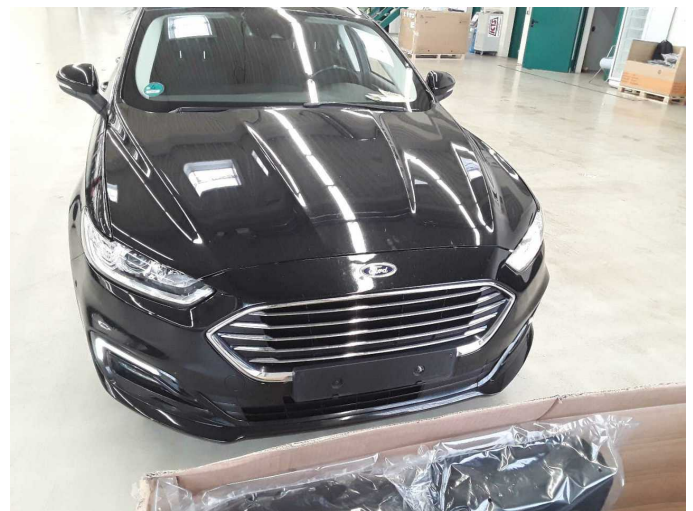
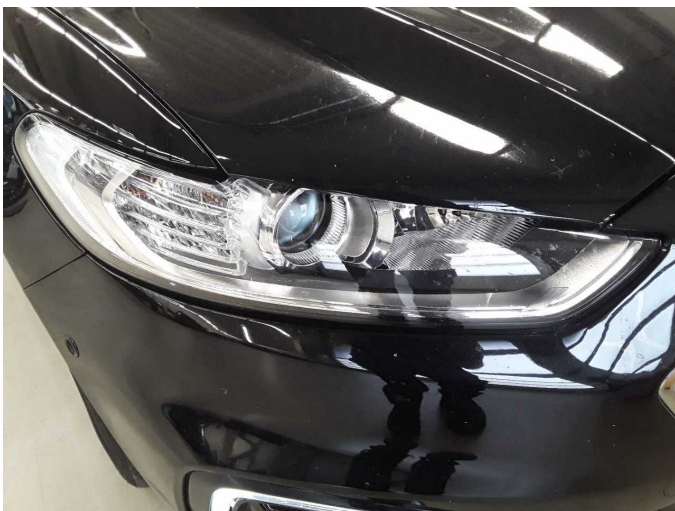
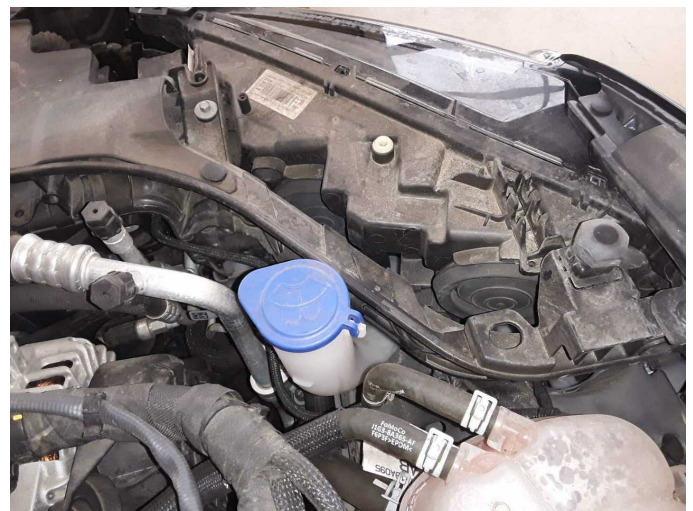
| No. | Component group | Description |
|---|---|---|
| 3 | Headlight | Headlight - right side (Leuchtmittel H7) - Non-operational - Perform diagnosis |

**Damage 3:** Headlight: Headlight - right side (Leuchtmittel H7) - Non-operational - Perform diagnosis

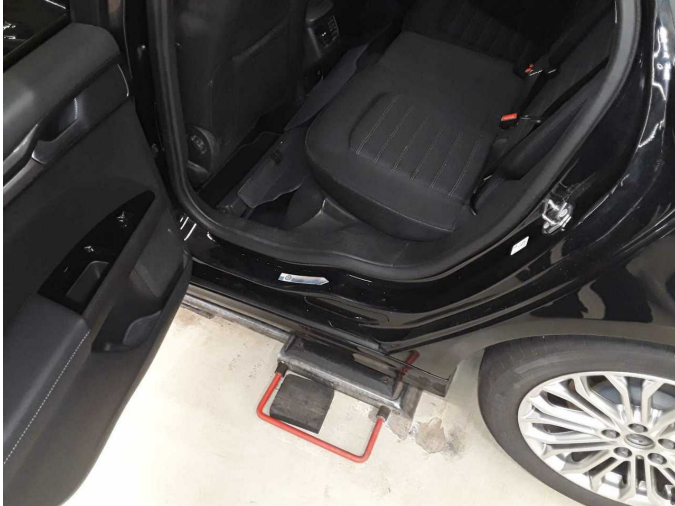
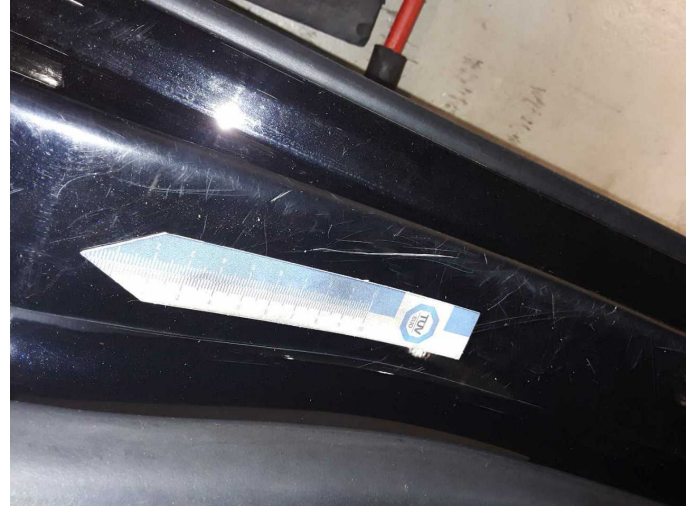
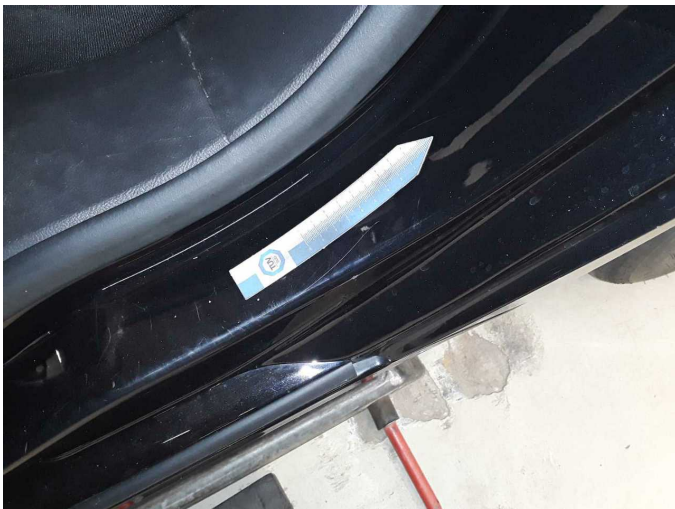
| No. | Component group | Description |
|---|---|---|
| 4 | Side panel - rear left side | Sill - Scratch(es) - Smart repair |

**Damage 4:** Side panel - rear left side: Sill - Scratch(es) - Smart repair

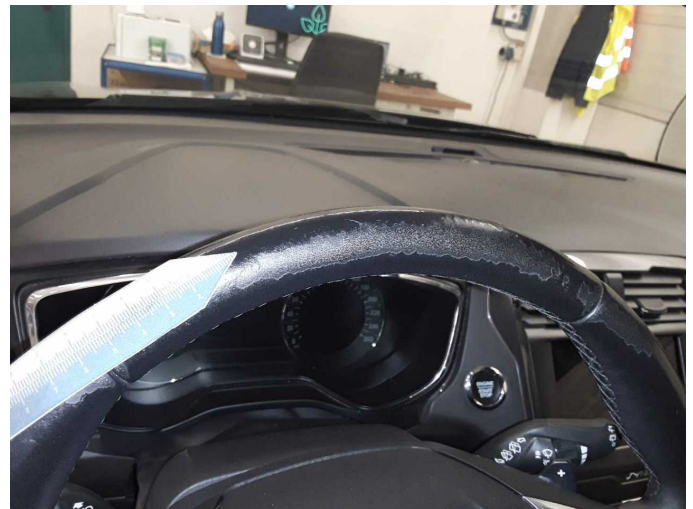
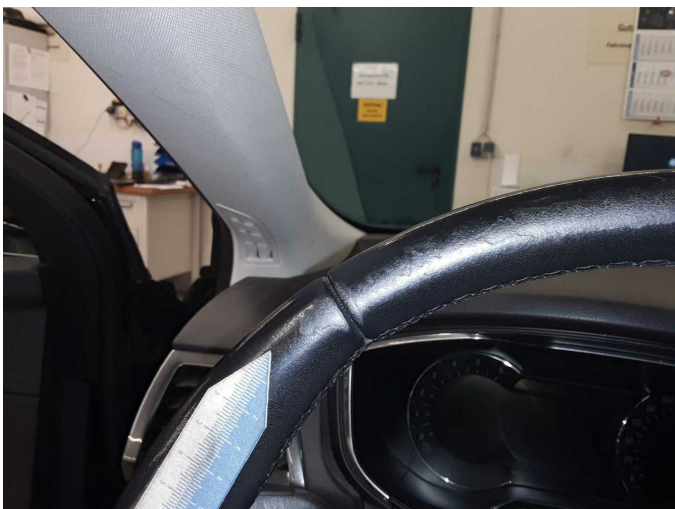
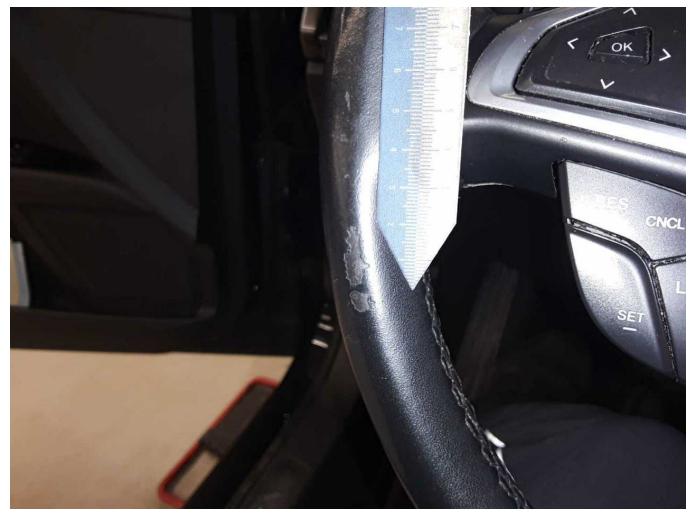
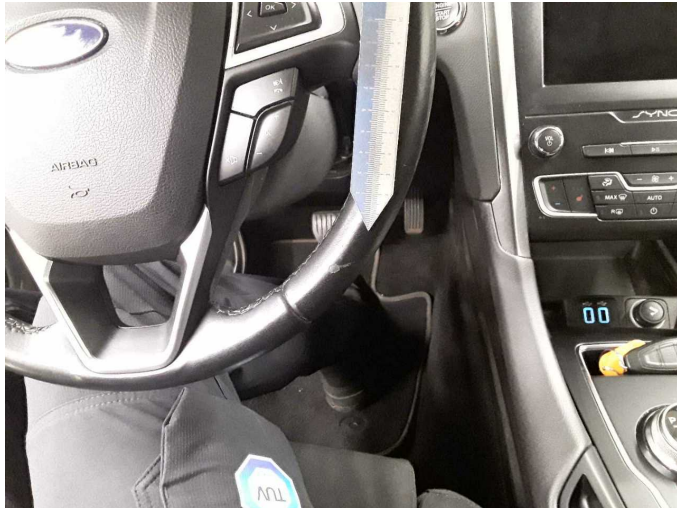
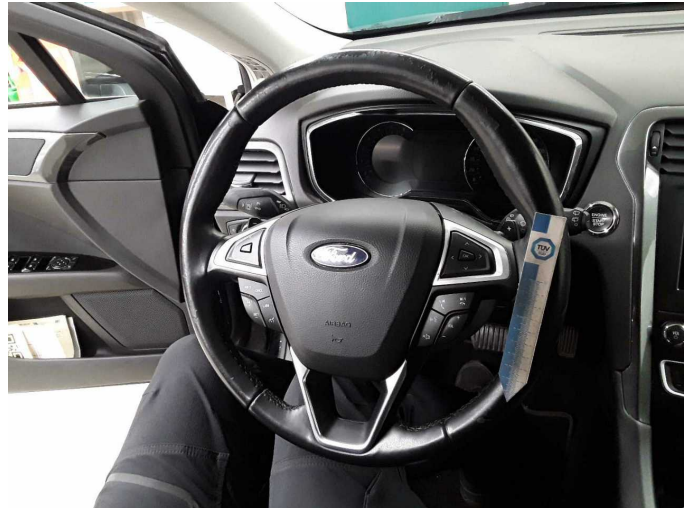
| No. | Component group | Description |
|---|---|---|
| 5 | Steering system | Steering wheel sheath - Scratched - Smart repair |

**Damage 5:** Steering system: Steering wheel sheath - Scratched - Smart repair

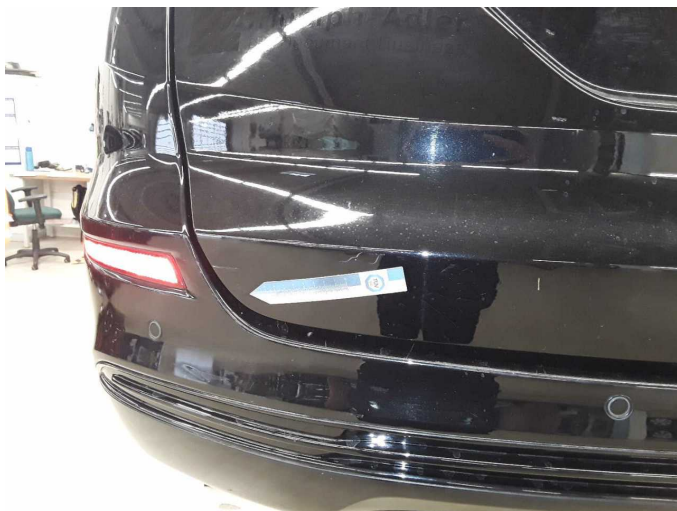
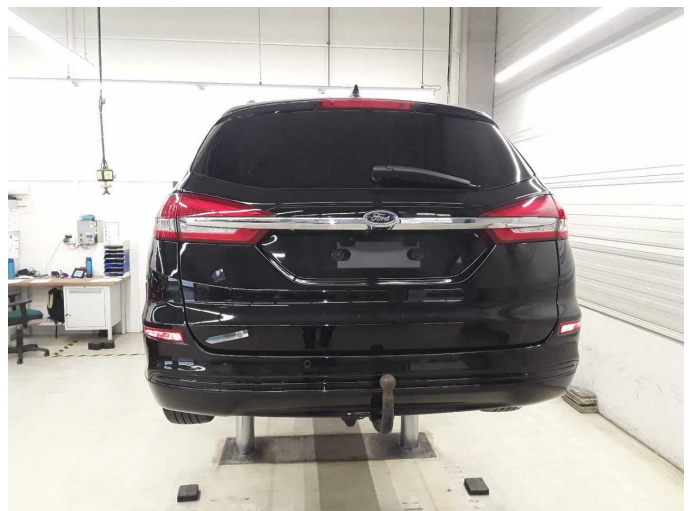
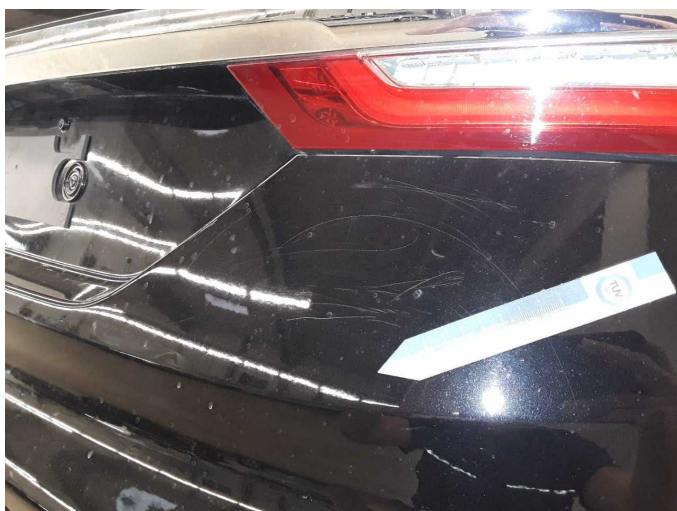
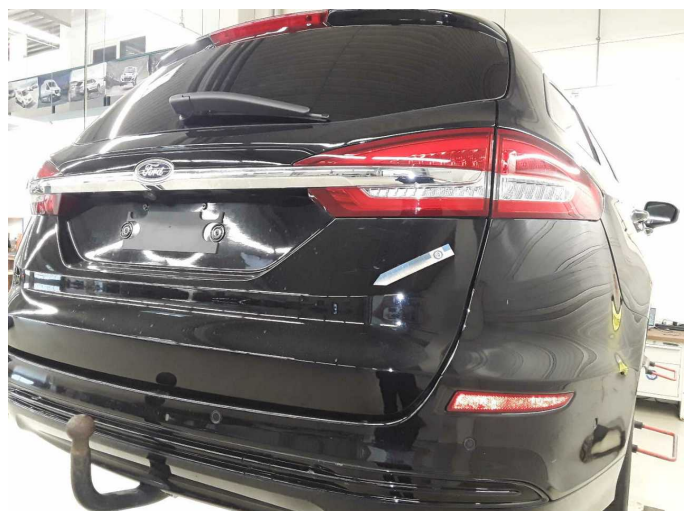
| No. | Component group | Description |
|---|---|---|
| 6 | Boot lid / rear door | Boot lid (Unterteil) - Scratch(es) - Paint |

**Damage 6:** Boot lid / rear door: Boot lid (Unterteil) - Scratch(es) - Paint

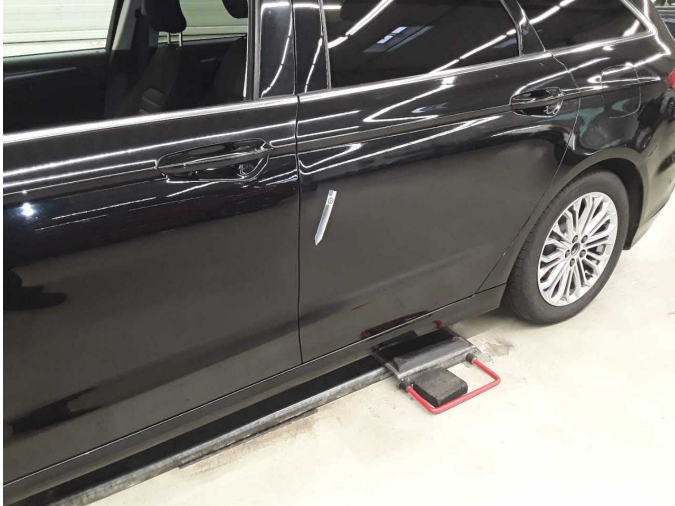
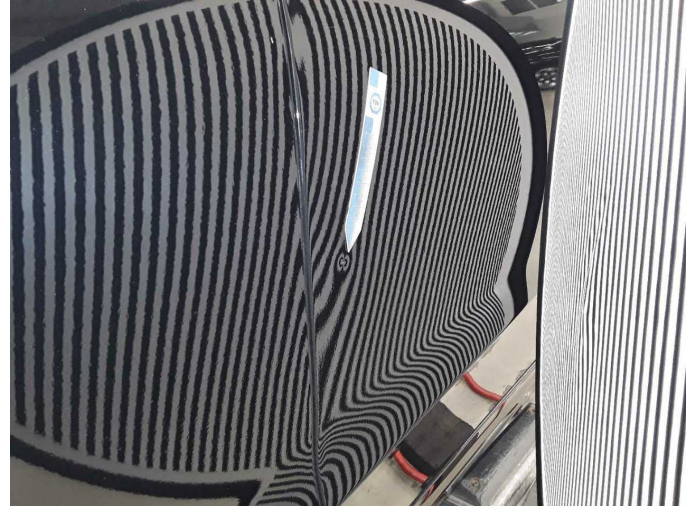
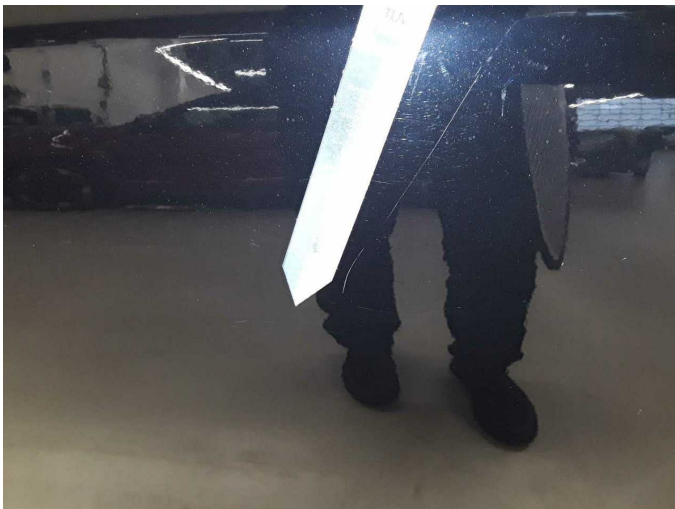
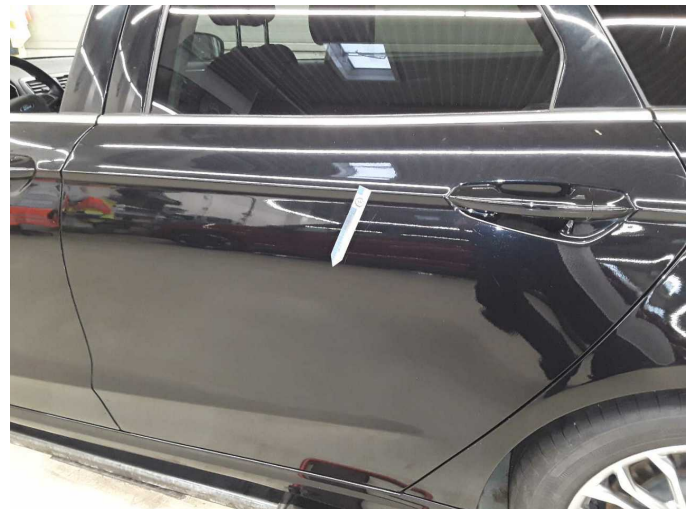
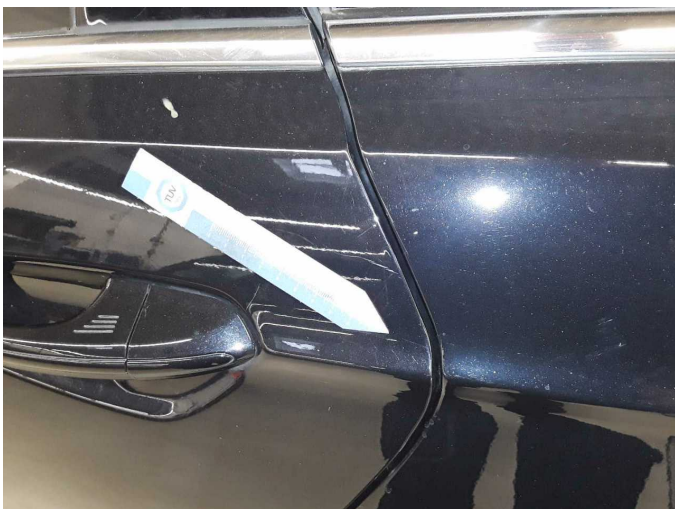
| No. | Component group | Description |
|---|---|---|
| 7 | Door - rear left side | Door - Dent / paintcoat damage - Repair and paint |

**Damage 7:** Door - rear left side: Door - Dent / paintcoat damage - Repair and paint

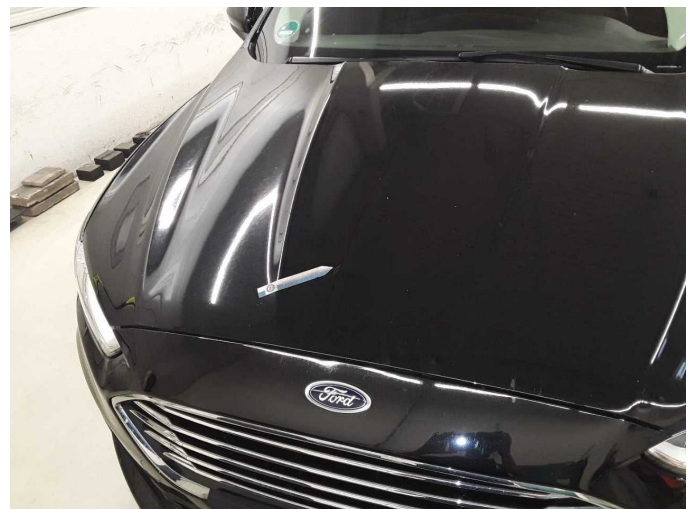
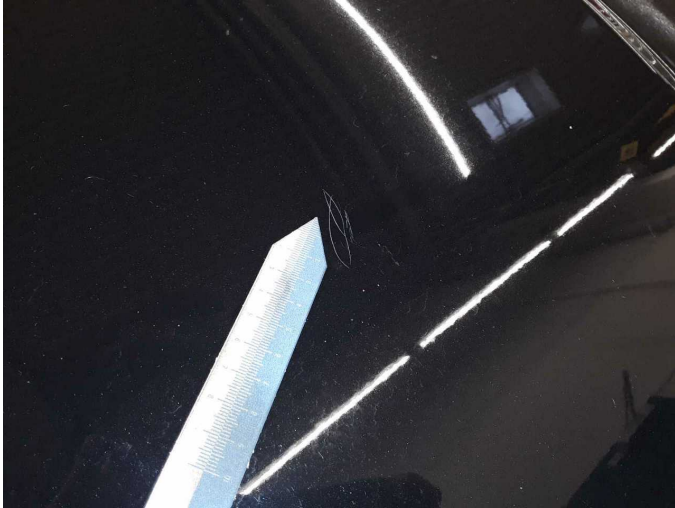
| No. | Component group | Description |
|---|---|---|
| 8 | Bonnet | Bonnet - Scratch(es) - Paint |

**Damage 8:** Bonnet: Bonnet - Scratch(es) - Paint

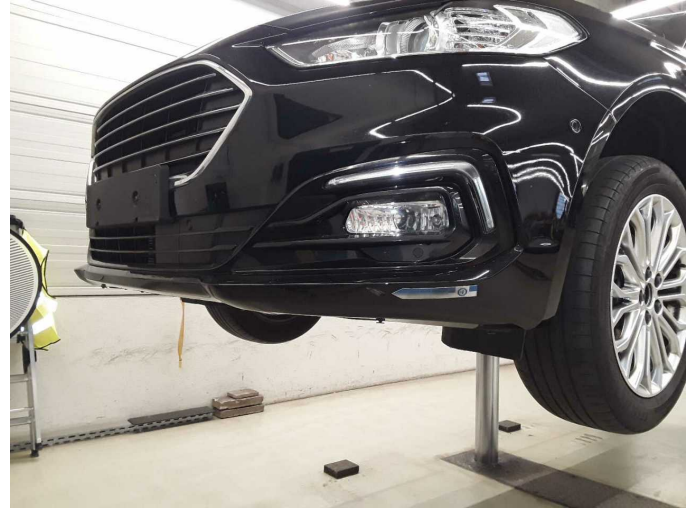
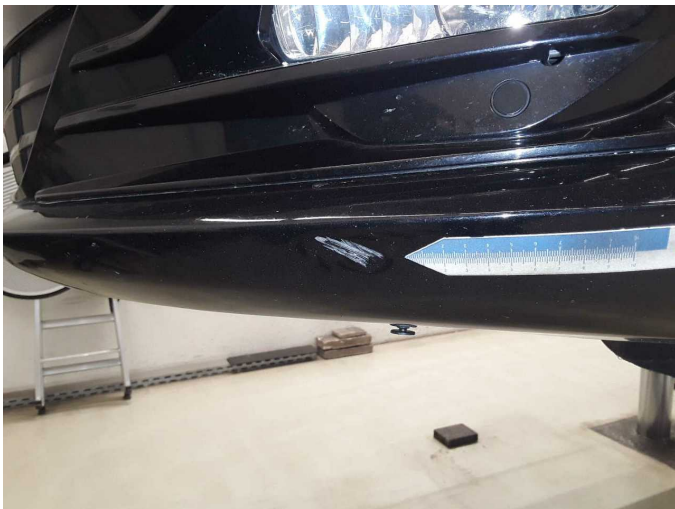
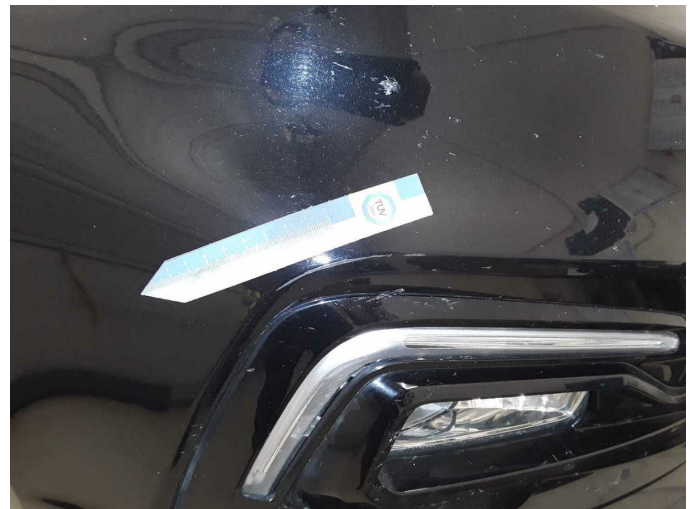
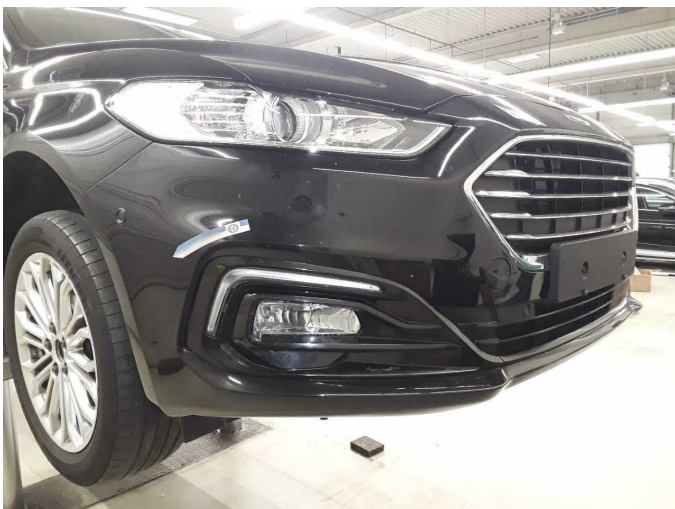
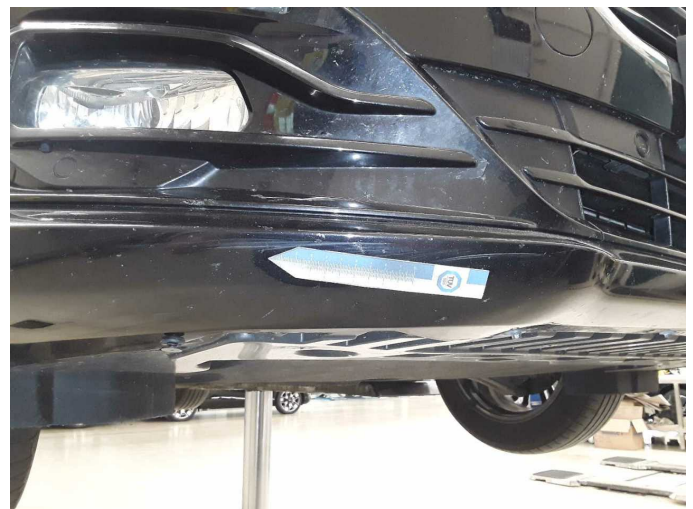
| No. | Component group | Description |
|---|---|---|
| 9 | Front bumper | Front bumper - Scratched - Repair and paint |

**Damage 9:** Front bumper: Front bumper - Scratched - Repair and paint

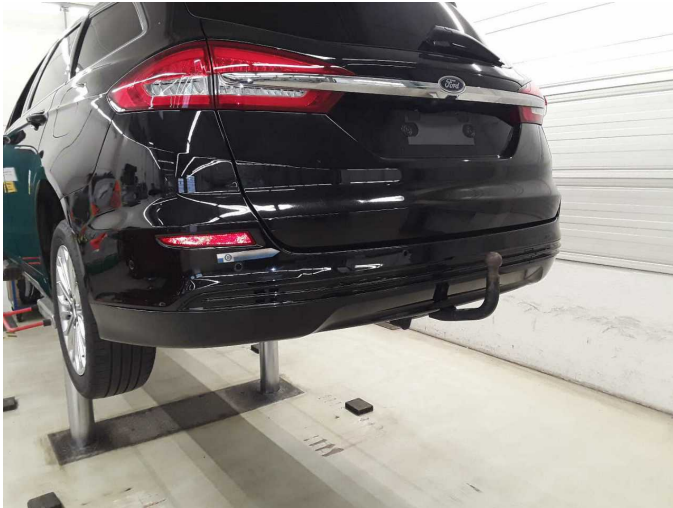
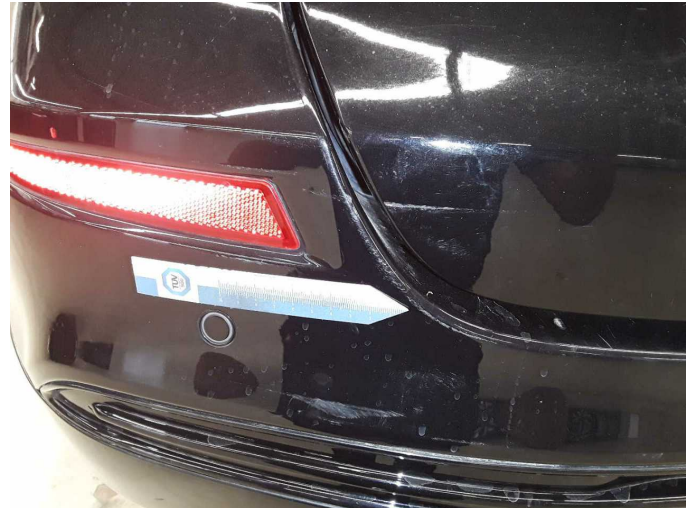
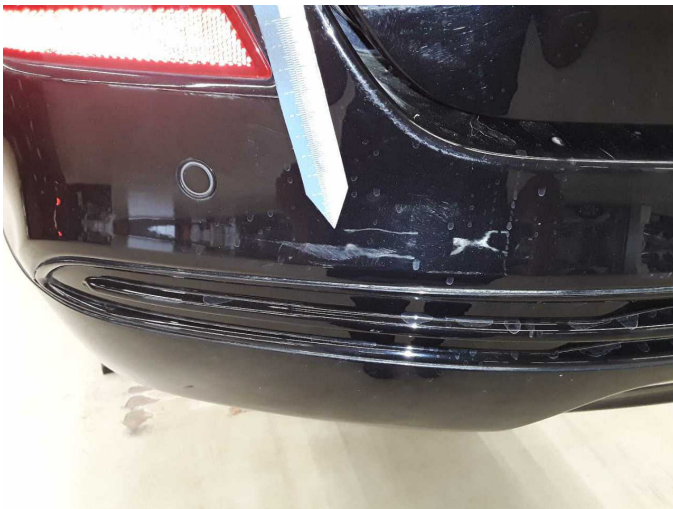
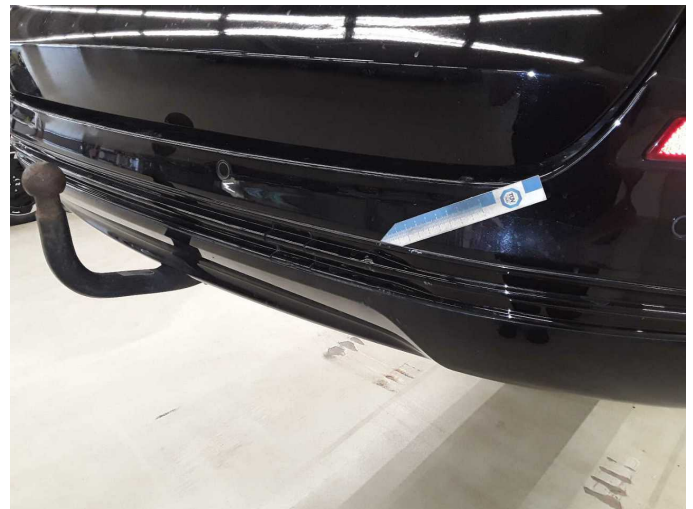
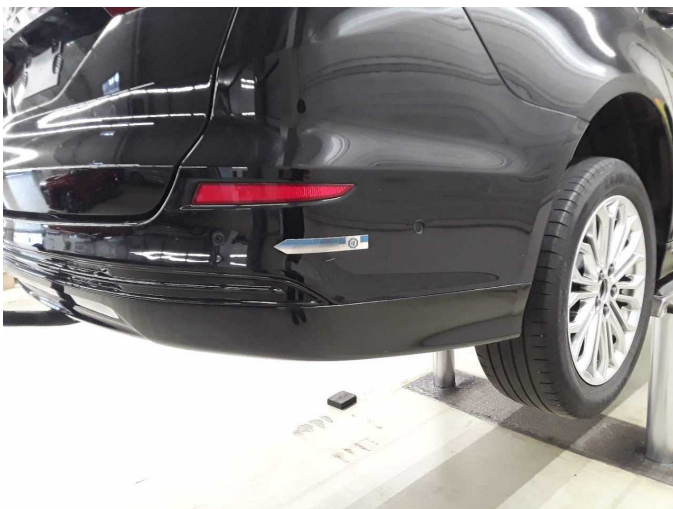
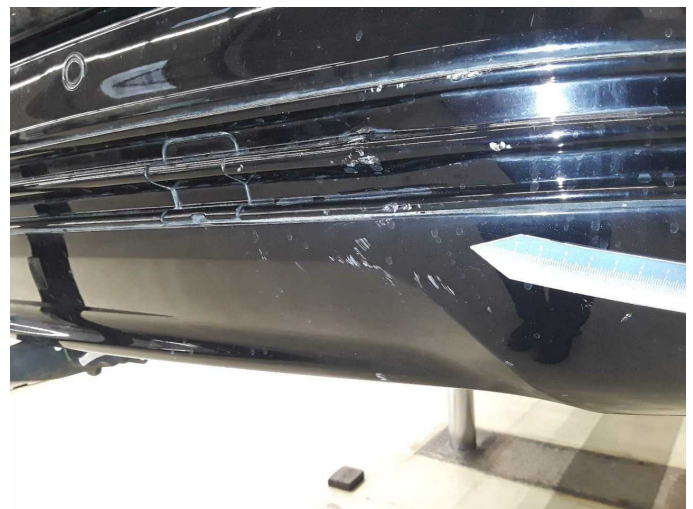
| No. | Component group | Description |
|---|---|---|
| 10 | Rear bumper | Rear bumper (Incl. Zierleiste schwarz erneuern+AHK prüfen) - Scratched - repair according to calculation |

**Damage 10:** Rear bumper: Rear bumper (Incl. Zierleiste schwarz erneuern+AHK prüfen) - Scratched - repair according to calculation

Die beigefügte Reparaturkostenkalkulation wurde nach bestem Wissen und Gewissen unter eingeschränkter Besichtigungsbedingung im demontagefreien Zustand erstellt. Es können aufgrund verdeckter Beschädigung, Mehrkosten und somit Abweichung der für die Stoßstange ausgewiesenen Reparaturkosten nicht ausgeschlossen werden.

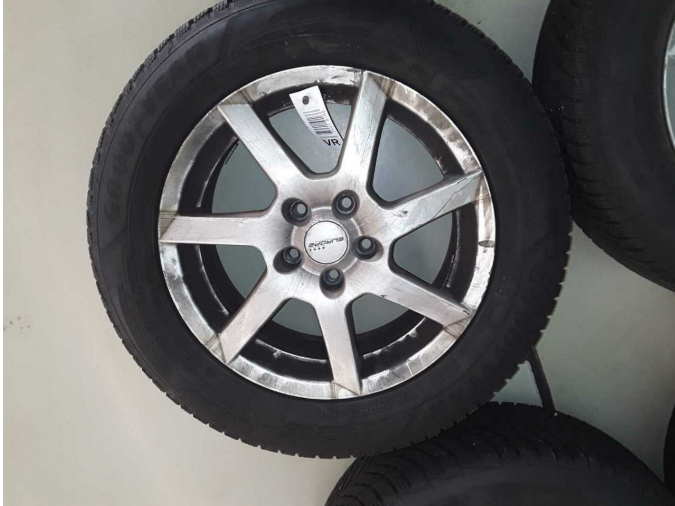
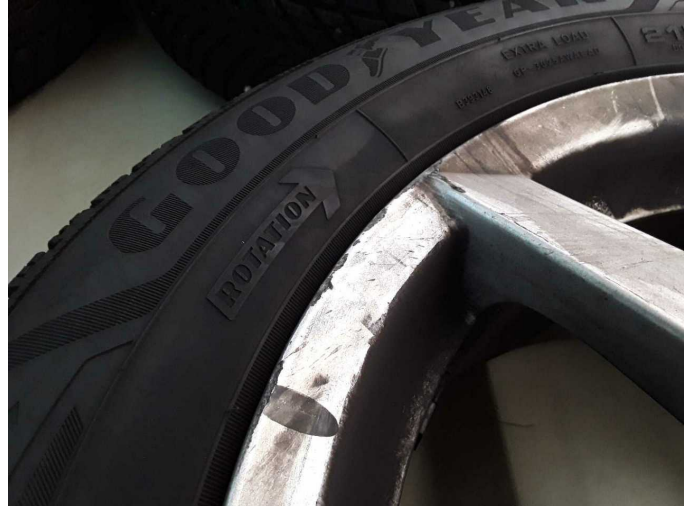
| No. | Component group | Description |
|---|---|---|
| 1 | 2nd wheel set | 1 alloy rim - Scratched - No deduction |

**Wear and tear 1:** 2nd wheel set: 1 alloy rim - Scratched - No deduction

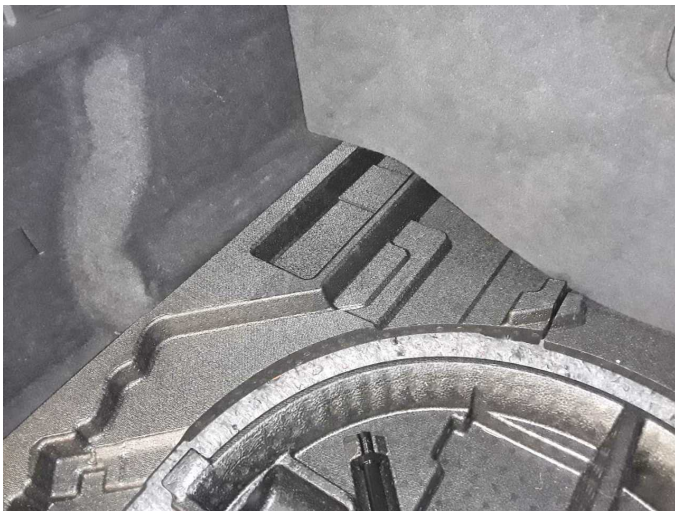
**Missing part 1:** Rear of vehicle: Key trailer hitch (2x) - Missing - Replace

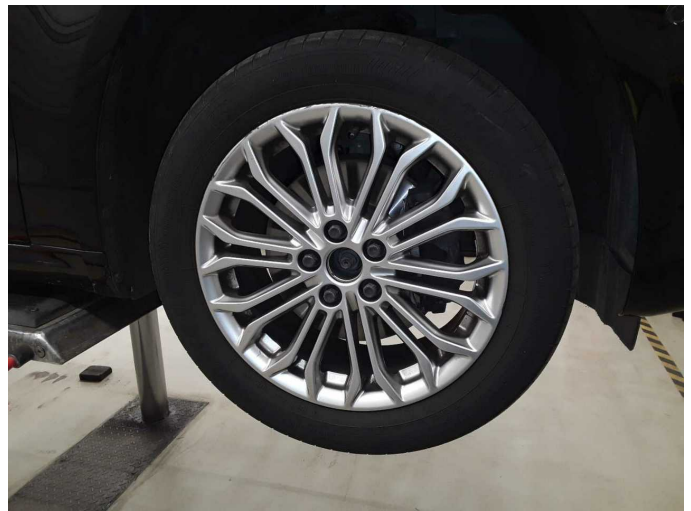
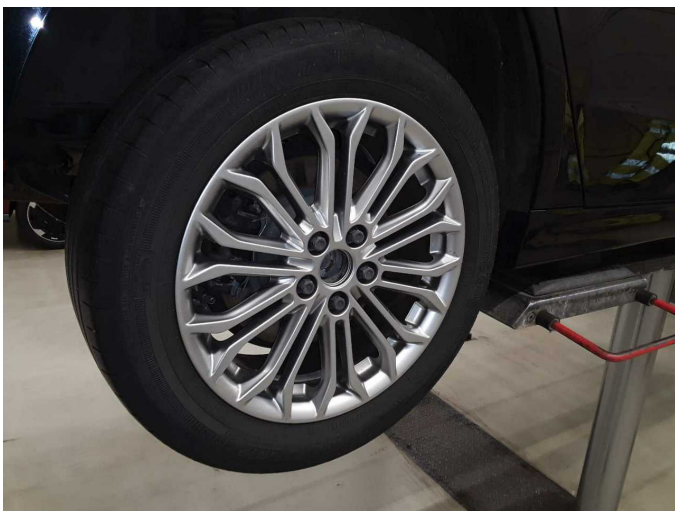
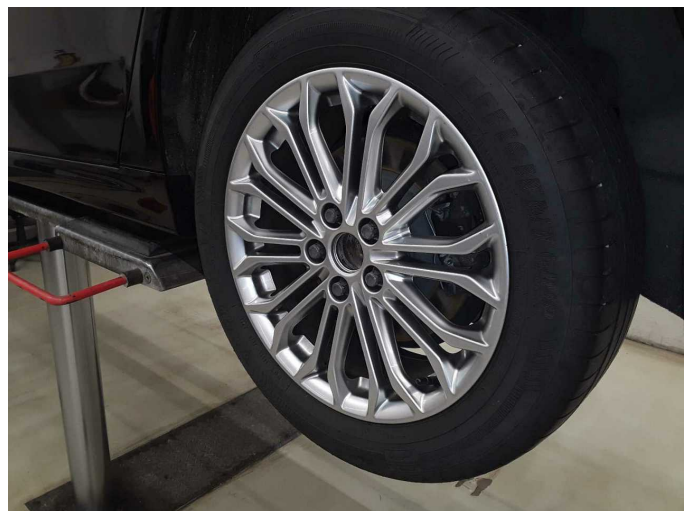
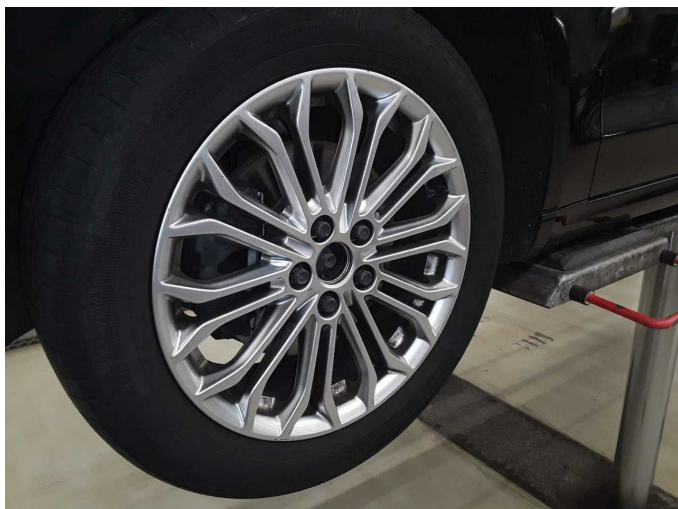
**Missing part 2:** Wheel / tyres: Wheel cover set - complete (Nabendeckel)  
- Missing - Replace

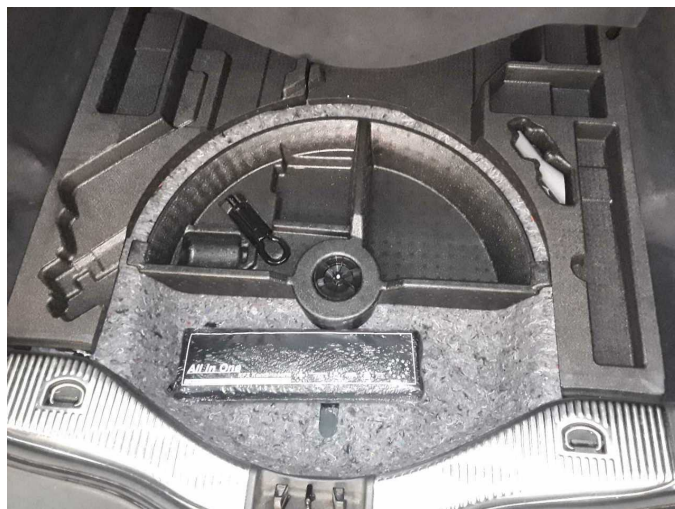
**Missing part 3:** Equipment: Tirefit complete - Missing - Replace

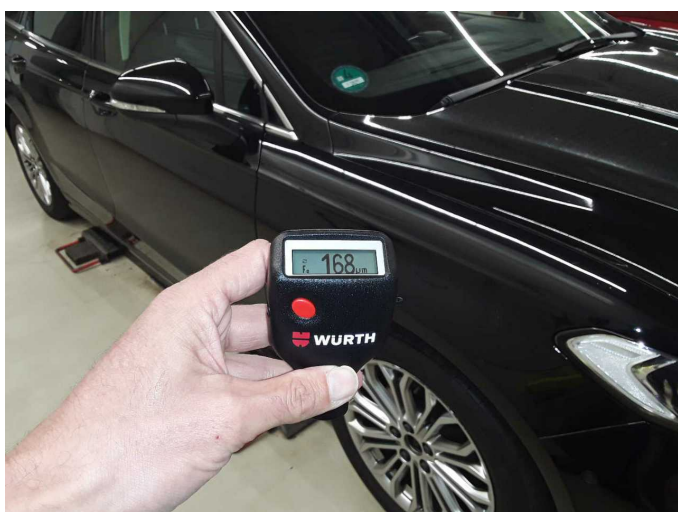
1 Mudguard - right side, Door - rear right side, Door - front right side, Professionally carried out

**Mudguard - right side:** 168 µm

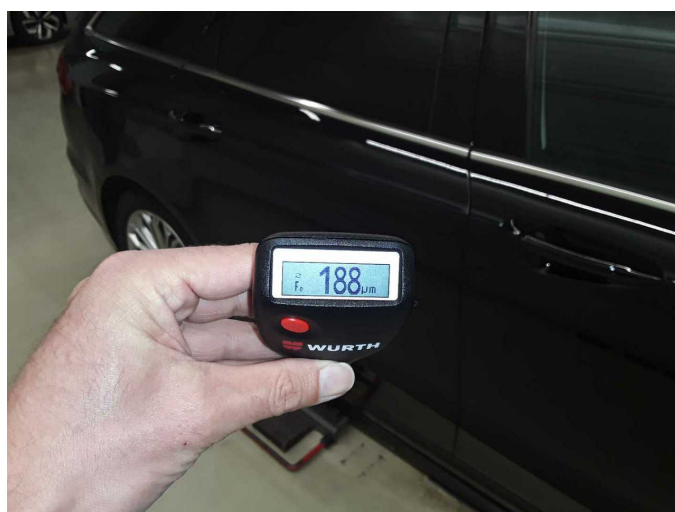
**Door - rear right side:** 188 µm

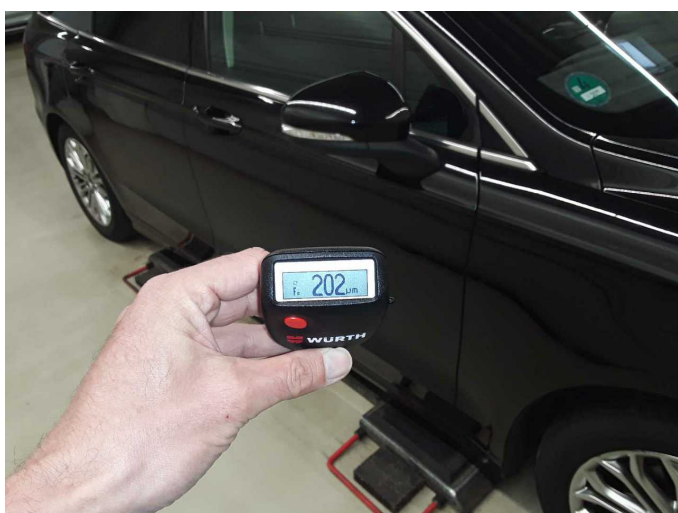
**Door - front right side:** 202 µm
