Expertise

Protocol number: 46373642  
Order No. / Reference: 26547034  
Inspection date: 3 Jul 2026

Manufacturer: Skoda  
VIN: TMBJC9NYXNF055784

Model: Enyaq iV 80

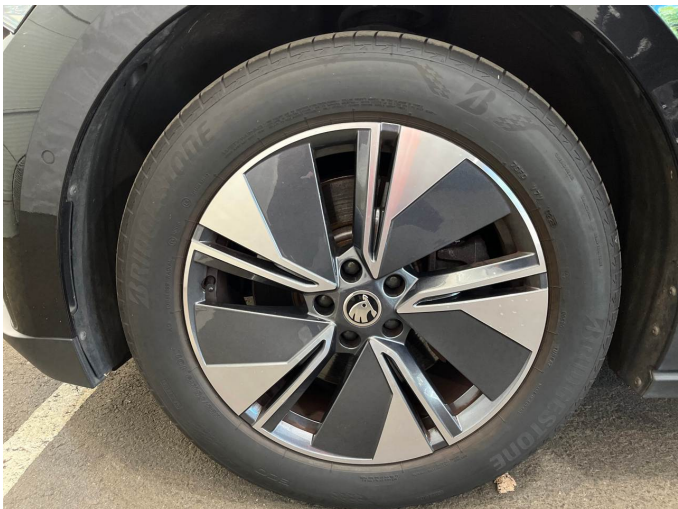
| # | Tyre size | Type of tyre | Manufacturer | Tread depth |
|---|---|---|---|---|
| 1) | 235/55 R19 101T | Summer tyres on Light alloy | Bridgestone | 6mm / 6mm |
| 2) | 255/50 R19 103T | Summer tyres on Light alloy | Bridgestone | 6mm / 6mm |

Figure 12: Mounted tyres

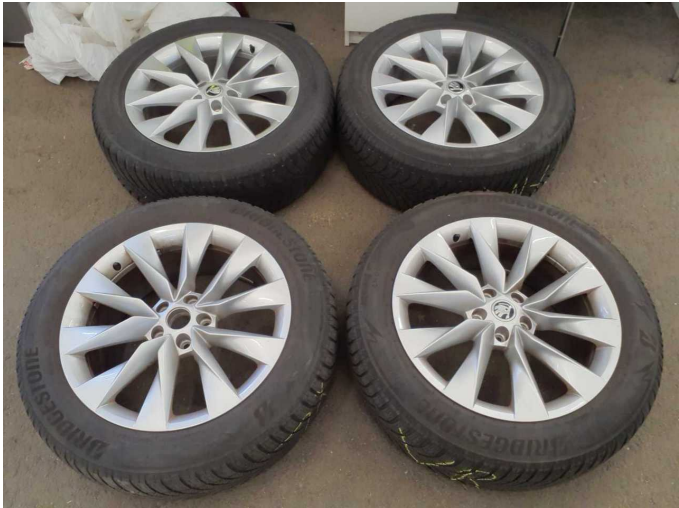
| # | Tyre size | Type of tyre | Manufacturer | Tread depth |
|---|---|---|---|---|
| 1) | 235/55 R19 105V | Winter tyres on Light alloy | Bridgestone | 5mm / 5mm |
| 2) | 255/50 R19 107V | Winter tyres on Light alloy | Bridgestone | 4mm / 4mm |

Figure 16: Additional tyres

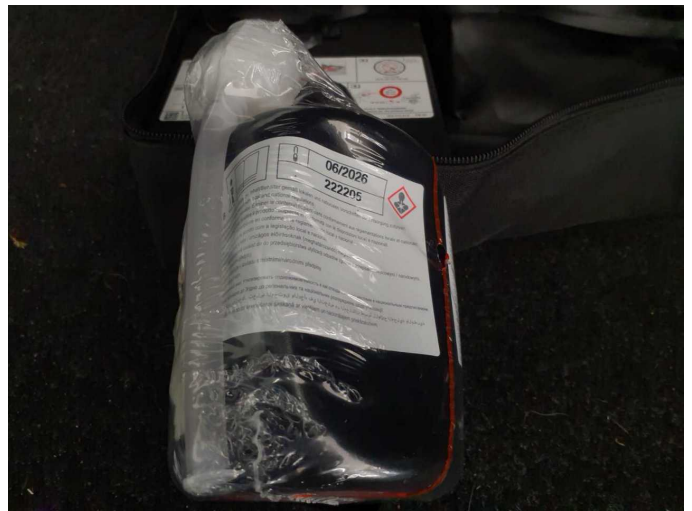
| No. | Component group | Description |
|---|---|---|
| 1 | Equipment | Tirefit filler - Expired - Replace |

Damage 1: Equipment: Tirefit filler - Expired - Replace

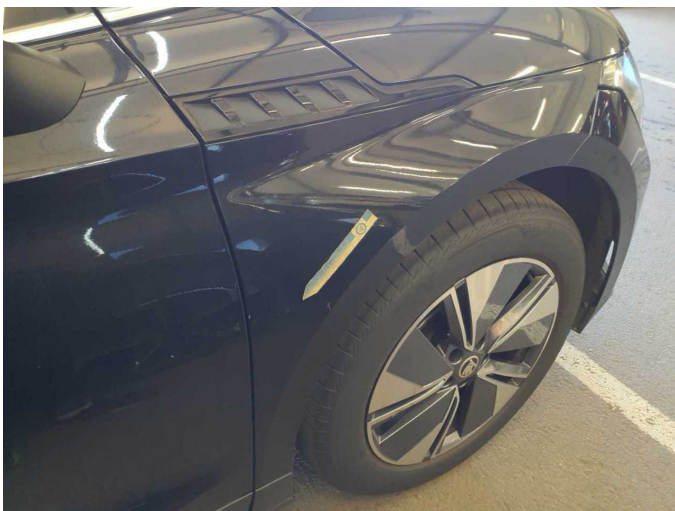
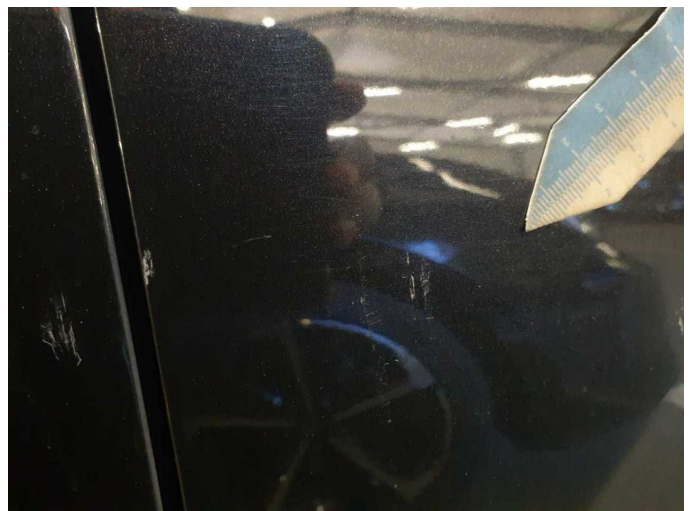
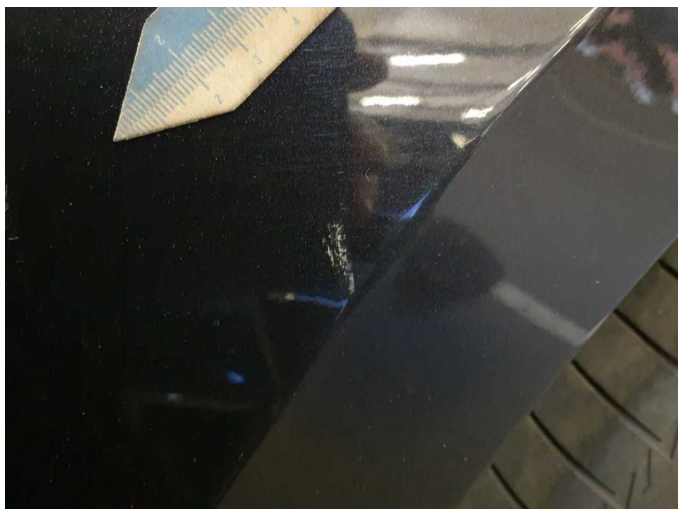
| No. | Component group | Description |
|---|---|---|
| 2 | Mudguard - right side | Mudguard - right side - Scratch(es) - Smart repair |

Damage 2: Mudguard - right side: Mudguard - right side - Scratch(es) - Smart repair

**Damage 2:** Mudguard - right side: Mudguard - right side - Scratch(es) - Smart repair

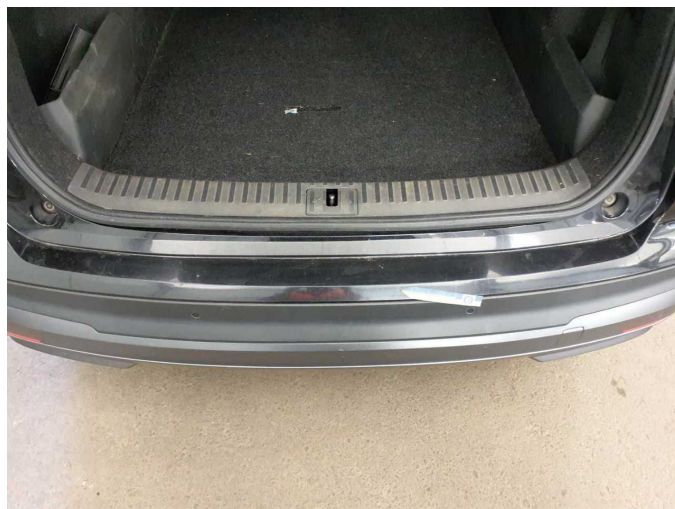
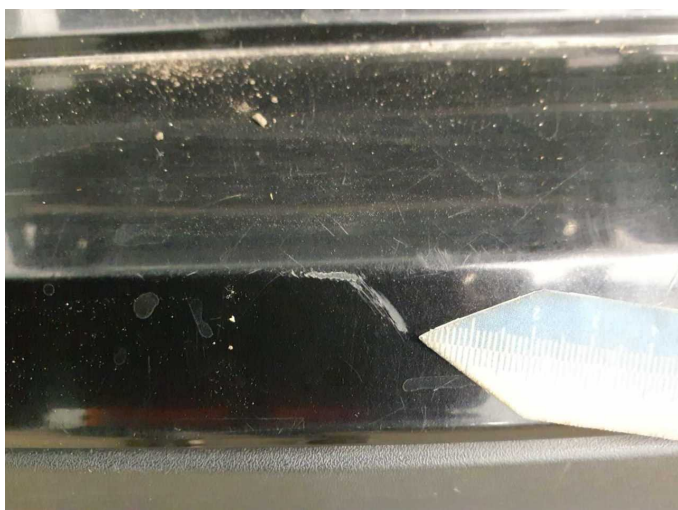
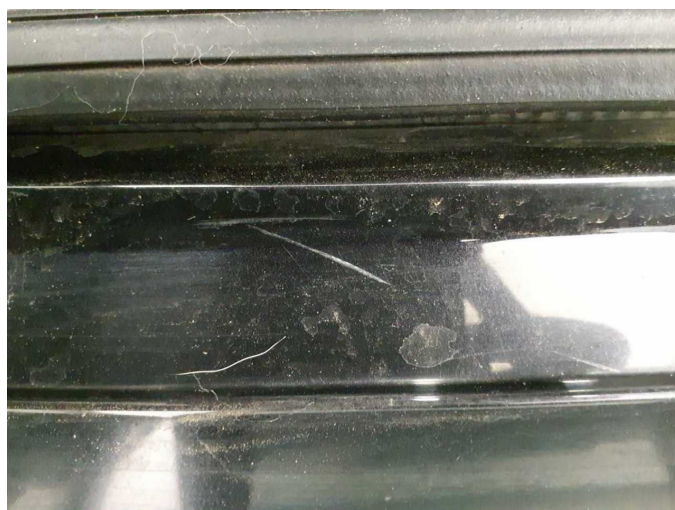
| No. | Component group | Description |
|---|---|---|
| 3 | Rear bumper | Rear bumper - Scratch(es) - Smart repair |

**Damage 3:** Rear bumper: Rear bumper - Scratch(es) - Smart repair

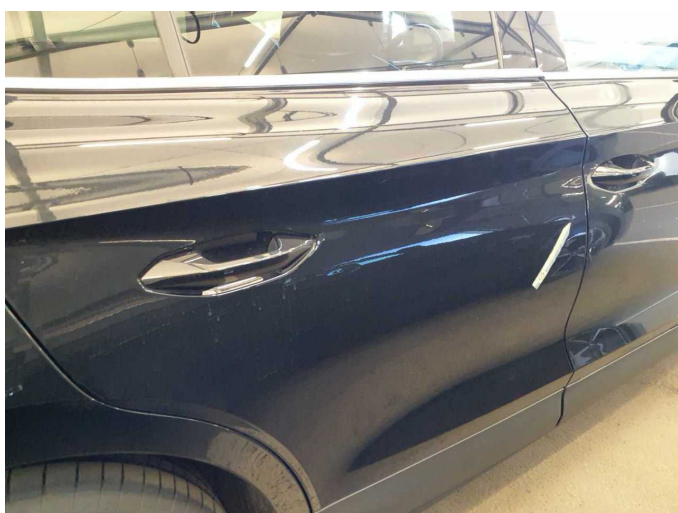
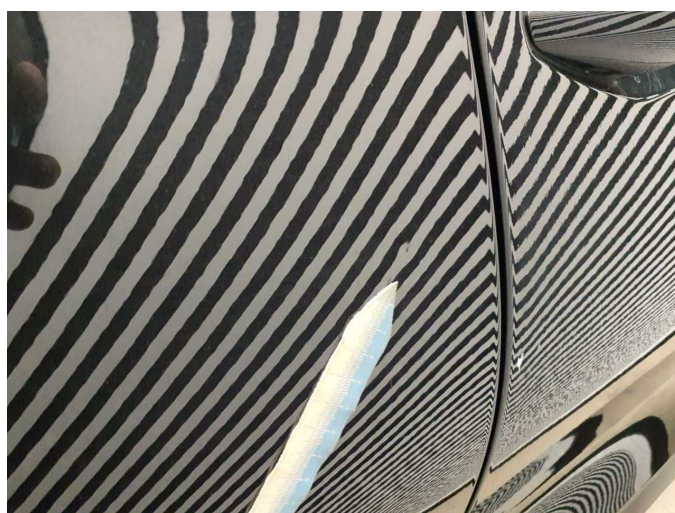
| No. | Component group | Description |
|---|---|---|
| 4 | Door - rear right side | Door - dent(s) - Smart repair |

**Damage 4:** Door - rear right side: Door - dent(s) - Smart repair

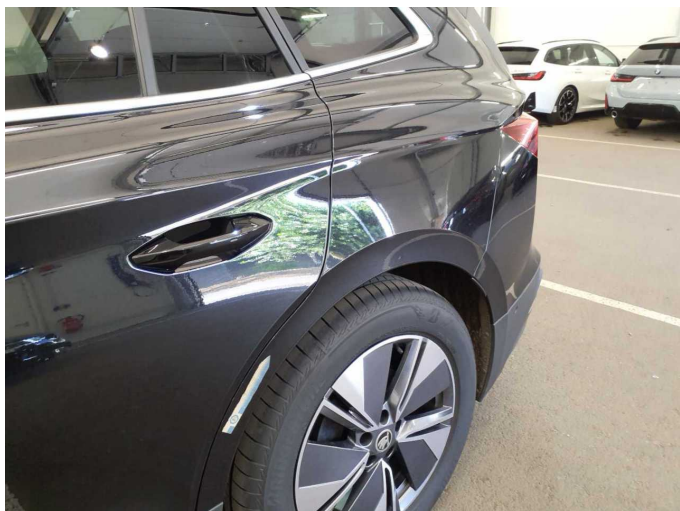
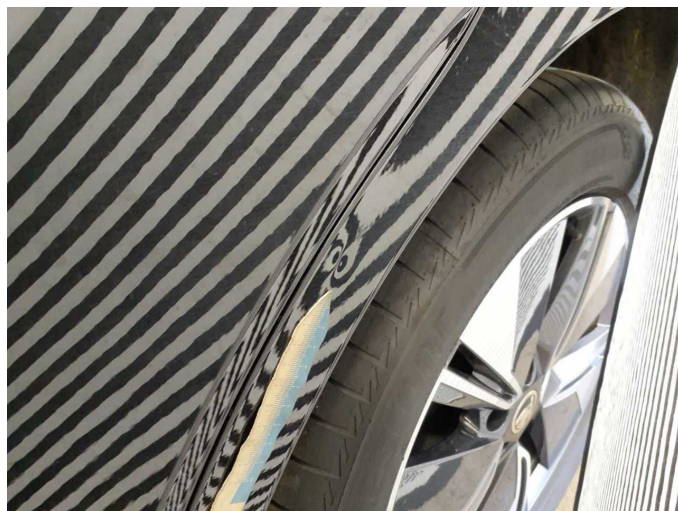
| No. | Component group | Description |
|---|---|---|
| 5 | Side panel - rear left side | Side panel - dent(s) - Smart repair |

**Damage 5:** Side panel - rear left side: Side panel - dent(s) - Smart repair

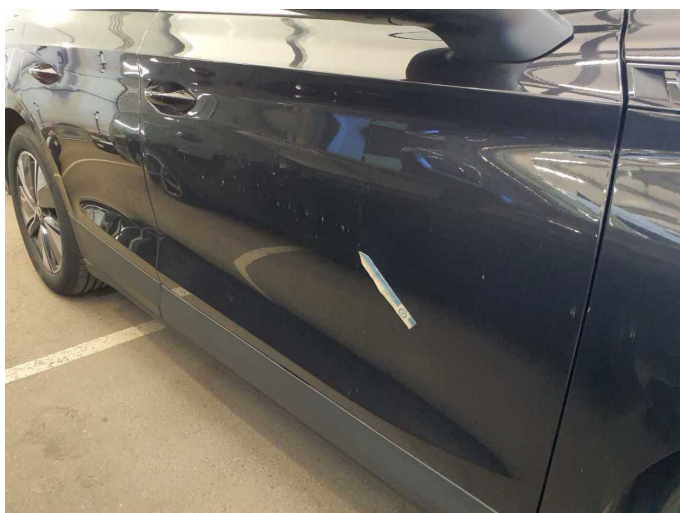
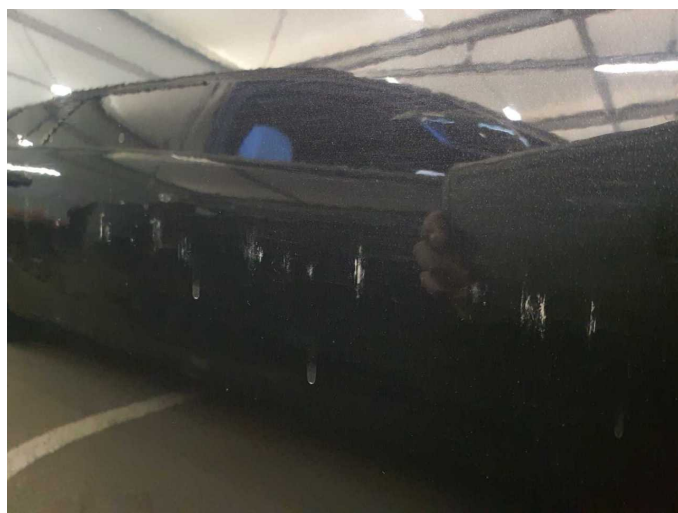
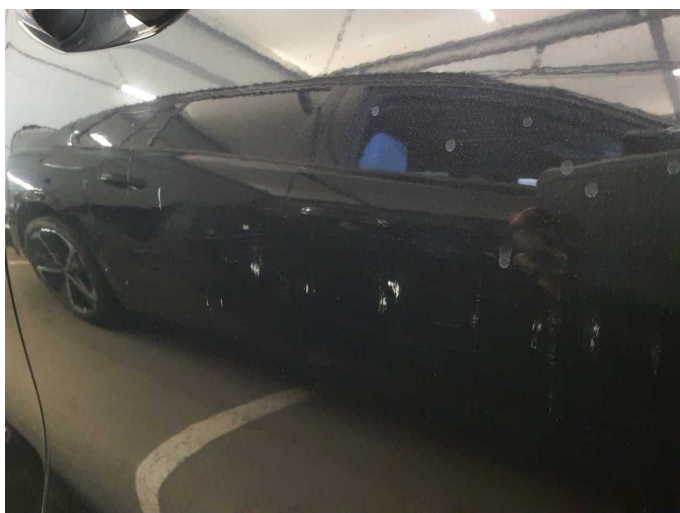
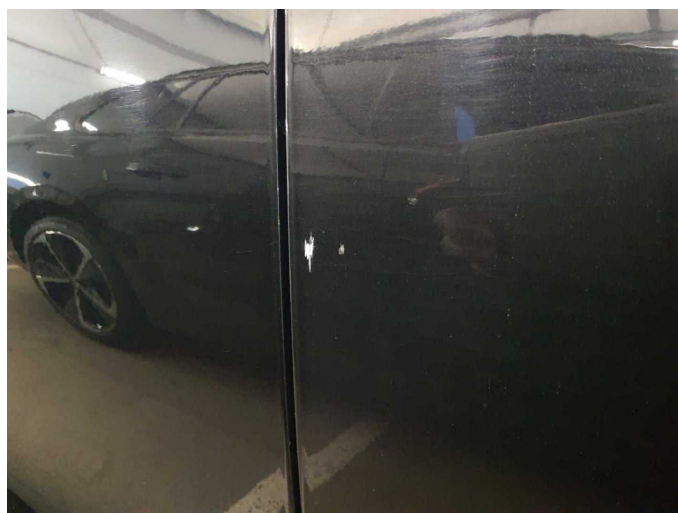
| No. | Component group | Description |
|---|---|---|
| 6 | Door - front right side | Door - Scratch(es) - Paint |

**Damage 6:** Door - front right side: Door - Scratch(es) - Paint

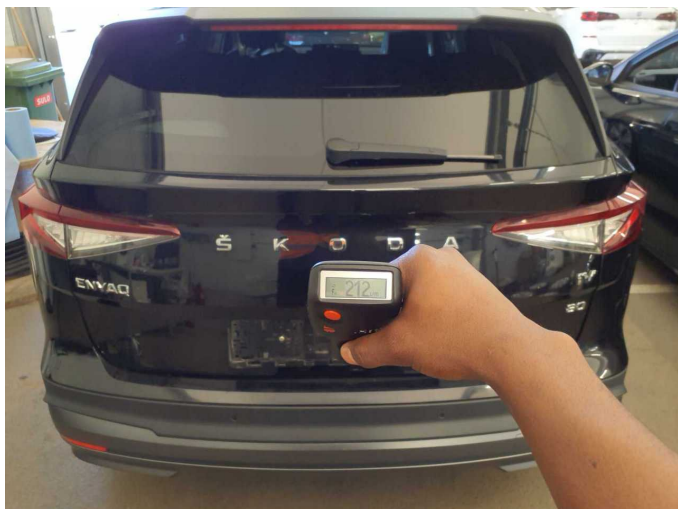
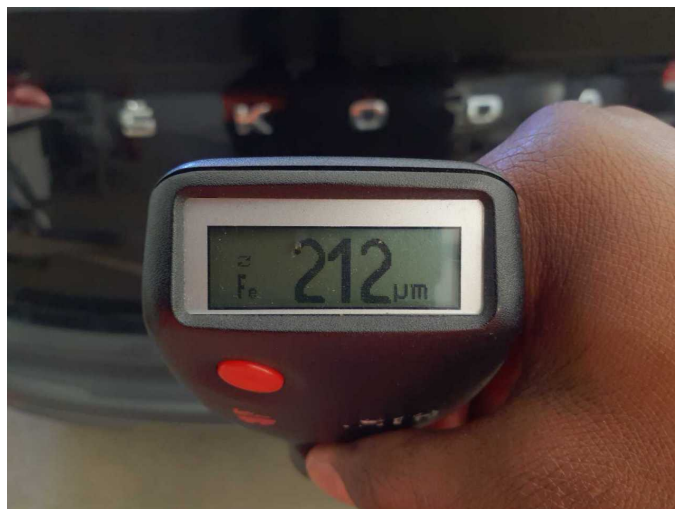
| No. | Repainting |
|---|---|
| 1 | Boot lid / rear door, Professionally carried out, Invoice of repair done Non-existent |

| Boot lid / rear door | 212 µm | Door - rear right side | 204 µm |

**Repainting 1:** Boot lid / rear door

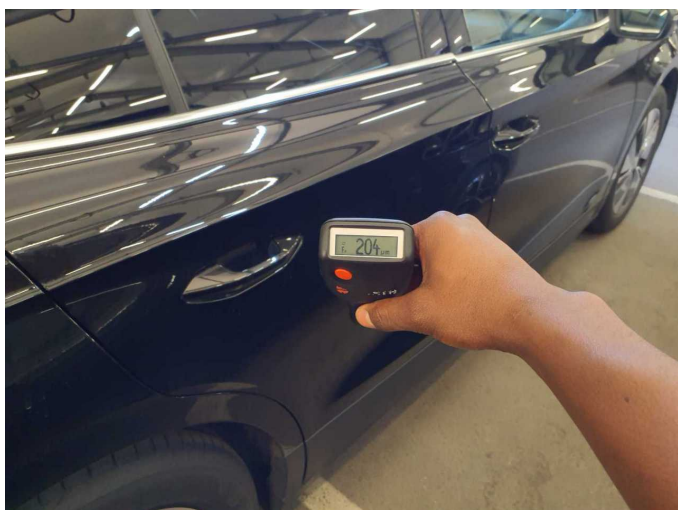
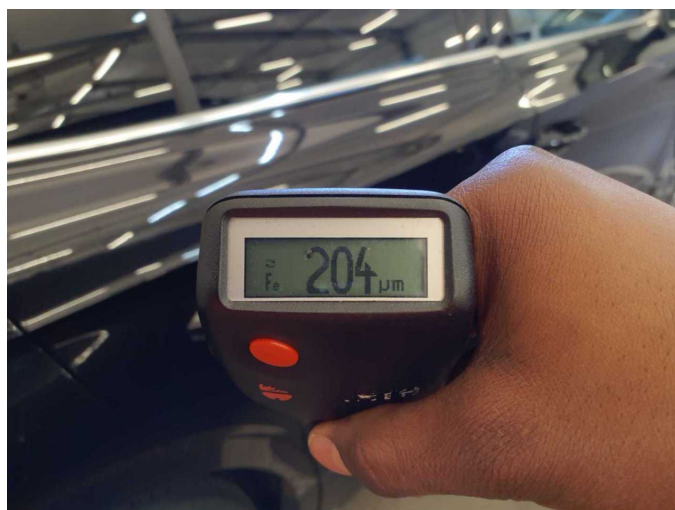
| No. | Repainting |
|---|---|
| 2 | Door - rear right side, Professionally carried out, Invoice of repair done Non-existent |

**Repainting 2:** Door - rear right side

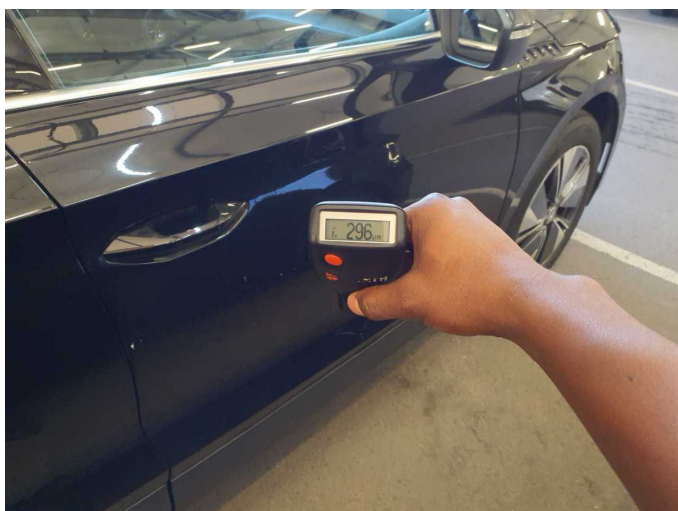
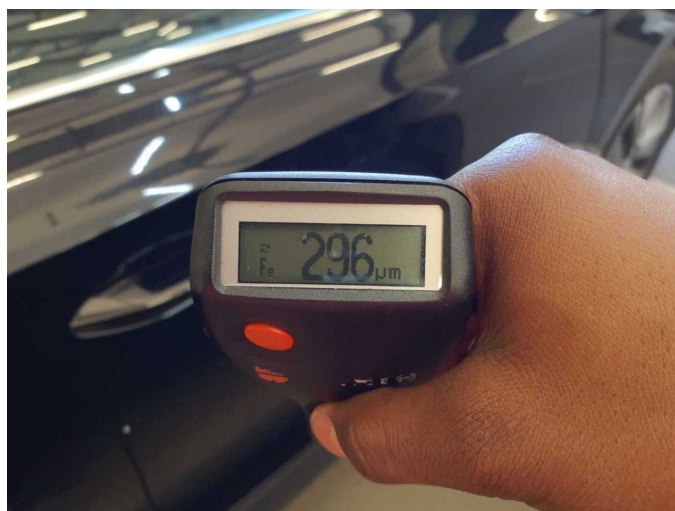
| No. | Repainting |
|---|---|
| 3 | Door - front right side, Professionally carried out, Invoice of repair done Non-existent |

| Door - front right side | 296 µm | | |

**Repainting 3:** Door - front right side
