Expertise

Protocol number: 46304476  
Order No. / Reference: 26527680-1  
Inspection date: 22 Jun 2026

Manufacturer: Ford  
VIN: WF0JXXWPCJNJ44487

Model: S-Max 2.0 EcoBlue TITANIUM

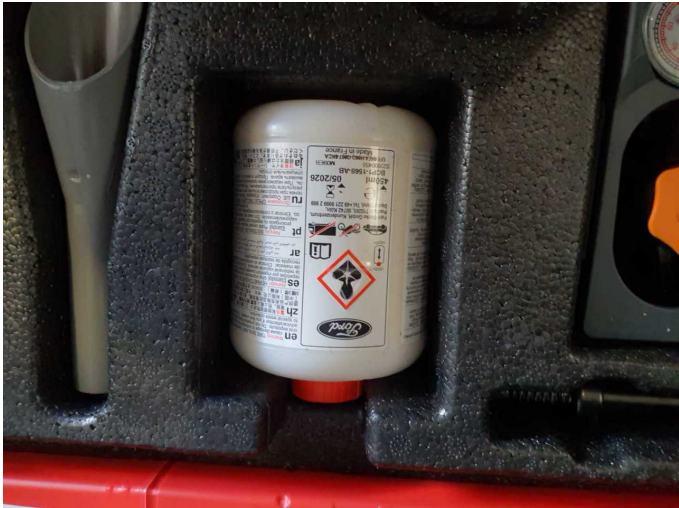
| No. | Component group | Description |
|---|---|---|
| 2 | Equipment | Tirefit filler - Expired - Replace |

Damage 2: Equipment: Tirefit filler - Expired - Replace

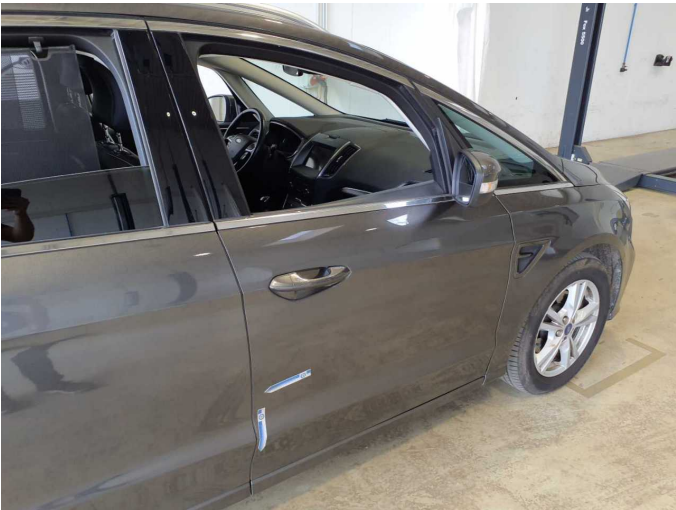
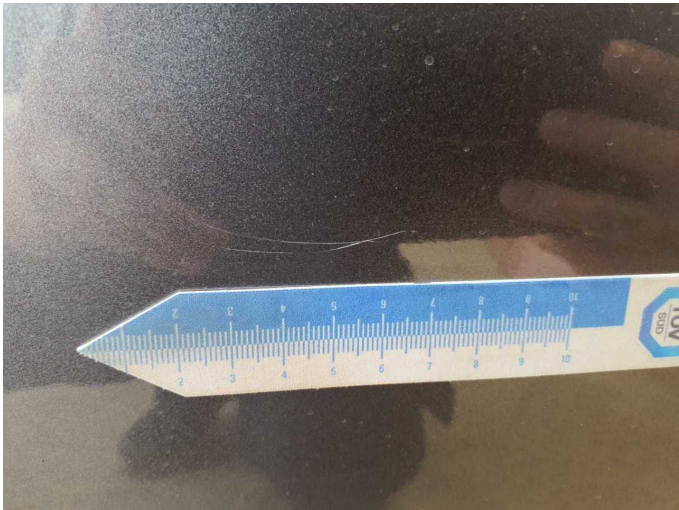
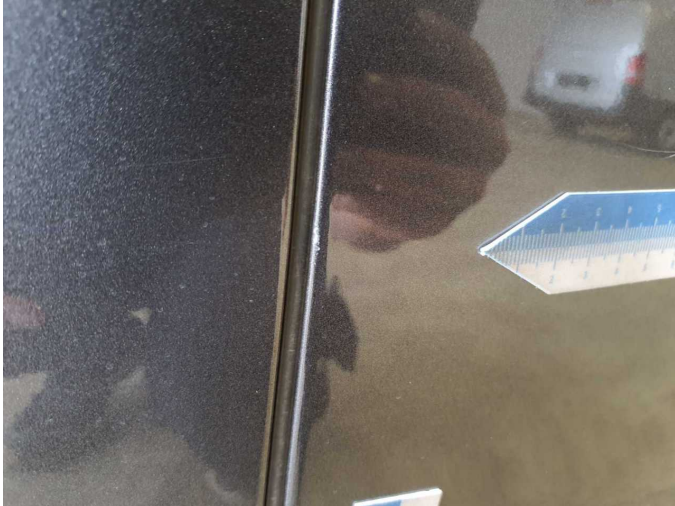
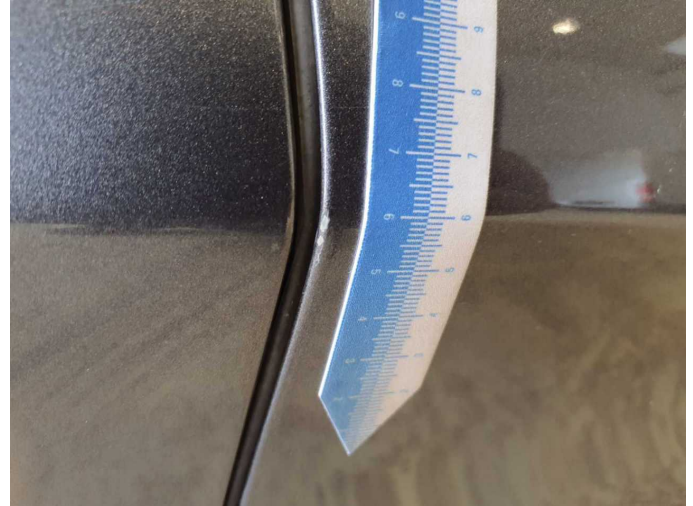
| No. | Component group | Description |
|---|---|---|
| 3 | Door - front right side | Door - Scratch(es) - Paint |

Damage 3: Door - front right side: Door - Scratch(es) - Paint

**Damage 3:** Door - front right side: Door - Scratch(es) - Paint

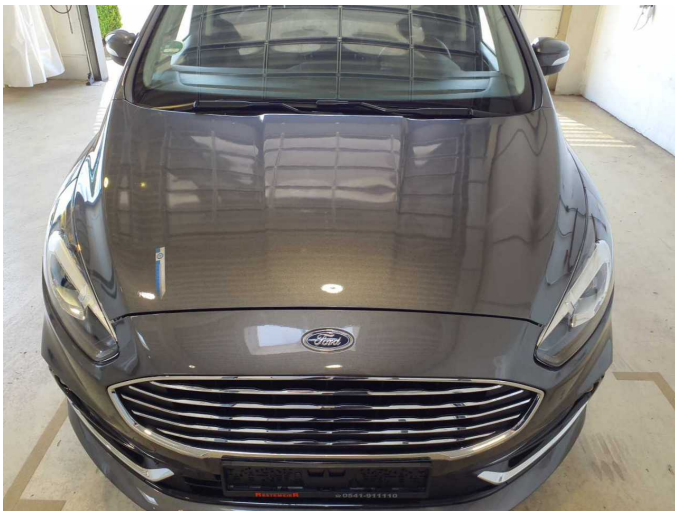
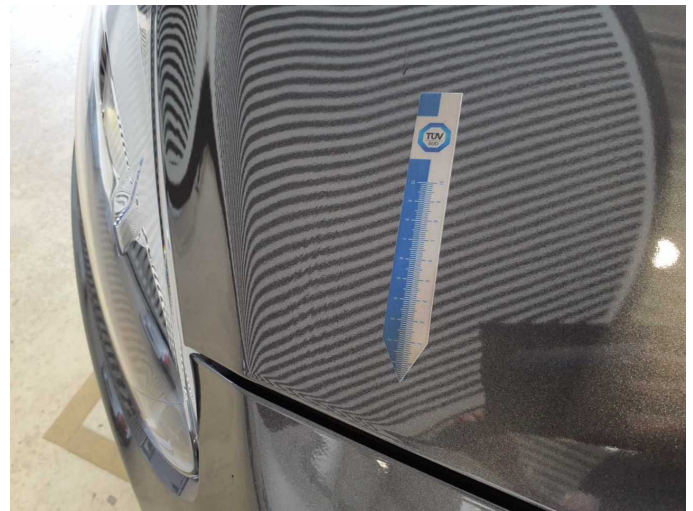
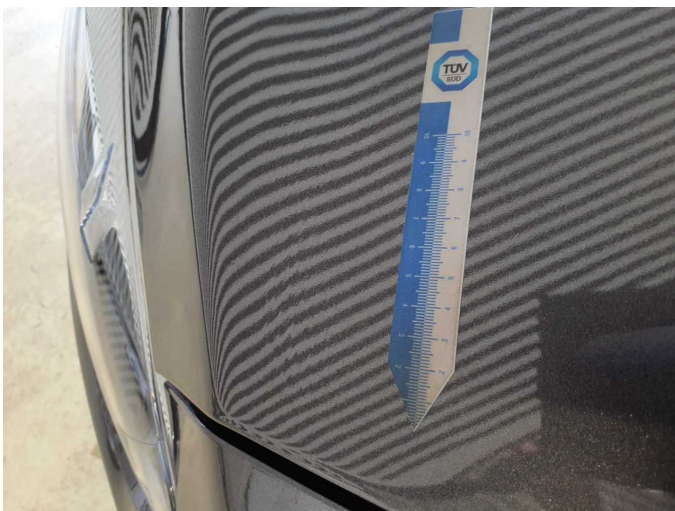
| No. | Component group | Description |
|---|---|---|
| 4 | Bonnet | Bonnet (Spachtelmasse eingefallen) - Unprofessionally repaired - Repair and paint |

| No. | Repainting |
|---|---|
| 2 | Bonnet, Unprofessionally carried out, Invoice of repair done Non-existent |

| Bonnet | 543 µm | | |

**Damage 4:** Bonnet: Bonnet (Spachtelmasse eingefallen) - Unprofessionally repaired - Repair and paint

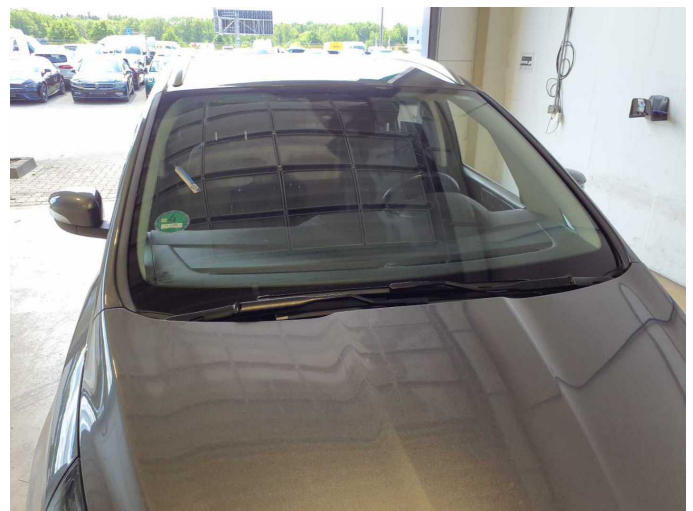
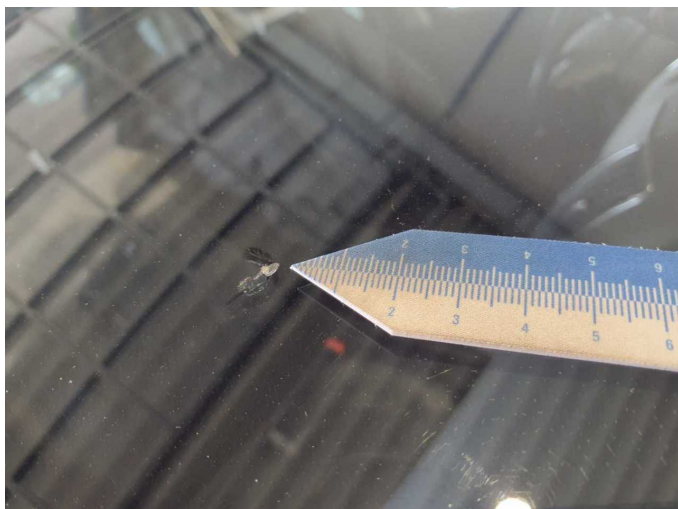
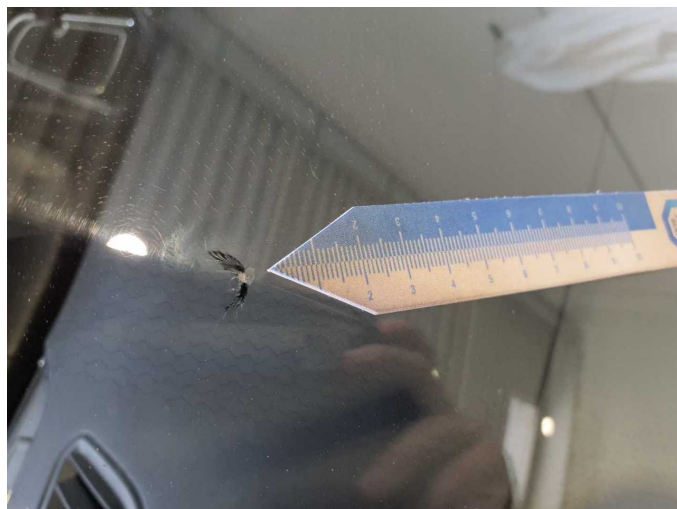
| No. | Component group | Description |
|---|---|---|
| 5 | Vehicle glazing | Windscreen - Broken / torn - Replace |

**Damage 5:** Vehicle glazing: Windscreen - Broken / torn - Replace

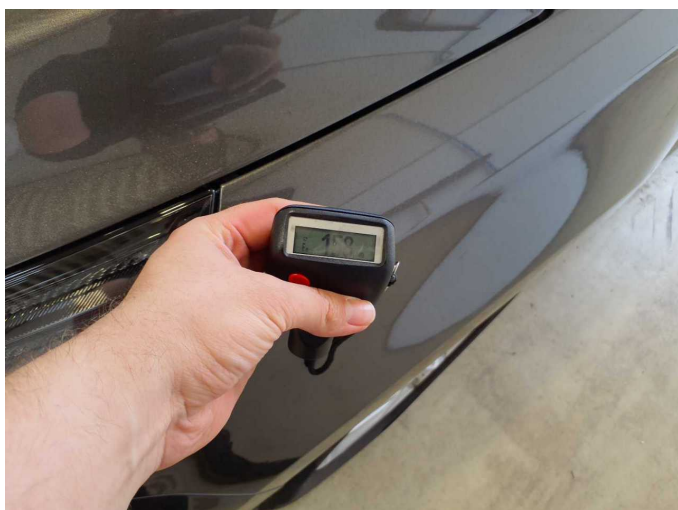
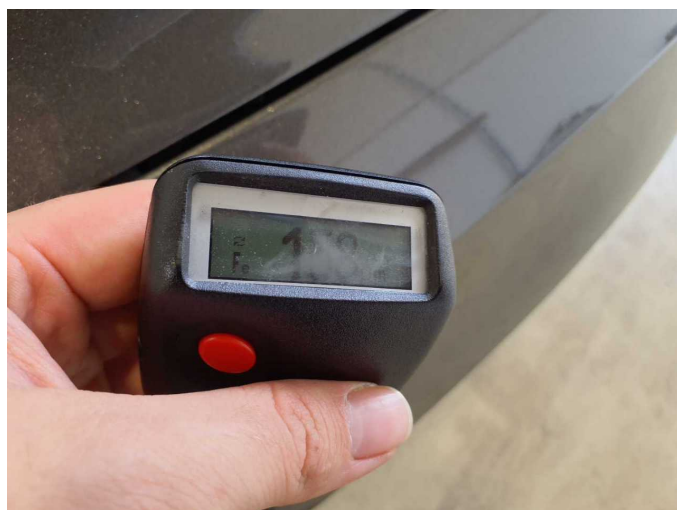
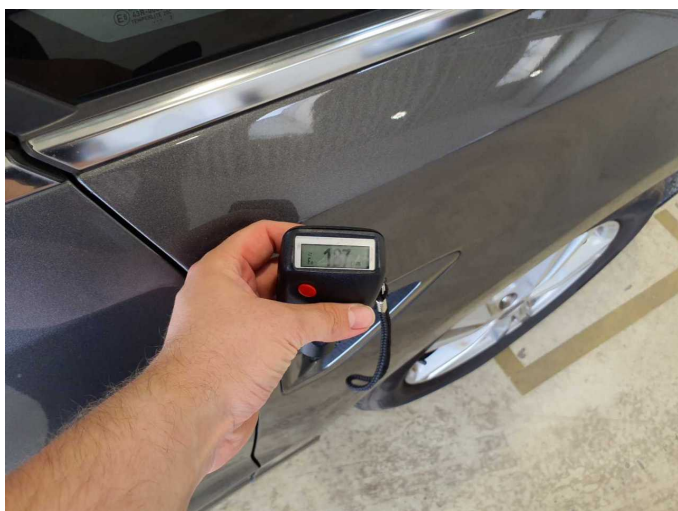
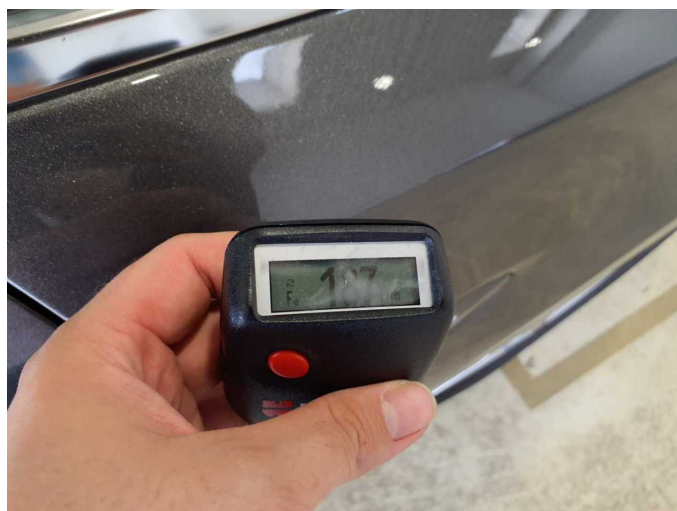
| No. | Repainting |
|---|---|
| 1 | Mudguard - left side, Mudguard - right side, Professionally carried out, Invoice of repair done Non-existent |

| Mudguard - left side | 158 µm | Mudguard - right side | 187 µm |

**Repainting 1:** Mudguard - left side, Mudguard - right side

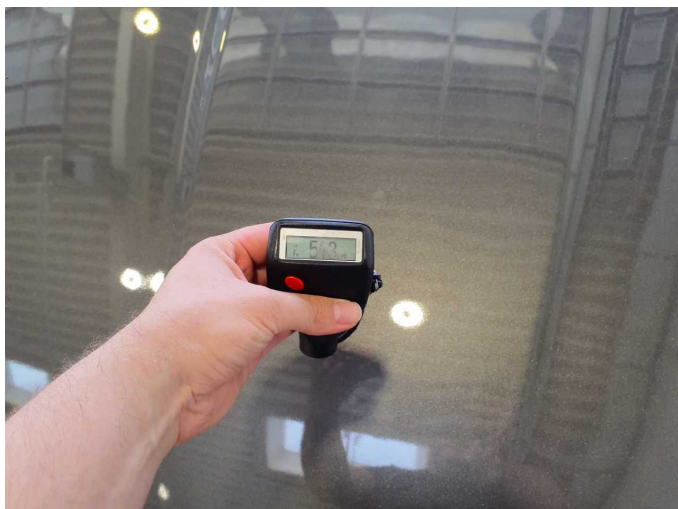
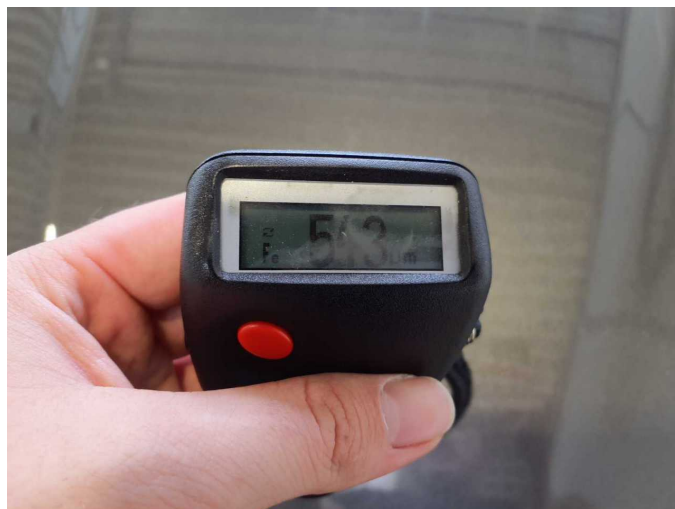
**Repainting 2:** Bonnet
