Expertise

Protocol number: 46373695  
Order No. / Reference: 26504852  
Inspection date: 7 Jul 2026

Manufacturer: Volkswagen

Model: Golf Variant 2.0 TDI SCR DSG Style

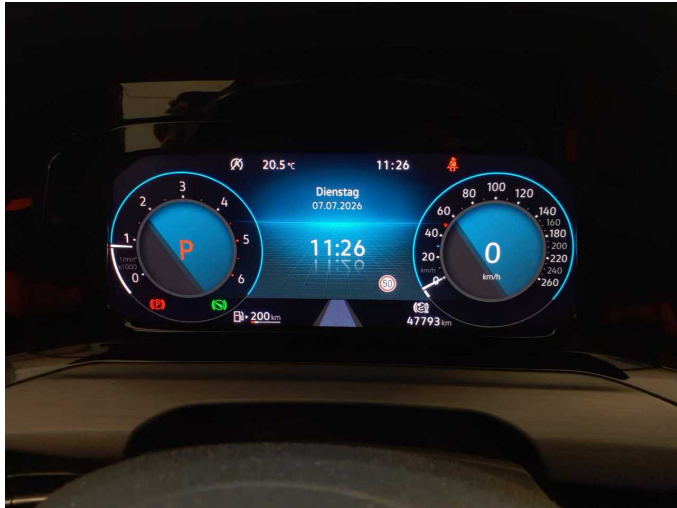
| Vehicle details | |
|---|---|
| Mileage (Read) | 47,793 km |

Figure 7: Instrument cluster

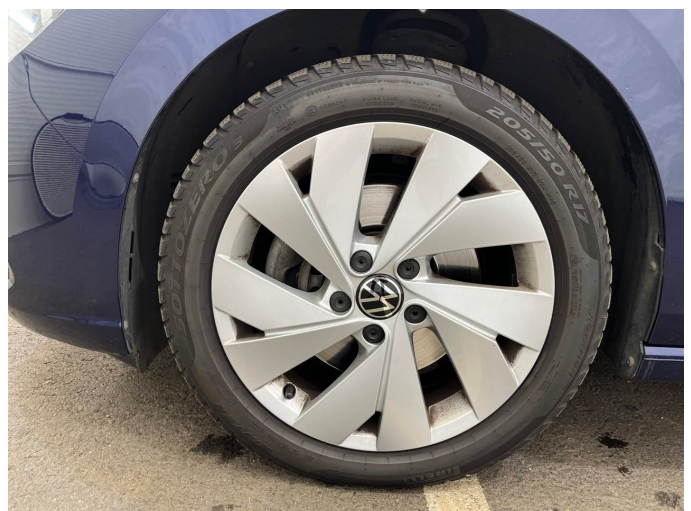
| Tyres | | | | |
|---|---|---|---|---|
| 1) | 205/50 R17 93H | Winter tyres on Light alloy | Pirelli | 4mm / 4mm |
| 2) | 205/50 R17 93H | Winter tyres on Light alloy | Pirelli | 6mm / 6mm |

Figure 12: Mounted tyres

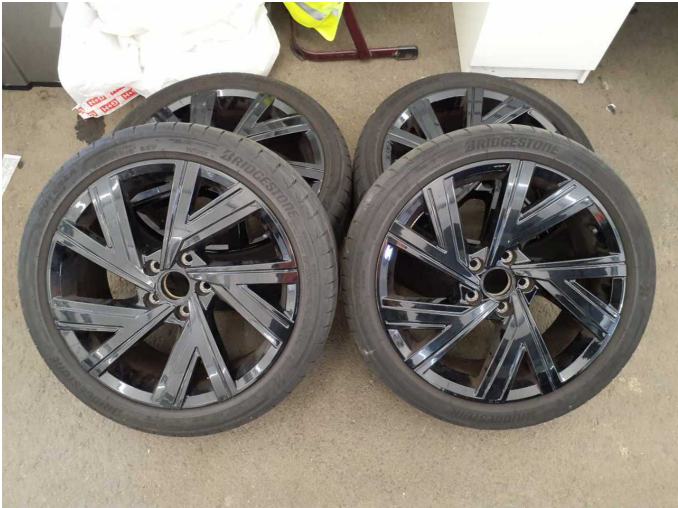
| Tyres | | | | |
|---|---|---|---|---|
| 1) | 225/40 R18 92Y | Summer tyres on Light alloy | Bridgestone | 4mm / 4mm |
| 2) | 225/40 R18 92Y | Summer tyres on Light alloy | Bridgestone | 5mm / 5mm |

Figure 16: Additional tyres

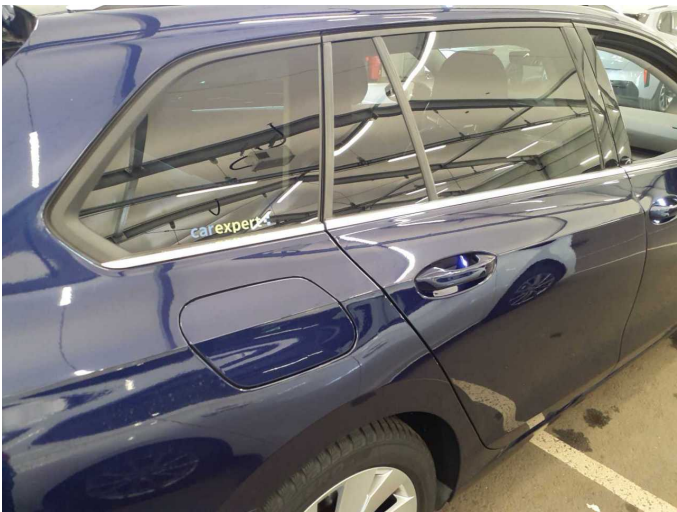
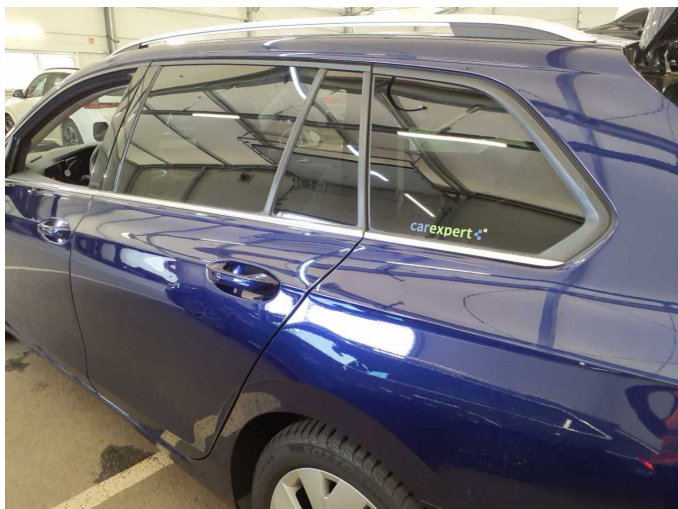
| No. | Component group | Description |
|---|---|---|
| 1 | Body | Body - Glued / labelled - De-glue / neutralise |

Damage 1: Body: Body - Glued / labelled - De-glue / neutralise

**Damage 1:** Body: Body - Glued / labelled - De-glue / neutralise

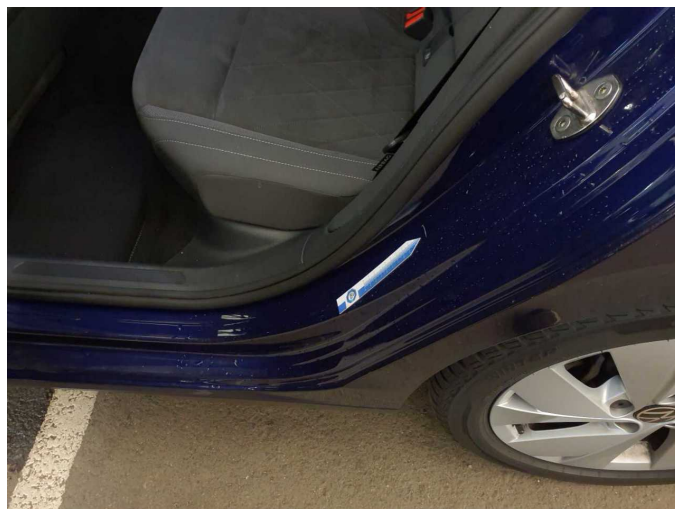
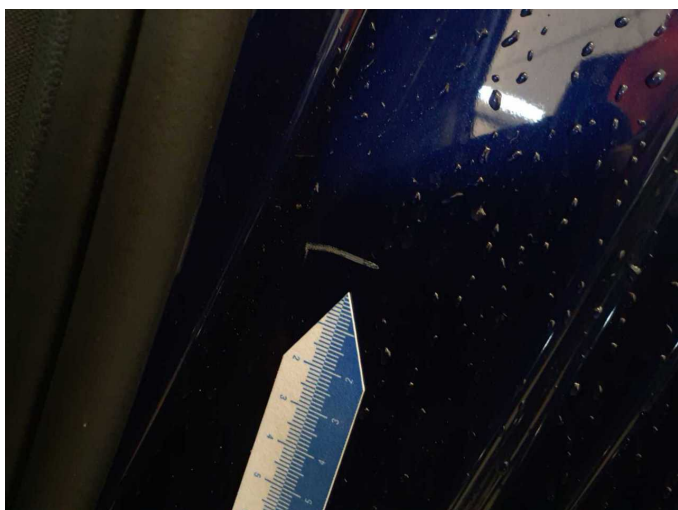
| No. | Component group | Description |
|---|---|---|
| 2 | Side panel - rear left side | Sill - Scratch(es) - Smart repair |

**Damage 2:** Side panel - rear left side: Sill - Scratch(es) - Smart repair

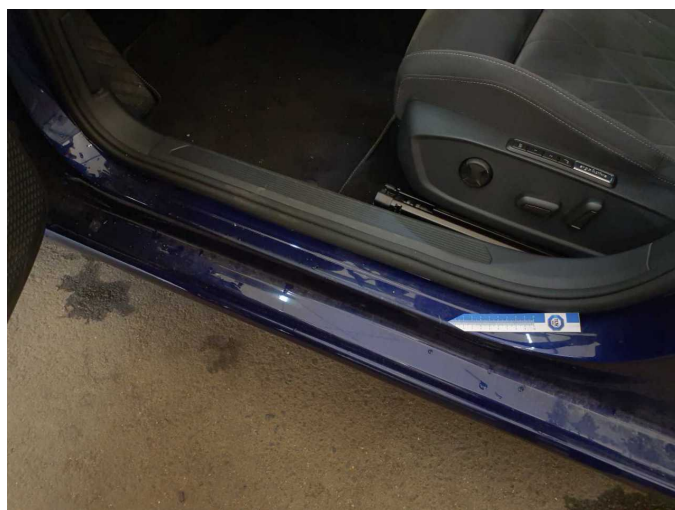
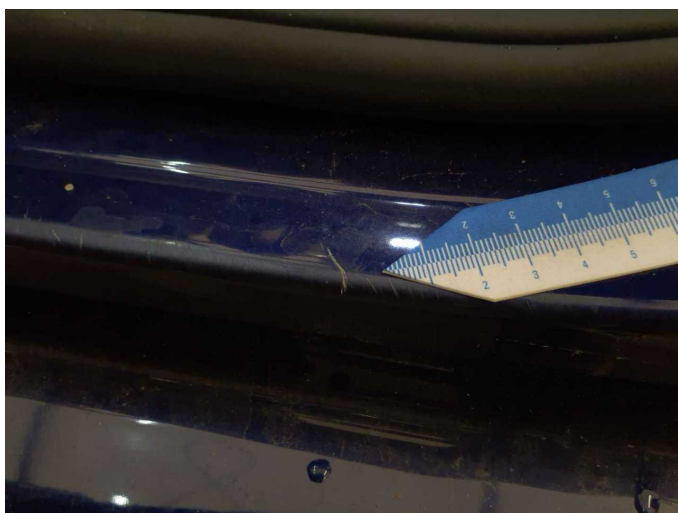
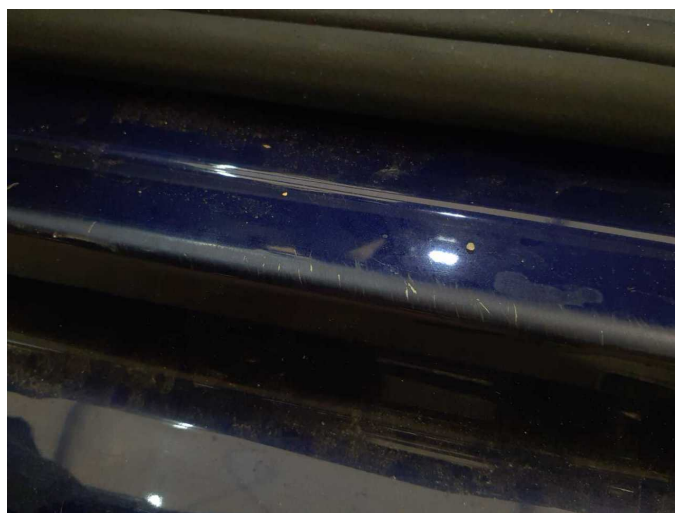
| No. | Component group | Description |
|---|---|---|
| 3 | Sill - left side | Sill - Scratch(es) - Smart repair |

**Damage 3:** Sill - left side: Sill - Scratch(es) - Smart repair

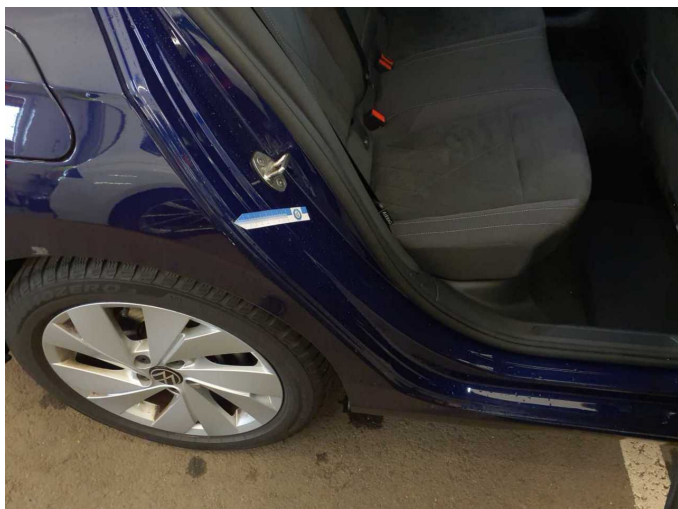
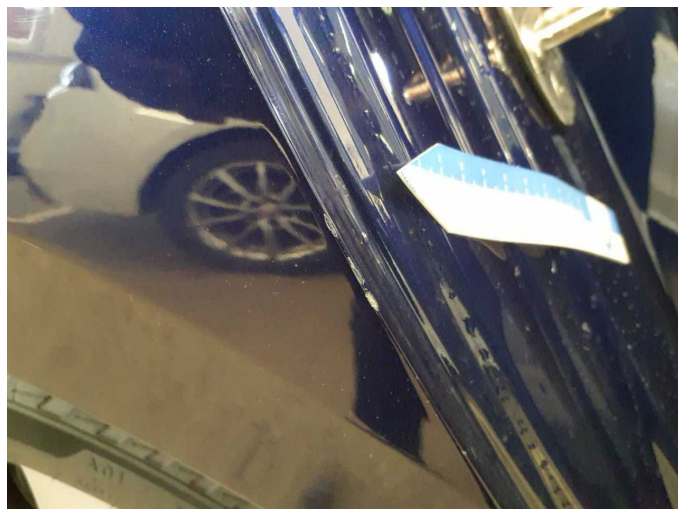
| No. | Component group | Description |
|---|---|---|
| 4 | Side panel - rear right side | Sill - Scratch(es) - Smart repair |

**Damage 4:** Side panel - rear right side: Sill - Scratch(es) - Smart repair

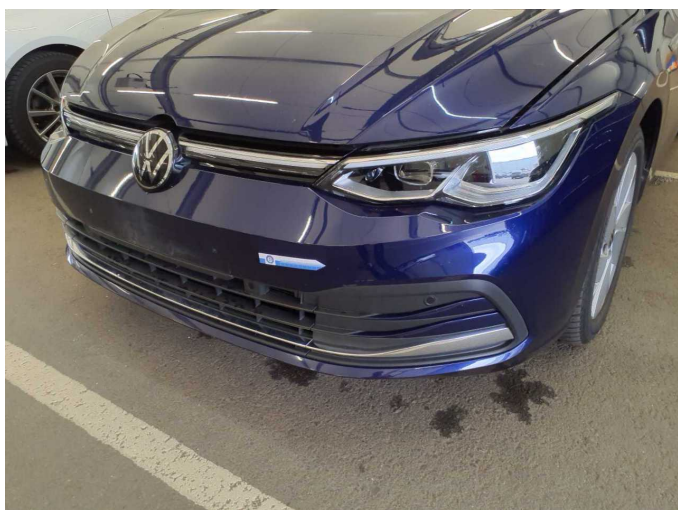
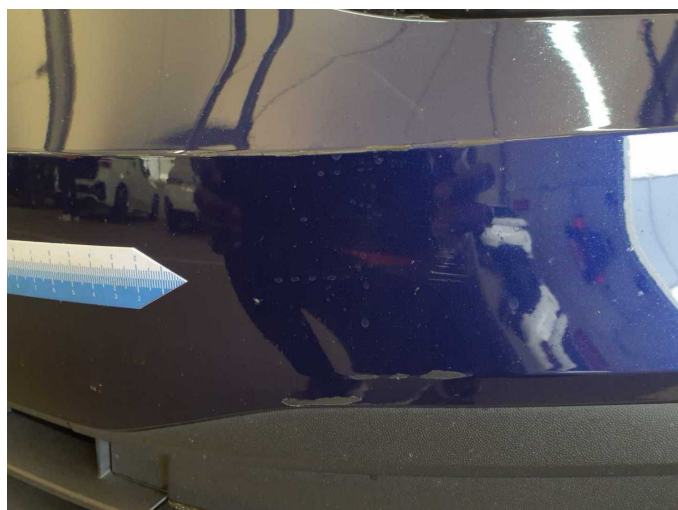
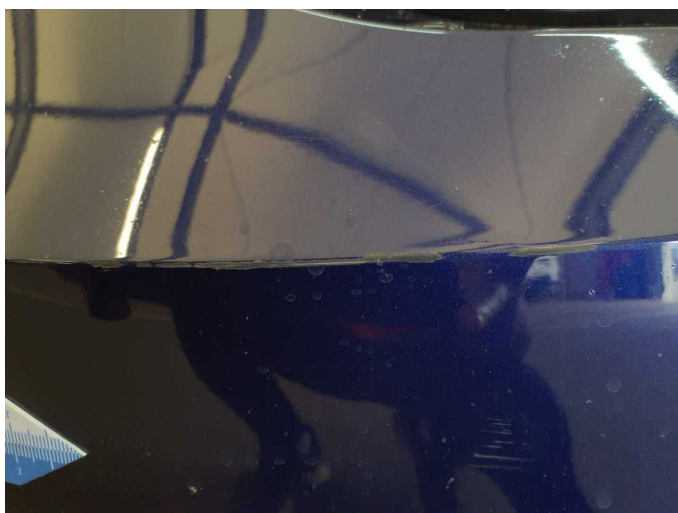
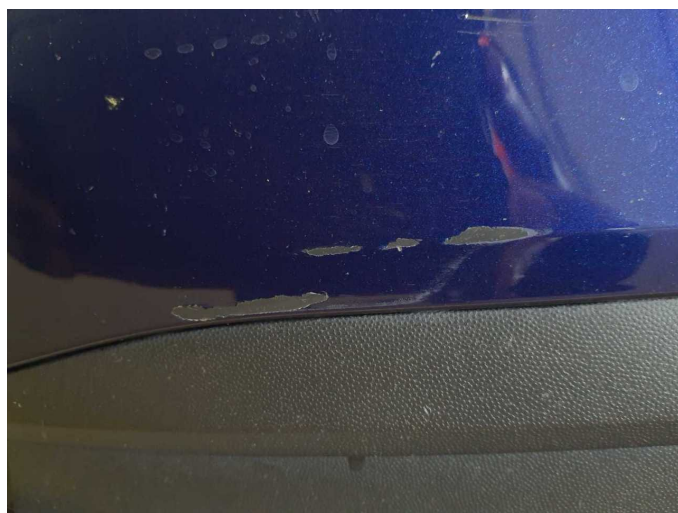
| No. | Component group | Description |
|---|---|---|
| 5 | Front bumper | Front bumper - Scratch(es) - Paint |

**Damage 5:** Front bumper: Front bumper - Scratch(es) - Paint

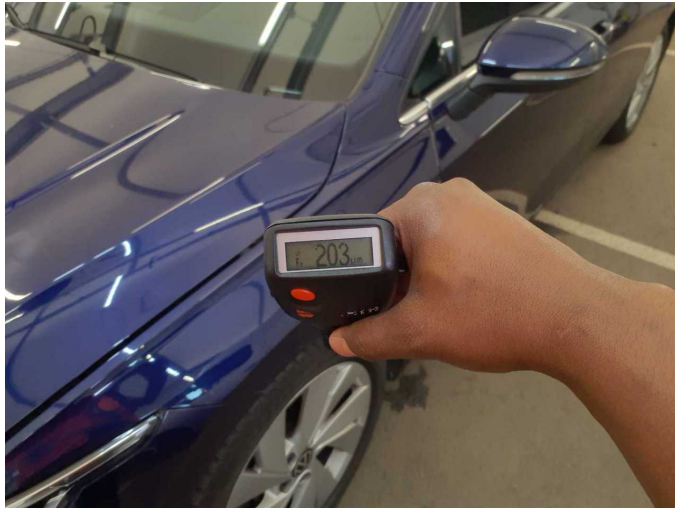
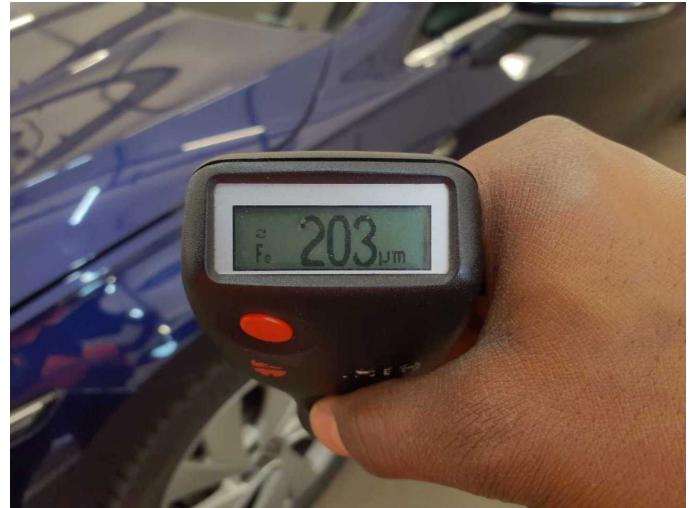
| Mudguard - left side | 203 µm | Mudguard - right side | 213 µm |

**Repainting 1:** Mudguard - left side

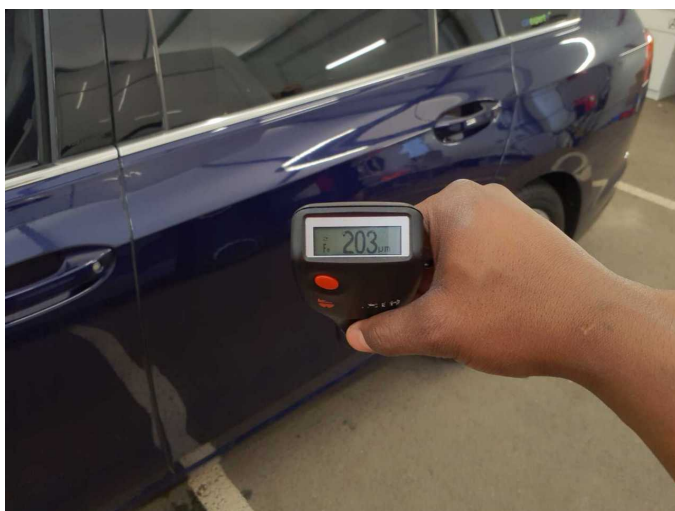
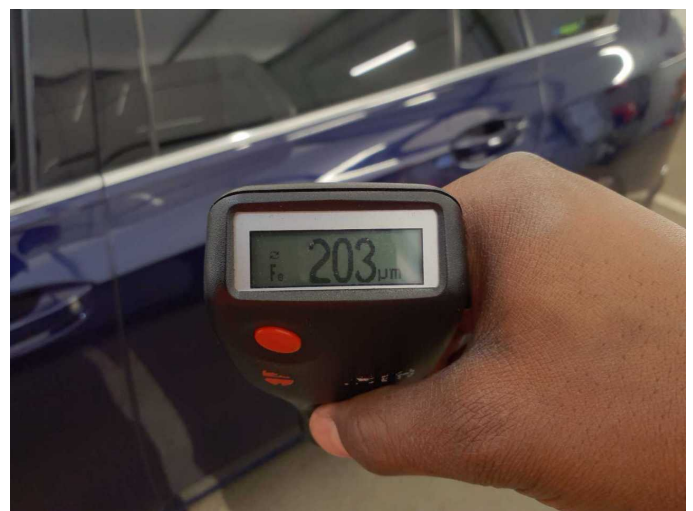
| Door - rear left side | 203 µm | Door - rear right side | 216 µm |

**Repainting 3:** Door - rear left side

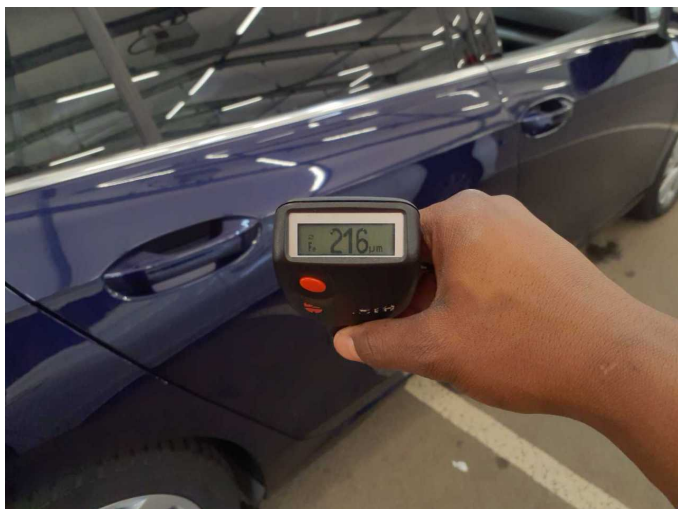
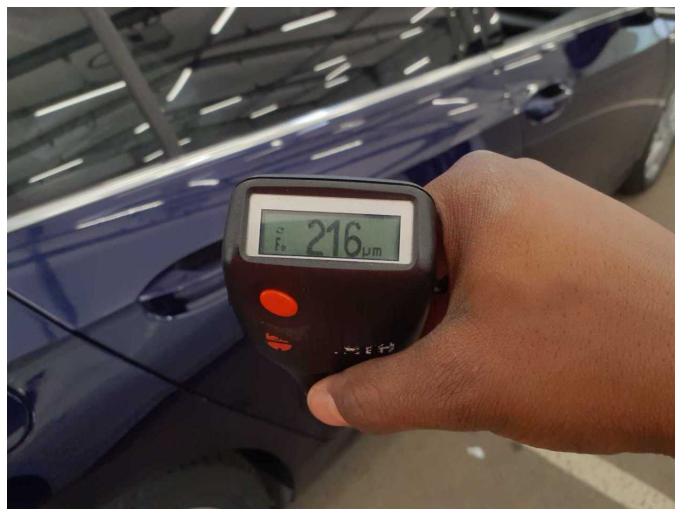
**Repainting 4:** Door - rear right side

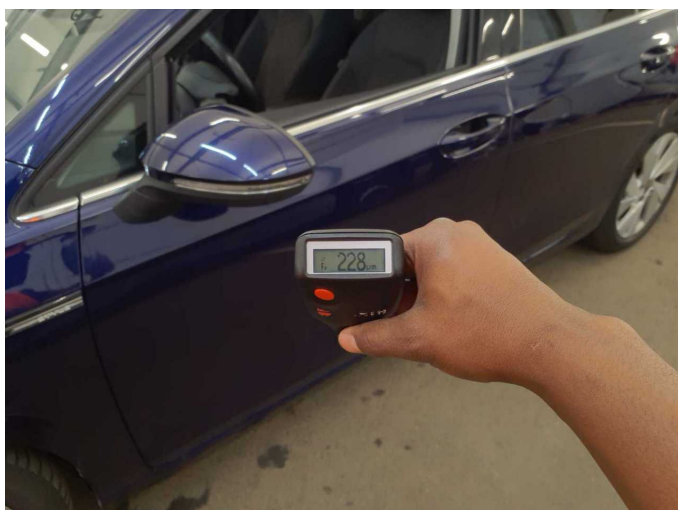
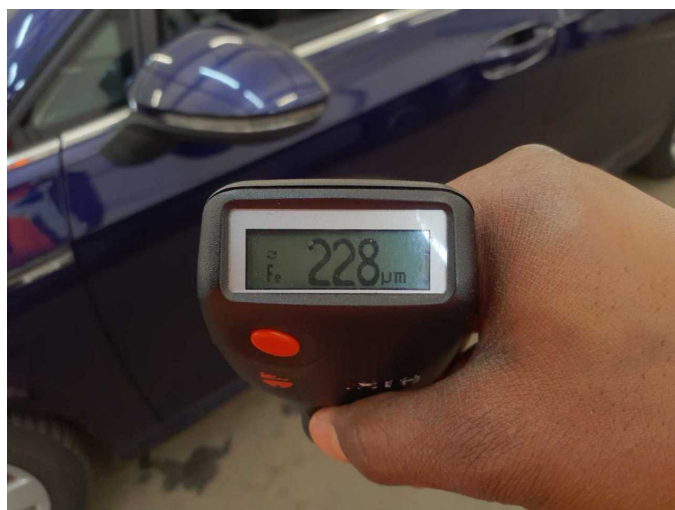
| Door - front left side | 228 µm | Door - front right side | 212 µm |

**Repainting 5:** Door - front left side

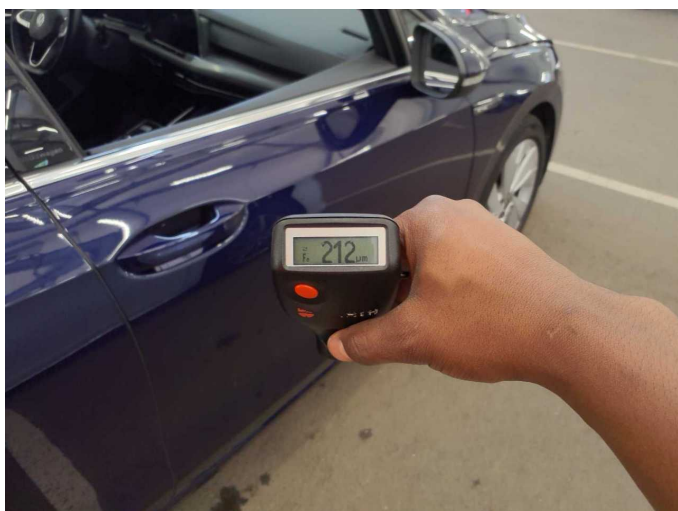
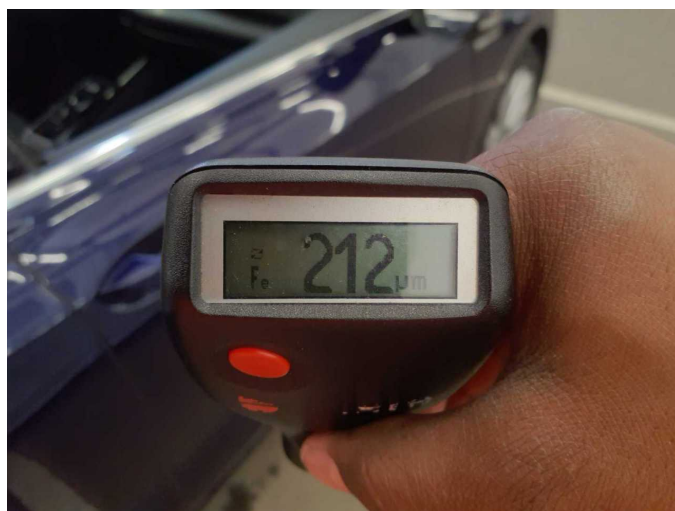
**Repainting 6:** Door - front right side
